**[Docket No. FAA-2009-1253; Directorate Identifier 2009-NM-080-AD; Amendment 39-16629; AD 2011-06-05]**

### **Airworthiness Directives; The Boeing Company Model 737-600, -700, -700C, -800, -900, and -900ER Series Airplanes**

**ACTION:** Final rule.

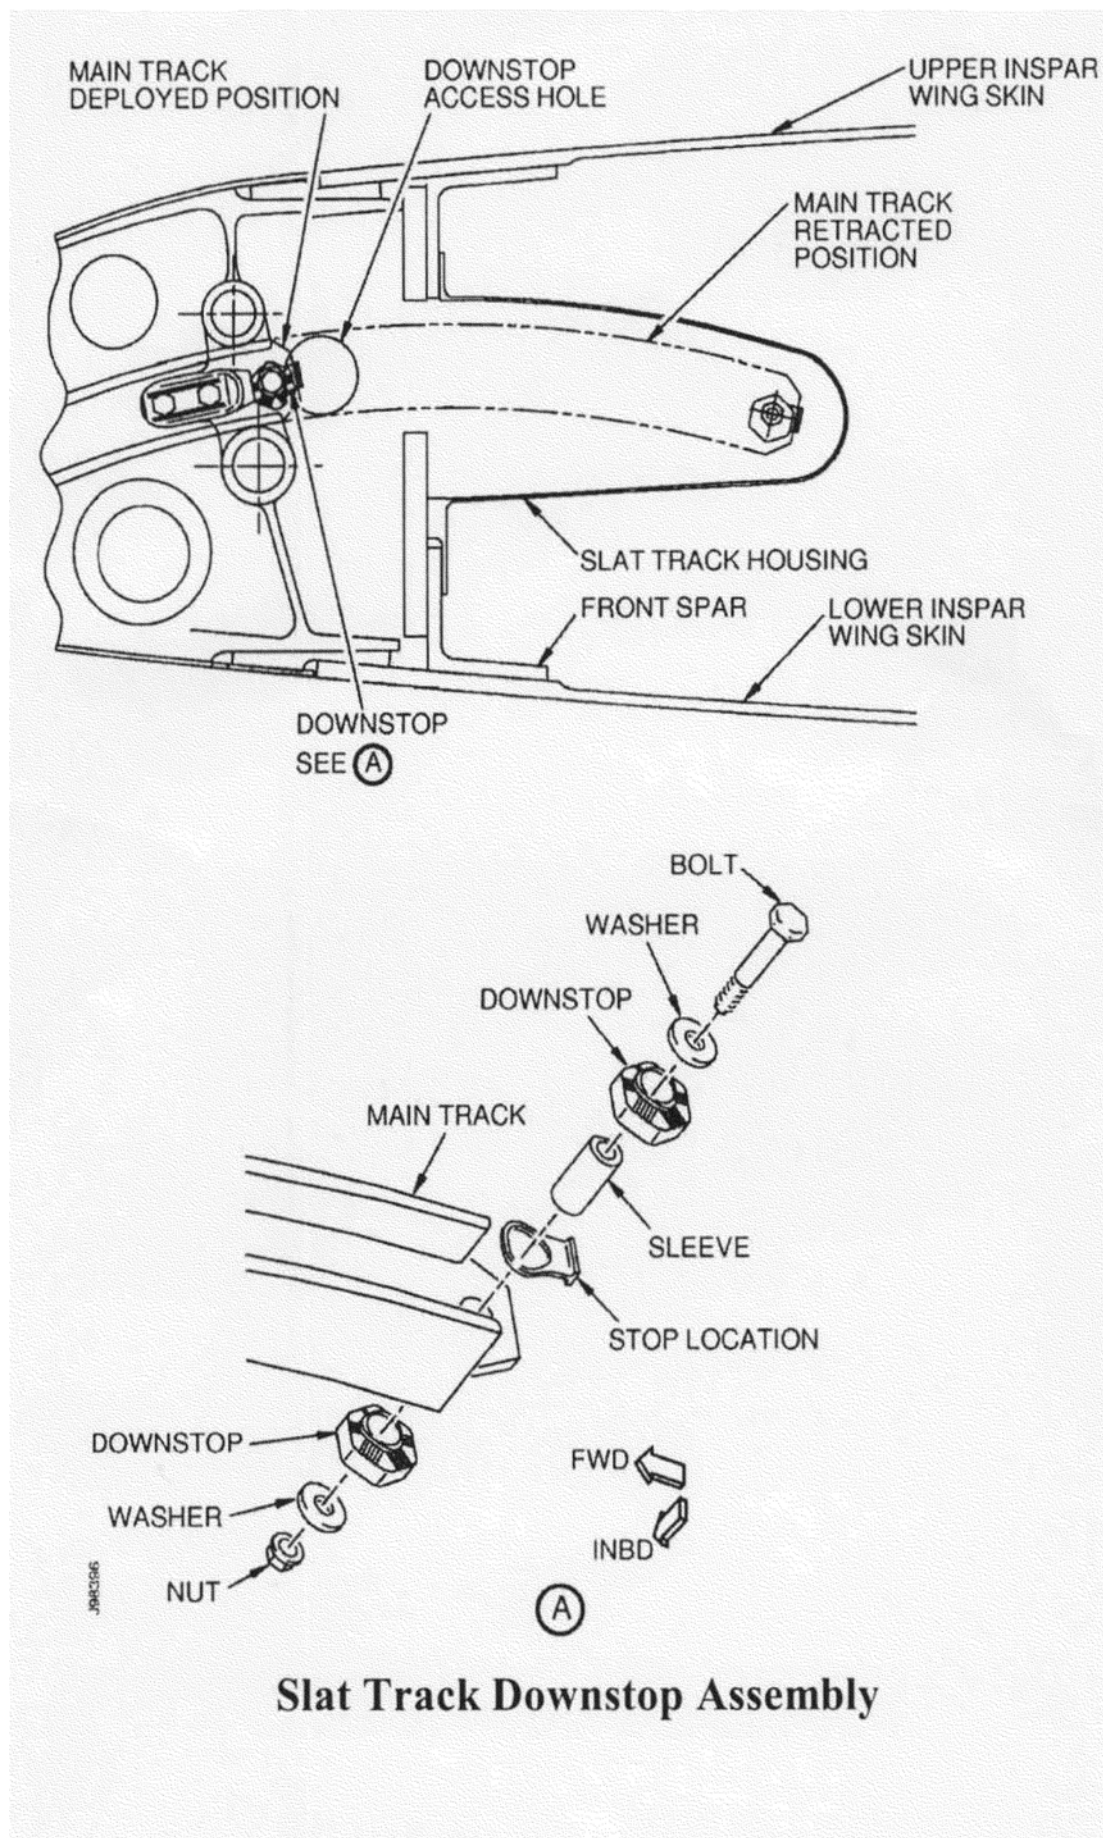
**Figure 1**

- (e) This AD results from reports of parts coming off the main slat track downstop assemblies. The Federal Aviation Administration is issuing this AD to prevent loose or missing parts from the main slat track downstop assemblies from falling into the slat can and causing a puncture, which could result in a fuel leak and consequent fire.

proper installation of the slat track hardware (i.e., the bolt, washers, downstops, stop location, and nut shown in Figure 1 of Boeing Service Letter 737-SL-57-084-B, dated July 10, 2007, and in this AD). Proper installation of the sleeve need not be confirmed, and the stop location part may be installed on either the inboard or the outboard side of the slat track. If any part is missing or is installed improperly, before further flight, install a new or serviceable part using a method approved in accordance with the procedures specified in paragraph (j) of this AD; and do a detailed inspection of the inside of the slat can for foreign object debris (FOD) and damage. Before further flight, remove any FOD found and repair any damage found using a method approved in accordance with the procedures specified in paragraph (j) of this AD. Verify proper installation; install a new or serviceable part; and inspect for damage and FOD, and remove FOD and repair damage; in accordance with a method by approved by the Manager, Seattle Aircraft Certification Office, FAA; or in accordance with Boeing Multi Operator Message Number 1-523812011-1, issued August 25, 2007, or 1-527463441-1, issued August 28, 2007. Repeat the actions required by paragraph (g) of this AD thereafter at intervals not to exceed 3,000 flight cycles.

(h) Within 24 days after receipt of emergency AD 2007-18-51: Apply a torque between 50 to 80 inch-pounds to the nut. The bolt head must be held with the torque applied to the nut.

(i) Within 36 months after the effective date of this AD: Replace the hardware of the down stop assembly with new hardware, do a detailed inspection or a borescope inspection of the slat cans on each wing and the lower rail of the slat main tracks for debris, and replace the bolts of the aft side guide with new bolts, in accordance with Part 2 of the Accomplishment Instructions of Boeing Alert Service Bulletin 737-57A1302, dated December 15, 2008; or Boeing Service Bulletin 737-57A1302, Revision 1, dated October 18, 2010; except, where Boeing Alert Service Bulletin 737-57A1302, dated December 15, 2008, and Boeing Service Bulletin 737-57A1302, Revision 1, dated October 18, 2010, specify to replace the slat main track or to contact Boeing for further repair instructions if the hole diameter is greater than 0.5005 inch, before further flight, replace the slat main track in accordance with Boeing Alert Service Bulletin 737-57A1302, dated December 15, 2008, Boeing Service Bulletin 737-57A1302, Revision 1, dated October 18, 2010, or repair using a method approved in accordance with the procedures specified in paragraph (j) of this AD. If debris is found during any inspection required by this AD, before further flight, remove the debris in accordance with the Accomplishment Instructions of Boeing Alert Service Bulletin 737-57A1302, dated December 15, 2008; or Boeing Service Bulletin 737-57A1302, Revision 1, dated October 18, 2010. Doing the actions required by paragraph (i) of this AD terminates the actions required by paragraphs (g) and (h) of this AD. Installation of stainless steel lockwire having part number (P/N) MS20995C32 is acceptable for compliance in lieu of lockwire P/N MS20995NC32, as specified in Boeing Alert Service Bulletin 737-57A1302, dated December 15, 2008, for this AD.
