## AIRCRAFT ACCIDENT REPORT

ATLANTIC SOUTHEAST AIRLINES, INC., FLIGHT 2311  
UNCONTROLLED COLLISION WITH TERRAIN  
AN EMBRAER EMB-120, **N270AS**  
BRUNSWICK, GEORGIA  
APRIL 5, 1991

**Adopted: April 28, 1992  
Notation 5511A**

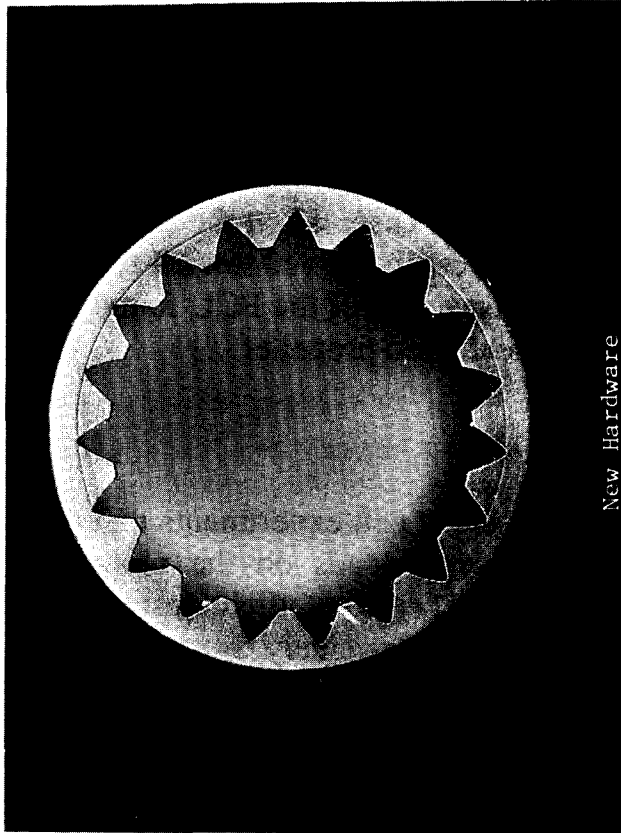
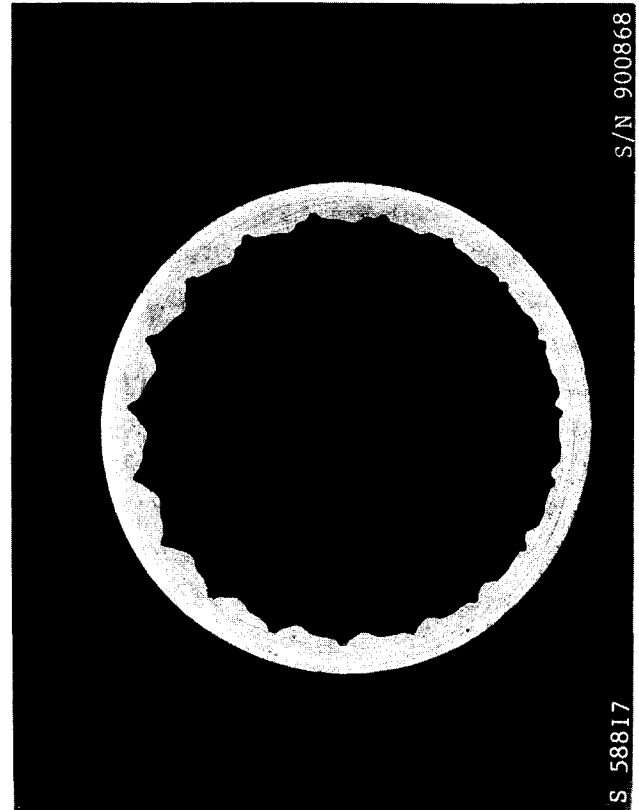
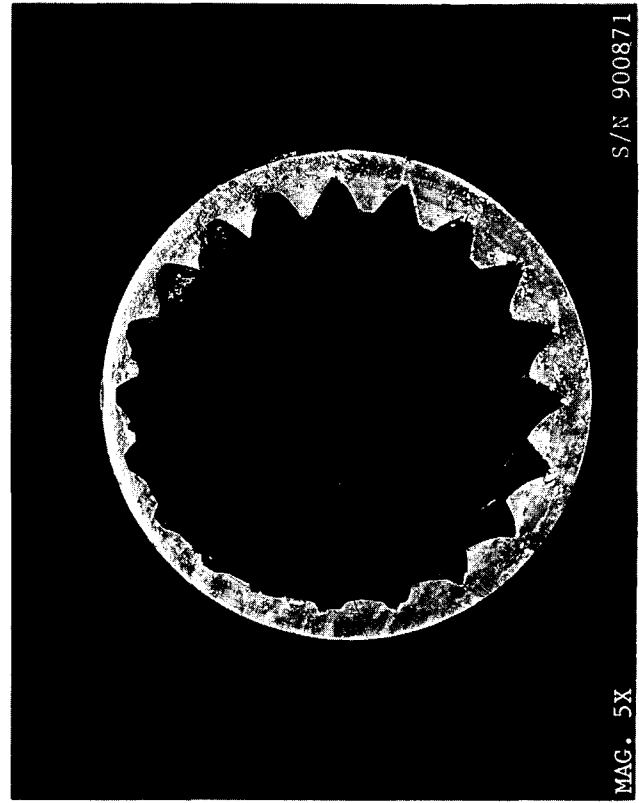
Figure 3.--PCU quill.

The discrepancy in the propeller control unit was found to have been extreme wear on the propeller control unit quill **spline** teeth which normally engaged the titanium-nitrided splines of the propeller transfer tube. It was found that the titanium-nitrided surface was much harder and rougher than the nitrided surface of the quill. Therefore, the transfer tube splines acted like a file and caused abnormal wear of the gear teeth on the quill. The investigation found that wear of the quill was not considered during the certification of the propeller system.

The ballscrew quills were removed from the PCUs for examination. The quills from both PCUs had severely worn internal splines. (See figure 3). The spline teeth on the left quill were almost entirely worn away, and the wear pattern was slightly off the axial centerline. The right quill spline wear was more eccentric with a heavy wear pattern on one side and relatively little wear on the opposite teeth. The left quill was assembled on the left oil transfer tube for measuring radial displacement of the quill when engaged on the spline teeth of the transfer tube. While thus assembled, the quill would rotate freely about the tube, and the quill teeth were worn to the extent that they did not engage the grooves or teeth on the tube. A similar test accomplished with the right quill indicated that the quill would engage the spline teeth of the transfer tube.

However, based upon the number of worn quills found, including those from the accident airplane, the manufacturer issued Alert Service Bulletin 14RF-9-61-A49 on May 7, 1991, that advised all operators to inspect PCUs for worn quills and began a fleet campaign to remove from service the titanium nitrided transfer tubes and to replace them with the original nitrided tubes. The Alert Service Bulletin defined the manufacturer's recommended inspection intervals and wear limits for the quill.
