# **NATIONAL TRANSPORTATION SAFETY BOARD**

## **AIRCRAFT ACCIDENT REPORT**

**BRITT AIRWAYS, INC., d/b/a  
CONTINENTAL EXPRESS FLIGHT 2574  
IN-FLIGHT STRUCTURAL BREAKUP  
EMB-120RT, N33701  
EAGLE LAKE, TEXAS  
SEPTEMBER 11, 1991**

**Adopted: July 21, 1992  
Notation 5612B**

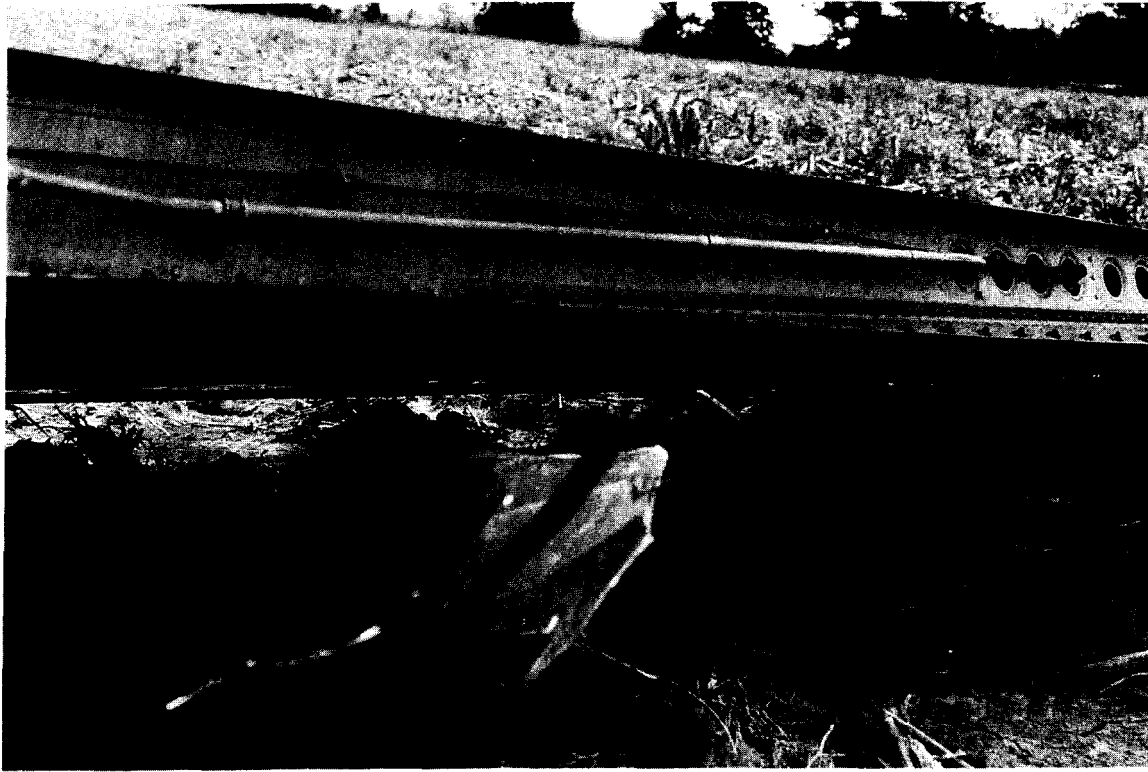
The lower attachment screws remained installed, but the leading edge assembly had separated from the stabilizer, with the exception of a small portion of composite structure remaining below the two farthest inboard screw heads. The spar cap on the lower left side of the horizontal stabilizer showed evidence of being pulled down so that it would project into the wind stream along with the leading edge. This pulling damage is consistent with the left side leading edge assembly having been ripped down and away from the lower attaching screws as it separated from the horizontal stabilizer. This evidence was consistent with screws missing on the top side of the left leading edge assembly, and the lower attaching screws holding fast, pulling down the frame (spar cap) on the lower side of the stabilizer, and thereby forming the lip.

Figure 1c.--Front frame of left side of horizontal stabilizer  
with lower screw attaching area angled downward.

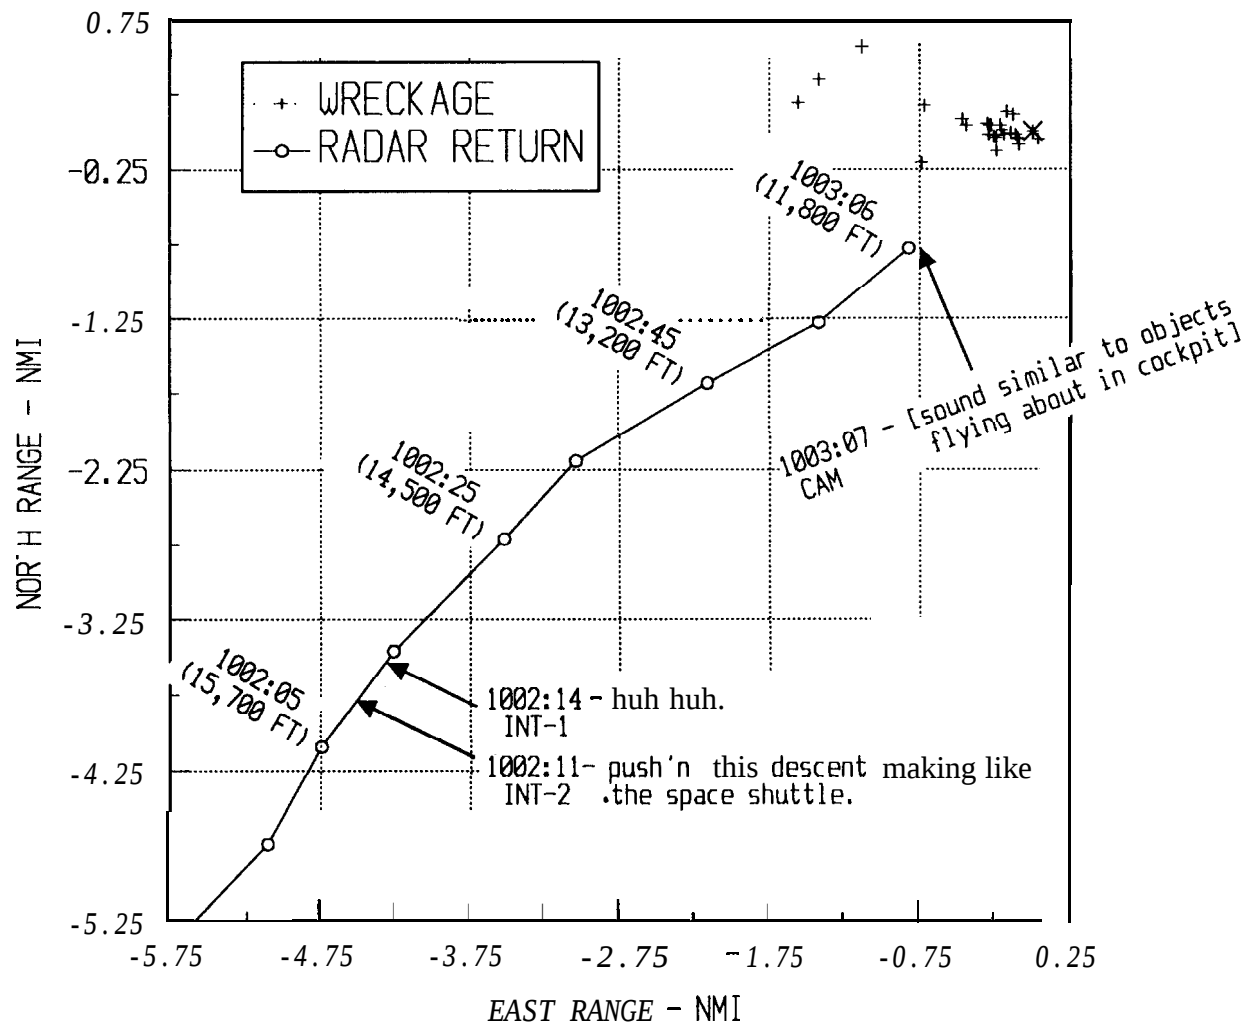
Figure 2.--Radar-derived ground track, CVR sounds, and wreckage distribution.

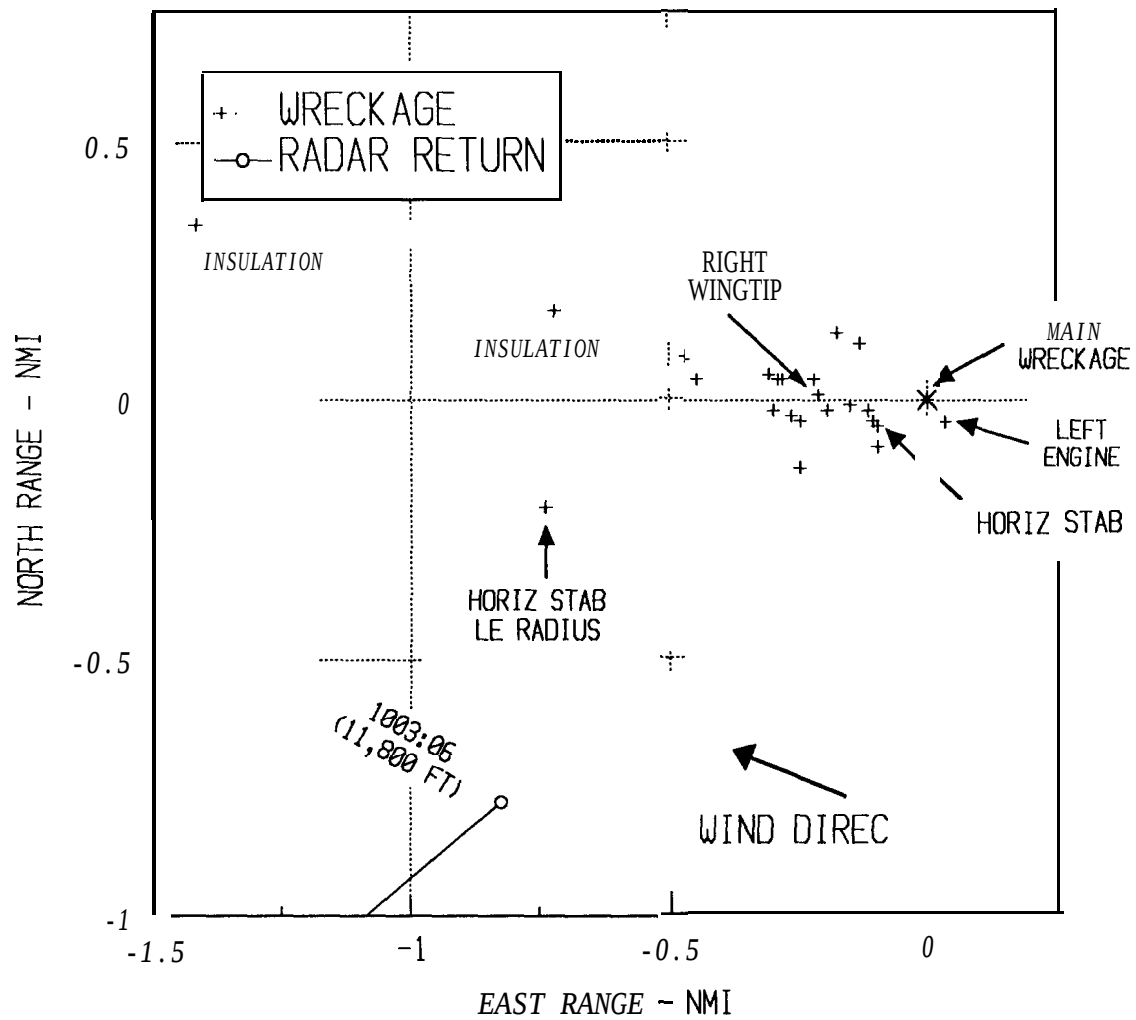
Figure 3 provides a closeup view of part of the ground track and wreckage distribution. The piece of airplane structure farthest from the main wreckage was the left side leading edge (LE) of the horizontal stabilizer. The LE

Figure 3.--Closeup view of part of ground track and wreckage distribution.

was the first piece of structure along the flight's northeasterly ground track, preceding the next piece by roughly 1/2 of a nautical mile.

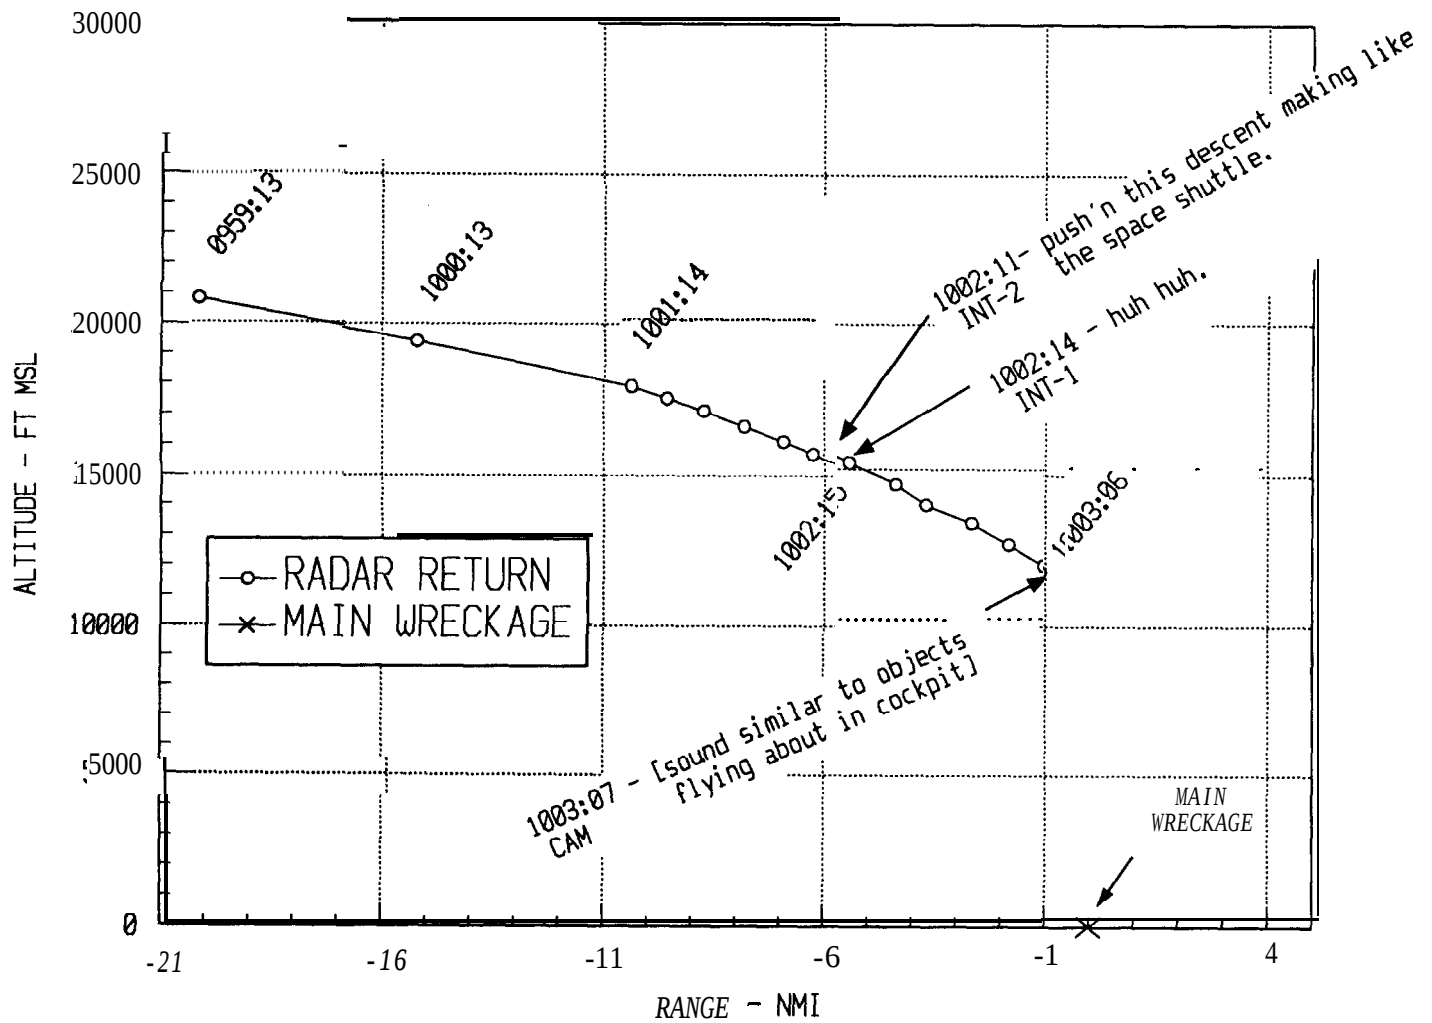
Figure 4.--Radar-derived descent profile.
