**A. I. A. PC 338-1 PROJECT**

**INVESTIGATION OF ENGINE POWER LOSS AND  
INSTABILITY IN INCLEMENT WEATHER**

**SUB-COMMITTEE - OPERATIONAL FACTORS AND  
PROCEDURES FOR HIGH BYPASS ENGINES**

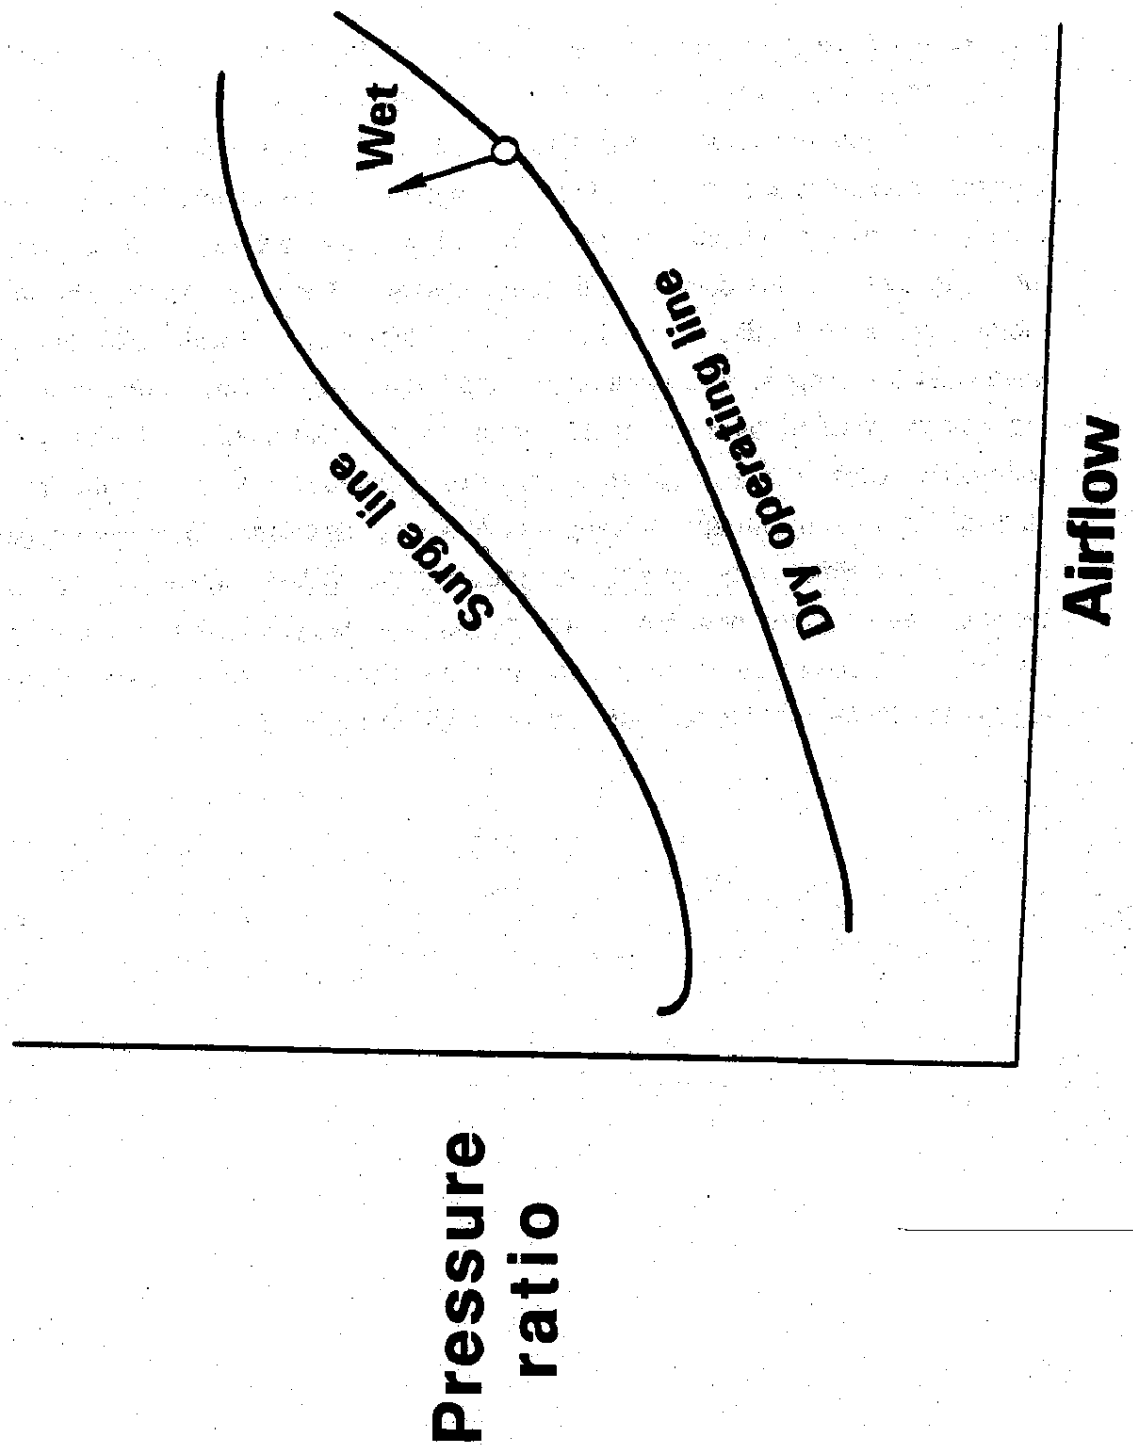
Figure 1

The ingestion of heavy amounts of water in the gaspath causes the compressors to assume new operating conditions. The reason for this compressor rematching is that when the water is vaporized within the engine, it absorbs about 1000 BTU per pound of evaporated water from the air passing through the engine, effectively reducing the air temperature in the downstream stages of the compressor and in the combustion chamber. The ingestion of ice can further increase the cooling in the compressors as it absorbs heat if it melts into water and then more heat if this water evaporates. The degree of compressor rematch is, of course, a function of the water/air ratio and the compressor design. The compressor rematch moves the high pressure compressor operating line toward the surge line, as illustrated in Figure 1, thus causing the compressor to be more susceptible to surge.

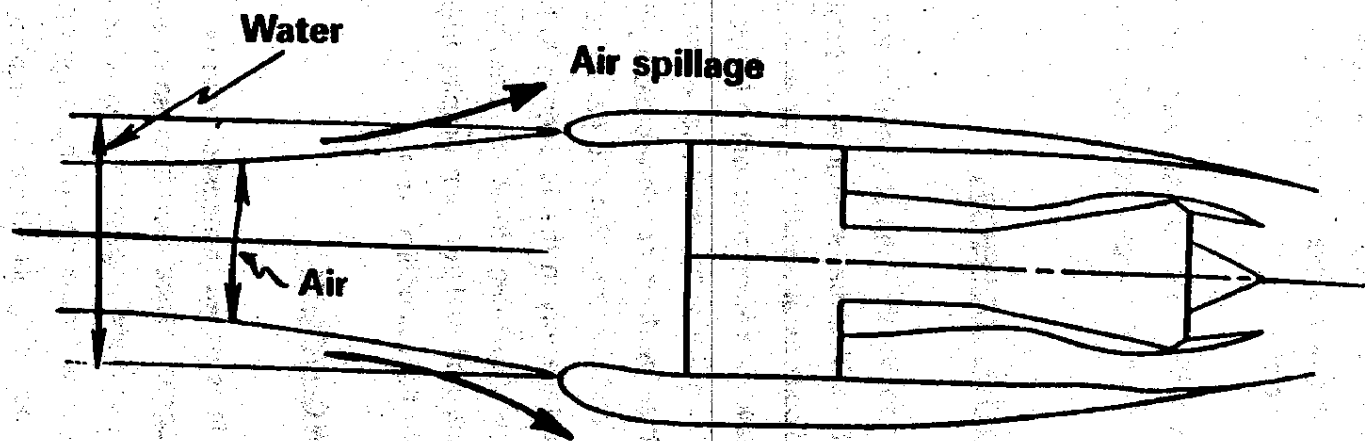
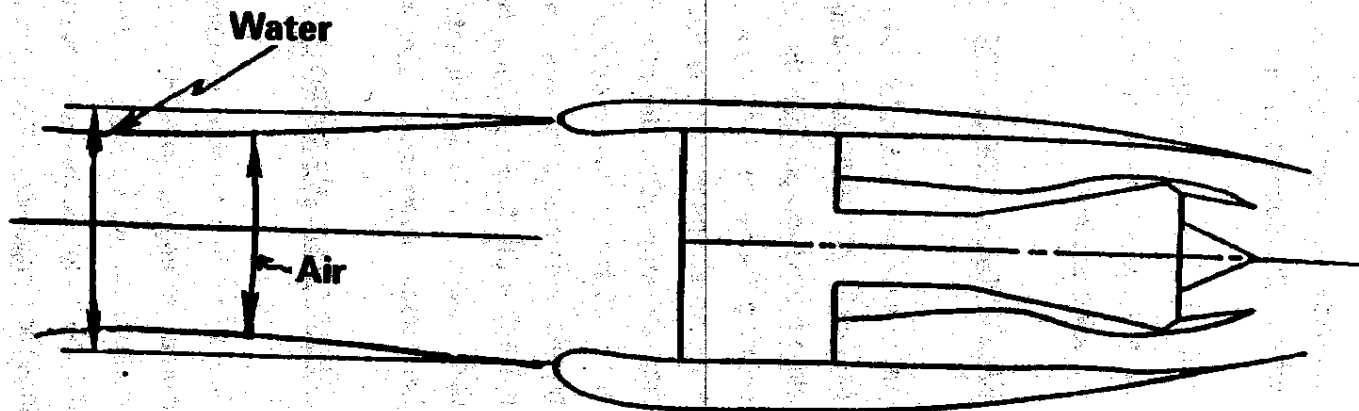
**Figure 2**

**Inlet air spillage at low engine rpm/high aircraft speed increases engine face water/air ratio**

**High engine rpm/low aircraft speed decreases engine face water/air ratio by reducing air spillage**

Air is usually ingested by the engine at a lower velocity than the airspeed of the airplane, especially at low thrust conditions. It has been verified that smaller water particles in the air stream tend to approach the fan at the same velocity as air; both air and water particles thereby entering the fan blades at the same angle of attack. Water particles which impact on the blade surfaces are centrifuged radially outward away from the compressor inlet as described above. Hail and larger diameter rain droplets, on the other hand, do not decelerate significantly. They enter the fan blades at essentially flight velocity and are more likely to pass through the fan blades directly into the compressor. Also, hail's trajectory in the inlet tends to be straight and not follow the flow field, thereby, allowing a larger percentage to be captured by the core/fan duct splitter. It is significant, therefore, that the hail or large rain droplet trajectory through fan blades allows more water into the compressor than does light rain.

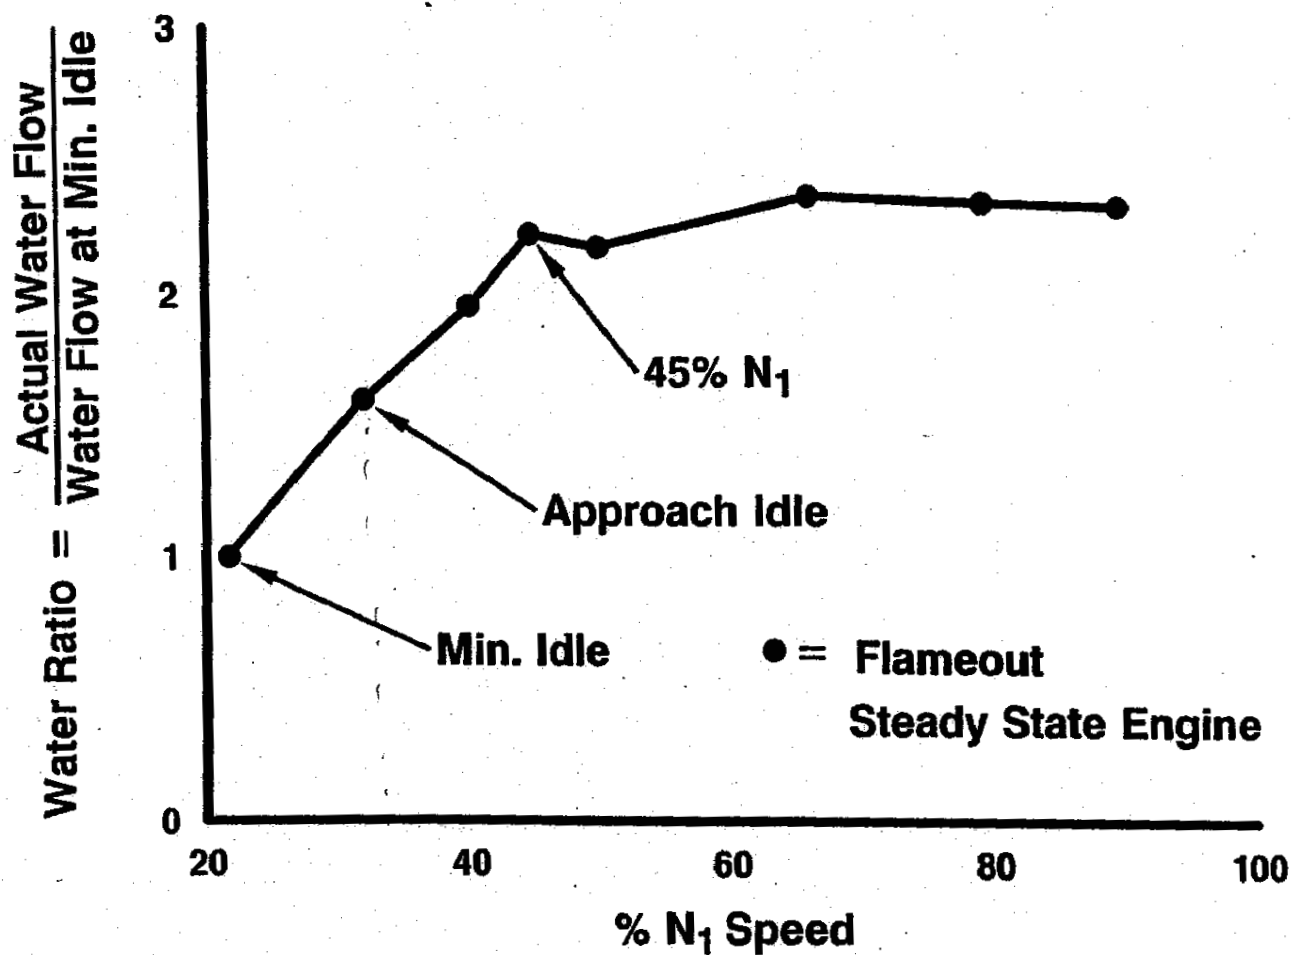
Figure 3 illustrates this effect. The test first determined the amount of water ingestion required to make the engine rundown or flameout at the minimum idle setting. The process was then repeated at several increasing N1 settings. In this test, the water ingestion capability was improved at each successive N1 setting and reached the optimum condition at 45% N1. At that point the capability had improved by a factor greater than two.

- Increase steady state N<sub>1</sub> from min. Idle to 45% N<sub>1</sub>
  - Improves water ingestion capability by factor greater than 2

Note that the optimum value of 45% N1 mentioned above pertains to a particular engine model. Refer to Section 7 for recommended operating procedures.

Based on analysis of engine operation in inclement weather, it is concluded that high by-pass turbine engines have a much greater tolerance to rain, hail and sleet when operated at thrust settings above minimum or low idle. (See Figure 3 in Section 6). Therefore, if moderate and/or heavy rain, hail or sleet cannot be avoided, the minimum thrust settings recommended by the engine and airplane manufacturers for operation in such conditions, or greater, should be maintained to minimize engine spooldown or flameout

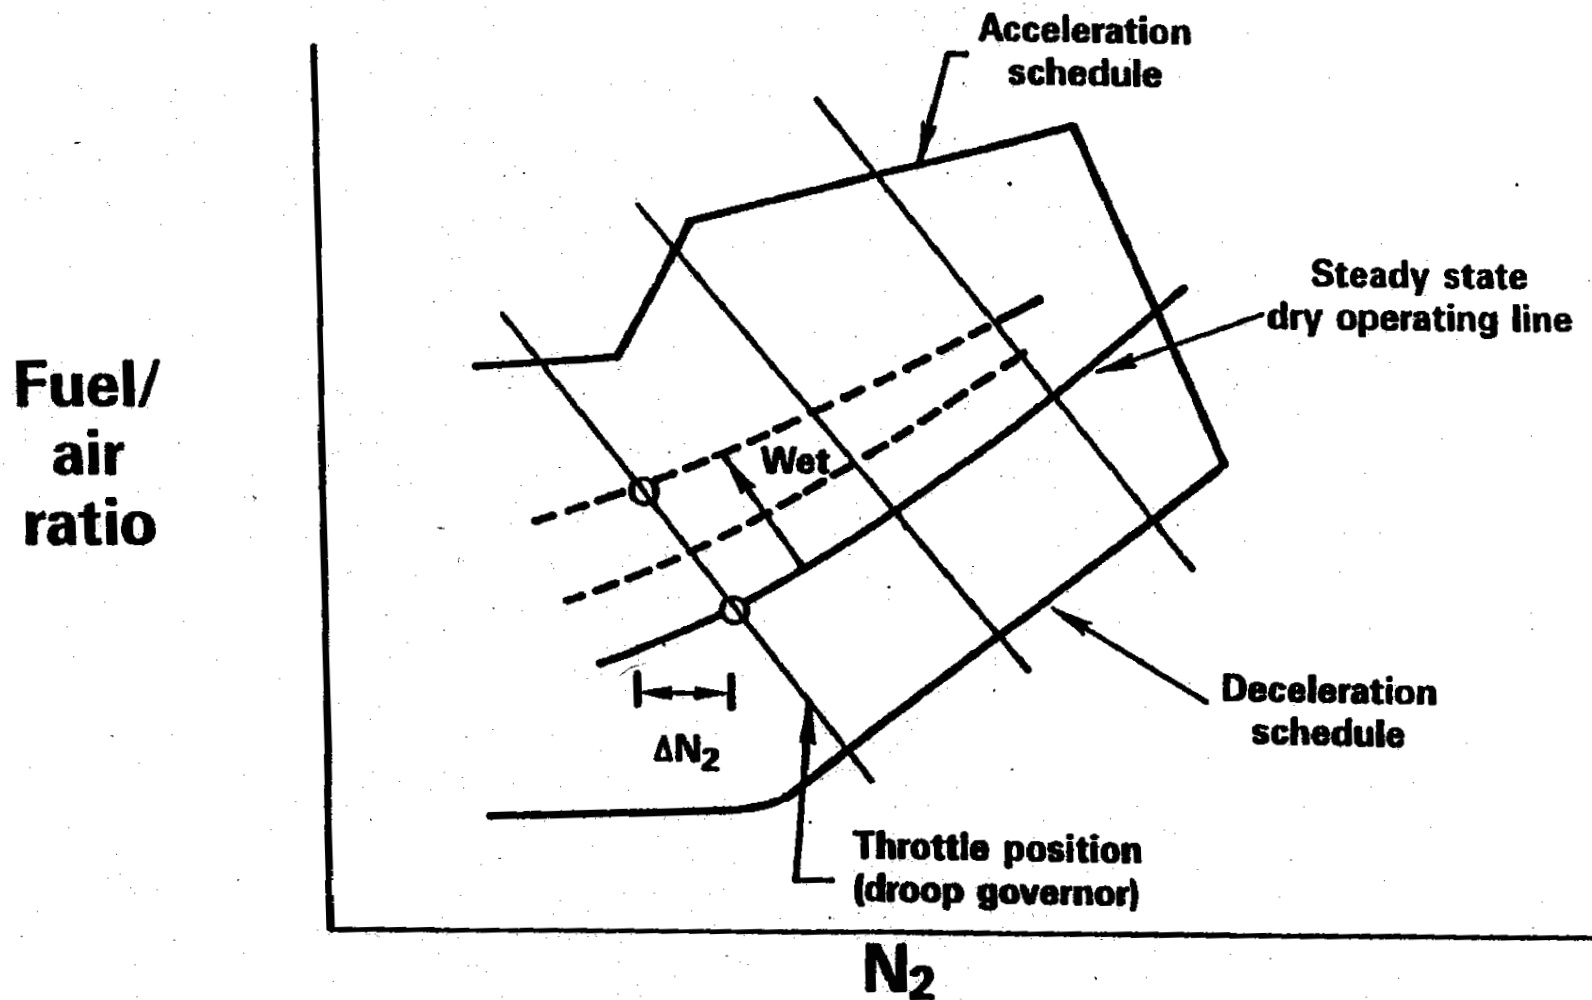
Figure 4

$N_2$  decay due to water ingestion at constant throttle position

The engine is most susceptible to flameout or compressor surge when it has entered a sub-idle operating condition. The above mentioned self-recovery, when exiting the rain encounter, is, of course, predicated on the engine not having experienced flameout or other non recoverable operating condition during the rundown event. Experience has also shown that an engine may hang in a sub-idle operating condition and not recover as mentioned above. In that case, the engine must be shut down and restarted by the flight crew in order to return to normal operation. For engine controls which use constant speed governing, the engine response will be similar to the above except that the rotor speed will not change at constant throttle as water ingestion is increased until the limiting acceleration fuel schedule is reached. At this point the engine will rapidly rundown
