# **NATIONAL TRANSPORTATION SAFETY BOARD**

## **AIRCRAFT ACCIDENT REPORT**

**AMERICAN AIRLINES, INC.,  
BOEING 727-95, N1963**

**REPORT NUMBER: NTSB-AAR-77-1**

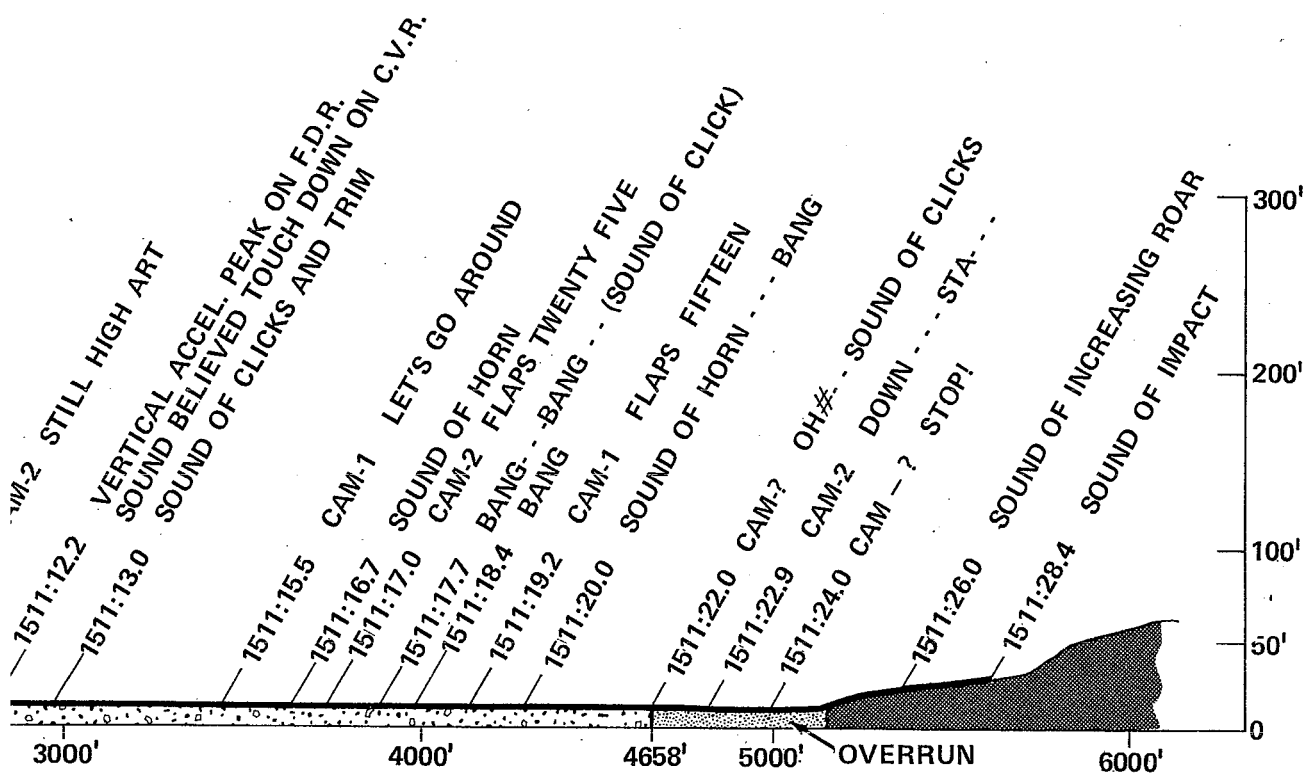
**APPROACH PROFILE**  
**AMERICAN AIRLINES, BOEING 727-95 N1963**  
**HARRY S. TRUMAN AIRPORT, ST. THOMAS, VIRGIN ISLANDS**  
**APRIL 27, 1976**

The profile shown in Appendix D was prepared using assumptions which seemed to be most logical to the investigators. These assumptions are noted thereon. This profile shows that the aircraft crossed the threshold at an airspeed of 131 knots and an altitude of about 80 feet. The touchdown was calculated to be about 2,800 feet beyond the threshold. At touchdown, about 1,850 feet of runway and 500 feet of overrun were available on which to stop the aircraft. When the captain stated "Let's go around," the aircraft was about 3,450 feet beyond the threshold, or 1,200 feet of runway and 500 feet of overrun remained.

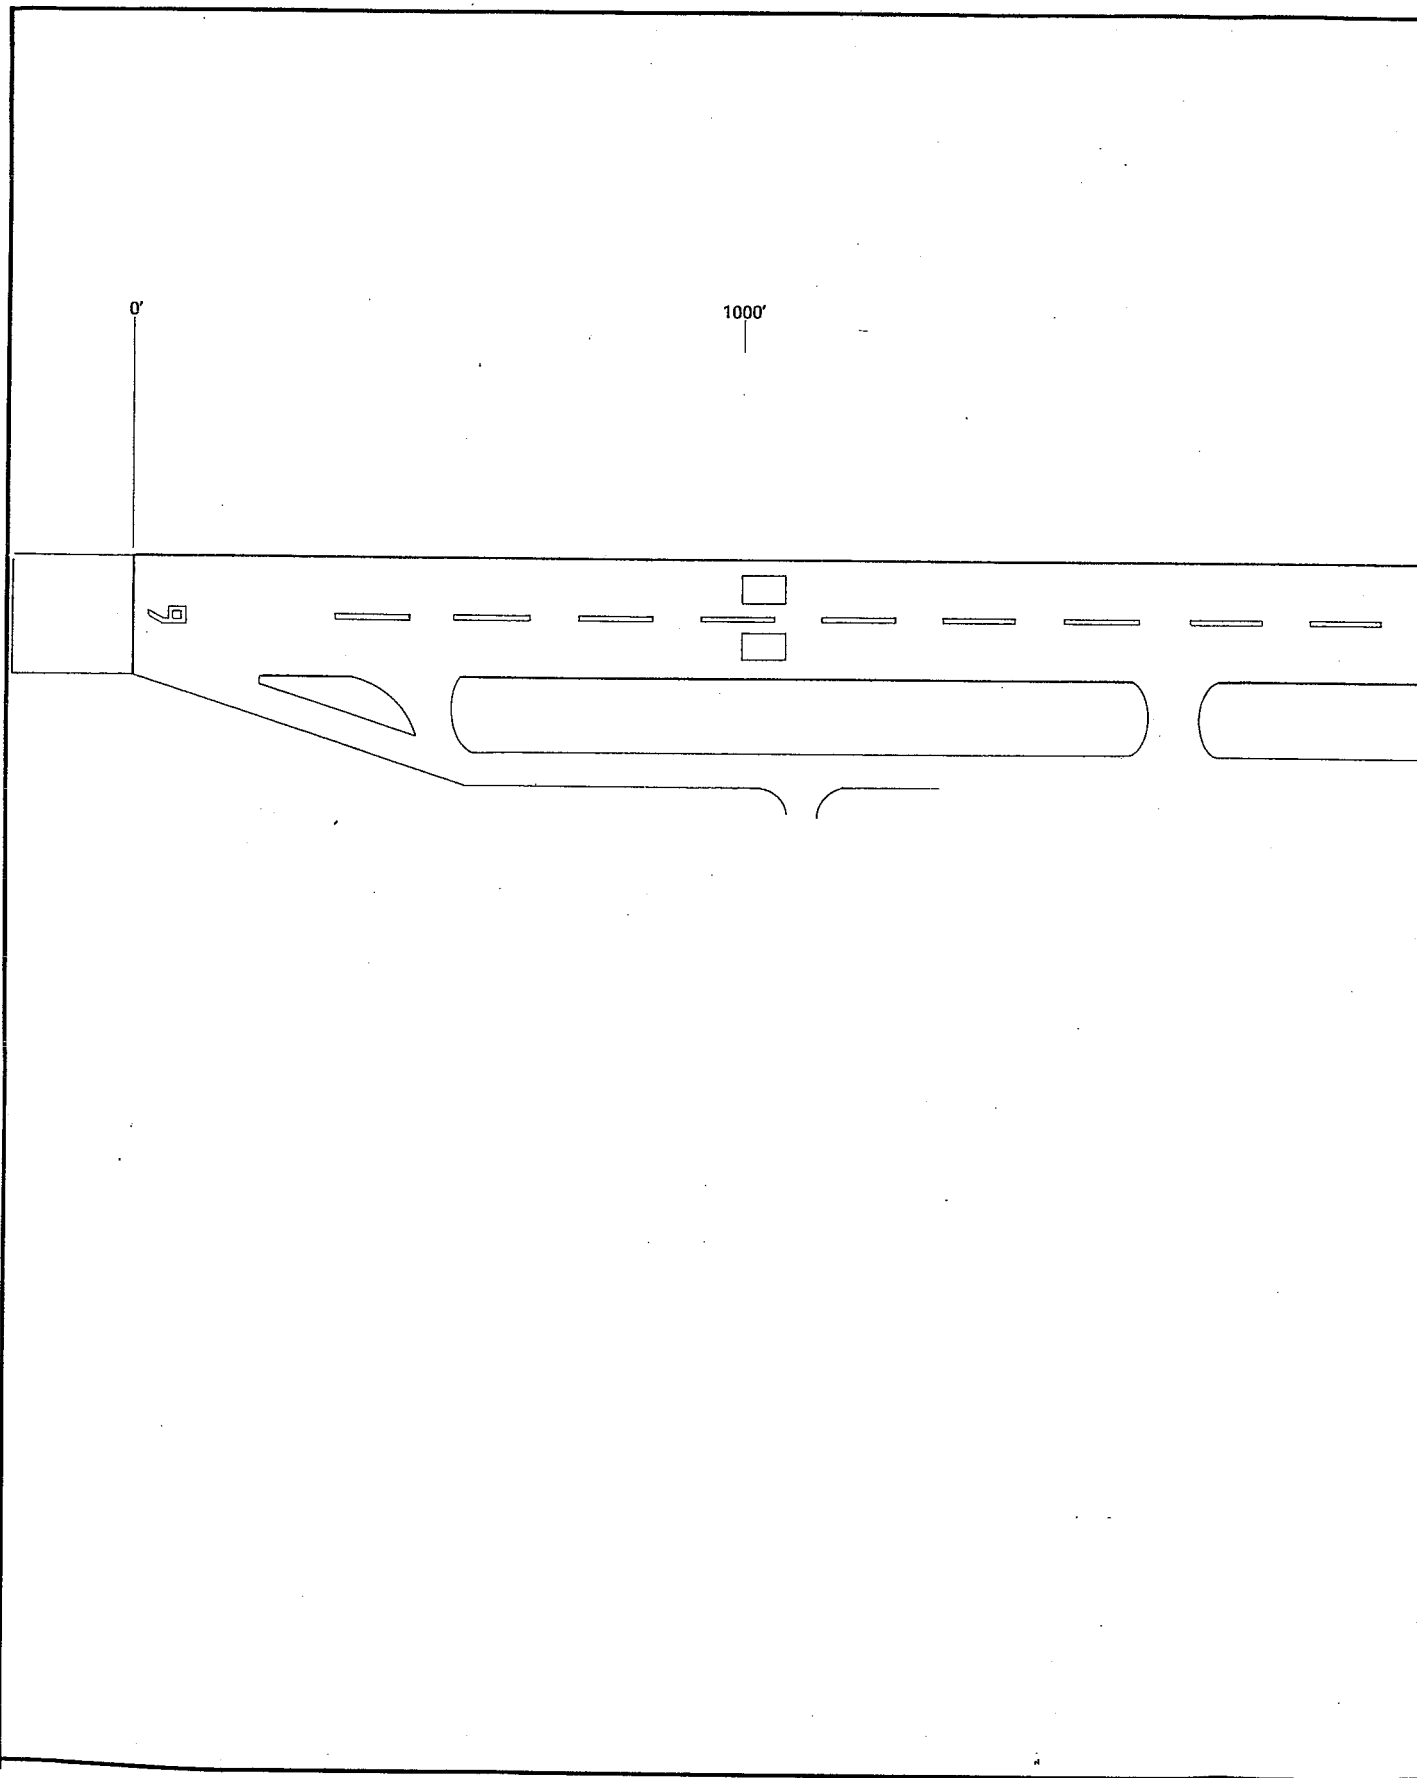
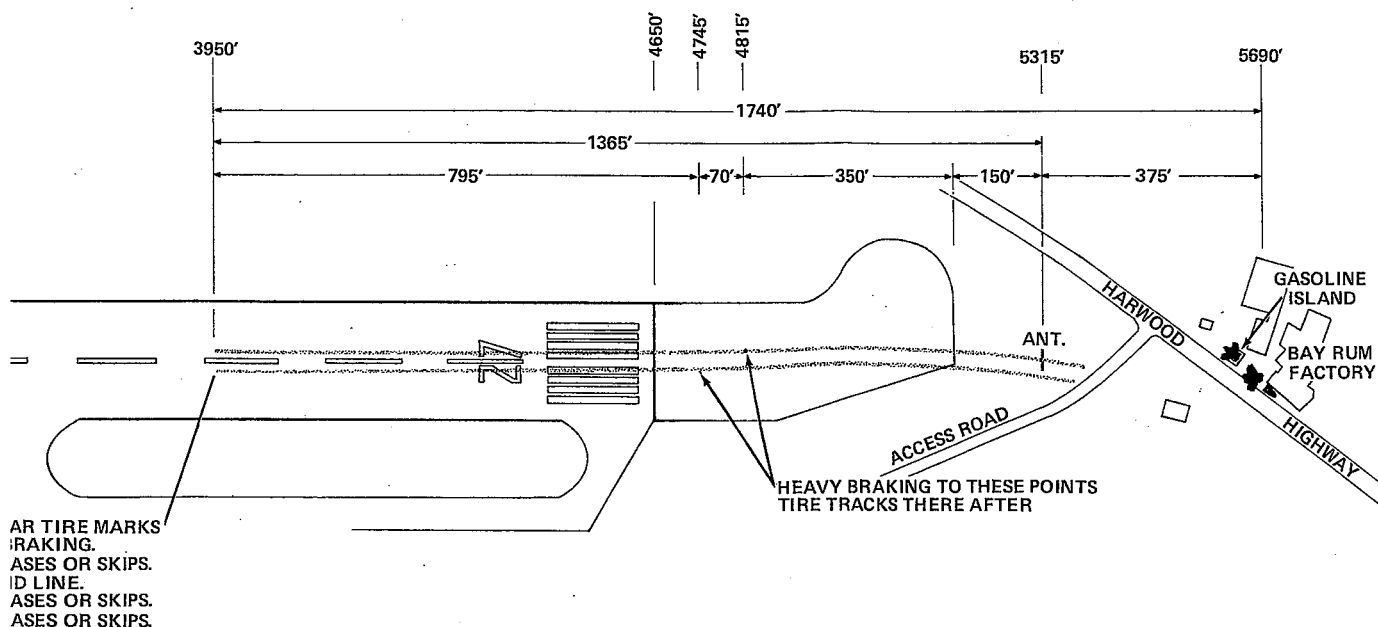
**RUNWAY EXAMINATION CHART**  
**AMERICAN AIRLINES, BOEING 727-95, N1963**  
HARRY S TRUMAN AIRPORT  
CHARLOTTE AMALIE, ST. THOMAS, VIRGIN ISLANDS  
APRIL 27, 1976

START OF LEFT AND RIGHT MAIN GEAR TIRE MARKS WHICH ARE INDICATIVE OF HEAVY BRAKING. WHEEL NO. 1 SHOWS ANTI SKID RELEASES OR SKIPS. WHEEL NO. 2 SHOWS UNBROKEN SOLID LINE. WHEEL NO. 3 SHOWS ANTI SKID RELEASES OR SKIPS. WHEEL NO. 4 SHOWS ANTI SKID RELEASES OR SKIPS.

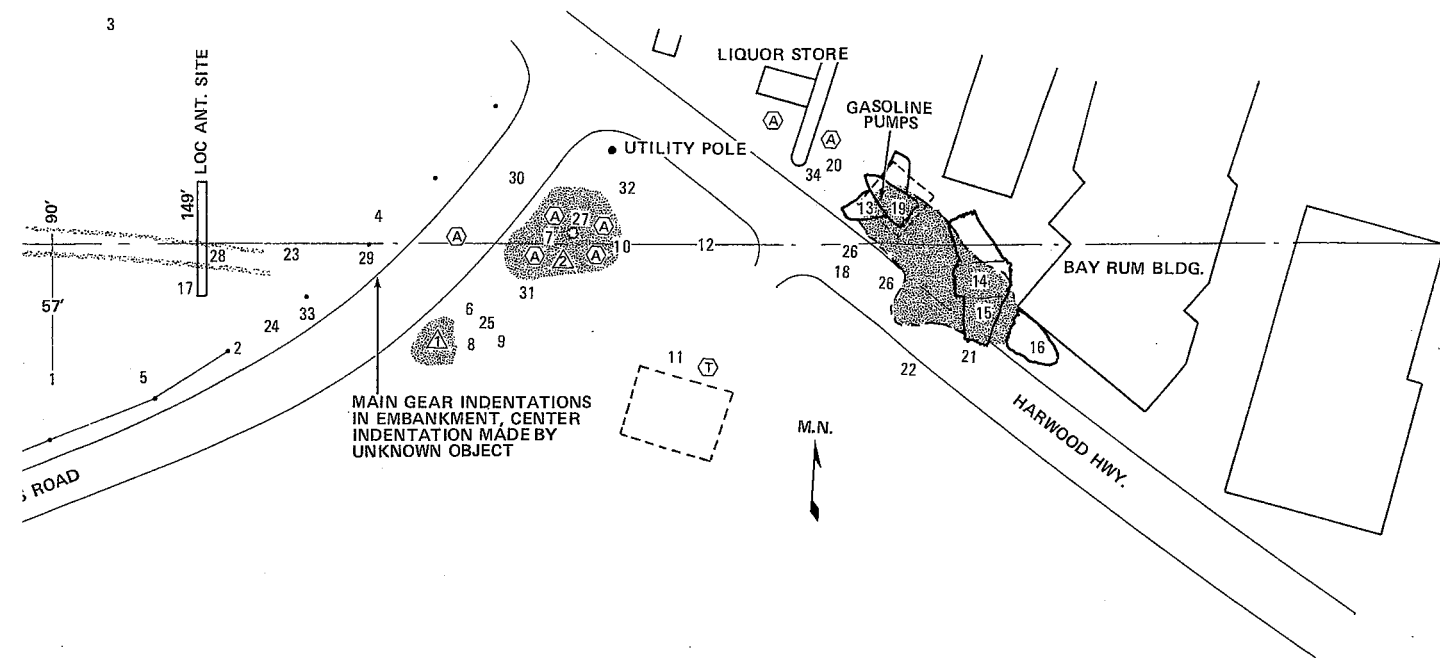
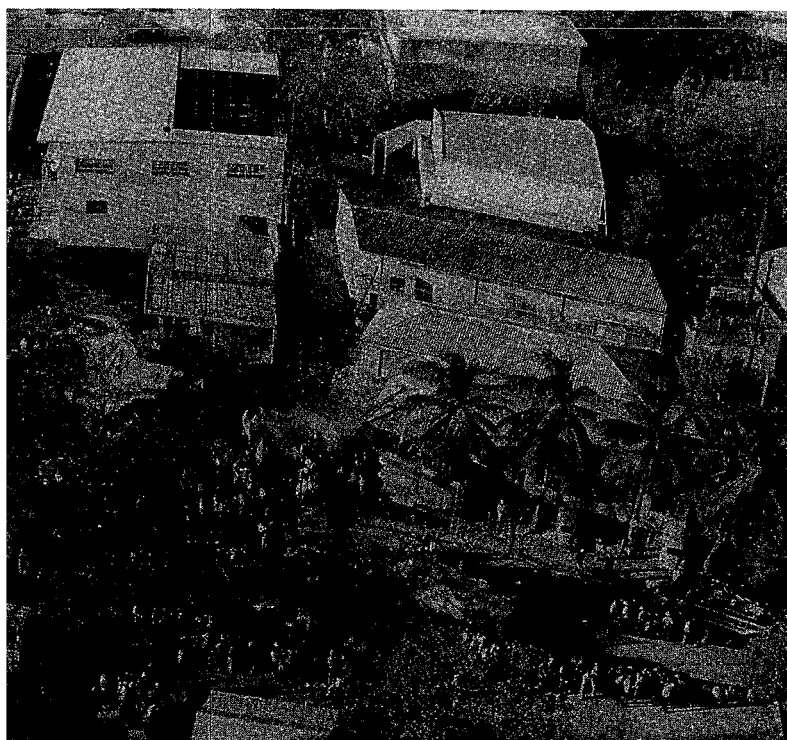
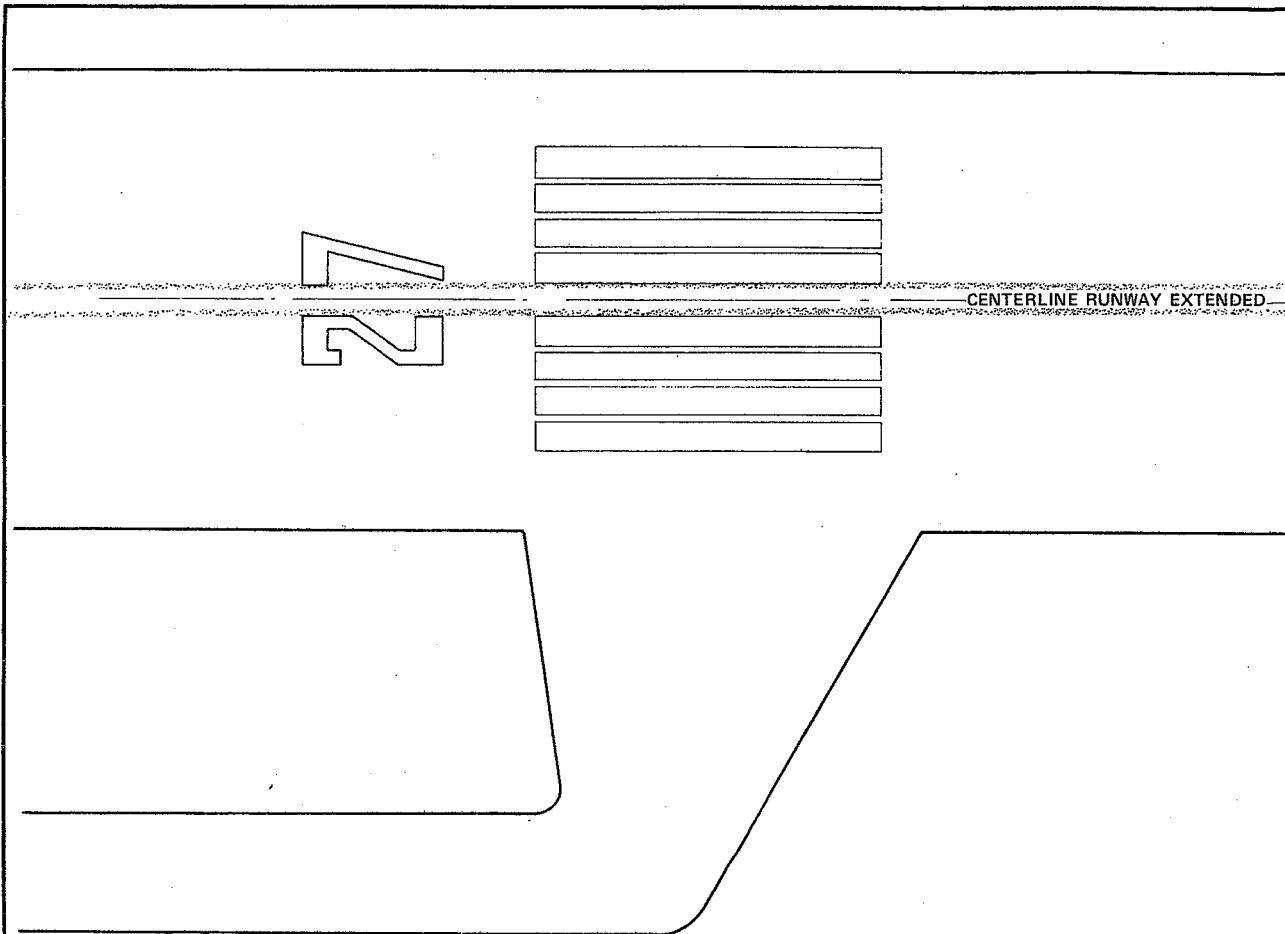
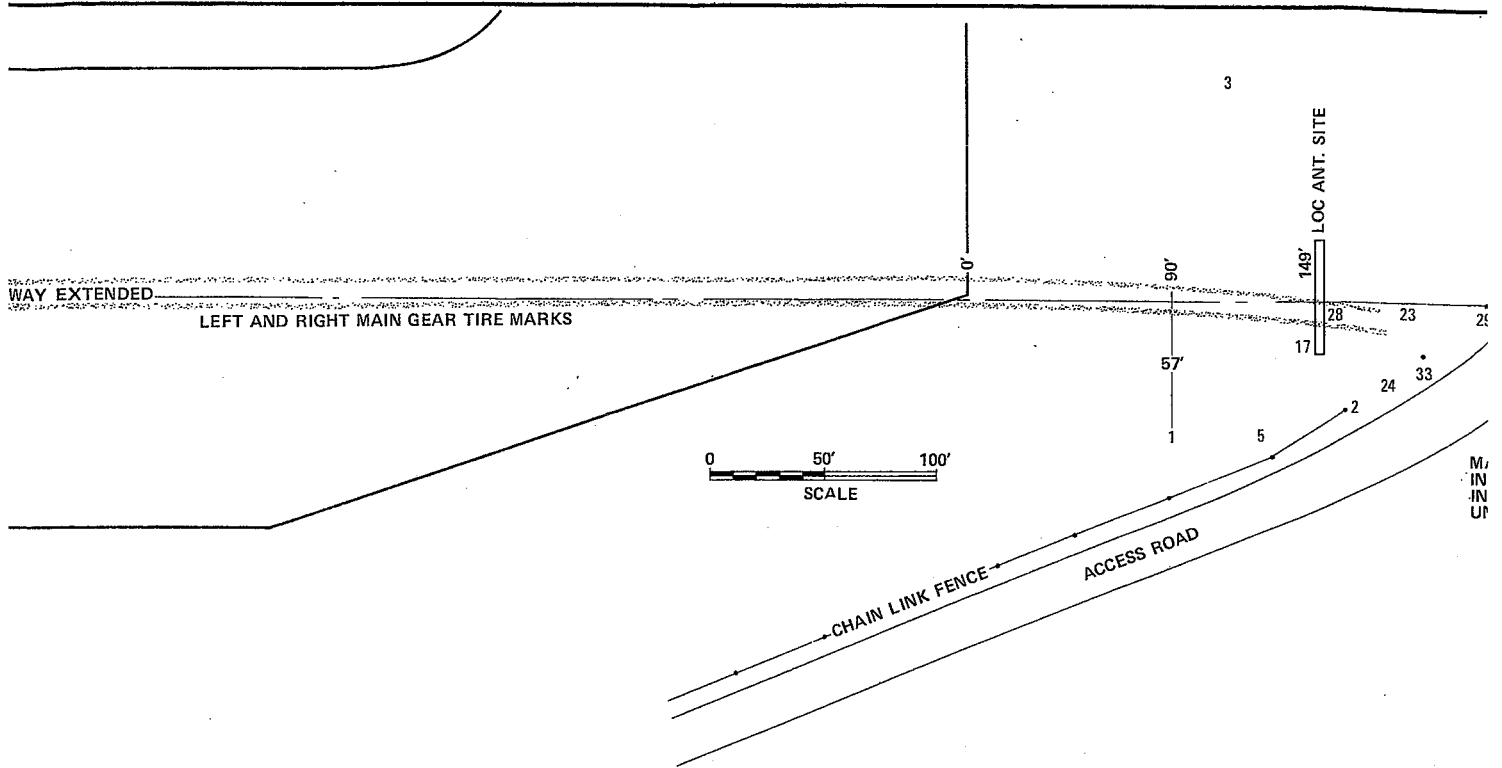
**WRECKAGE DISTRIBUTION CHART**  
**AMERICAN AIRLINES, BOEING 727-N1963**  
HARRY S. TRUMAN AIRPORT  
CHARLOTTE AMALIE, ST. THOMAS, VIRGIN ISLANDS  
APRIL 27, 1976

1. PIECES OF RIGHT WING TIP NAV. LIGHT PLEXIGLASS, BLUE AND CLEAR - FIRST POINT OF FUSELAGE IMPACT APPROX. 8 FEET ABOVE OVERRUN ELEVATION
2. IMPACT WITH CHAIN LINK FENCE

27. TREE BROKEN APPROX. 8 FEET ABOVE GROUND
28. HONYCOMB FOUND IN LOCALIZER ANTENNA SUPPORT STRUCTURE
29. PIECES OF LEADING EDGE SLAT TRACK
30. LEFT MAIN LANDING GEAR AFT TRUNION BEARING SLEEVE
