The investigation for this report was conducted by Aircraft and Railway Accidents Investigation Commission about the aircraft accident of Japan Airlines Boeing 747-400D (an approach to JA8546 of the same airline) in accordance with Aircraft and Railway Accident Investigation Commission Establishment Law and Annex 13 to the Convention of International Civil Aviation for the purpose of determining cause of the aircraft accident and contributing to the prevention of accidents and not for the purpose of blaming responsibility of the accident.

Junzo Sato,  
Chairman,  
Aircraft and Railway Accidents Investigation Commission

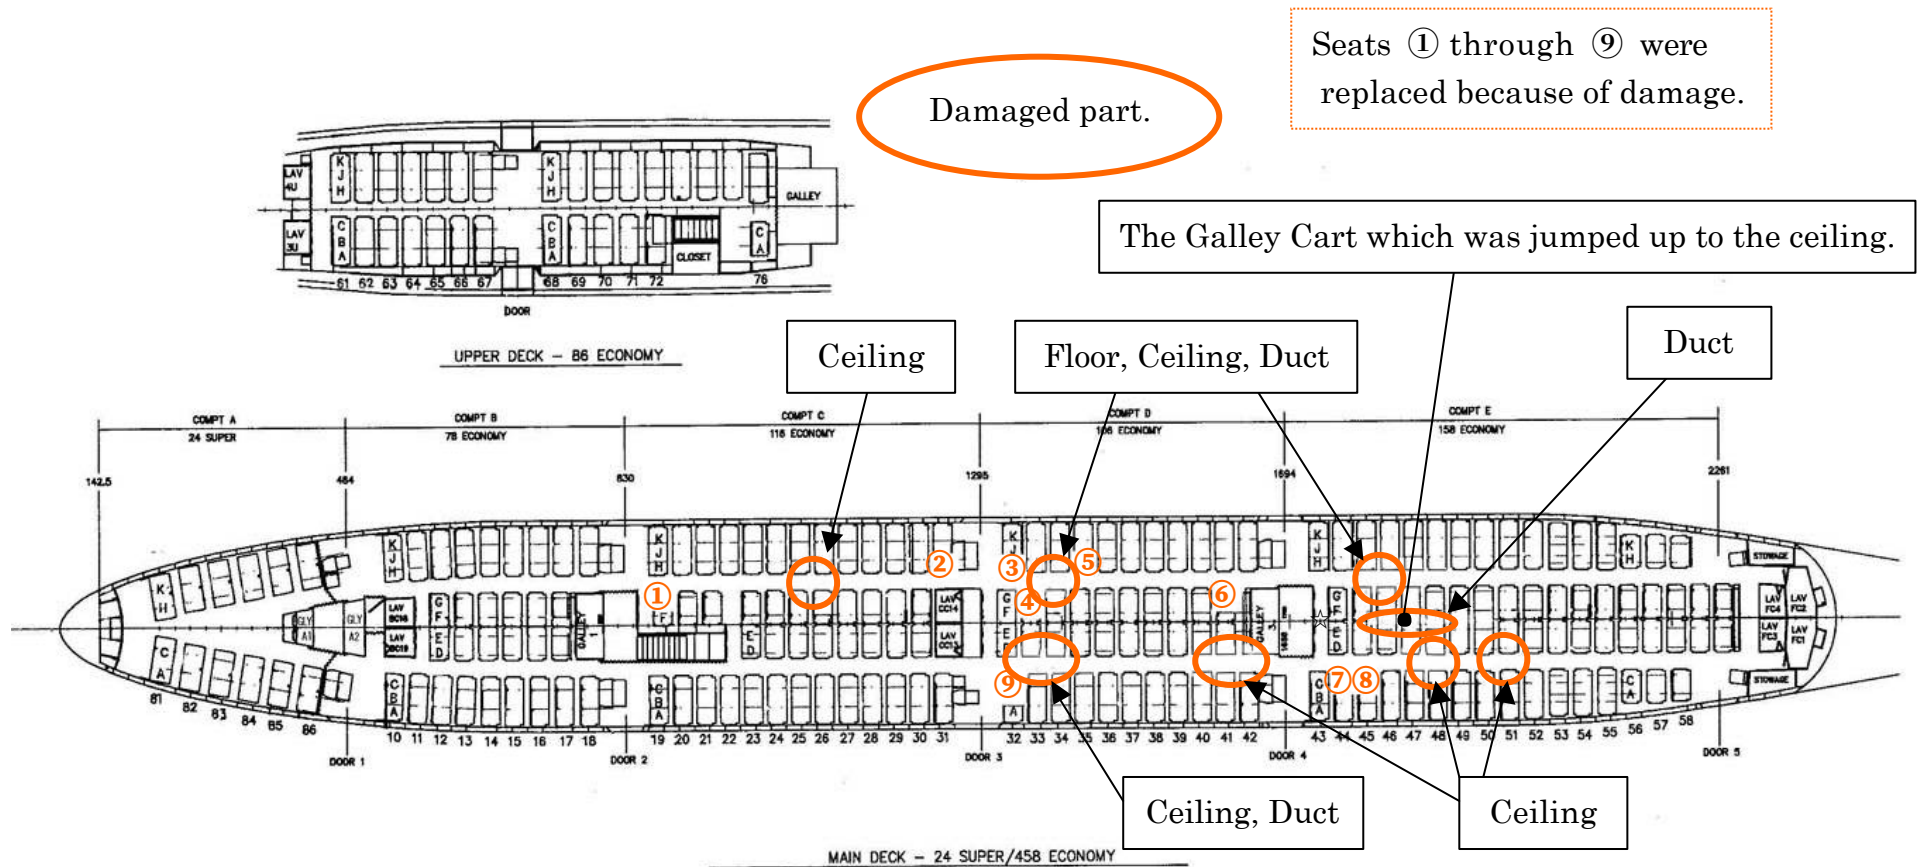
Figure 15 Damages to Aircraft A

The following is a list of seats that were replaced due to damage sustained. The numbers in parentheses indicate positions in the passenger cabin shown in Attached Figure 15.

- Seat 19G due to damage to its right armrest (①)
- Seat 31H due to damage to its left armrest (②)
- Seat 32H due to damage to its left armrest (③)
- Seat 33G due to damage to its right armrest (④)
- Seat 35H due to damage to its left armrest (⑤)
- Seat 41G due to damage to its right armrest (⑥)
- Seat 44C due to damage to its right armrest (⑦)
- Seat 45C due to damage to its right armrest (⑧)
- Seat 32B&C due to damage to their attached tables (⑨)

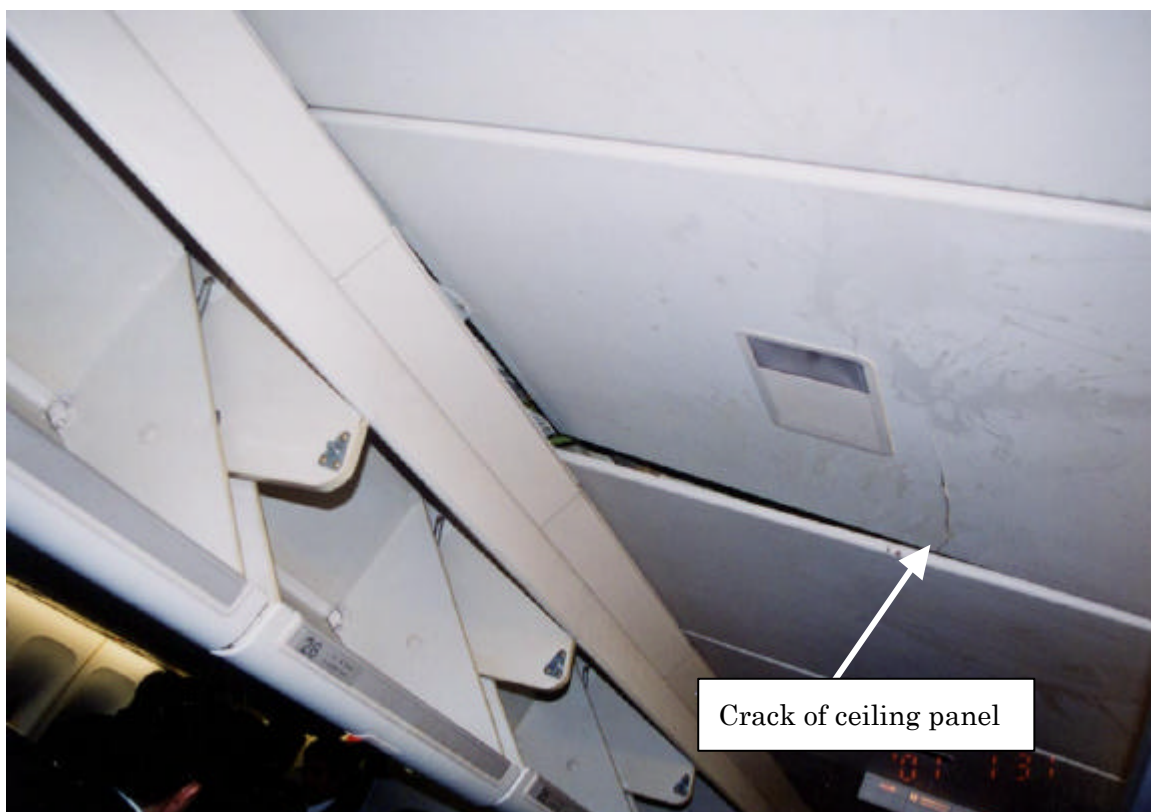
Photograph 1 Damage of the ceiling panel (Aircraft A) 1

Cracks were noted on part of the panel in the vicinity of seat 26

The damage of ceiling panel over right side pass way seat No. 26(view from backward)

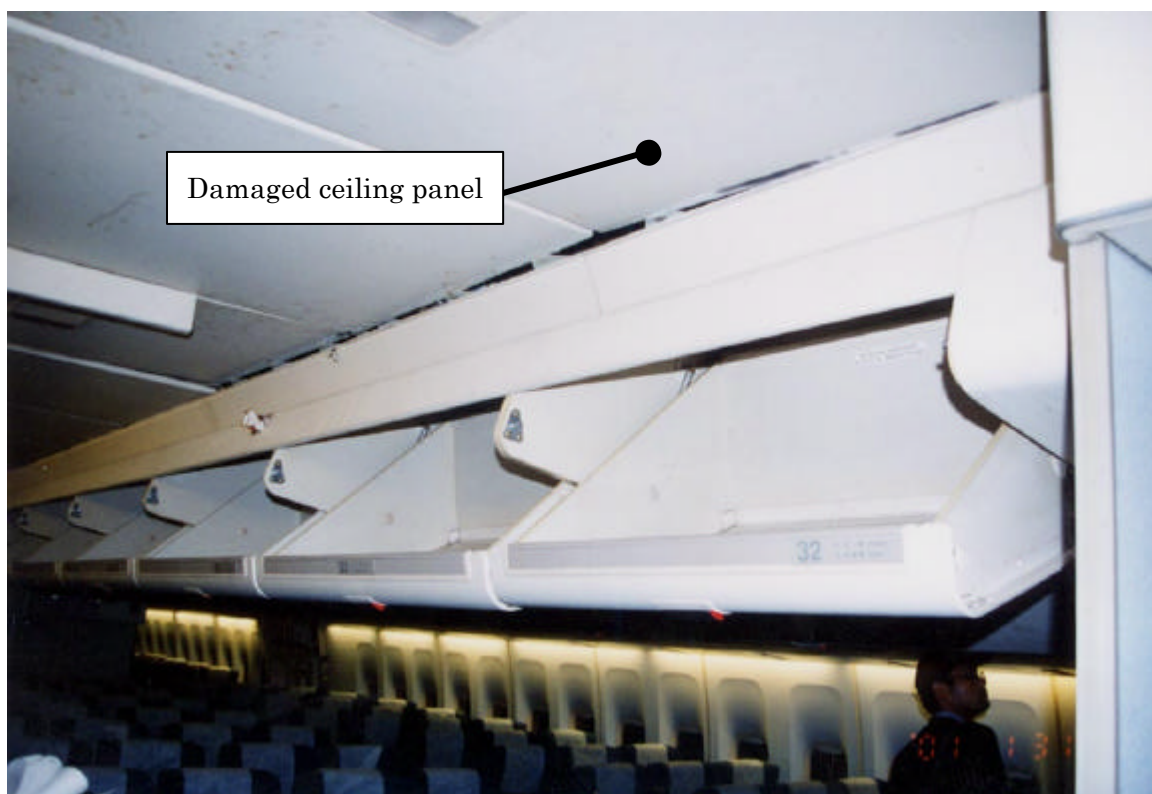
Photograph 2 Damage of the ceiling panel (Aircraft A) 2

Dents and bends were noted on part of the panel in the vicinity of seat 32

The damage of ceiling panel over right side pass way seat No. 32(view from front)

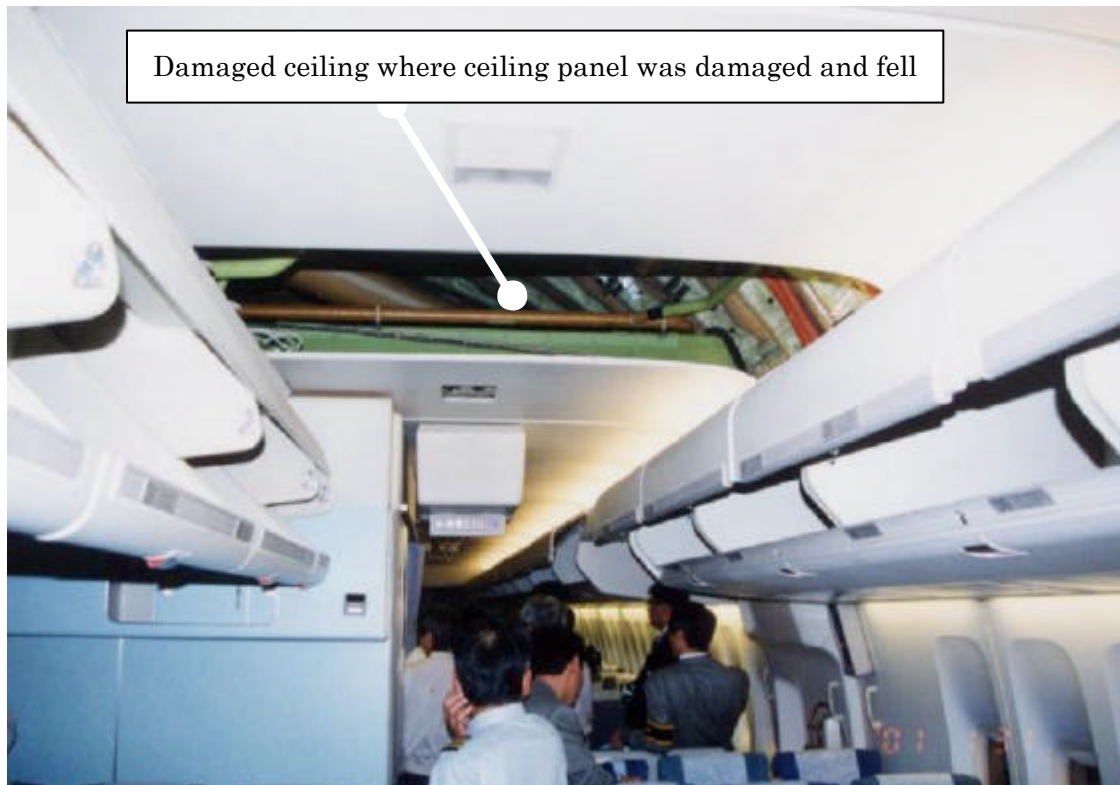
### Photograph 3 Damage of the ceiling panel (Aircraft A) 3

The panel in the vicinity of seat 41 was fractured and had dropped onto the cabin floor.

The damage of ceiling panel over left side pass way seat No. 41(view from front)

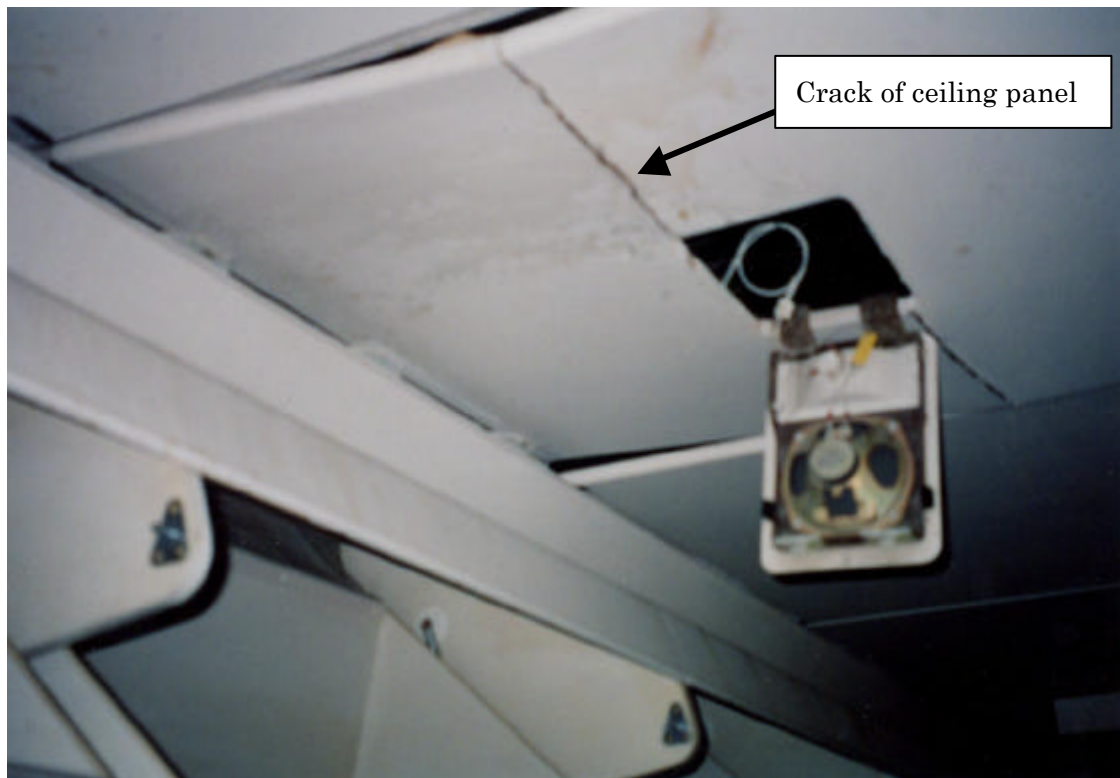
### Photograph 4 Damage of the ceiling panel (Aircraft A) 4

Cracks were noted on part of the panel in the vicinity of seat 48

The damage of ceiling panel over left side pass way seat No. 48(view from front)

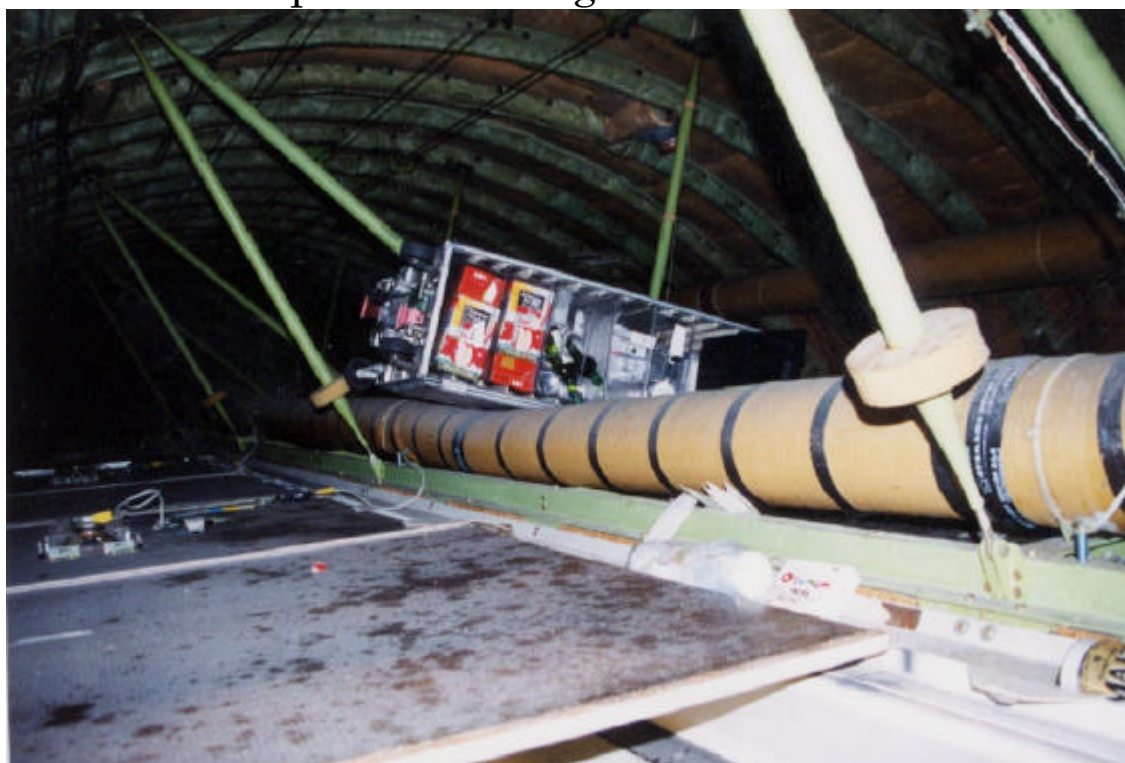
Photograph 5 Situation of the galley cart that was jumped up to the ceiling of Aircraft A 1

Five of the passenger service galley carts sustained damage. One of these was found resting on top of a ceiling panel in the vicinity of seats 47E and 47F.

The galley cart mentioned in the (4) above was found resting on an air-conditioning duct behind the ceiling in the vicinity of the seat 46–48EF, and the portion of the duct concerned was slightly crushed.

Rear view from the ceiling of right side pass way of seat No. 45

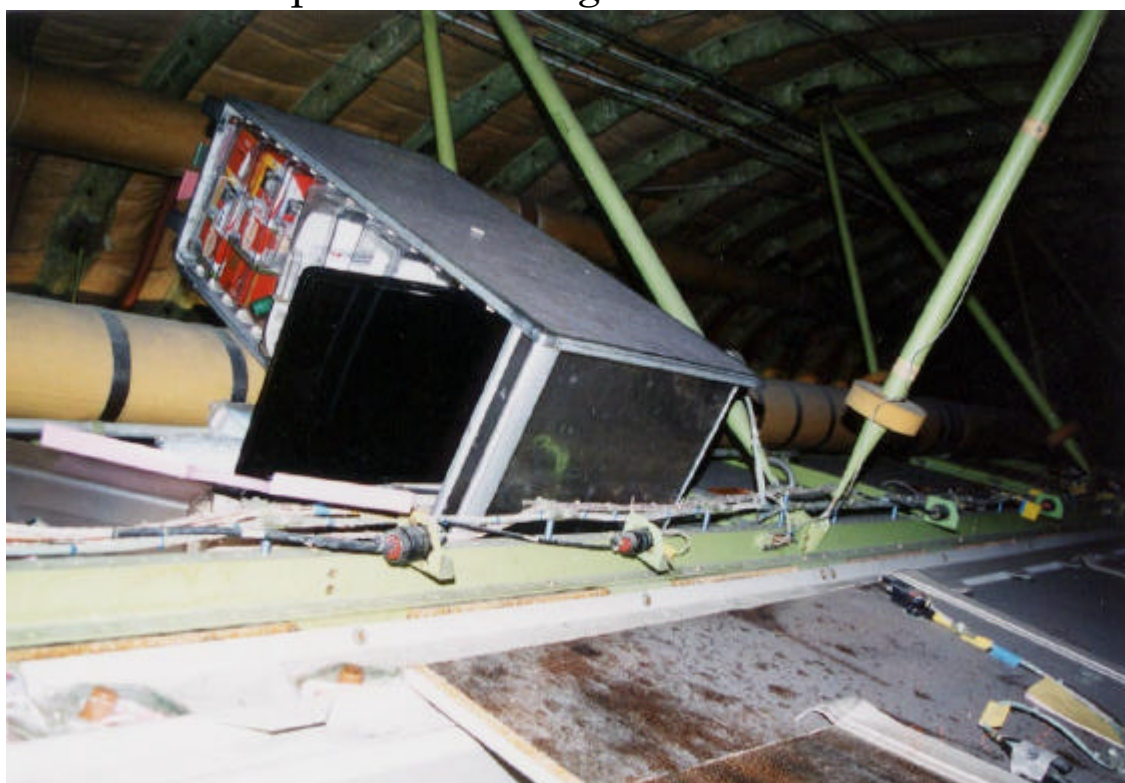
Photograph 6 Situation of the galley cart that was jumped up to the ceiling of Aircraft A 2

Rear view from the ceiling of left side pass way of seat No. 46

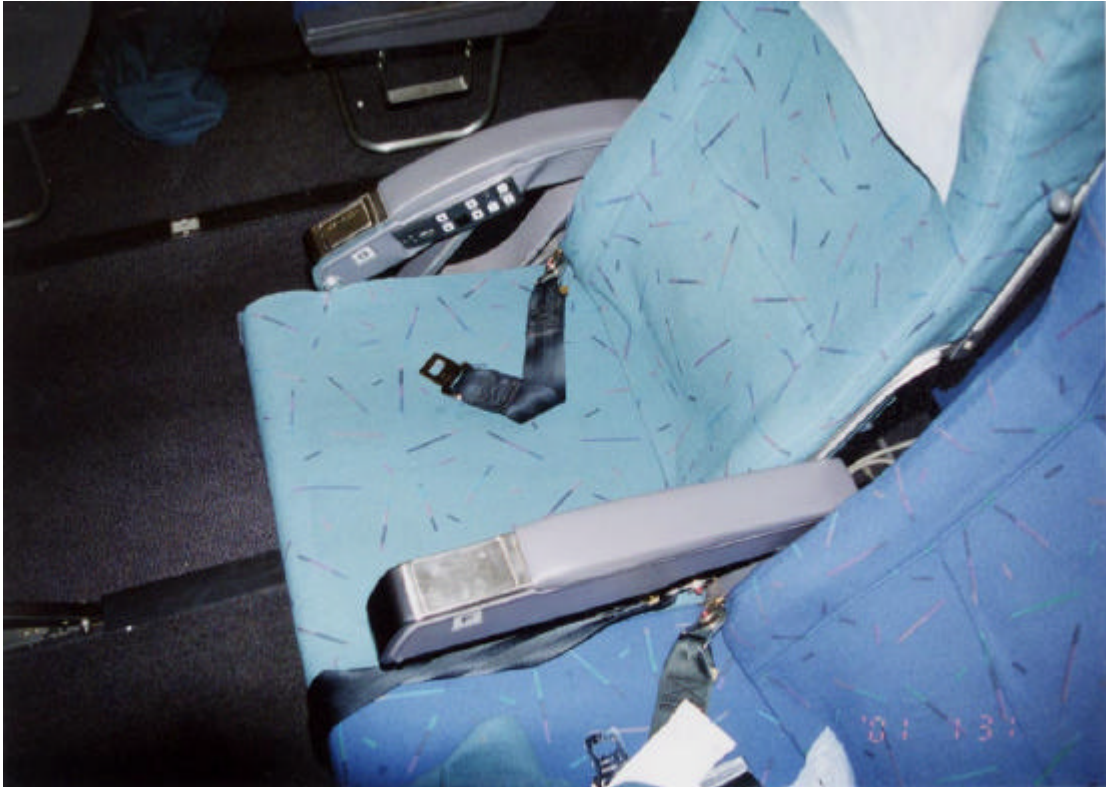
Photograph 7 Damage of seats (Aircraft A) 1

Damage of seat armrest of right side pass way seat No. 33

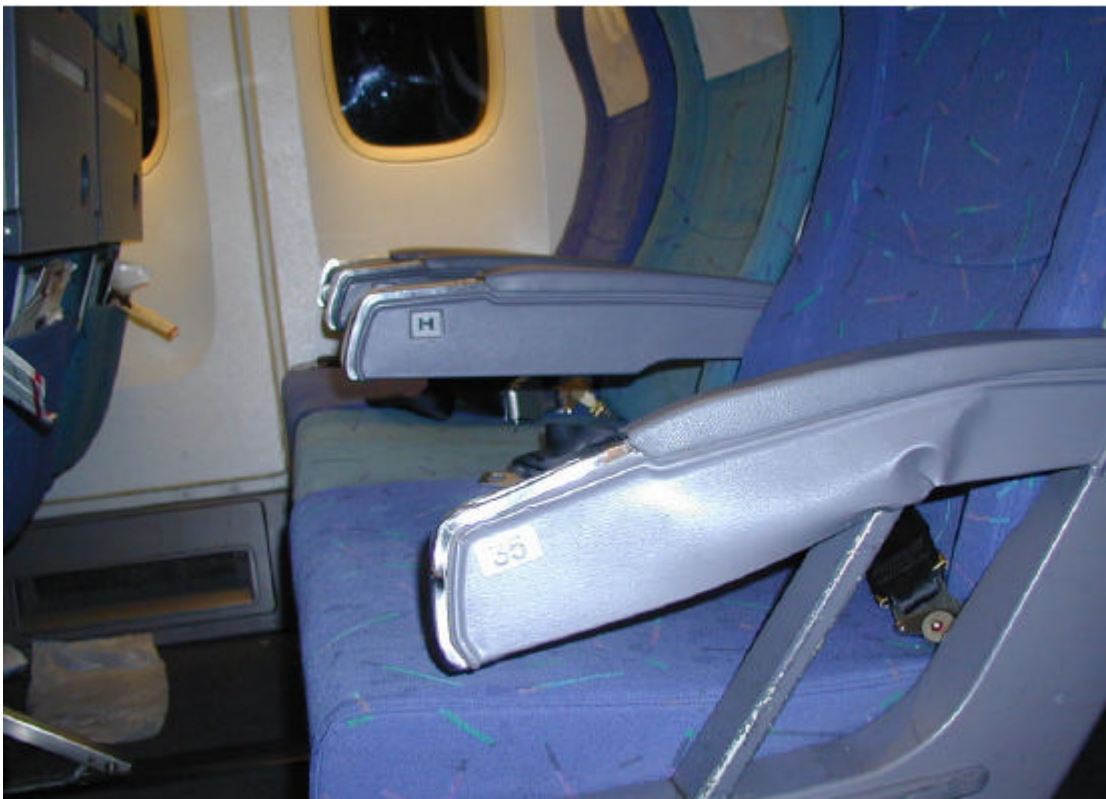
Photograph 8 Damage of seats (Aircraft A) 2

Damage of seat armrest of right side pass way seat No. 35
