# **NATIONAL TRANSPORTATION SAFETY BOARD**

**AIR CANADA FLIGHT 797  
McDONNELL DOUGLAS DC-9-32, C-FTLL  
GREATER CINCINNATI  
INTERNATIONAL AIRPORT  
COVINGTON, KENTUCKY  
JUNE 2, 1983**

**NTSB/AAR-86/02**

The National Transportation Safety Board determines that the probable causes of the accident were a fire of undetermined origin, an underestimate of fire severity, and misleading fire progress information provided to the captain.

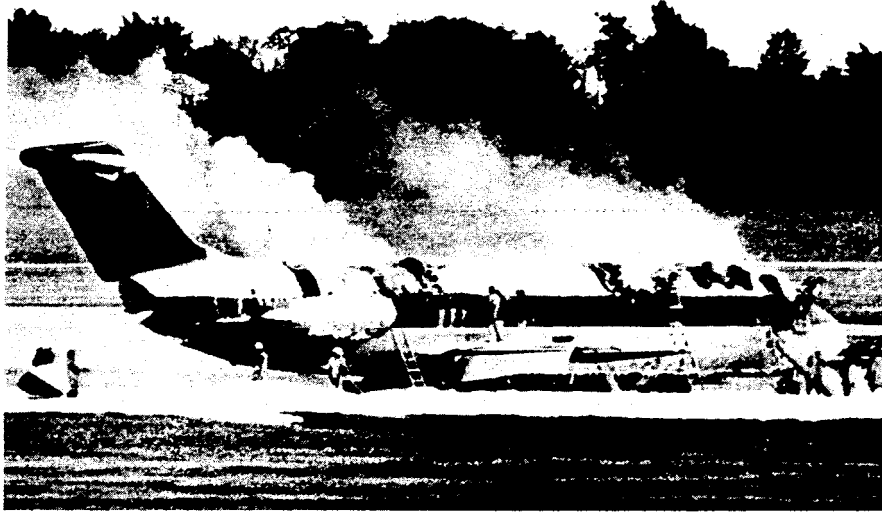
Figure 2.-Airplane after fire burned through top of fuselage.

The cabin area of the upper fuselage down to below the level of the cabin windows was damaged heavily by fire; below that level the fuselage was relatively intact. The majority of the cabin windows were either missing or had partially melted out. (See figures 3 and 4.) Forward of the aft pressure bulkhead, the upper areas of the cabin windows were discolored and burned away in several locations. The fuselage skin above the left aft lavatory was intact, but a rectangular area corresponding closely to the shape of the lavatory had been discolored to dark brown and a large area of paint had been burned away. The rectangular area began above the engine pylon and extended to the top of the fuselage. (See figures 3 and 4.)

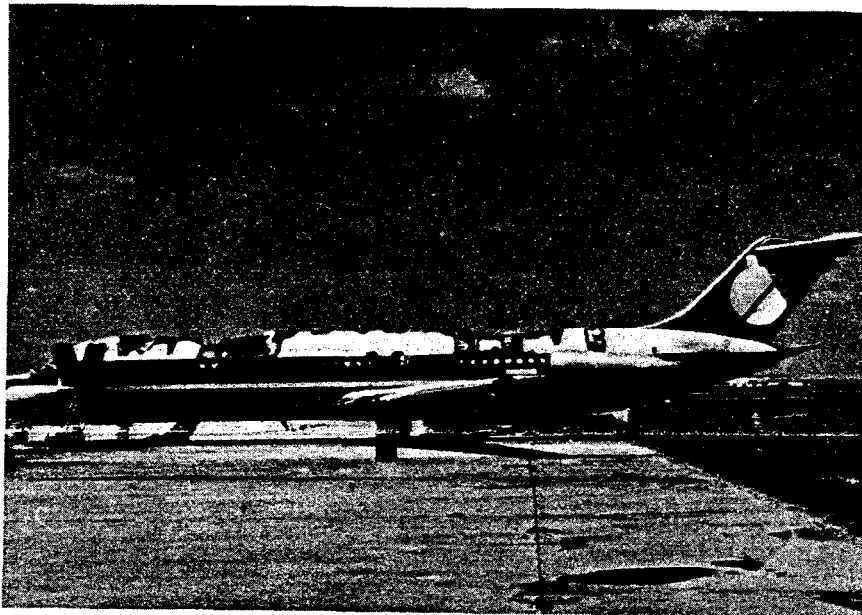
Figure S.-Left side of the airplane.

Forward of the aft lavatory, between fuselage station (**FS**) 929 and FS 758, the top of the fuselage was damaged heavily by heat and had been burned away down to the top of the cabin windows. Between FS 758 and FS 484, the fuselage upper skin was intact but was buckled and discolored by heat at the very top between the 11 o'clock and 2 o'clock positions (aft looking forward). Between FS 484 forward to the cabin entry door (**FS 200**), the upper skin of the fuselage had burned away partially. Except for some sooting around the edges of the left and right forward cabin entrance doors, the fuselage forward of FS 200 was intact with no apparent heat or fire damage.

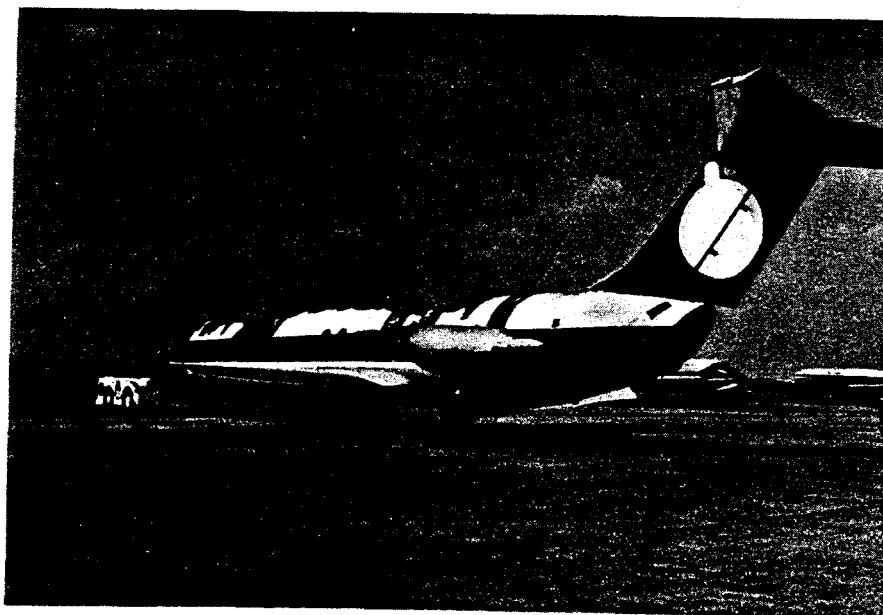
There were thick soot deposits along the lower side of the fuselage beginning at the cabin air outflow valve at FS 945 and from around the access **door** in the lavatory service panel at FS 965. The soot pattern trailed rearward along the airplane's side,

Figure 4.-Left side of the airplane, rear view, depicting rectangular burn pattern and Soot trail. .

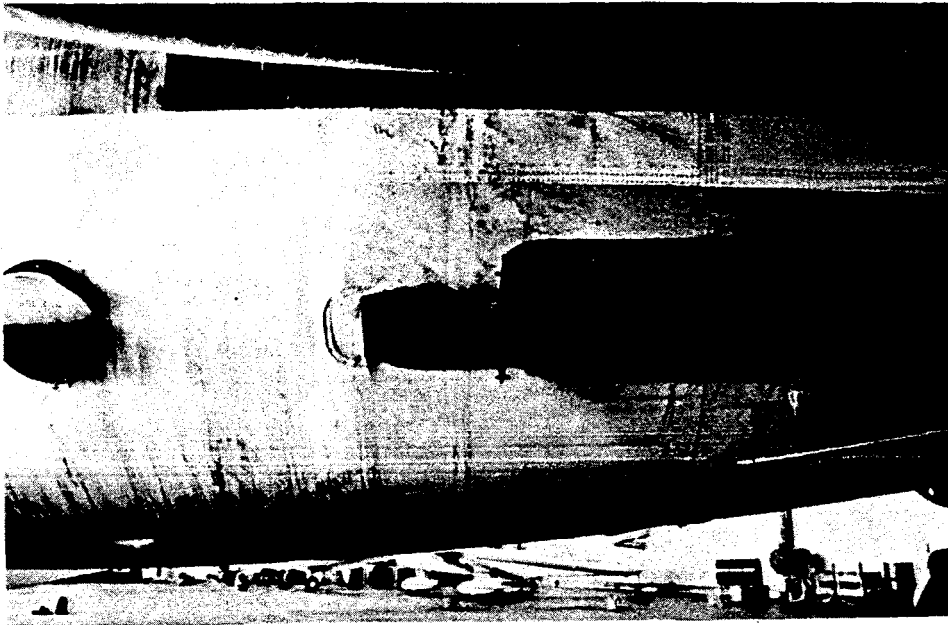
including the tailcone. The cabin air dump valve, at FS 920, was open, and light soot deposits trailed aft from around the edges of the valve. (See figure 5.)

Figure S.-Soot trail deposits on left side of fuselage at lavatory, service panel and outflow valve.

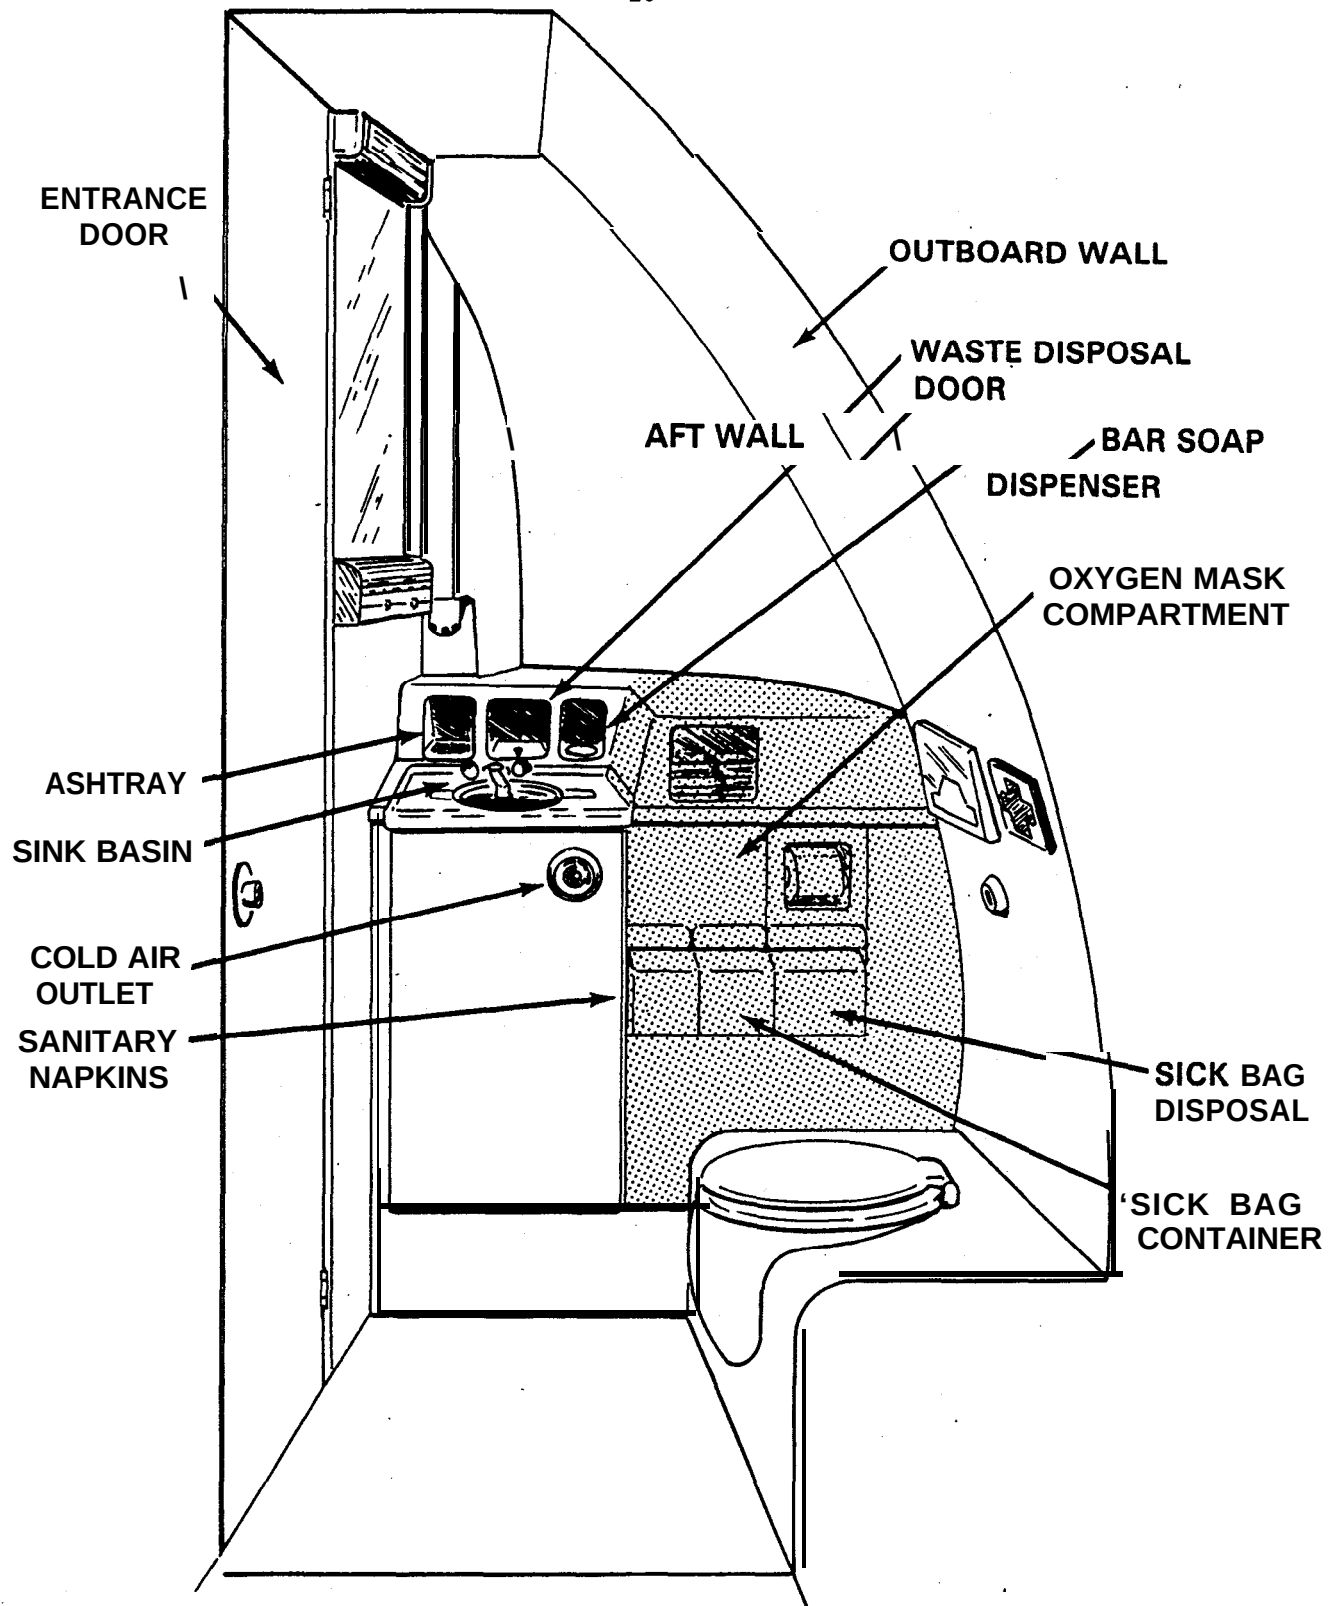
Figure 9.—Diagram of aff

The aft lavatory was on the left side of the cabin, and began at FS 965 and extended aft to FS 1019, or just forward of the aft pressure bulkhead. The lavatory's outboard wall conformed essentially to the shape of the airplane's fuselage. There was a vanity section containing a stainless steel sink and amenities located along and extending forward from the aft wall. The commode containing a flushing motor was located along the lavatory's outboard wall. A trash chute and container were located below and behind the sink, and a fresh air supply outlet was positioned below the sink in the door of the vanity. Also, below the trash container, an aluminum shelf was installed. In addition, there was an oxygen outlet located in the oxygen mask compartment in the amenities section. (See figures 9 and 10.)

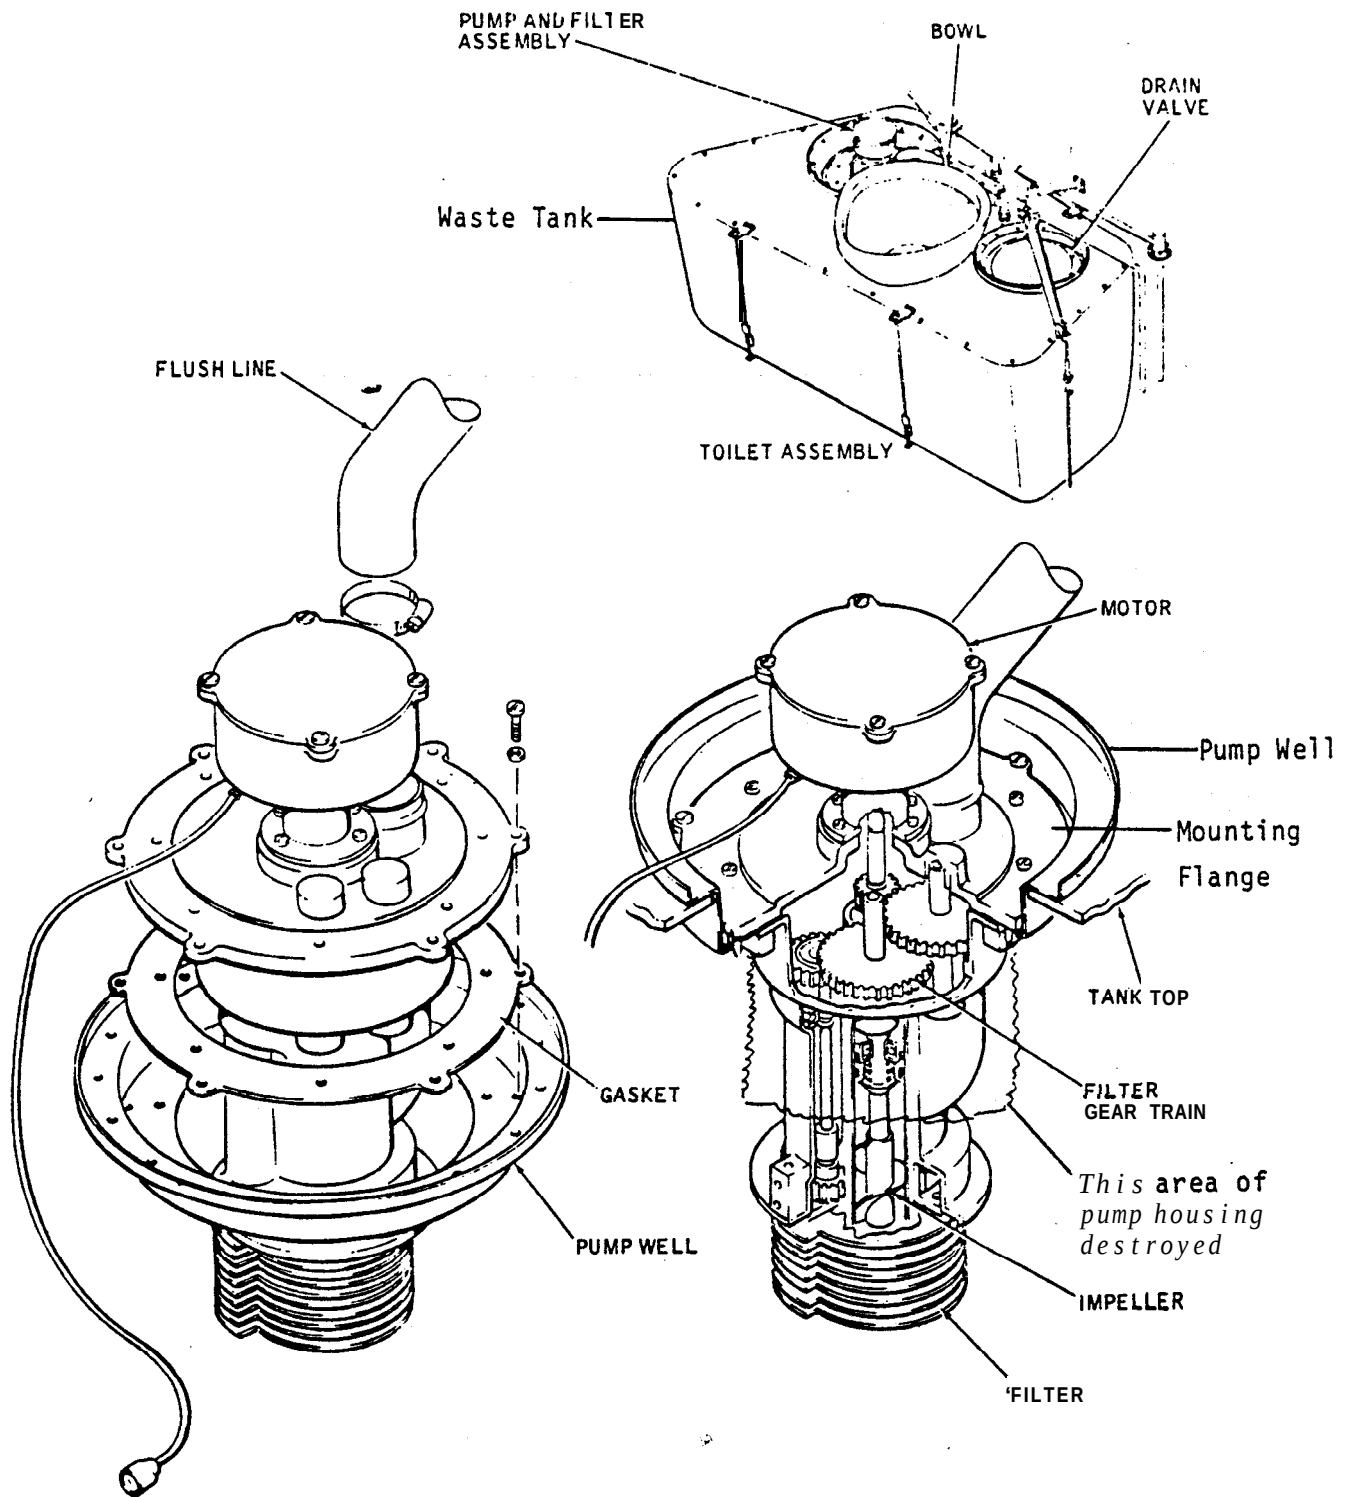
Figure 11.—Lavatory pump and filter system.

The flush motor was found attached to its mounting flange which was attached to the pump well. The flush motor assembly was found in approximately its normal position in the waste tank next to, but detached from, the flush pump and filter assembly. The motor housing was completely melted. Large concentrations of molten metal were found on the forward side of the mounting flange facing the toilet bowl, and on the aft side where the 3-phase electrical leads enter the motor housing. A portion of the wiring harness which supplies a.c. power to the flush timer, flush motor, and flush button was encased in the molten metal on the aft side of the motor. The rotor section of the flush motor was encased in molten metal above the field windings; however, the rotor did not appear to have been damaged extensively by heat. (See figure 11.)

The flush pump and filter assembly found in the waste tank was partially intact. The filter and pump mechanisms, which apparently had been located below the water line in the waste tank, were in good condition. Above the water line, the plastic housing for the pump and filter was melted away. This housing also encloses the filter gear train and is part of the assembly used to mount the pump and filter to the pump well. The exposed shaft and gears showed heat damage. The gears, which make up the filter gear train that connects the motor to the pump and filter, were found lying in the waste tank. The plastic mounting ring, which mates the pump and filter housing to the pump well, was found intact among the debris in the waste tank. There was some slight melting of the top surface of the mounting ring. All of the components of the flush motor and pump assembly were removed for further examination.
