PB94-910409  
NTSB/AAR-94/07

STALL AND LOSS OF CONTROL ON FINAL APPROACH  
ATLANTIC COAST AIRLINES, INC./  
UNITED EXPRESS FLIGHT 6291  
JETSTREAM 4101, N304UE  
COLUMBUS, OHIO  
JANUARY 7, 1994

**Adopted: October 6, 1994**

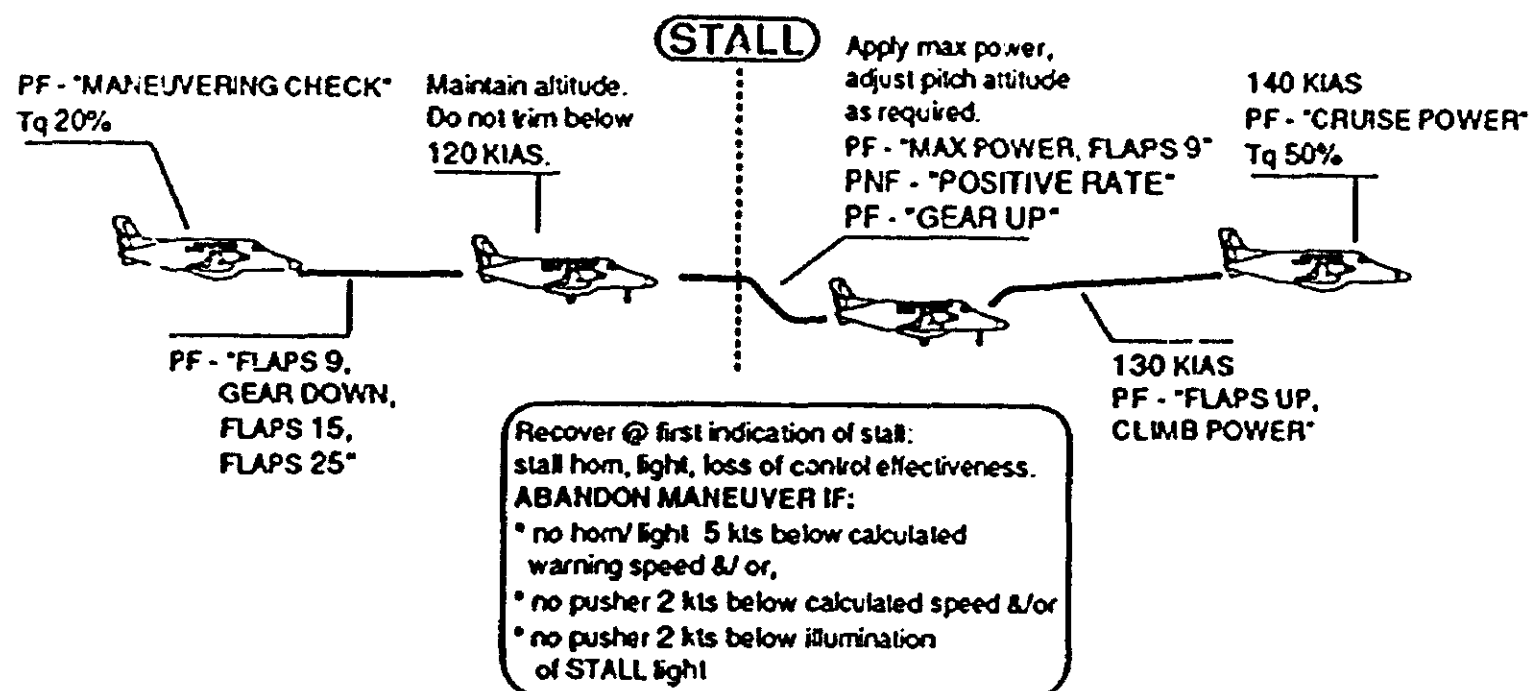
Figure 7.--J-4101 approach to stall -- landing configuration.

Figure 7 contains a graphic depiction of a J-4101 in landing configuration encountering a stall condition. It contains the procedure used to recover from such a situation.
