# NATIONAL TRANSPORTATION SAFETY BOARD

## AIRCRAFT ACCIDENT REPORT

IN-FLIGHT LOSS OF PROPELLER BLADE  
FORCED LANDING, AND COLLISION WITH TERRAIN  
ATLANTIC SOUTHEAST AIRLINES, INC., FLIGHT 529  
EMBRAER EMB-120RT, N256AS  
CARROLLTON, GEORGIA  
AUGUST 21, 1995

**Adopted: November 26, 1996  
Notation 6609B**

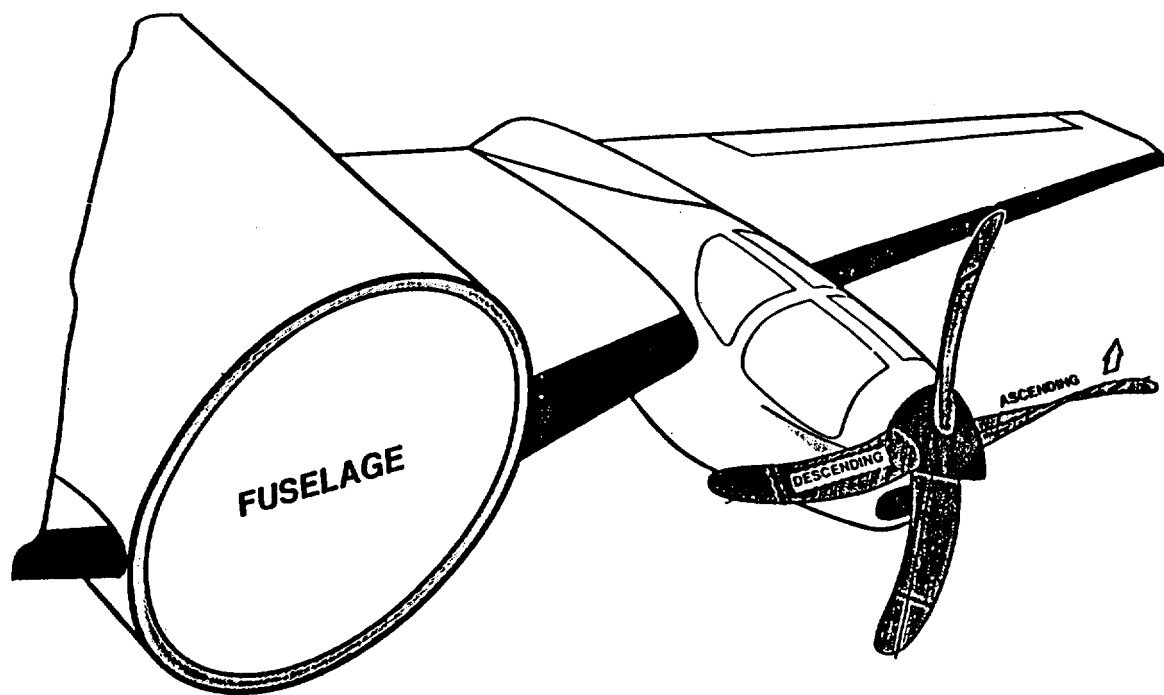
Figure 1.--Propeller installation - left wing.

Investigators found the left engine propeller assembly early in the ground debris path. The propeller hub contained three complete blades and about 1 foot of the inboard end of the fourth blade protruding from the hub. The remainder of the fourth blade was not at the accident site. (See Section 1.12 for more wreckage information.)

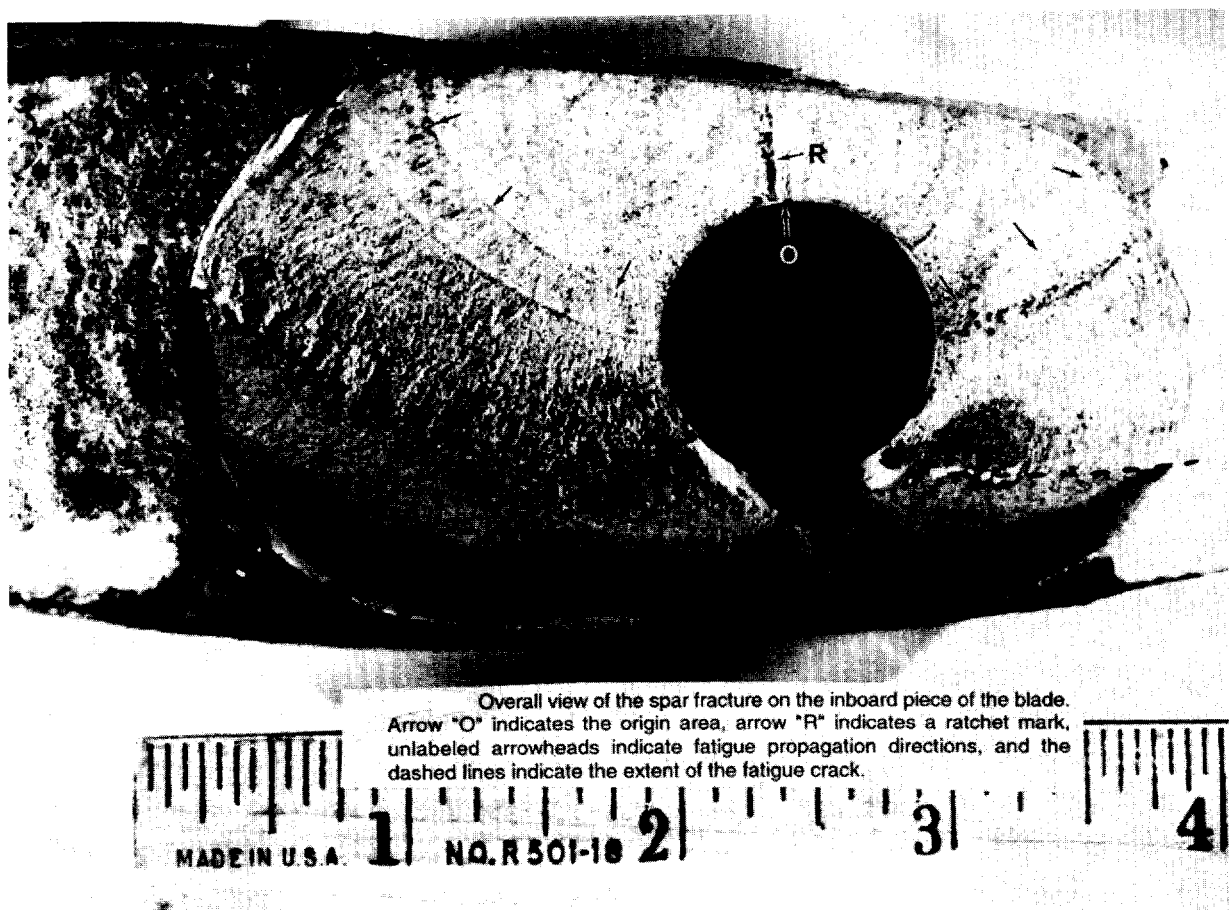
Figure 3.--Photo of the blade fracture surface.

The origin areas on both the inboard and outboard faces of the fracture were examined with a scanning electron microscope (SEM) before the faces of the fracture were cleaned. The fracture surface near the origin area on both faces of the fracture contained a layer of heavy oxide deposits that had a mud-cracked appearance. These deposits extended to a maximum depth of 0.049 inch from the taper bore surface. Their maximum circumferential width was 0.130 inch, based on the examination of the damaged outboard fracture face. X-ray energy dispersive spectroscopy (EDS) of the deposits of both faces generated similar spectra with a major peak for aluminum, a substantial peak for oxygen, and a minor peak for zinc.<sup>27</sup> EDS of the deposit area on the inboard fracture face also revealed the presence of chlorine.

After the fracture surface had been cleaned, additional SEM examination revealed that the fatigue cracking initiated from several corrosion pits in a line of pits in the taper bore that extended over a distance of about 0.070 inch. The maximum depth of the corrosion pitting at the fatigue origin area was measured as slightly less than 0.006 inch below the taper bore surface.

The taper bore surface, including the area adjacent to the fatigue initiation area, contained a series of nearly circumferential sanding marks. The marks extended over about 180 degrees of the circumference of the taper bore and to a maximum distance of about 1.5 inches inboard of the fracture surface. Outboard of the fracture, the sanding marks extended about 2 inches from the fracture surface.

The investigation revealed that sanding rework of the area had been accomplished using the blending repair procedures contained in PS960A.<sup>28</sup> The procedures required that the surface finish of the blended area should be restored to the original surface finish. Postaccident surface profilometer measurements conducted on the taper bore sanding marks indicated that the surface finish was much rougher than the manufactured surface not disturbed by the rework process.<sup>29</sup> Measurements also indicated that the nondisturbed surface met the manufacturing specifications.
