**AIRCRAFT ACCIDENT REPORT 1/2010**

**Air Accidents Investigation Branch**

**Report on the accident to  
Boeing 777-236ER, G-YMMM,  
at London Heathrow Airport  
on 17 January 2008**

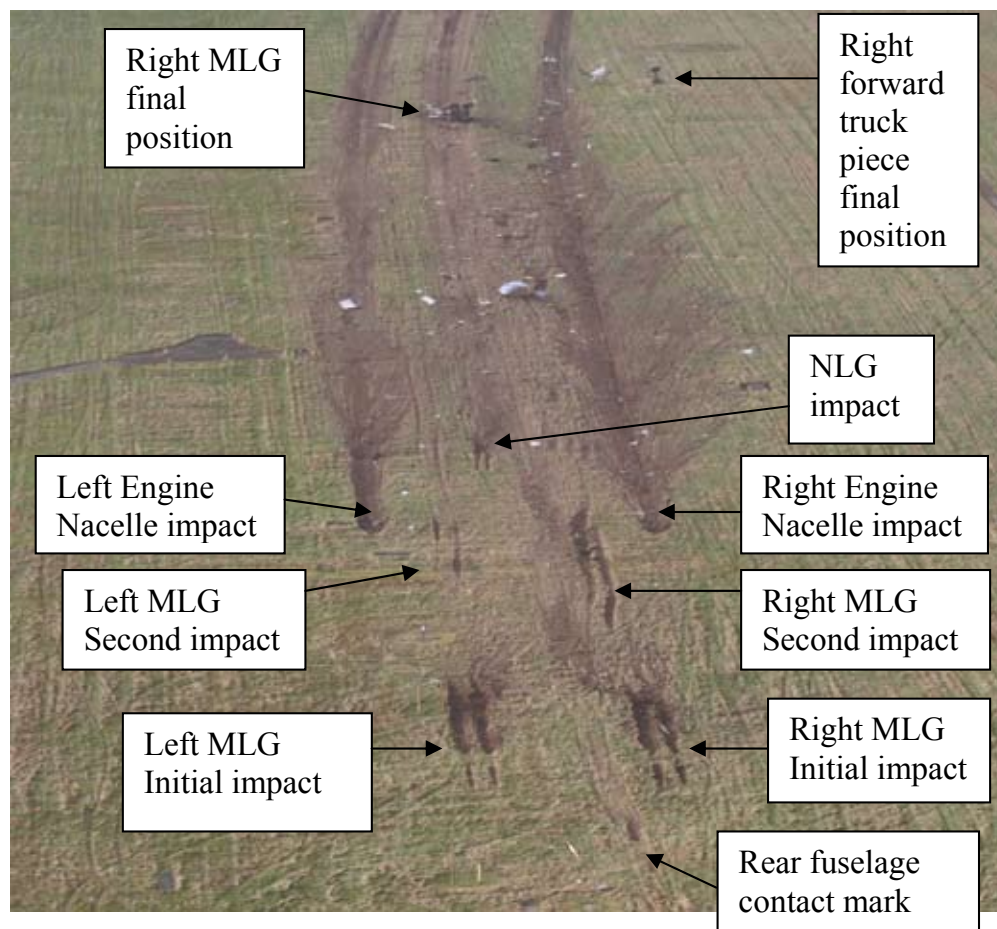
Approximately 40 m beyond its initial contact, the left engine struck the concrete cover of the southern inspection pit, which caused severe disruption to the front and lower engine area and the failure of the majority of its fan blades.

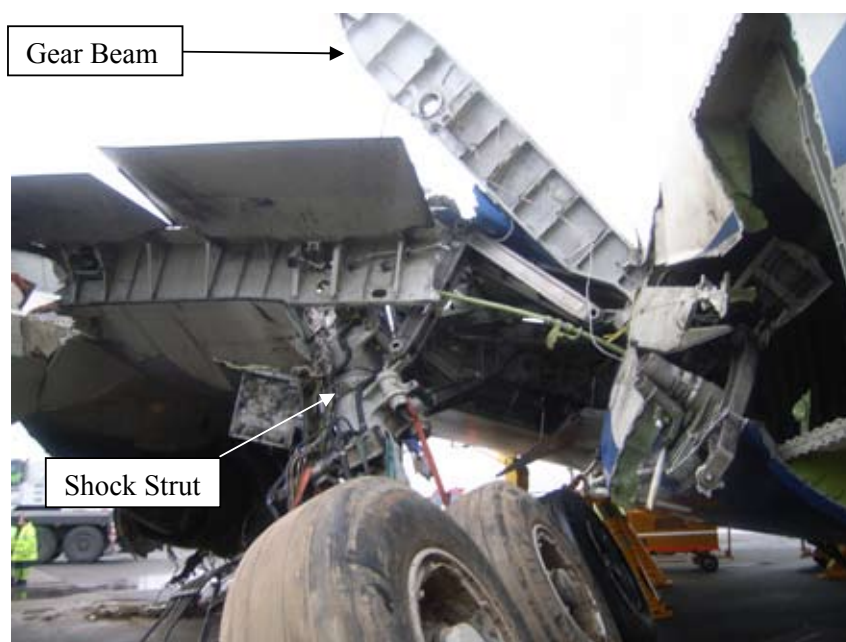
**Figure 25**

The left MLG had partially separated due to overload but remained attached to the fuselage by the drag and side braces. During the initial impact the gear beam outboard end fuse pin had fractured, which allowed the gear beam to rotate upwards. The trunnion housing fuse pins then also fractured, allowing the forward trunnion to move upwards. The significant vertical load had also resulted in a piece of top wing skin being removed. There were witness marks on the aft trunnion outer bearing race, consistent with the aft trunnion then having been pulled out. The attachment of the inboard end of the gear beam was damaged but remained intact; the drag strut fuse pin had 'crankshafted' in a direction indicating that a load had been applied in tension but this had also remained intact.

The truck beam had evidence of damage due to over-travel in the truck pitch-up direction. There was no visible damage to the shock strut or centre axle

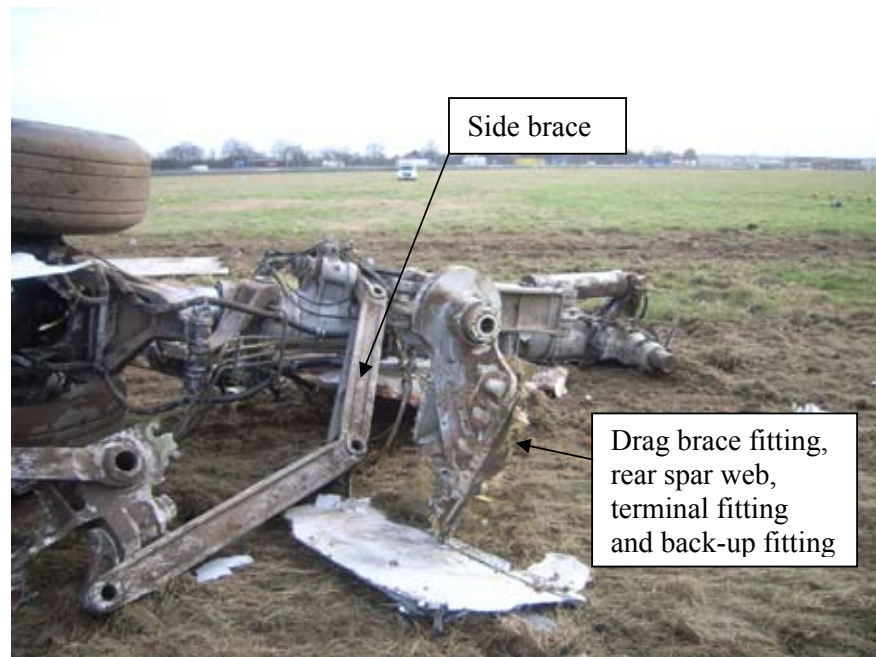
**Figure 26**

During the subsequent ground slide the right MLG had separated from the aircraft, rupturing the rear wing spar web. The drag brace support fitting, together with portions of the rear spar web, rear terminal fitting and the internal back-up fitting remained attached to the right main landing gear around the drag brace fitting. Examination of the fracture surfaces indicated an overload in the aft direction.

Right Main Landing Gear with rear spar web

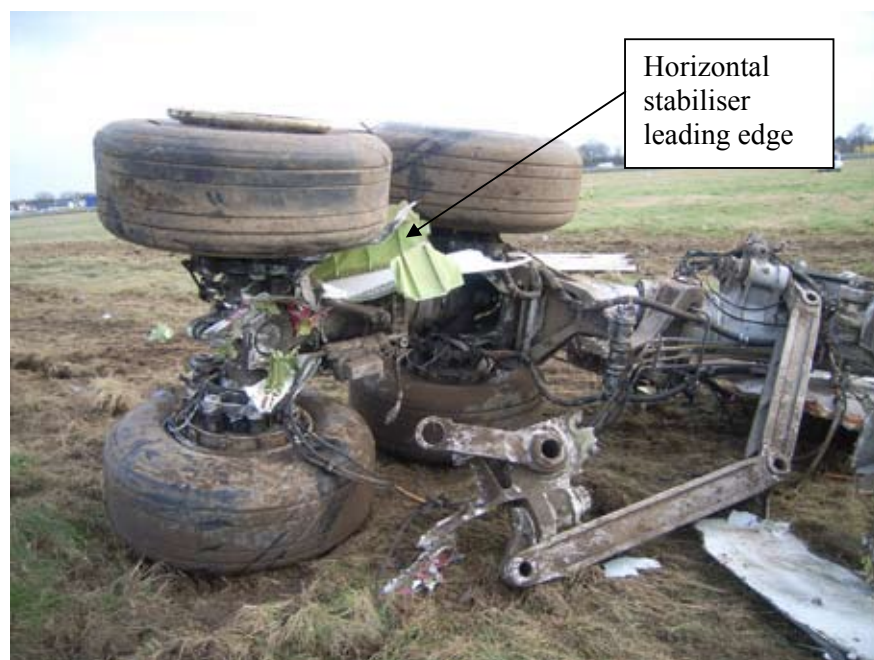
**Figure 27**

Right Main Landing Gear with embedded portion of right horizontal stabiliser leading edge

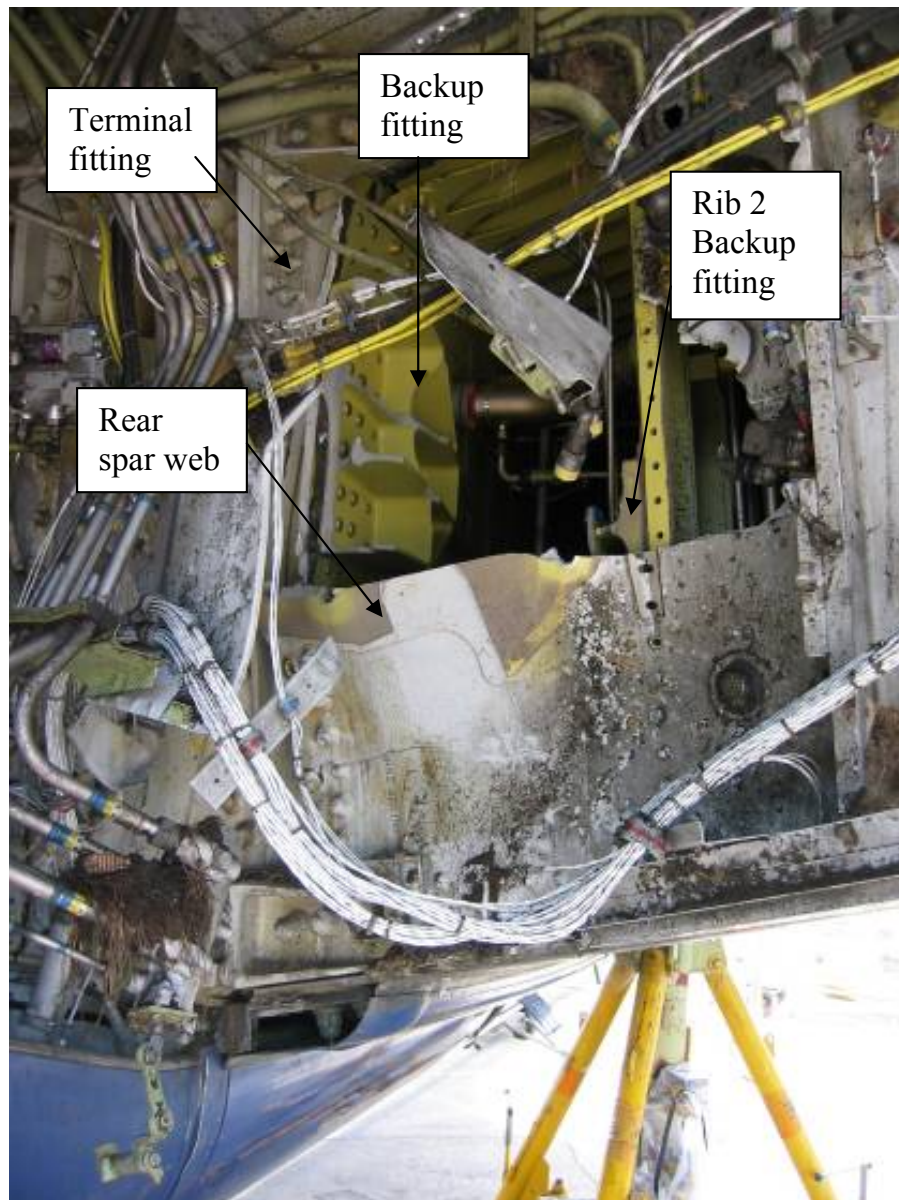
**Figure 28**

Right rear spar showing missing drag brace attachment point and centre fuel tank structure

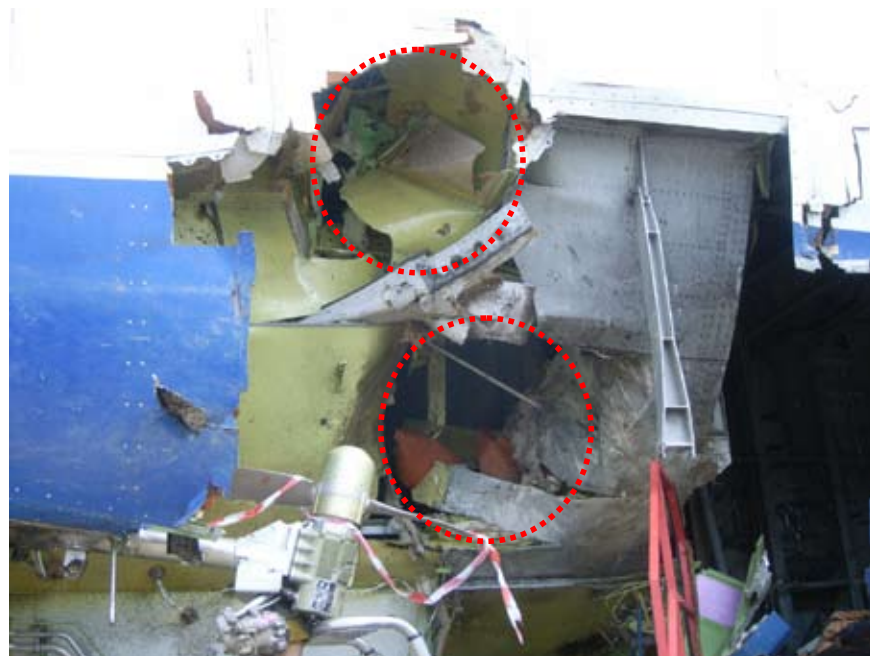
**Figure 29**

The two front wheels of the right MLG, together with the forward section of the truck beam ahead of the centre axle became detached and impacted the right side of the fuselage.

View showing damage to right fuselage aft of the MLG bay.  
(Dotted lines indicate impact marks from the rear two wheels of  
the truck beam)

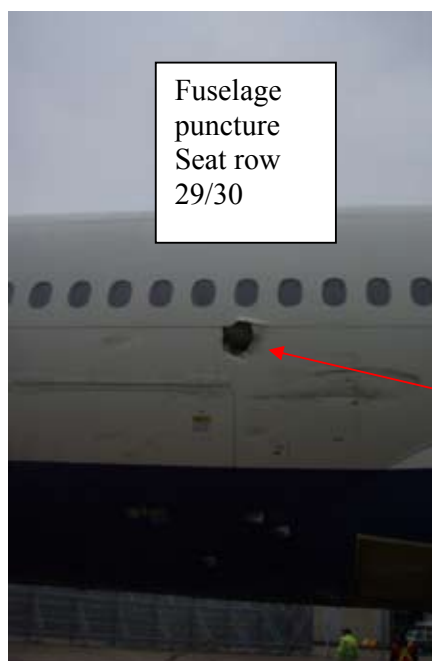
**Figure 30**

Right side of fuselage showing  
damage at seat rows 29/30

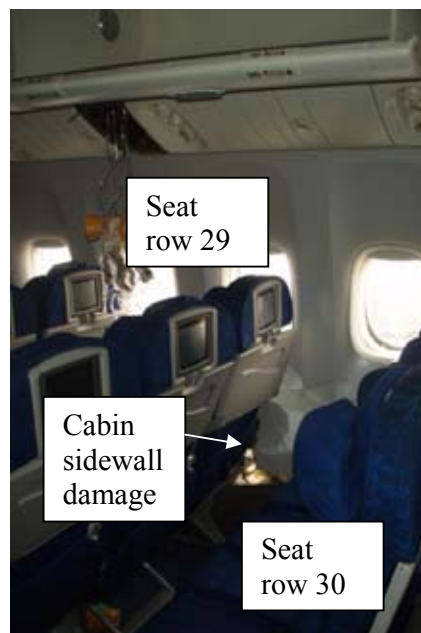
**Figure 33**

The right MLG forward truck beam and its wheels had punctured the right side of the fuselage adjacent to seat rows 29-30, at the height of the seat armrest (Figures 33 and 34). This had breached the fuselage outer skin, insulation blankets and the cabin lining panel. The sidewall lining had been pushed into the cabin, resulting in the injury to the passenger seated in 30K and the failure of the outboard spreader bar extension of seat 29K.

Cabin damage at rows 29/30

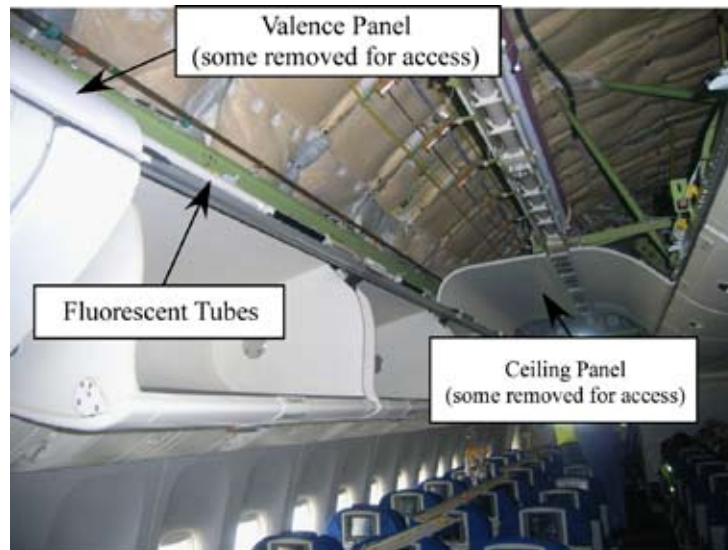
**Figure 36**

A further, detailed examination showed that on the right side there were eight fluorescent tubes missing. Of these, five had separated from the fixtures but were intact and were lodged above the overhead bins behind the valence panels. Three fluorescent tubes had broken. On the left side there were ten fluorescent tubes missing; five tubes had separated but were intact and five had broken. Three of the fixtures were damaged but the tube retaining end fittings were still functional. The gap between the ceiling panel and the valence panel contained numerous fragments from the fluorescent tubes.

Overhead lighting, showing loose fluorescent tubes

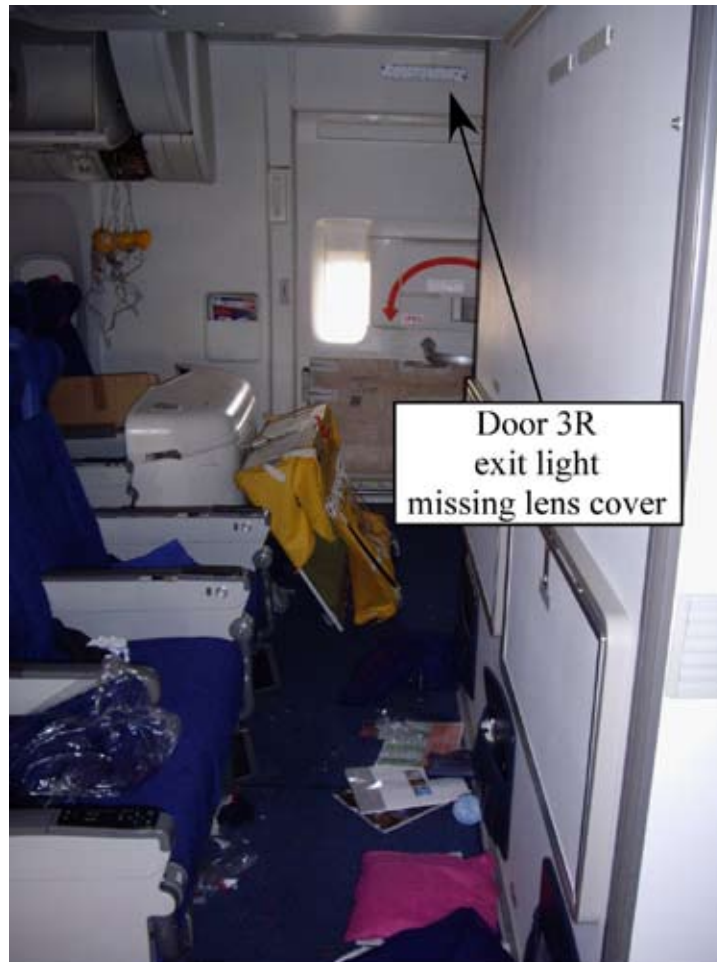
**Figure 38**

The exit signs light lenses were found to have detached from Door 3L and 3R (Figure 38) and it was evident that any misalignment of the plastic door mouldings resulted in difficulty in engaging all four of the mounting clips.

View showing Door 3R with the exit light lens cover missing

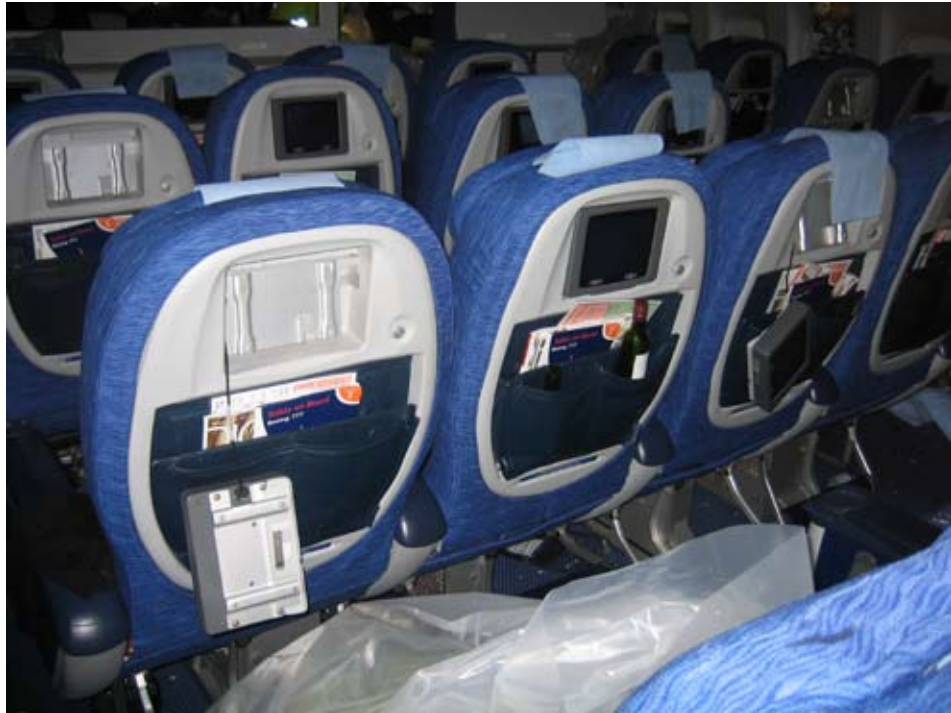
**Figure 39**

Further examination revealed that by exerting a downward force by hand, it was possible to detach one of the monitors which otherwise appeared to be correctly located. The spring clip attachments were found to be loose, allowing movement of the clip and preventing correct engagement in the detent.

Business Economy section showing video monitors detached from the seat backs

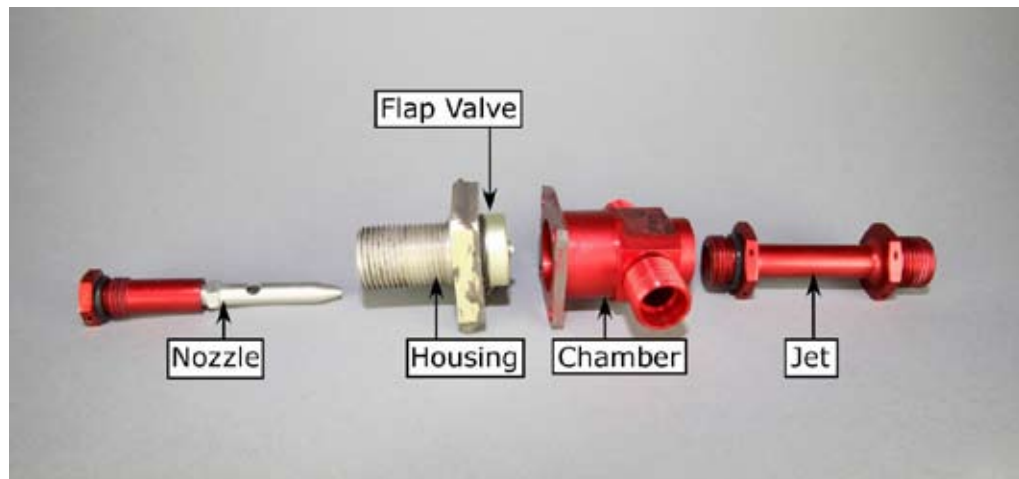
**Figure 44**

When the nozzle from the right main scavenge jet pump was removed from its housing half a teaspoon of a 'jelly-like' substance, later identified in a laboratory as "water", was found in the housing. It is not known if this water was originally lodged in the nozzle and was pulled through the flap valve into the housing, or whether the water had been introduced into the housing during a previous maintenance activity. The water was tested for microbiological contamination and the quantity of contamination was assessed as negligible.

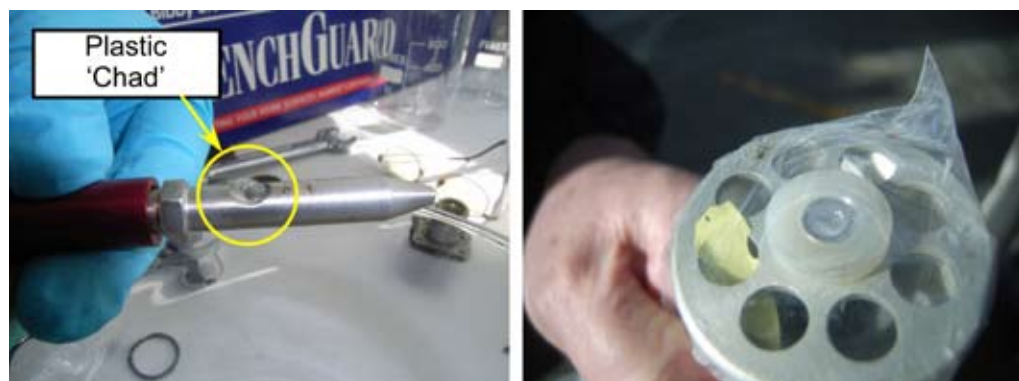
**Figure 45**

A 6 mm plastic disc (chad) was found in the chamber of the right main scavenge jet pump, which was large enough to block one of the ports in the nozzle, Figure 45. A flake of paint was found trapped in the pipe between the scavenge inlet and the chamber (Figure 45). From a swab taken from the inside of the chamber, it was established that there was a moderate amount of microbiological contamination on the internal surfaces of the chamber.

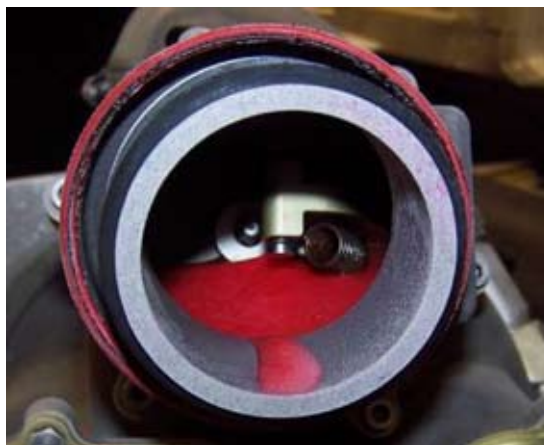
**Figure 51**

To explore this theory, a number of tests were carried out using dyed water that had been frozen in a check valve housing (Figure 51). In one test, compressed air was applied to the valve which started to open when the pressure was approximately 3 to 4 psi. On another test, with the housing fitted to the rig, it was possible to achieve a flow of 28,000 pph. At the end of these tests the ice chip was still located in the housing.
