## ENGINEERING REPORT

ENGINEERING REPORT EP 36/90  
RAPPORT TECHNIQUE

FLIGHT RECORDER PLAYBACK

Airbus A320, VT-EPN  
Bangalore, India  
February 14, 1990

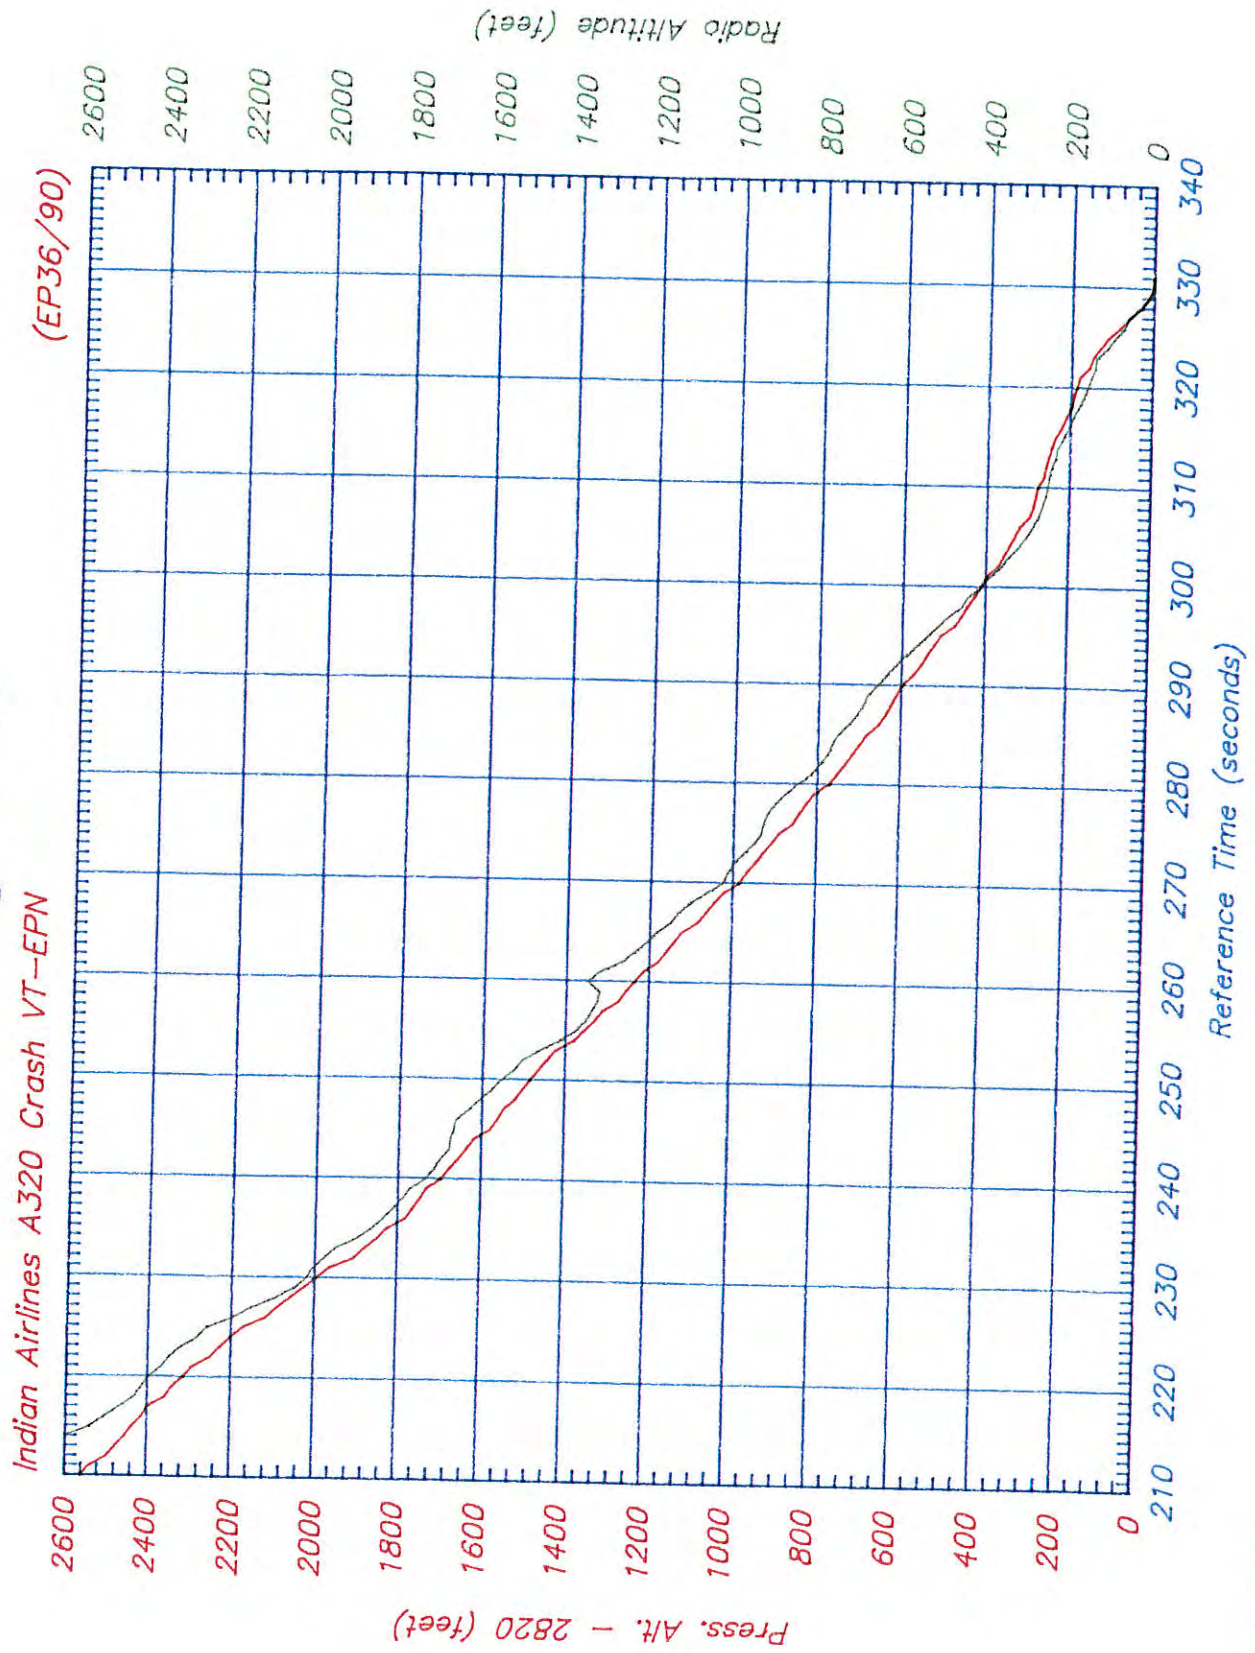
# Figure 2a

- 3.4 The altitude for the flight reconstruction was determined by plotting the radio altitude and the pressure altitude on the same scales and attempting to correlate the two (Figures 2a and 2b of Appendix 'A'). The pressure altitude was matched to the radio altitude of 12 feet at time 328 (subtracting 2830 feet). The values of pressure altitude at 329 and 330 were set to the corresponding radio altitude values as the pressure altitude values were obviously in error, probably due to ground effect and impact. The aircraft was 'flown' for the purposes of flight reconstruction, with the pressure altitude, matched to the radio altitude and corrected for the last two pressure altitude values which were determined to be invalid.
