# BEA

*Accident  
on 25 July 2000  
at La Patte d'Oie  
in Gonesse (95)  
to the Concorde  
registered F-BTSC  
operated by Air France*

**REPORT translation**  
**f-sc000725a**

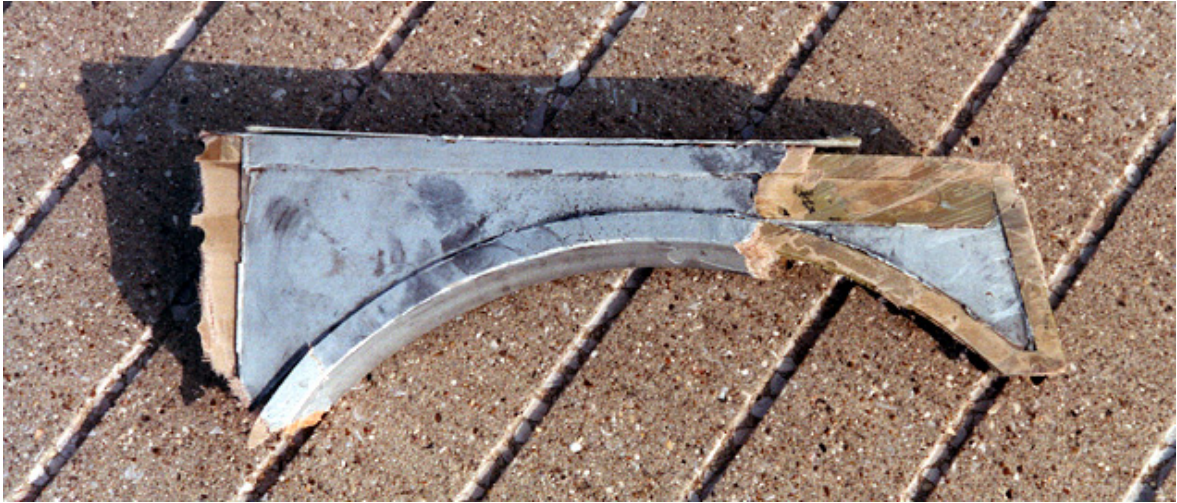
**Figure 19: Part located at line 157 - right part of deflector**

Parts of the water deflector of the left main landing gear were found between Slabs 139 and 166, that is 1,642 to 1,845 m from the beginning of runway 26 right, more precisely at 139, 149, 151, 157 and 166. The parts found did not include metallic parts.

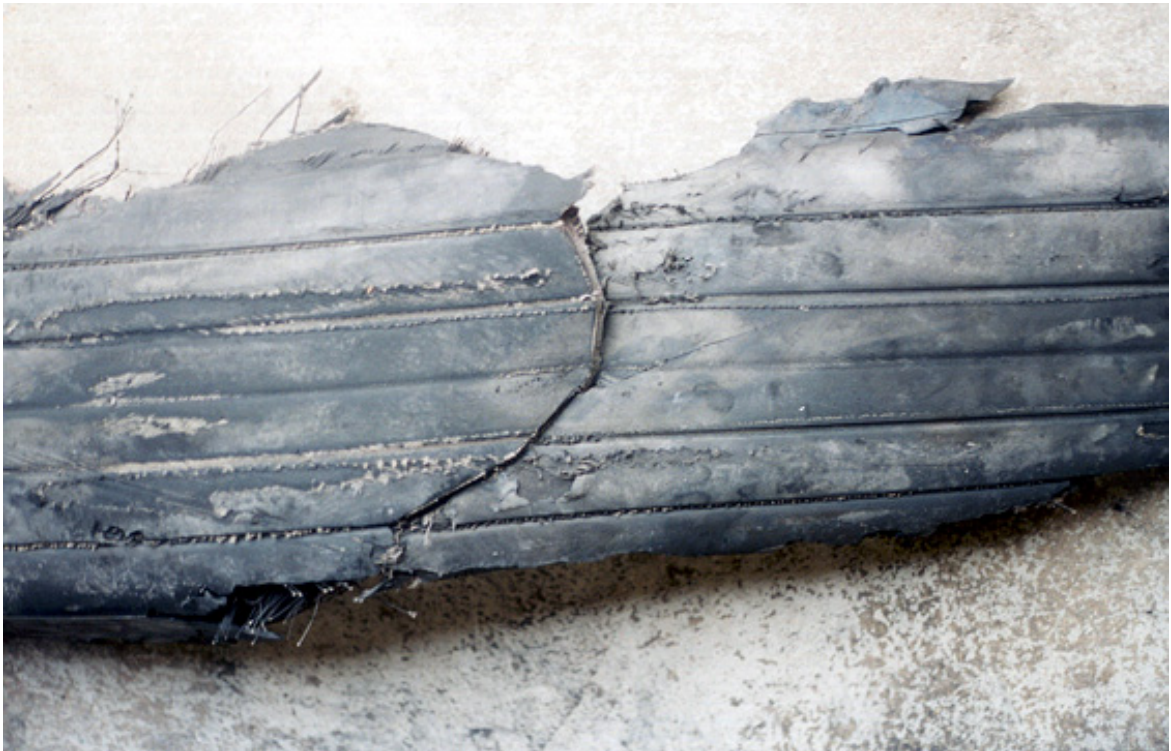
**Figure 20: Piece of tyre at line 180 - piece of tyre at line 152**

Pieces of tyre from the Concorde were found at slab levels 146, 152, 166, 180, 186 and 187. The parts found at Slab 152 level (a piece measuring 100 x 33 cm and weighing about 4.5 kg) and that found at Slab 180 level fitted together. Visual inspection revealed a transverse cut about 32 centimetres long.

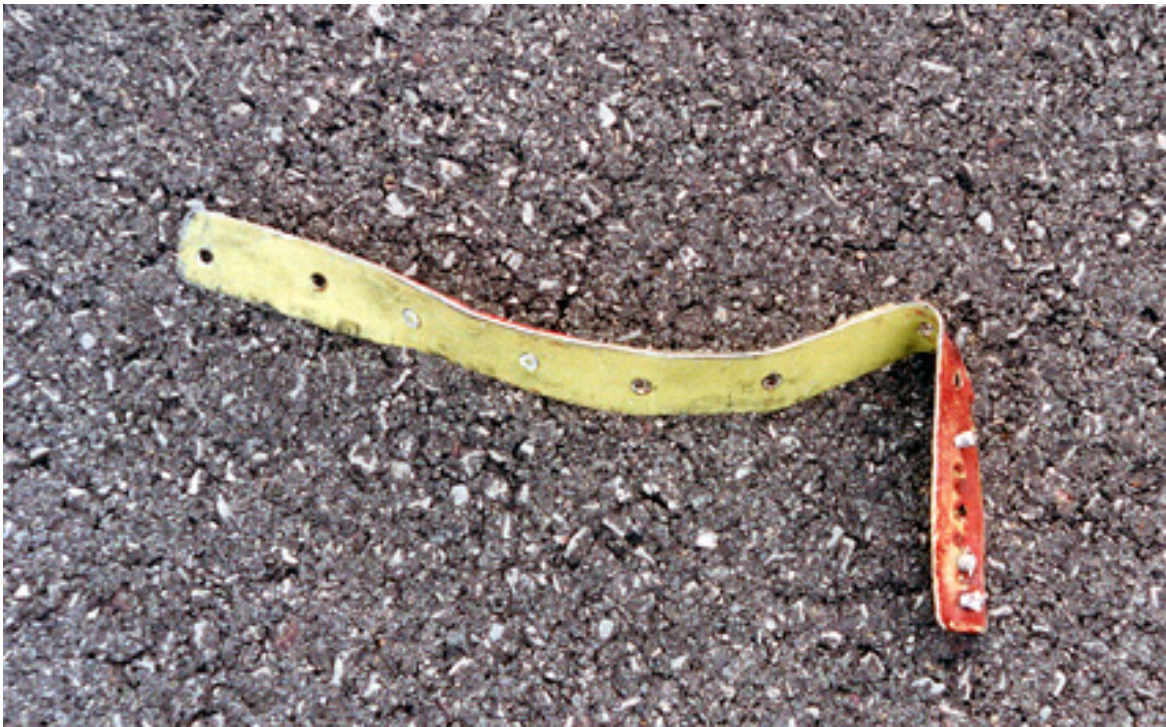
Figure 21: Piece found at line 152

This piece was not identified as part of the Concorde.

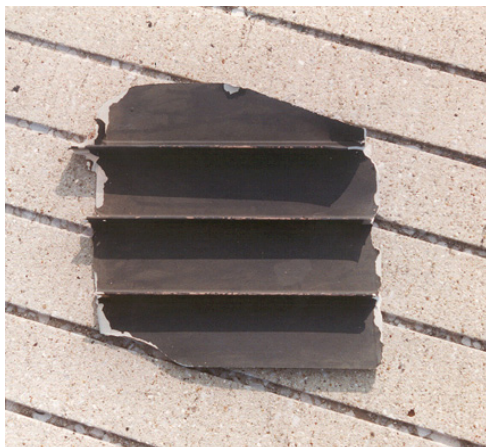
Figure 22: Part found at line 160

A ribbed structural part measuring about 32 x 32 cm was found at Slab 160 level. It was white on the external side and dark on the ribbed side. It came from the aircraft's No 5 fuel tank. It showed no signs of impact damage.

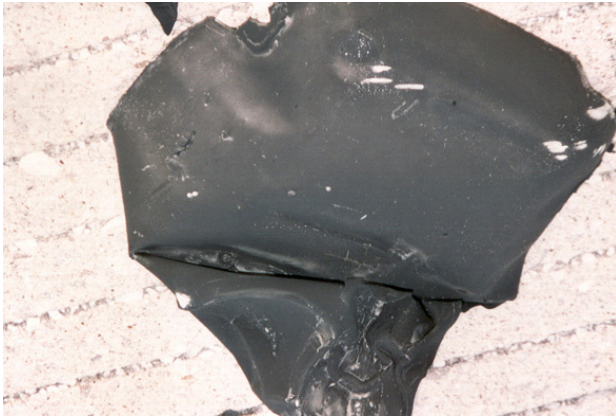
An inboard alloy part, identified as the brake servo valve cover, from the left main landing gear, was found at Slab 175 level. This part was sooted and had clearly been overheated. It had impact deformation.

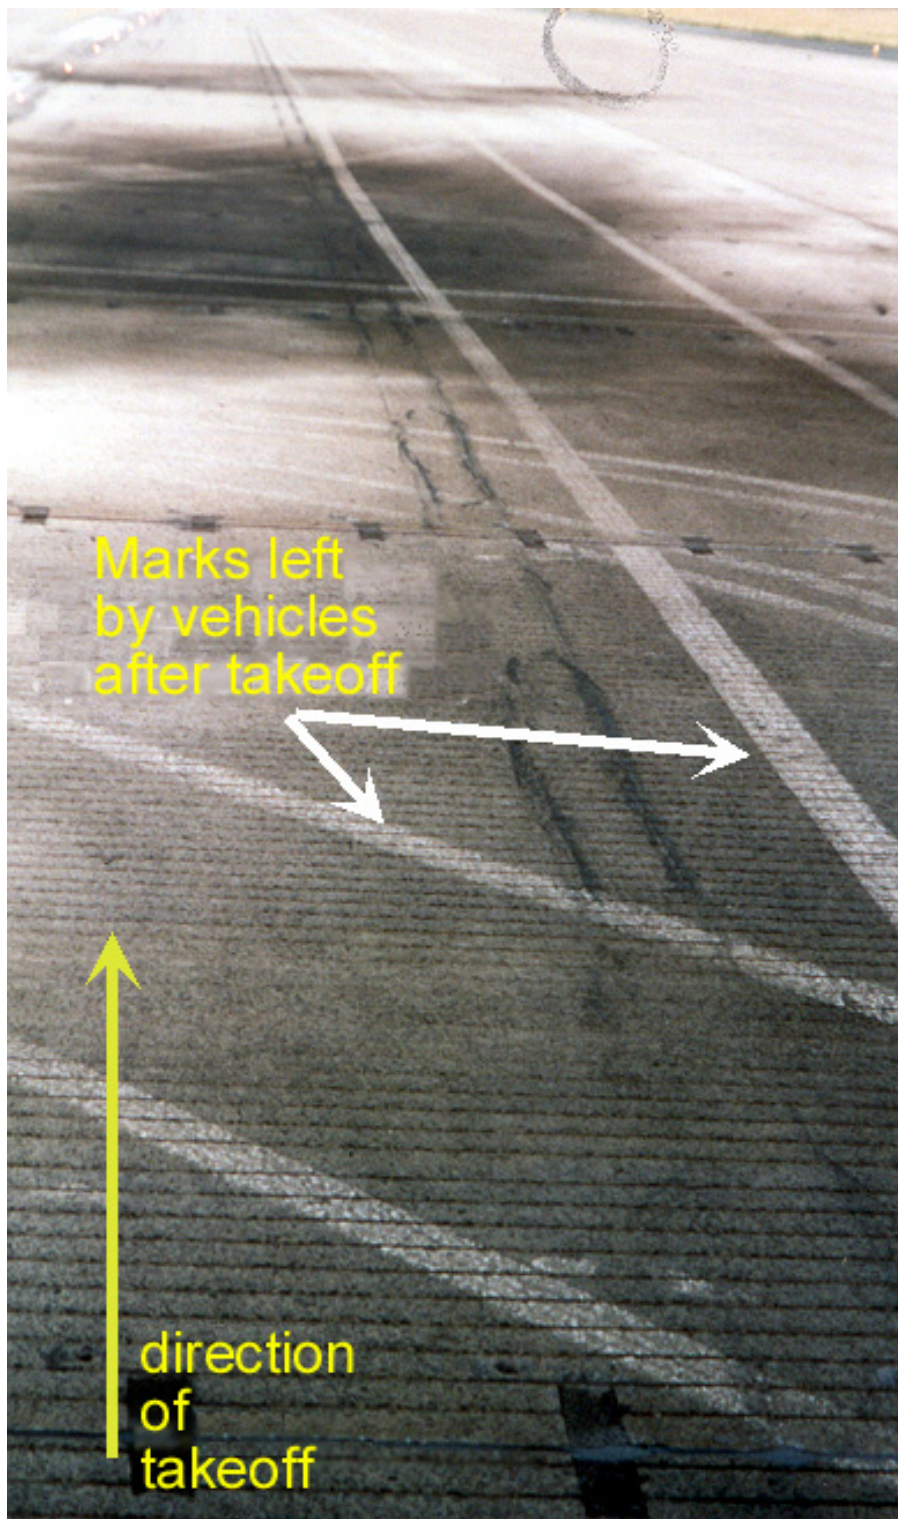
**Figure 24: Marks of Wheel No 2 and soot on the runway**

When this mark disappeared at about 2,340 m, its displacement from the centreline was about 8 m. This corresponded to the right front tyre of the aircraft's left landing gear.

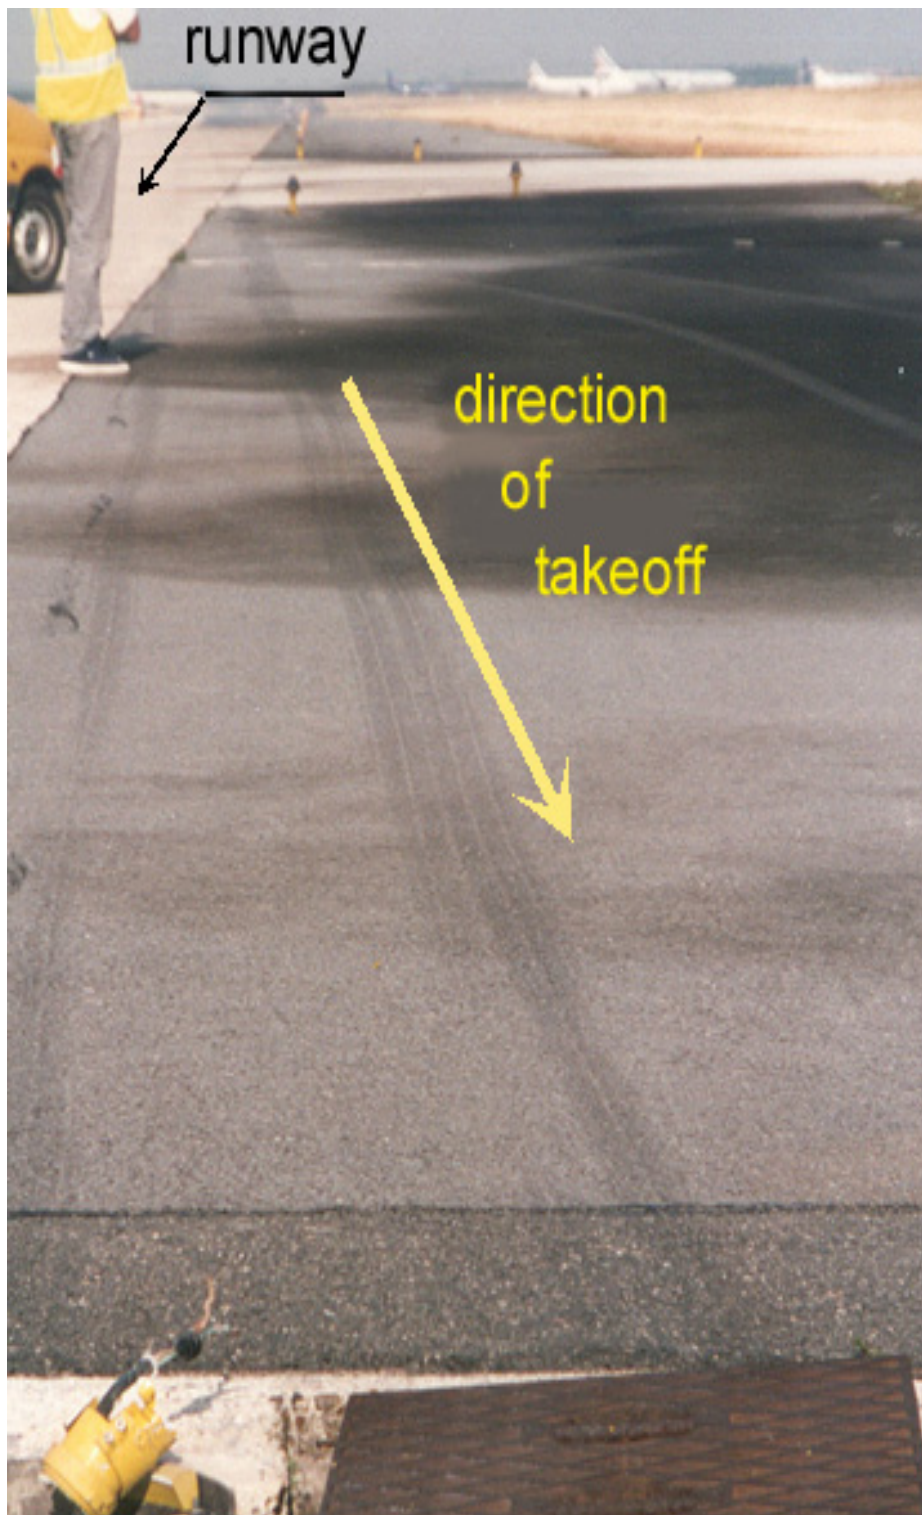
**Figure 25: Marks of left bogie tyres and edge light**

After that point, the tracks become intermittent then disappear at about 2,830 metres from the runway threshold

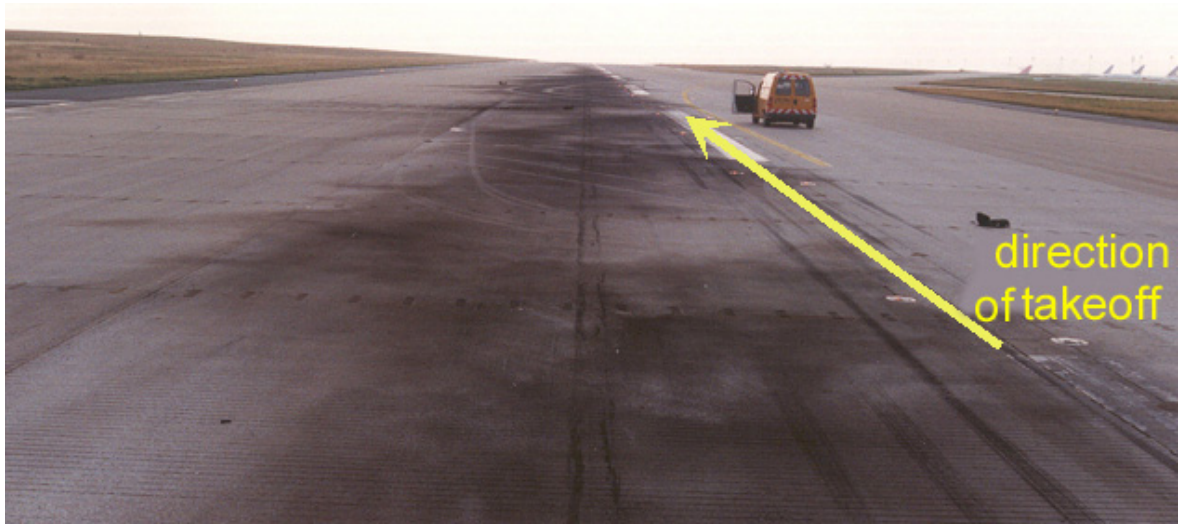
**Figure 26: Soot marks on the runway**

combustion of kerosene, were apparent on the runway 1,860 m onward from the origin (Slab 168). These were large and dense up to 2,300 m and then became less dense and rich in carbon up to taxiway S4, at 2,770 metres. The traces, which were on average 7 m wide, were initially centred on the damaged wheel ground mark and progressed towards the left.

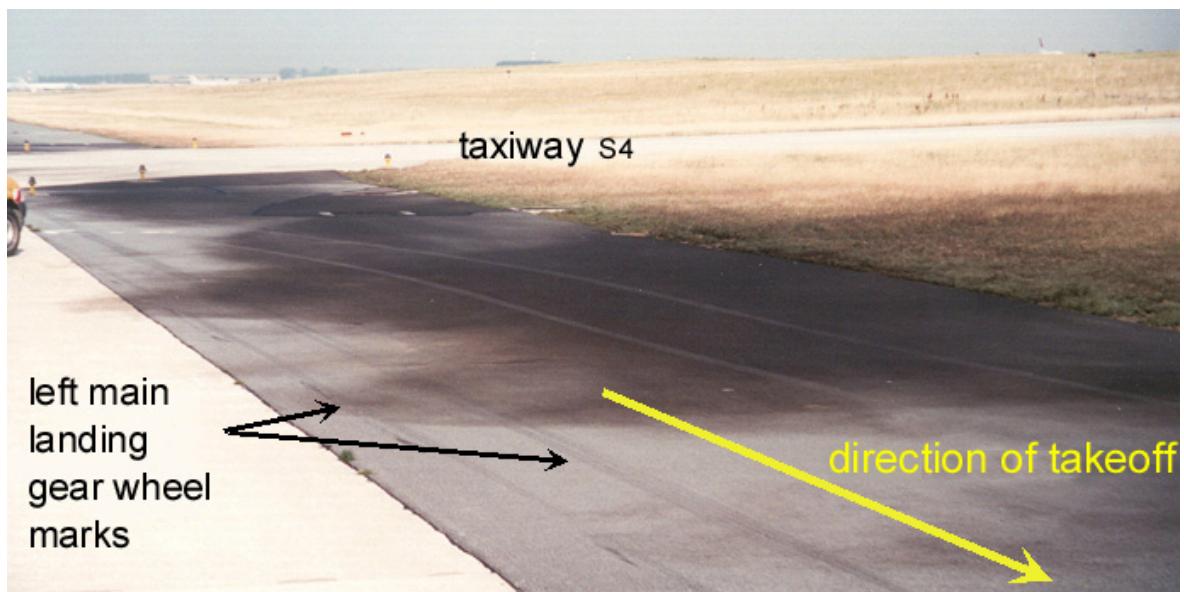
**Figure 27: Left main gear wheel marks**

A further sooted area was apparent after taxiway S4 up to the broken edge light.

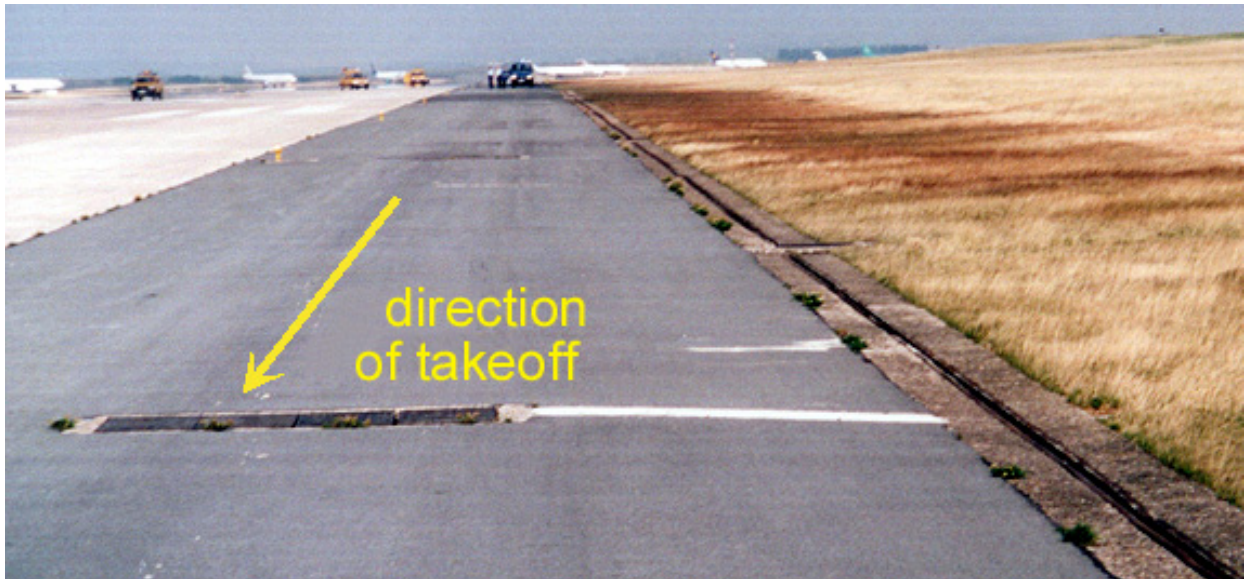
**Figure 28: Burnt grass on the edge on the runway**

The grass was burnt adjacent to the runway edge, between 2,902 and 3,165 metres. This area, also featuring soot deposits, indicated that there was an extensive flame after the aircraft became airborne.

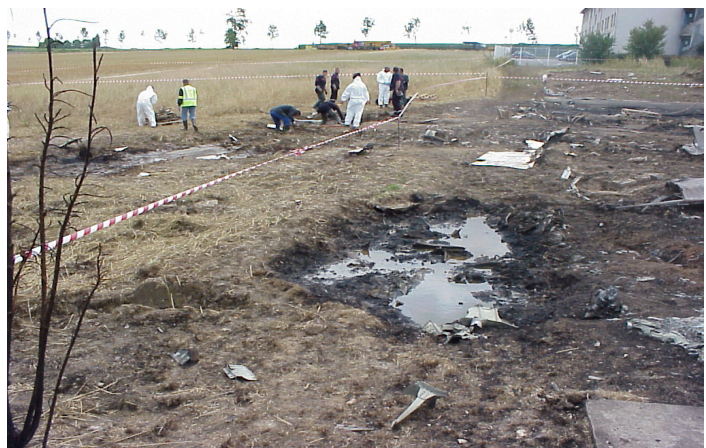
**Figure 32: Impact marks**

Signs of ground impact were found to the north of the site at the intersection of areas A and B. There was a row of trees about three metres high, oriented east to west, then a crater at the bottom of which was rear tank 11. Pieces of engine air intake were found half-buried at A3 and signs of ground impact were apparent at A3 and CB2-North. Wheel No 6 was embedded in the ground.

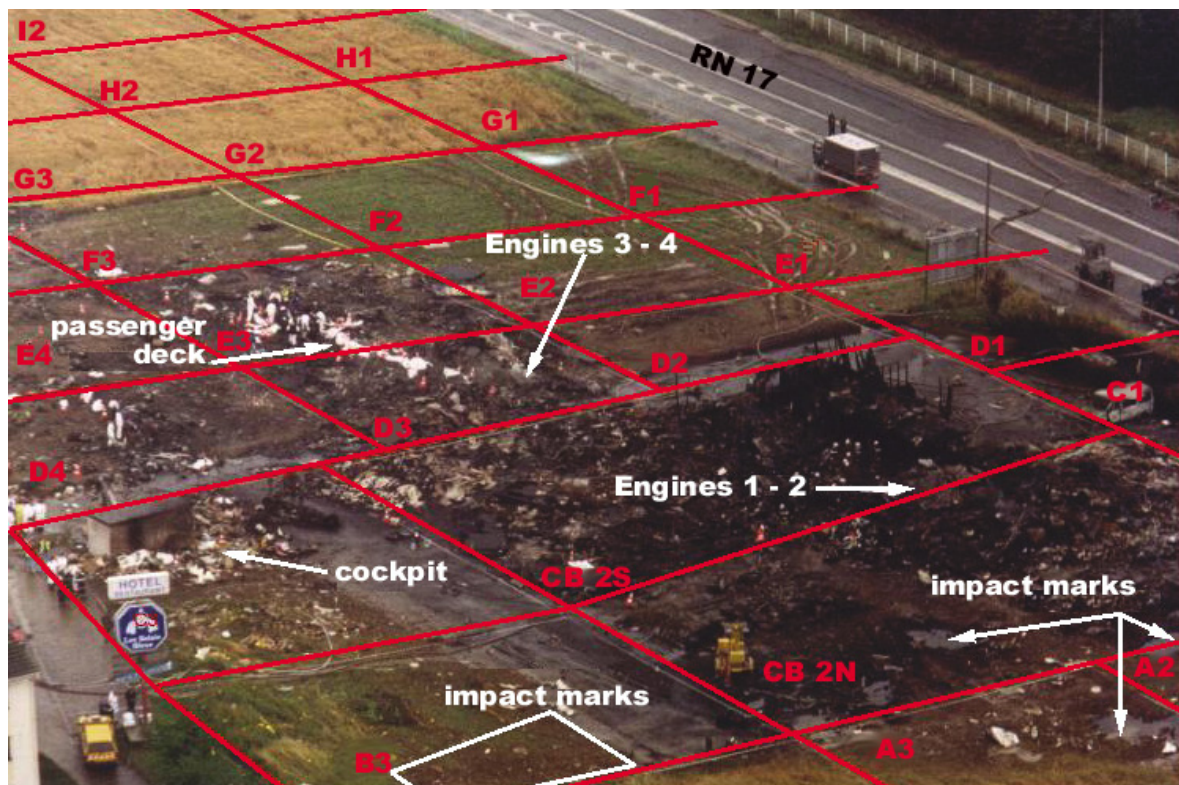
**Figure 33: Aerial view with position of main parts**

The left main landing gear leg, still connected to its side strut, was found at CB2-South. Examination of the strut's locking mechanism showed that the landing gear was down and locked at the time of impact.

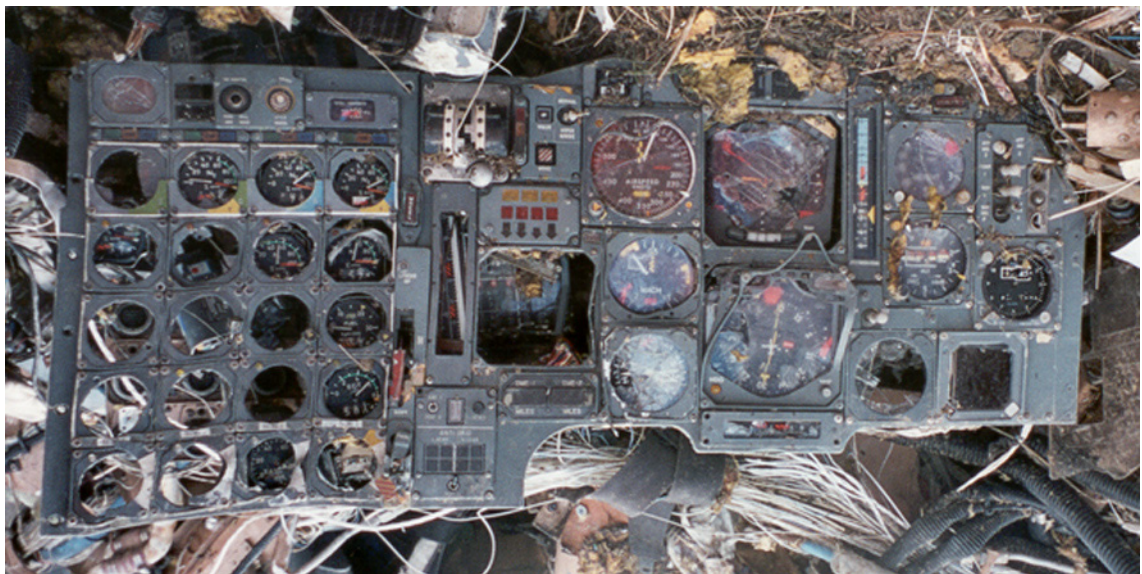
**Figure 34: Overall view of instrument panel**

- the Nose/Visor lever was in the "Down" position
- the landing gear selector was towards the "Down" position, past the gate
- on the rudder position indicator (damaged on impact), the rudder indicators were at 20° left for the upper control surface and 12° right for the lower control surface on "G" (Green). The indicators for the elevons were on "M" (Mechanical) and provided no information
- the airspeed shown on the airspeed indicator was 99 Kt, "STBY" flag, and V2 bug was on 230 kt
- HSI heading 105°, ADI 30° roll to the left and 32° nose down. Vz - 1,800 ft/min, altimeter - 240 feet "STBY" flag, radio altimeter unreadable, VOR1 028°, VOR2 038°
- FD switch on number 2
- attitude selector on ATT INS3, comparator on COMP2, deviation on DEV2, navigation on NAV INS2
- clock on 14 h 45 UTC

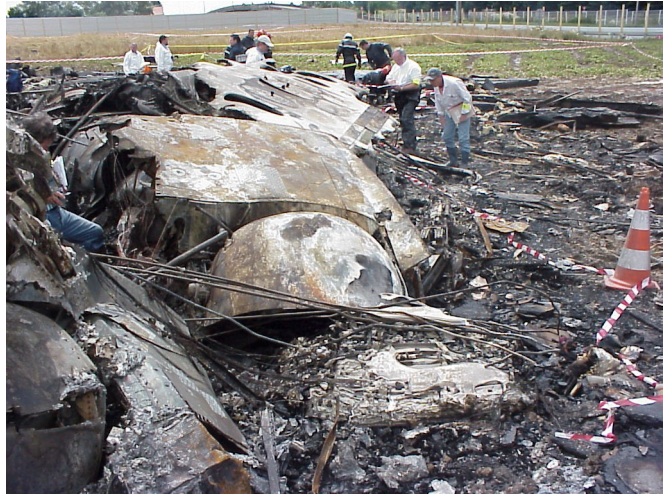
**Figure 35: General view of engine 4 upper nozzle**

The upper secondary exhaust nozzles were still in place on engines 1, 2, 4 and separated from the nozzle structure on engine 3. The lower secondary exhaust nozzles were separated from the structure and three of them were found intact. The upper actuators from engines 2 and 4 were attached to the structure and to the nozzles. The lower actuators were found at the site with the exception of that of engine 3.

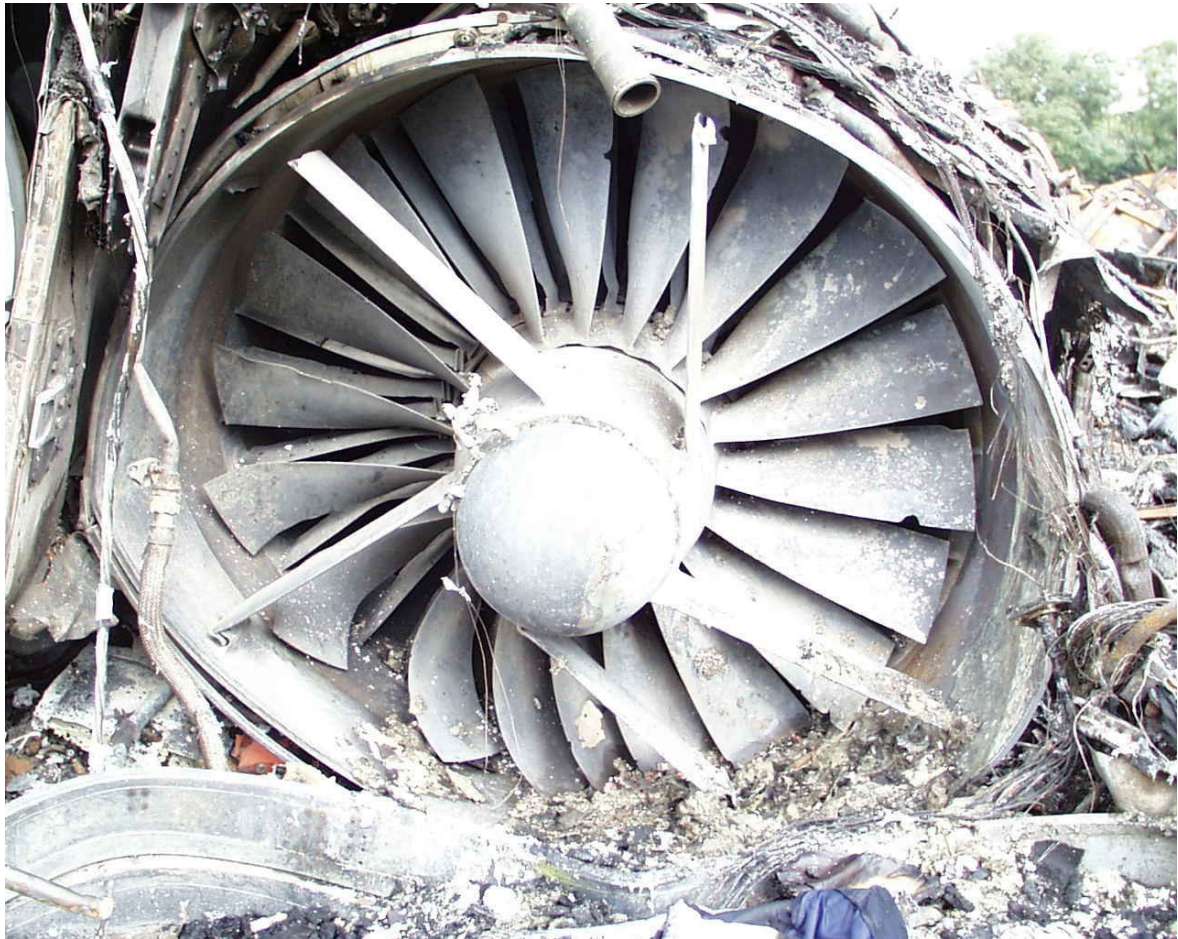
**Figure 37: Engine 1 LP compressor**

Examination of engine 2 appears to indicate a negligible N1 before impact. The rotor of the LP compressor of engine 1 apparently made less than a quarter of a revolution after the impact before being stopped by the casing being crushed.
