REPORT # H80001

Aircraft Accident

*Boeing 737, C-FPWC*

*Cranbrook, B.C.*

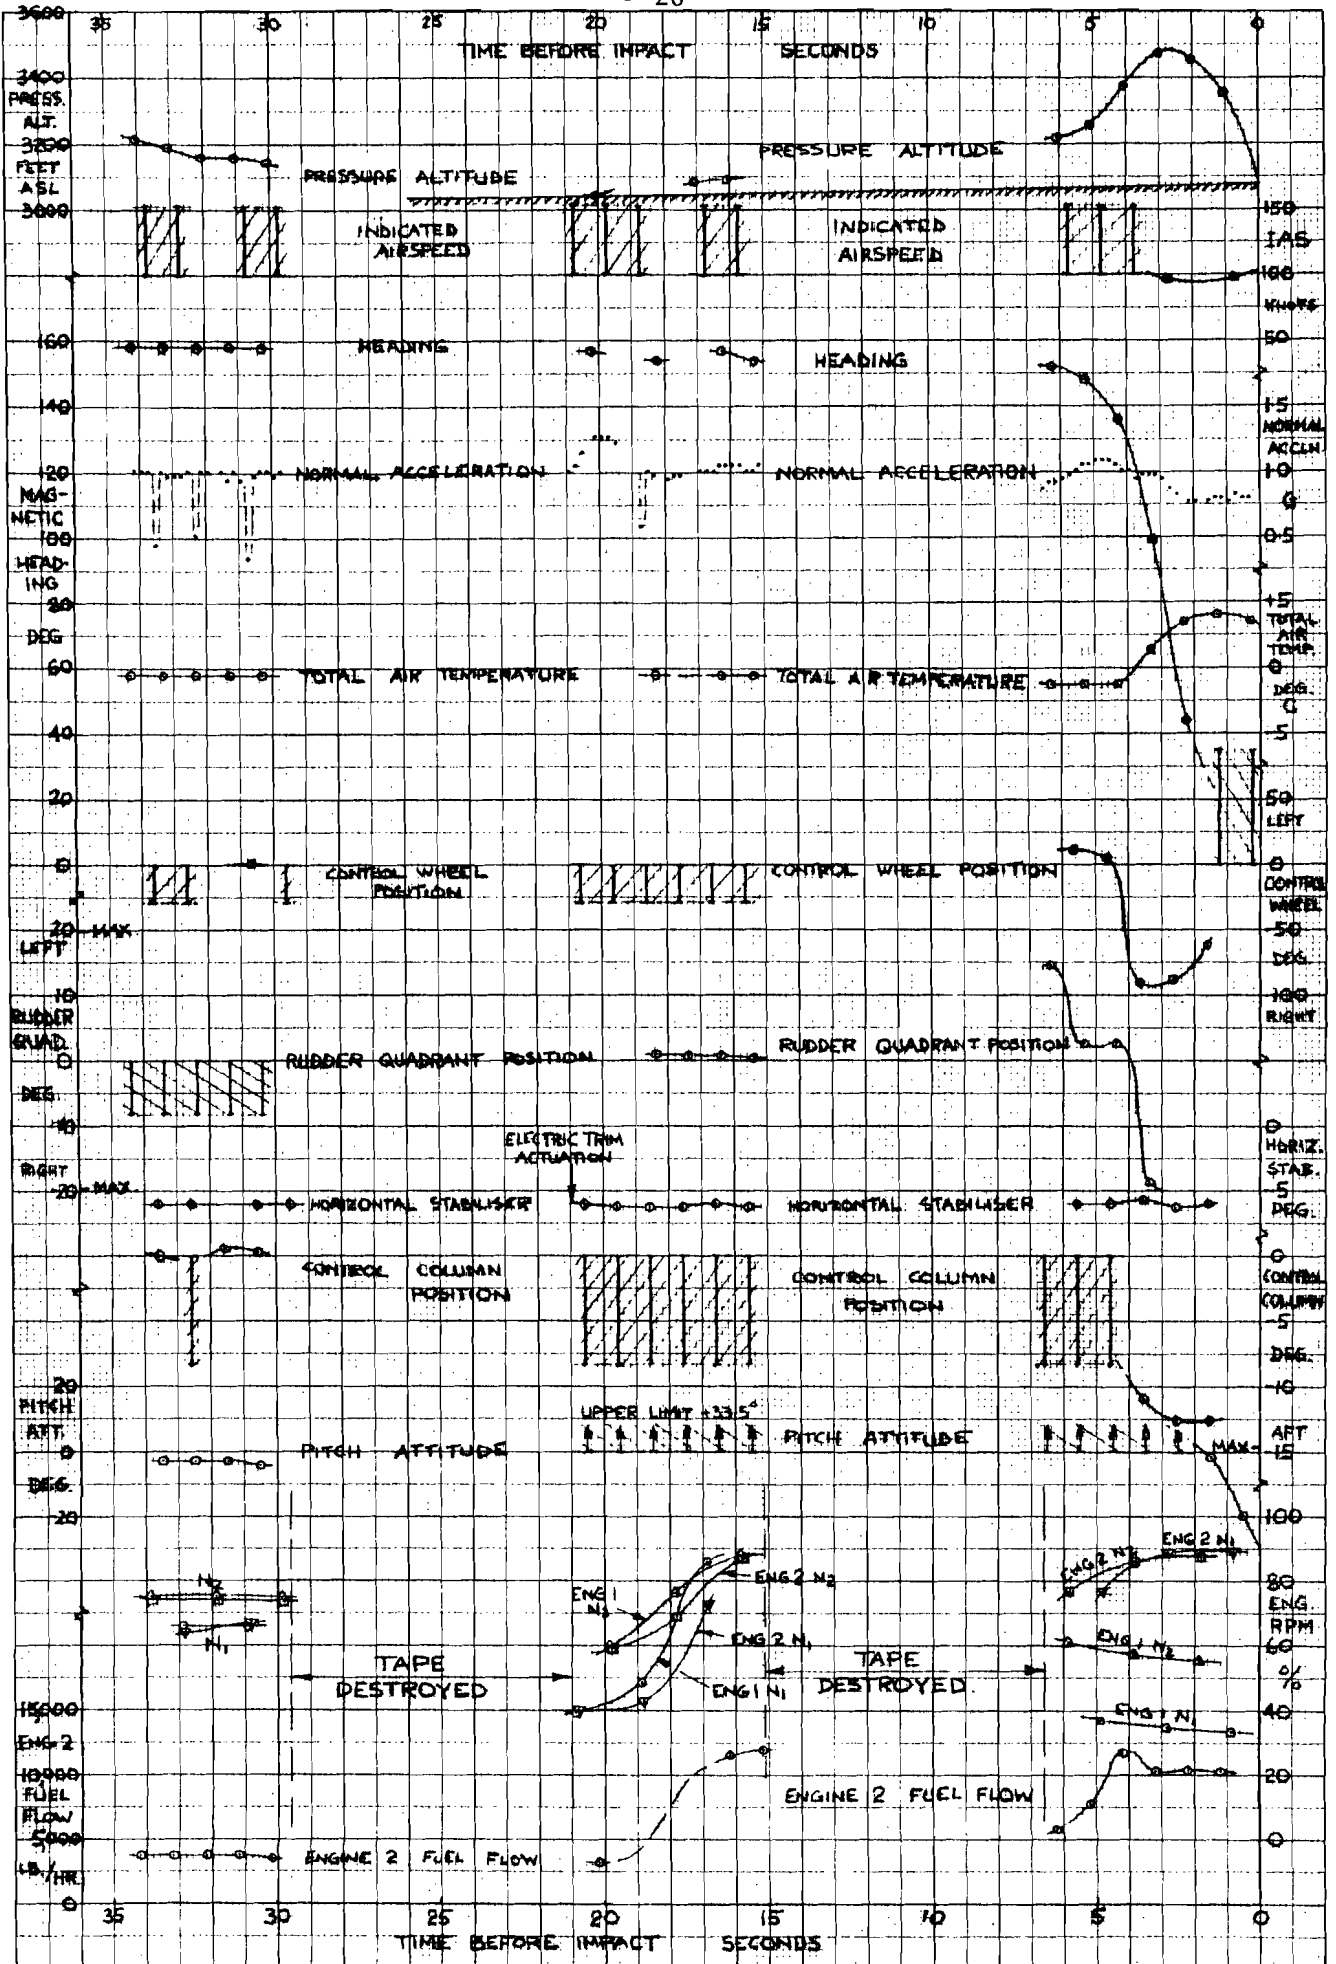
PWA BOEING 737 C-FPMC OVERSHOOT ACCIDENT CRANBROOK B.C. 11 FEB. 1978. FLIGHT RECORDER DATA  
FIGURE 1.

Considering the data derived from C-FPWC, all synchro measurement points outside of the indeterminate range indicated in Figure 1 appear reasonably consistent either in terms of the time-history of their relation to other parameters, with the exception of the one rudder quadrant position in question. The defect found in the synchro converter

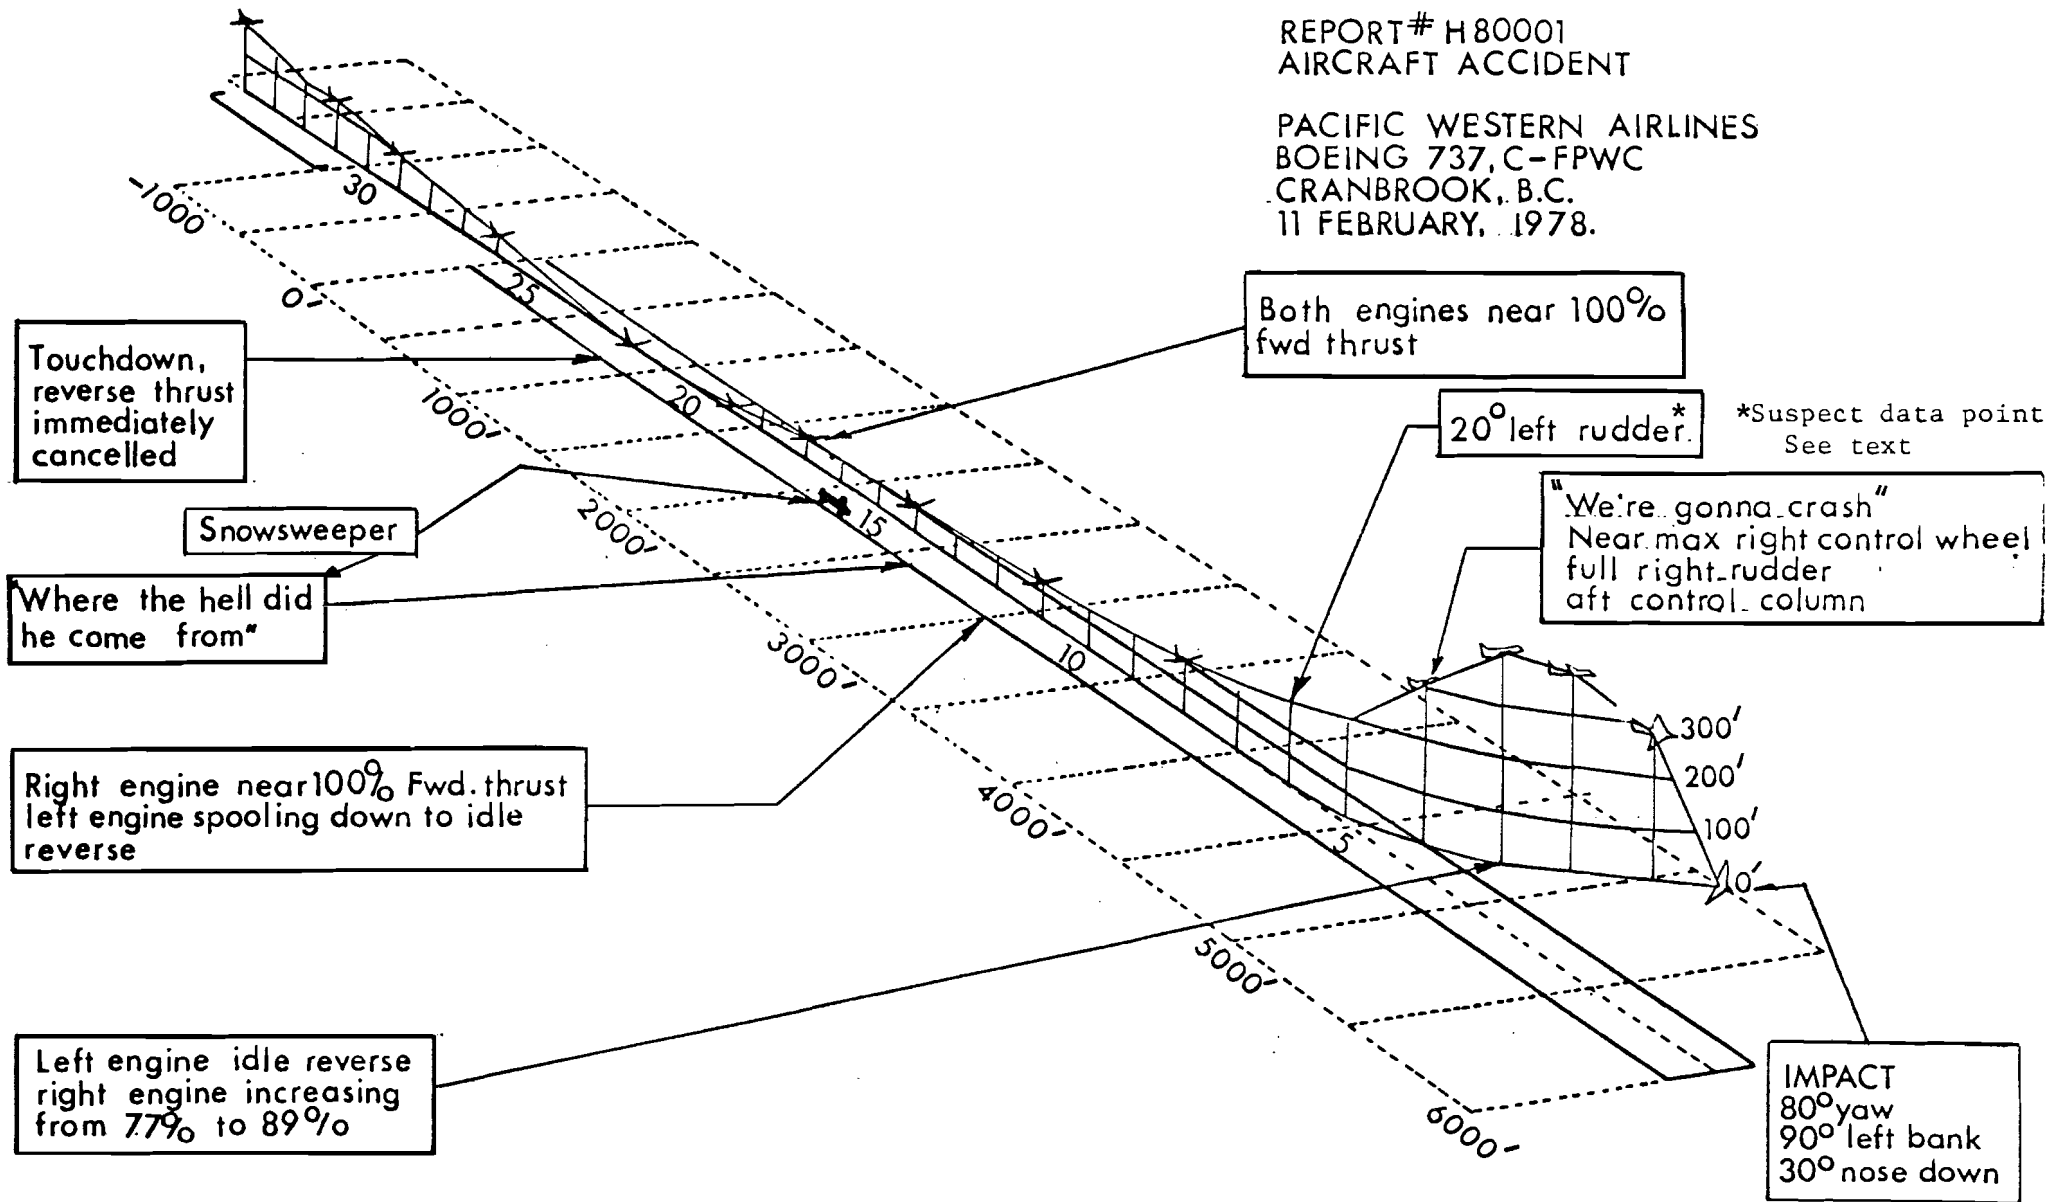
FIGURE 2

After passing over the snow sweeper the aircraft flew level for a few seconds; the left thrust reverser slowly deployed. The aircraft was flown straight down the runway for a few seconds, indicating that right rudder had been applied to correct the assymetry (not shown on damaged FDR record), then, either the <sup>sp</sup>corrective right rudder pressure was removed, or momentary left rudder was applied. The aircraft yawed and rolled to the left climbing slightly and then dived into the ground.

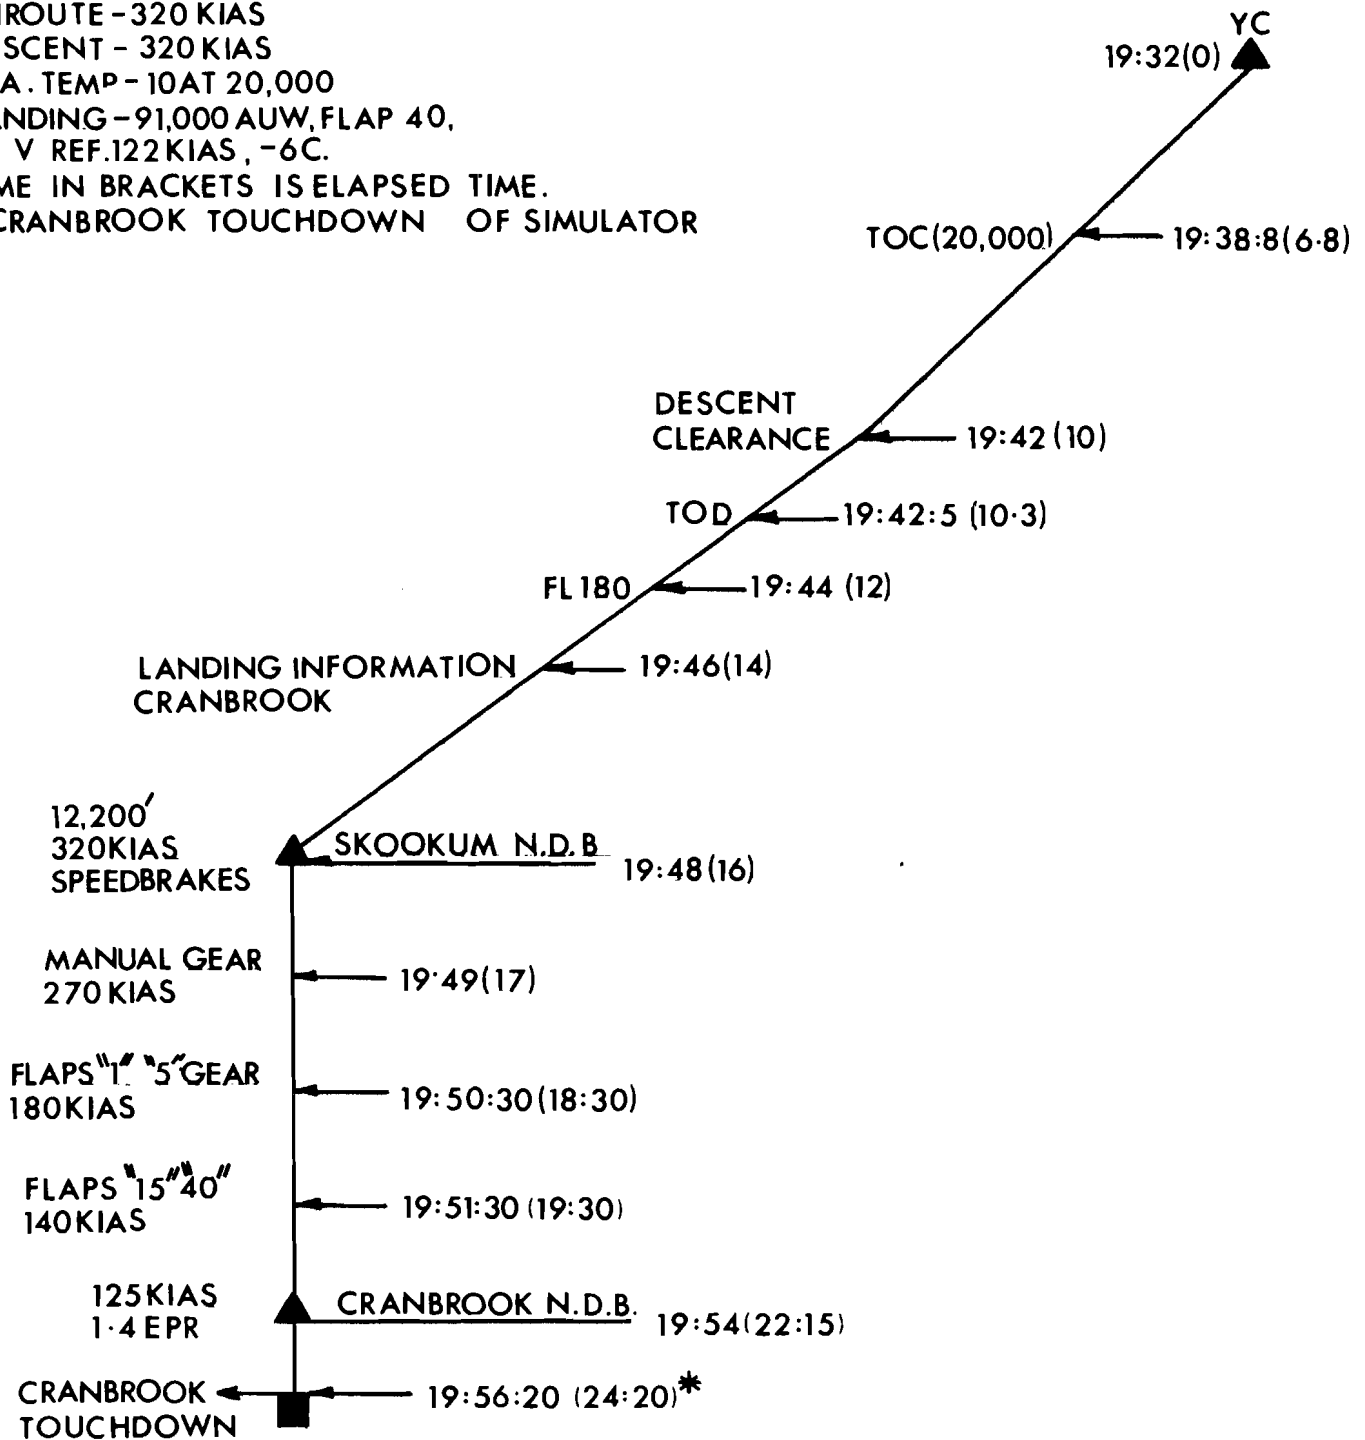
FIGURE 4.

Evidence indicates the aircraft passed the Skookum beacon inbound on a straight-in instrument approach, and flew the ILS for runway 16 to touchdown.<sup>1</sup> According to witnesses and estimates partially derived from flight data recorder information, the aircraft touched down at 1955Z approximately 800 feet from the threshold and reverse thrust was selected. Reverse thrust was cancelled immediately after touchdown and a go-around was initiated. The aircraft became airborne prior to the 2000 foot mark, and flew down the runway at a height of 50 to 70 feet, flying over a snow removal vehicle which was still on the runway, 2050 feet from the threshold and 20 feet from the right edge. About this time the left engine thrust reverser doors deployed. A few seconds later, the flap was selected up from 40<sup>0</sup> to 15<sup>0</sup>. The landing gear remained down and locked. Six seconds before impact and just over 4,000 feet from the runway threshold, the flight recorder data indicates that a large amount of left rudder was momentarily applied.<sup>2</sup> The aircraft climbed to 300 to 400 feet above the airfield, banked steeply to the left, lost height and side-slipped into the ground to the left of the runway. Fire broke out on impact.
