AIRCRAFT ACCIDENT REPORT

NORTHWEST AIRLINES, INC.
McDONNELL DOUGLAS DC-9-82, N312RC
DETROIT METROPOLITAN WAYNE COUNTY AIRPORT
ROMULUS, MICHIGAN
AUGUST 16, 1987

NTSB/AAR-88/05

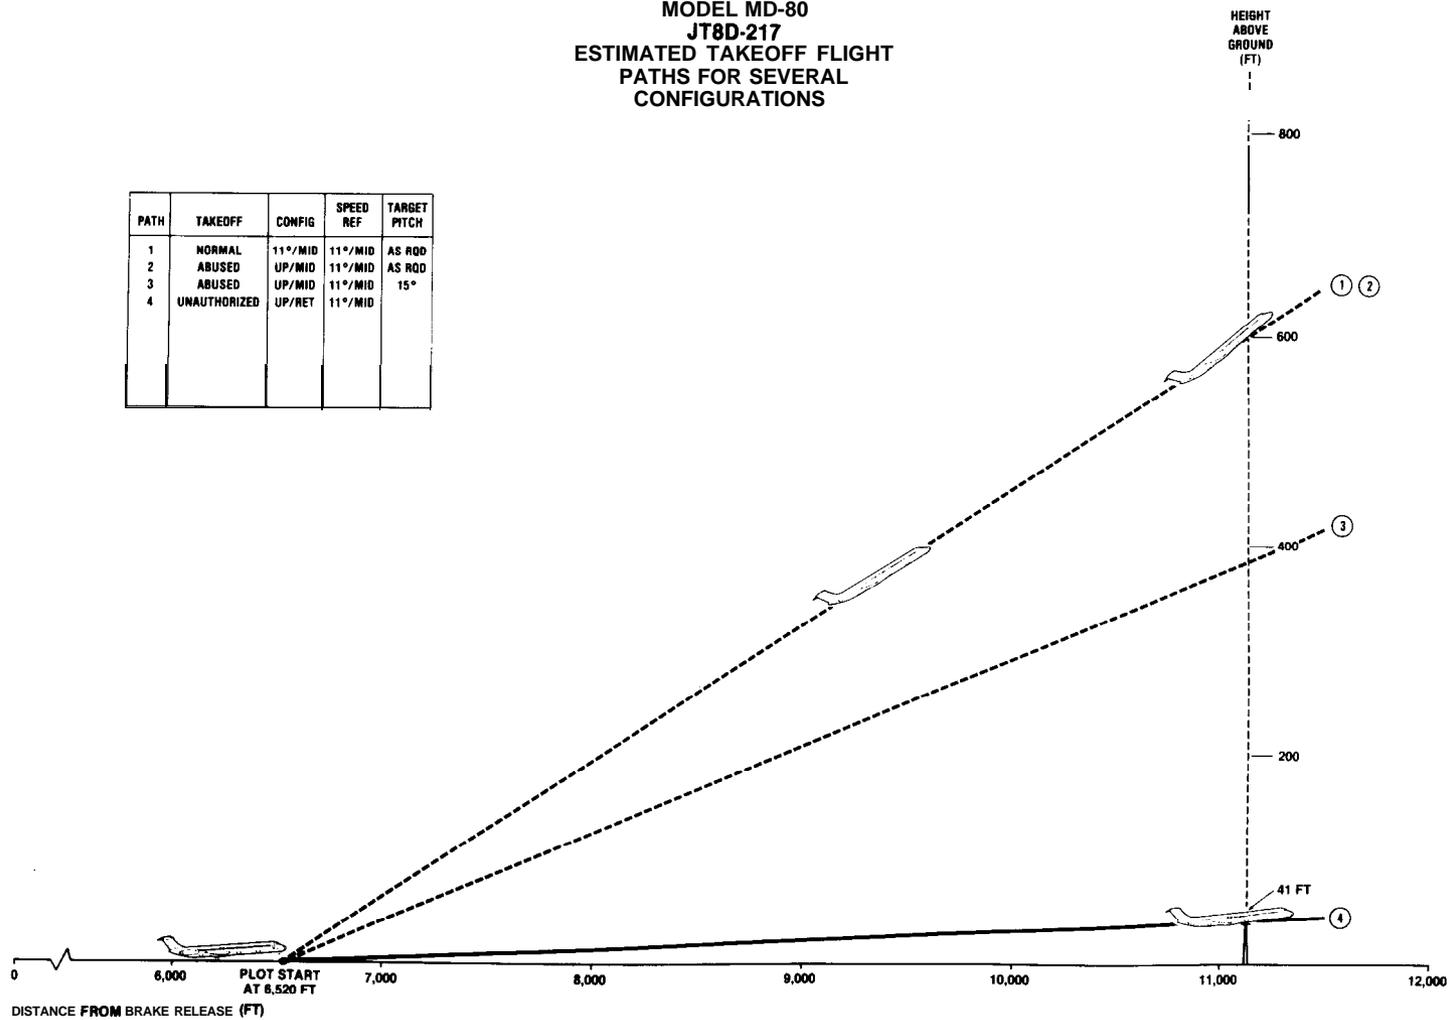
Figure 2.--Model MD-80, JT8D-17.
 Estimated takeoff flightpaths for several configurations.

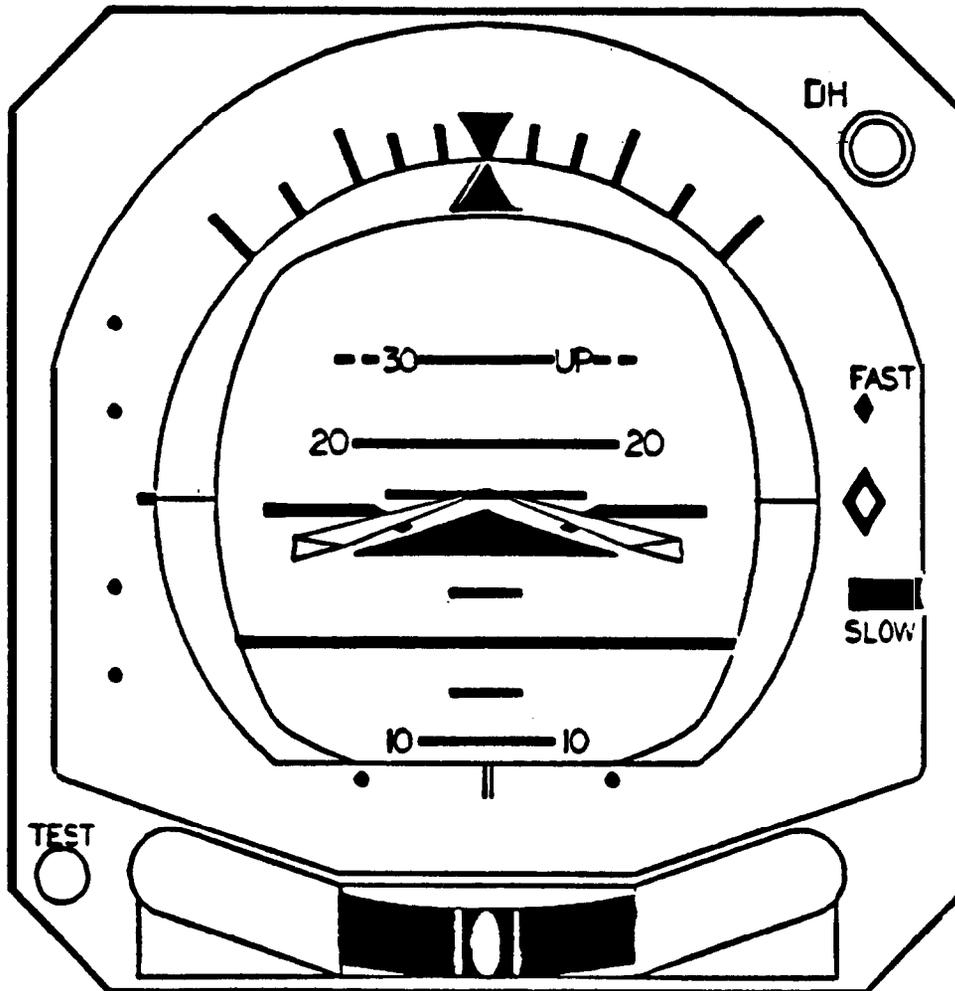
Figure 3.--Displays theoretical pitch attitude information presented by the ADI and the F/D command bar for the conditions existing 65seconds after the start of the takeoff roll and after the F/D has entered the go-around mode. Roll attitude information and command bar roll guidance information is not displayed.

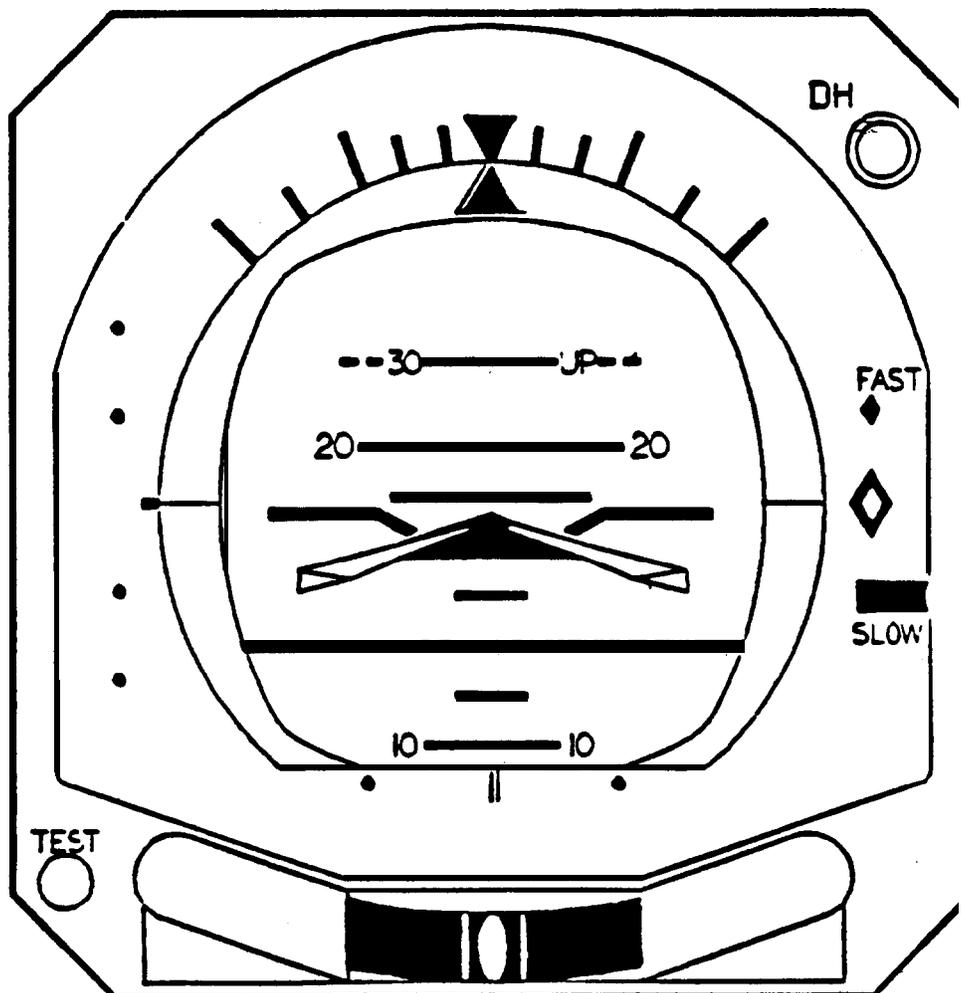
Figure 4.--Displays theoretical pitch attitude information presented by the ADI and the F/D command 65 seconds after the start of the takeoff roll with the F/D in Takeoff mode. Roll attitude information and command bar roll guidance is not displayed.
