# LX-LGB

Fokker 27-Mk050, Luxair

**Accident  
survenu le 6 novembre 2002  
en approche de l'aéroport  
de Luxembourg  
au Fokker 50  
immatriculé LX-LGB  
exploité par Luxair**

*Accident  
occurred on November 6, 2002,  
on approach to  
Luxembourg Airport  
to the Fokker 50  
registered LX-LGB  
operated by Luxair*

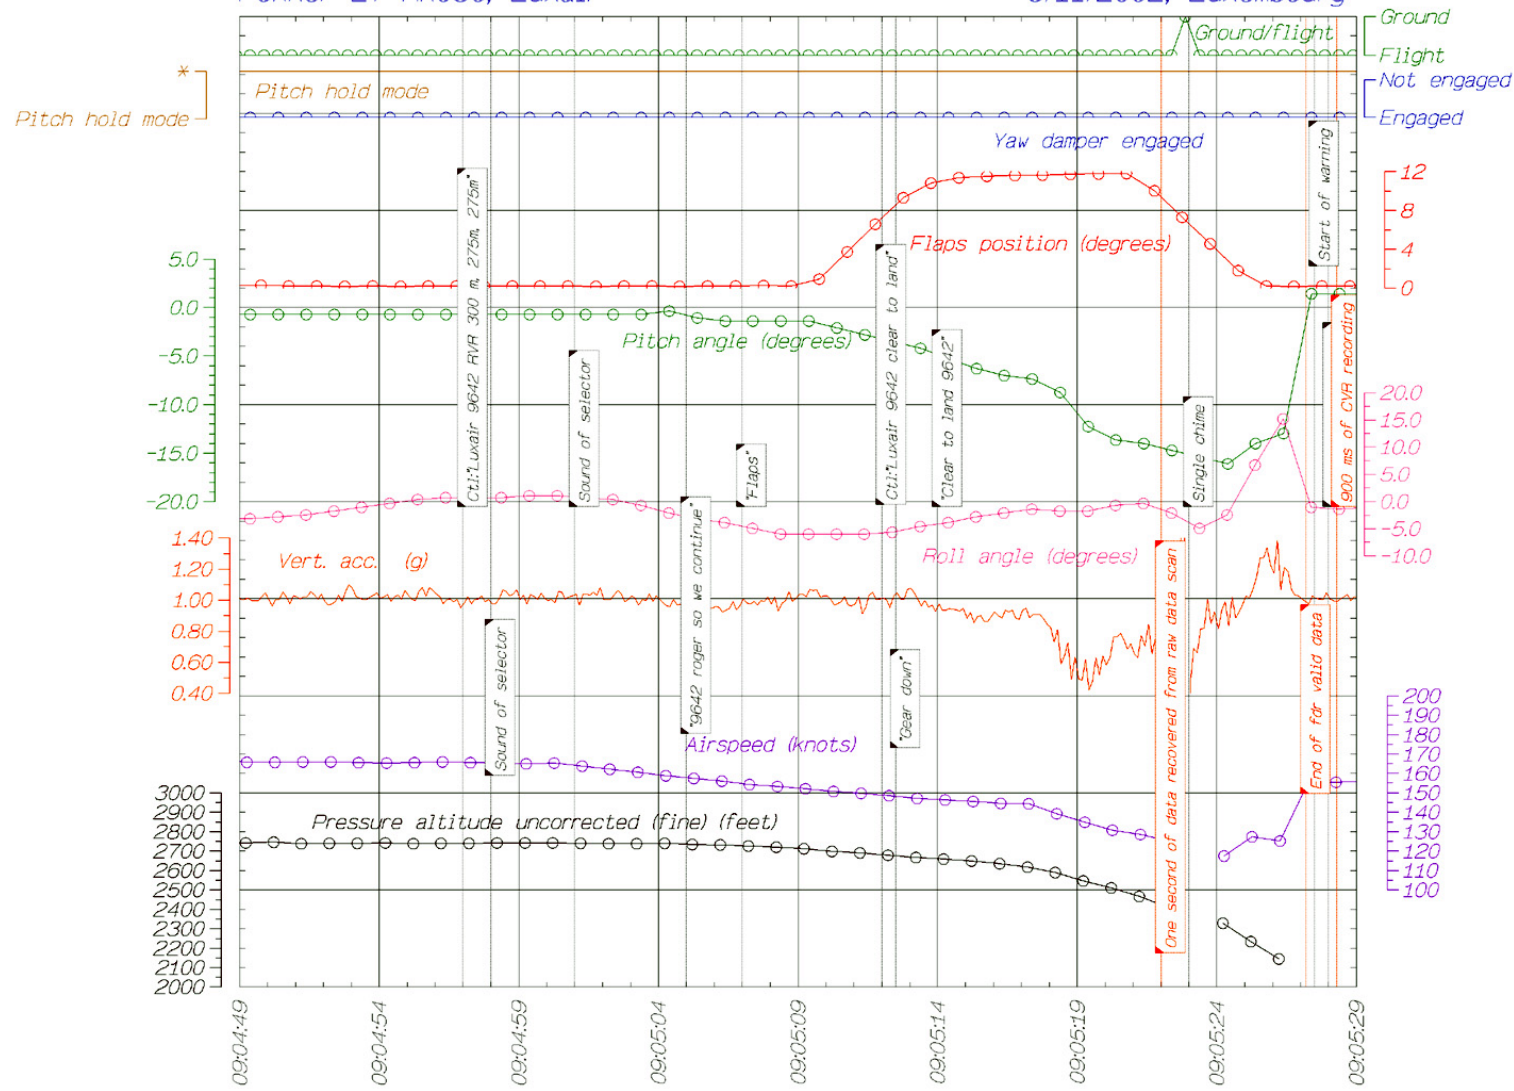
General parameters, last 40 seconds

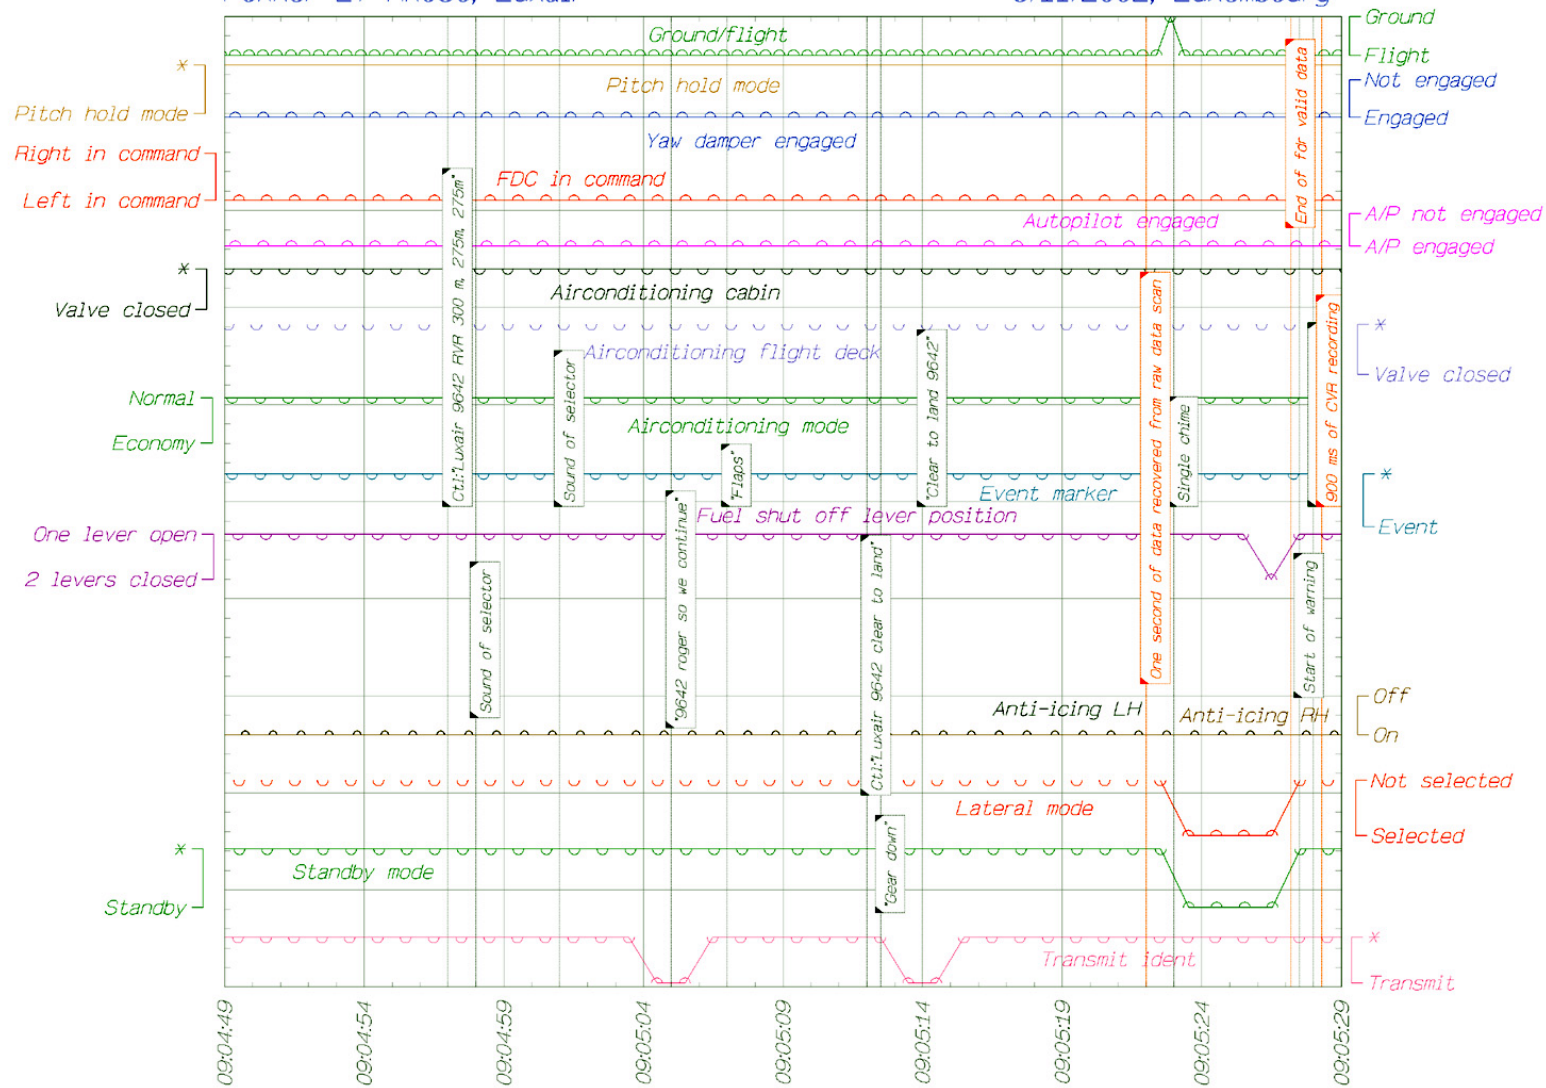
Discrete parameters, last 40 seconds

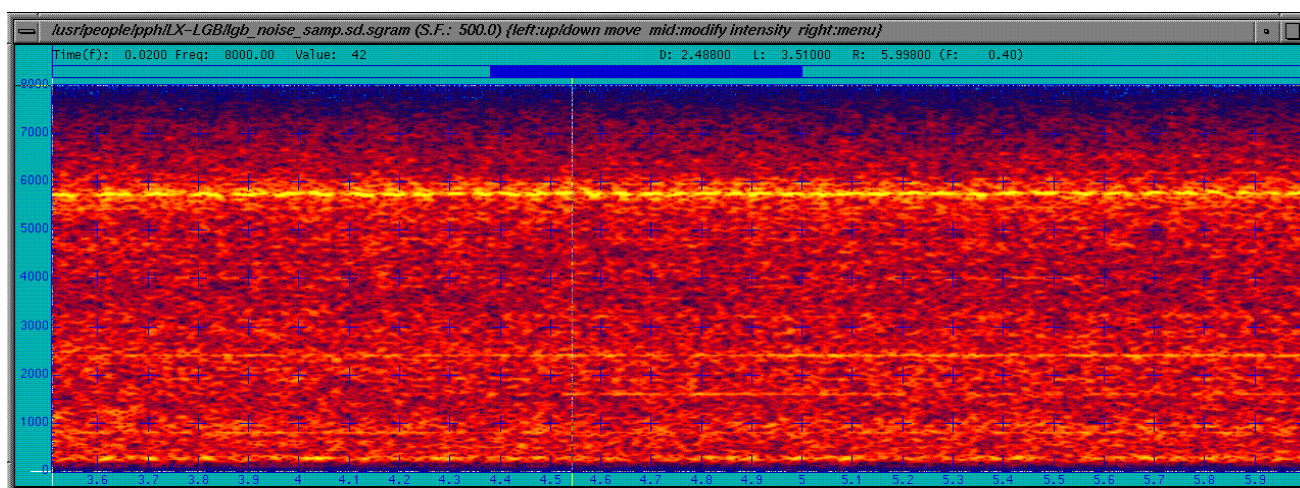
**Fig. 1: Représentation Temps – Fréquence du bruit de fond du LX-LGB en vol. Time – Frequency representation of the background noise on LX-LGB in flight.**

Comme l'illustrent les deux figures précédentes, le LX-LGB (fig. 1) présente un signal plus bruité que celui du LX-LGC (fig. 2). Les hautes fréquences (autour de 5700 Hz) correspondent au bruit de la turbine de l'avion. Le bruit de fond est globalement plus élevé en raison du bruit aérodynamique caractérisé par un spectre large bande.

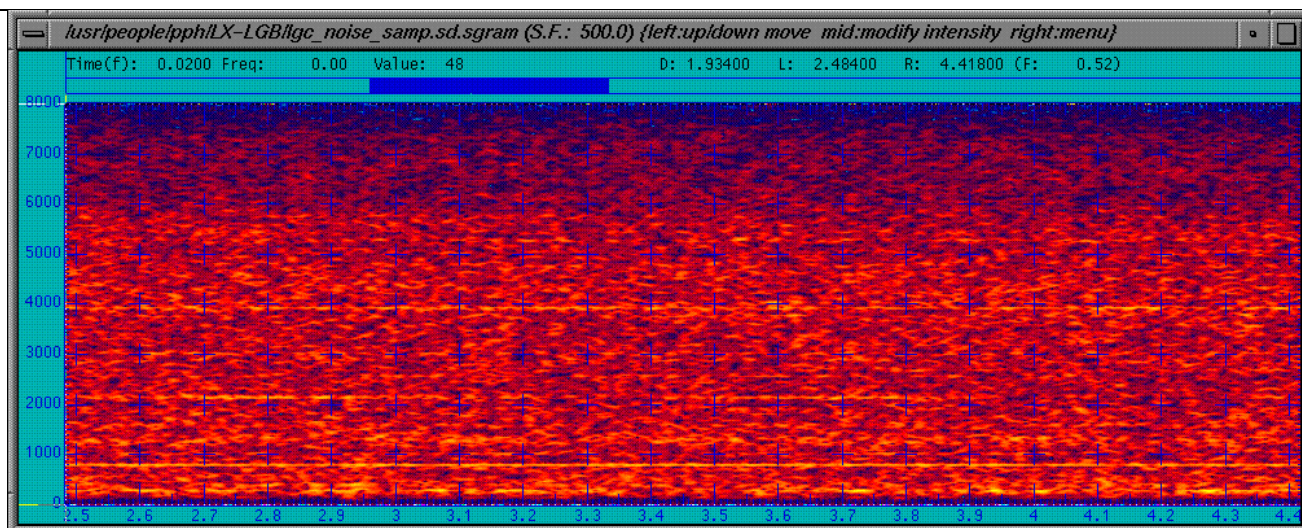
**Fig. 2: Représentation Temps – Fréquence du bruit de fond du LX-LGC au sol. Time – Frequency representation of the background noise on LX-LGC on the ground.**

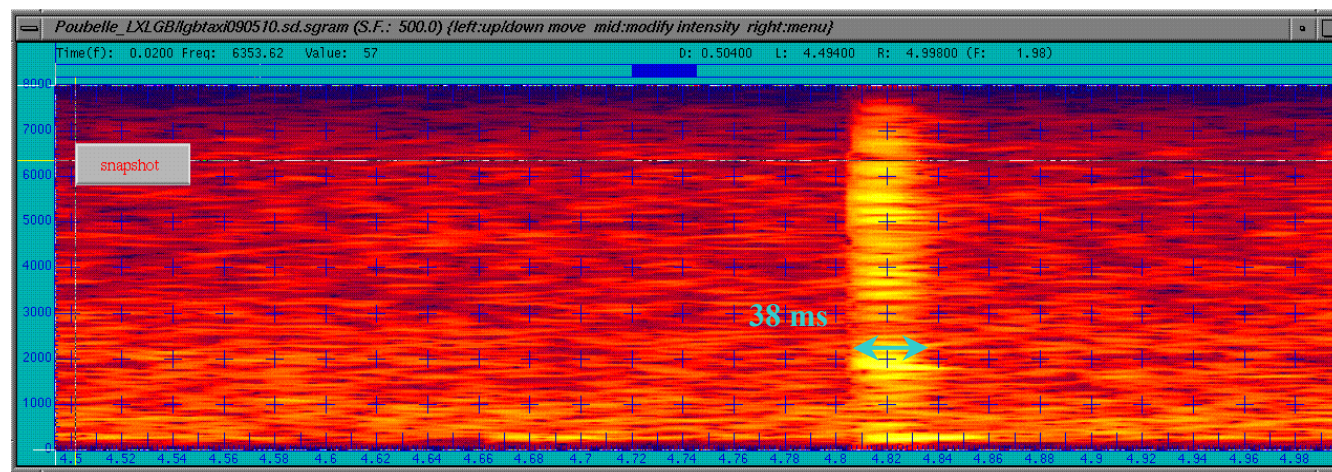
**Fig. 3: Représentation Temps – Fréquence du bruit transcrit. *Time – Frequency representation of the transcribed noise.***

La figure ci-dessus représente le bruit enregistré sur le CVR de l'accident et transcrit comme l'activation des taxi lights. La figure suivante représente un enregistrement du bruit généré par l'activation des taxi lights lors des essais au sol.

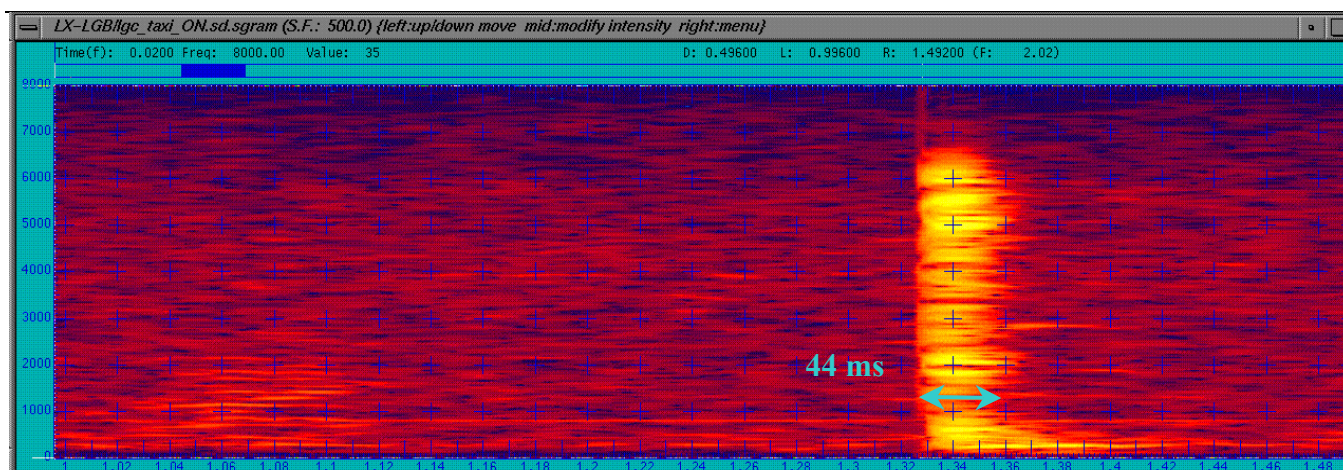
**Fig. 4: Représentation Temps-Fréquence du bruit généré. Time – Frequency representation of the generated noise.**

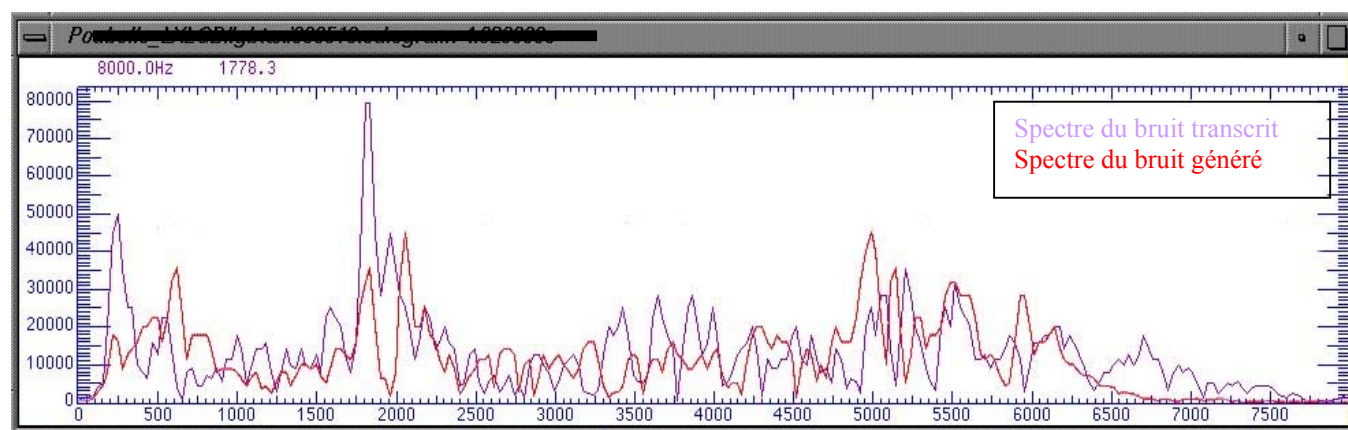
**Fig. 5: Comparaison des composantes fréquentielles des bruits transcrit (en mauve) et généré (en rouge). Spectrum comparison between the transcribed noise (in mauve) and the generated noise (in red)**

On retrouve les mêmes composantes fréquentielles, notamment aux basses fréquences et autour de **2000** et **5000** Hz.

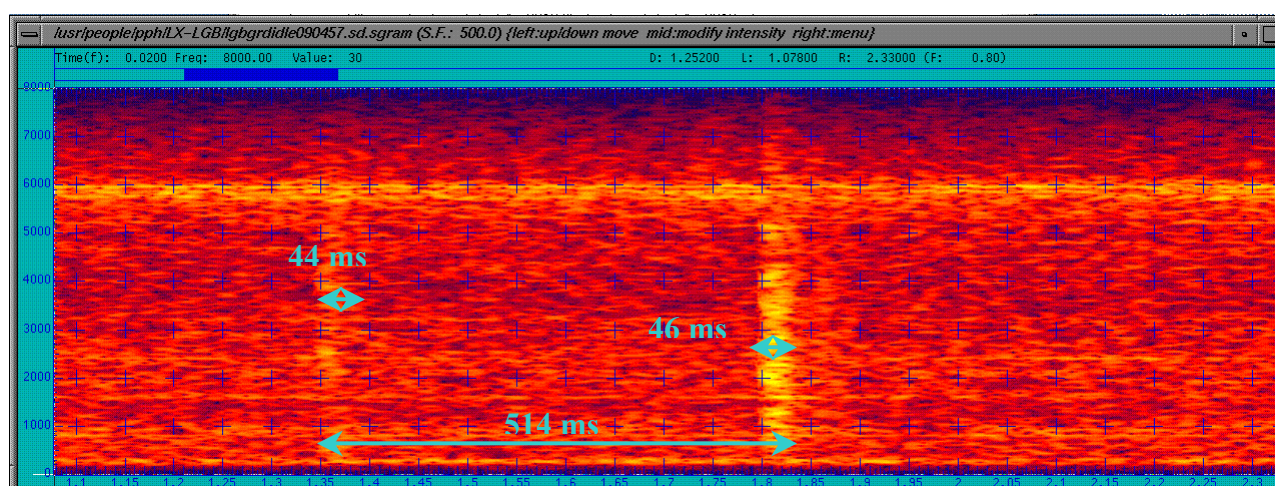
**09 h 04 min 58 s : "Bruit de sélecteur similaire au déplacement du Ground Idle Stop" / "Sound similar to the operation of the Ground Idle Stop Selector"**

**Fig. 6: Représentation Temps – Fréquence du bruit transcrit. Time – Frequency representation of the transcribed noise.**

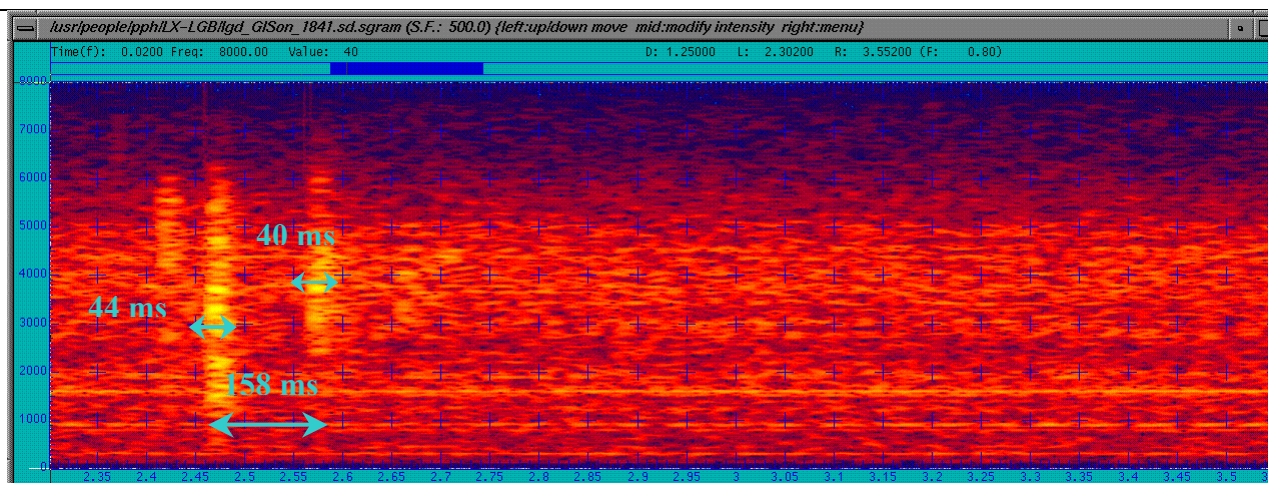
**Fig. 7: Représentation Temps-Fréquence du bruit généré. Time – Frequency representation of the generated noise.**

La figure précédente représente le bruit du déplacement du *Ground Idle Stop* vers la position OFF, dans le domaine temps- fréquence.

Dans le cas présent, les deux bruits ont une forme similaire et peuvent se décomposer en 2 parties. **Cette forme est a priori cohérente avec l'hypothèse de la manœuvre du sélecteur en question** (le *Ground Idle Stop*). En effet, manipuler ce sélecteur suppose sa levée d'une butée, sa translation puis son ré-enclenchement dans sa nouvelle position, d'où le double bruit. Cette cinématique est la seule à produire ce double bruit, à l'exception de la manœuvre des commandes de gaz, des volets et du train d'atterrissage. Ces deux dernières commandes cependant ont une signature spectrale bien différente que l'on ne peut confondre avec le bruit analysé ici.

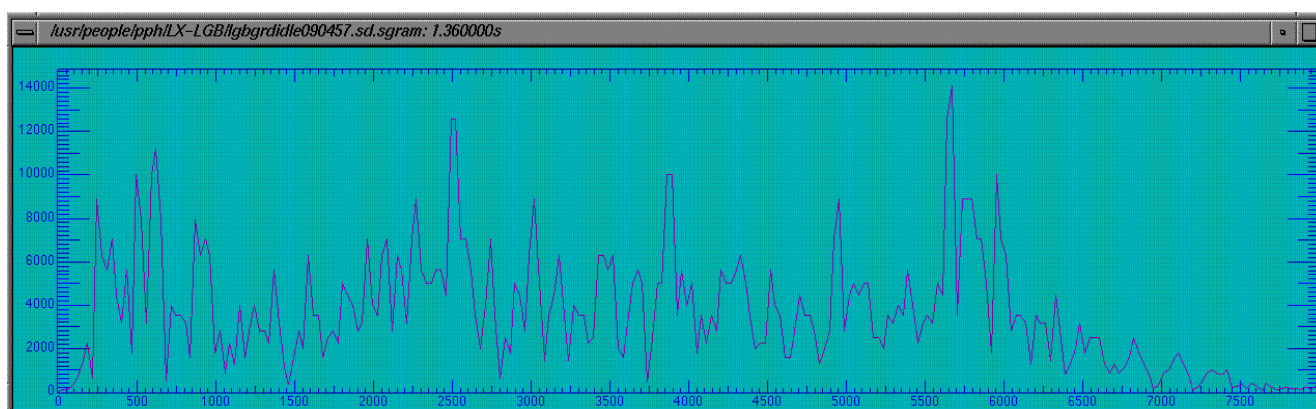
**Fig. 8: Représentation Fréquentielle du bruit à identifier. Frequency representation of the noise to be identified.**

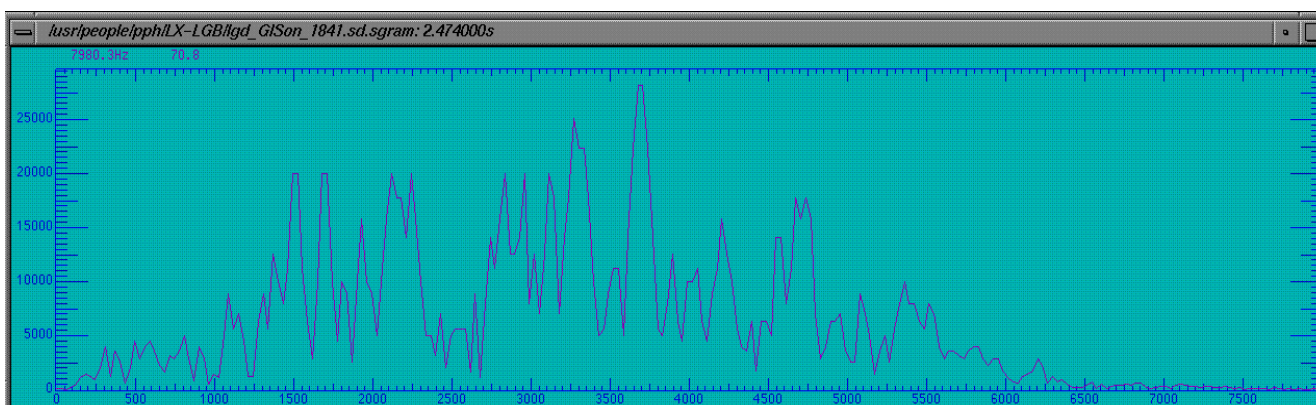
**Fig. 9: Représentation Fréquentielle du bruit généré. Frequency representation of the generated noise.**

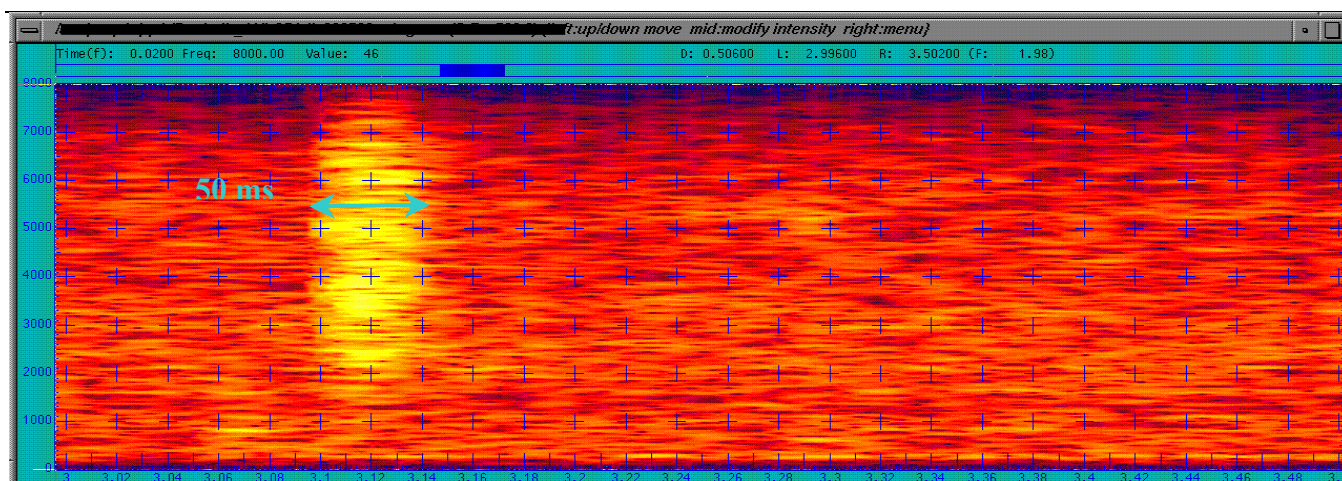
**Fig. 10: Représentation Temps – Fréquence du bruit transcrit. Time – Frequency representation of the transcribed noise.**

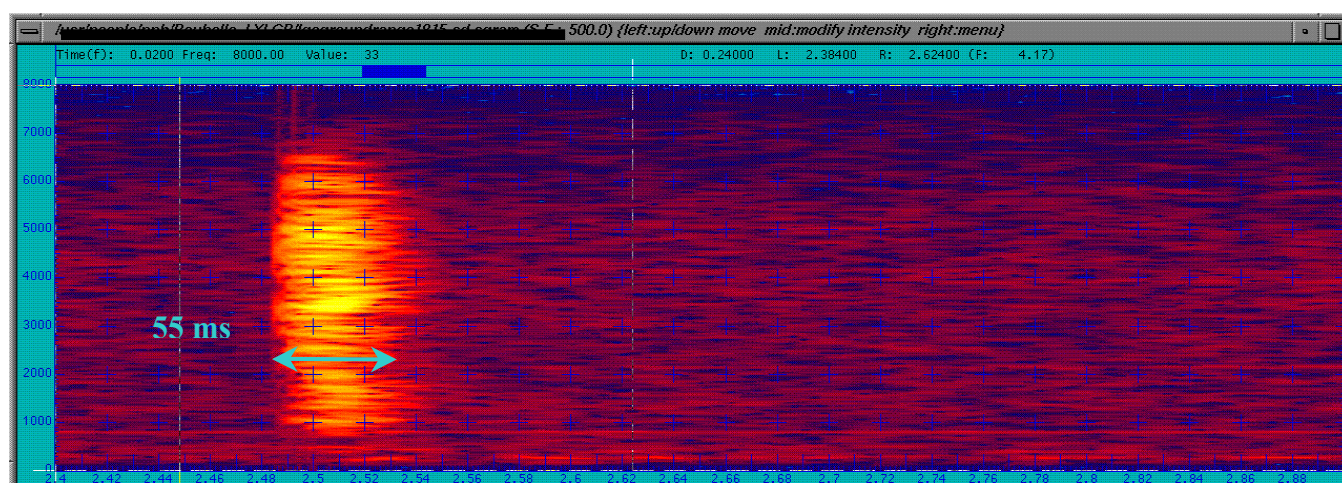
**Fig. 11: Représentation Temps-Fréquence du bruit généré. Time – Frequency representation of the generated noise.**

La figure ci-dessus représente le bruit du déplacement des *Ground Range Selector* dans le domaine temps - fréquence dans le cas où les deux leviers sont soulevés simultanément afin de retrouver une forme semblable à celle obtenue avec le bruit transcrit.

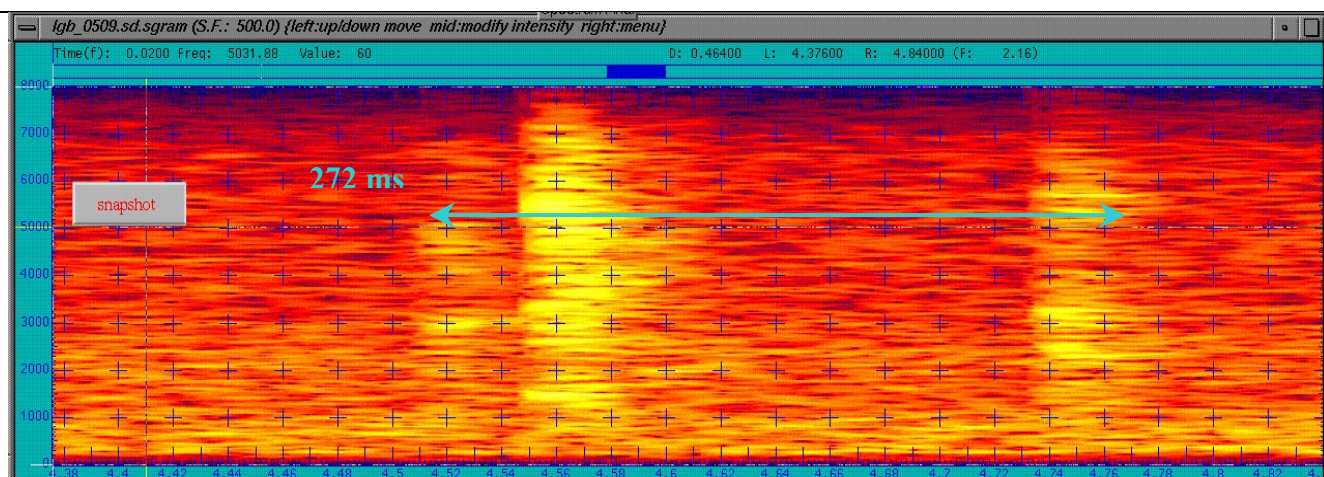
**Fig. 13: Représentation Temps – Fréquence du bruit transcrit. Time – Frequency representation of the transcribed noise.**

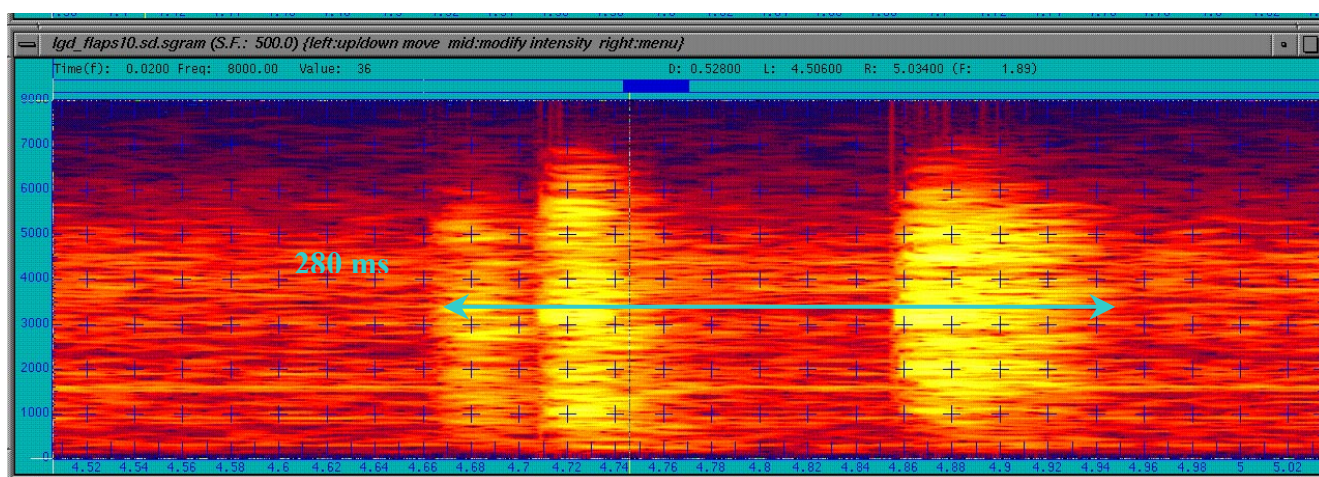
**Fig. 14: Représentation Temps-Fréquence du bruit généré. Time – Frequency representation of the generated noise.**

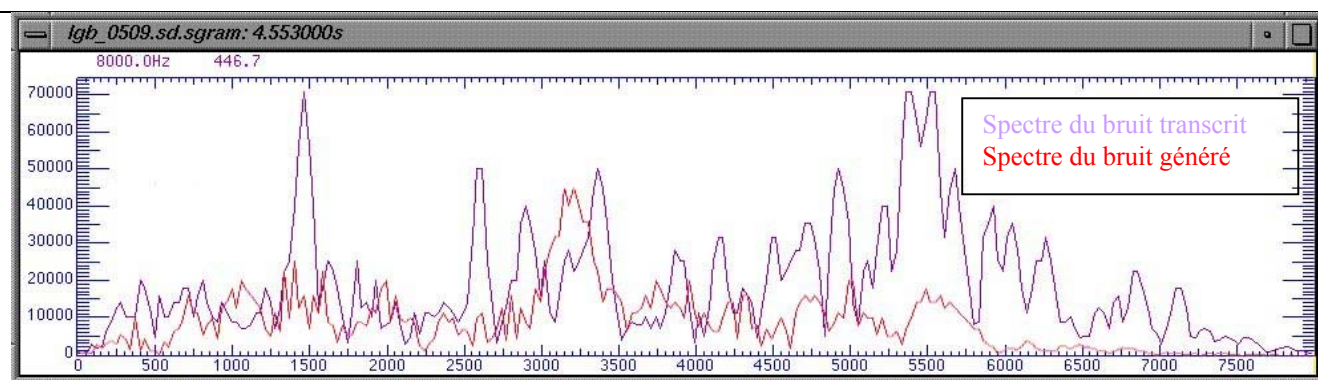
**Fig. 15:** Comparaison des composantes fréquentielles des bruits transcrit (en mauve) et généré (en rouge). **Spectrum comparison between the transcribed noise (in mauve) and the generated noise (in red)**

Bien que moins évidents, les résultats de la figure ci-dessus permettent de retrouver les points communs entre les deux bruits, notamment autour de **3250, 3800, 5000 et 5500 Hz**.

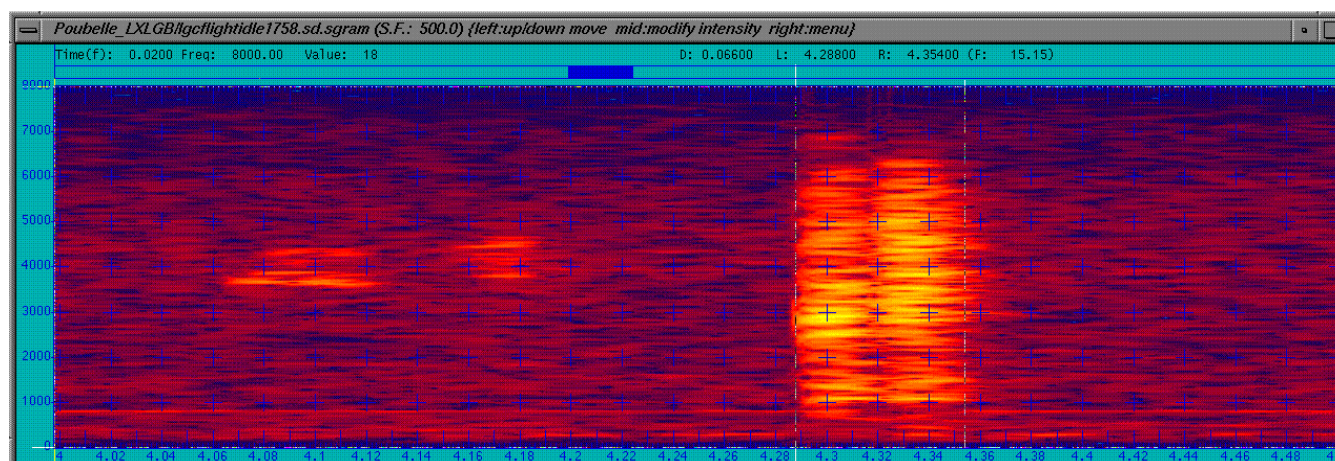
**Fig. 17:** Représentation Temps - Fréquence du mouvement de la manette des gaz mise en position « Flight Idle ». *Time Frequency representation of the operation of the throttle moved to « Flight Idle » position.*

La figure ci-dessus correspond à la manipulation des manettes des gaz sur le Fokker 50 immatriculé LX-LGC. Ces manettes étant en position *Ground Idle*, elles sont ramenées en position *Flight Idle*. On retrouve ici cette décomposition en deux clics distincts. La durée totale de ce bruit est de **70 ms**.

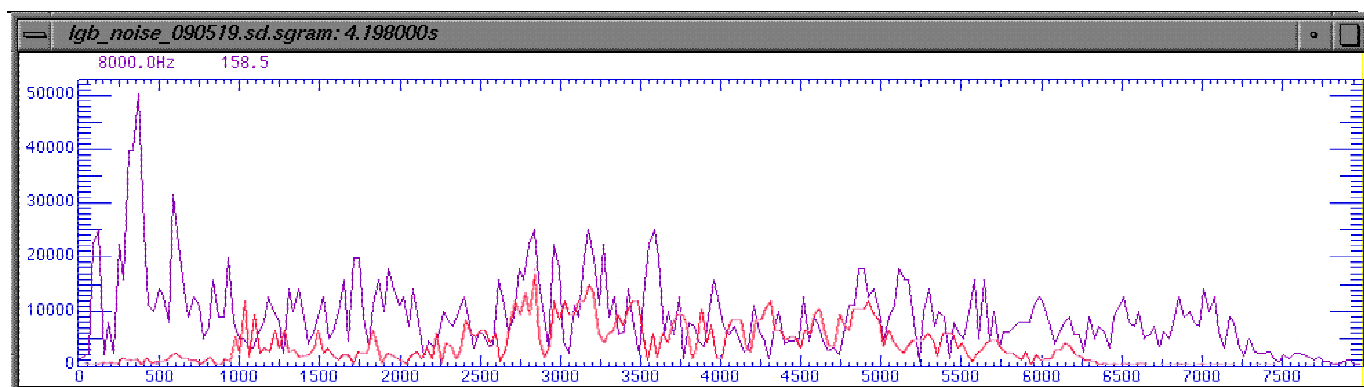
**Fig. 18:** Comparaison des composantes fréquentielles des bruits transcrit (en mauve) et généré (en rouge).  
**Spectrum comparison between the transcribed noise (in mauve) and the generated noise (in red)**

Le bruit à identifier est rapproché de celui de mouvement de la manette des gaz dans la mesure où ce dernier est cohérent avec le faciès du signal (deux clics). La figure ci-dessus illustre les fréquences communes à ces deux bruits (2800, 3200, 5000 Hz...). Il s'agit ici du déplacement des manettes des gaz vers la position *Flight Idle*.

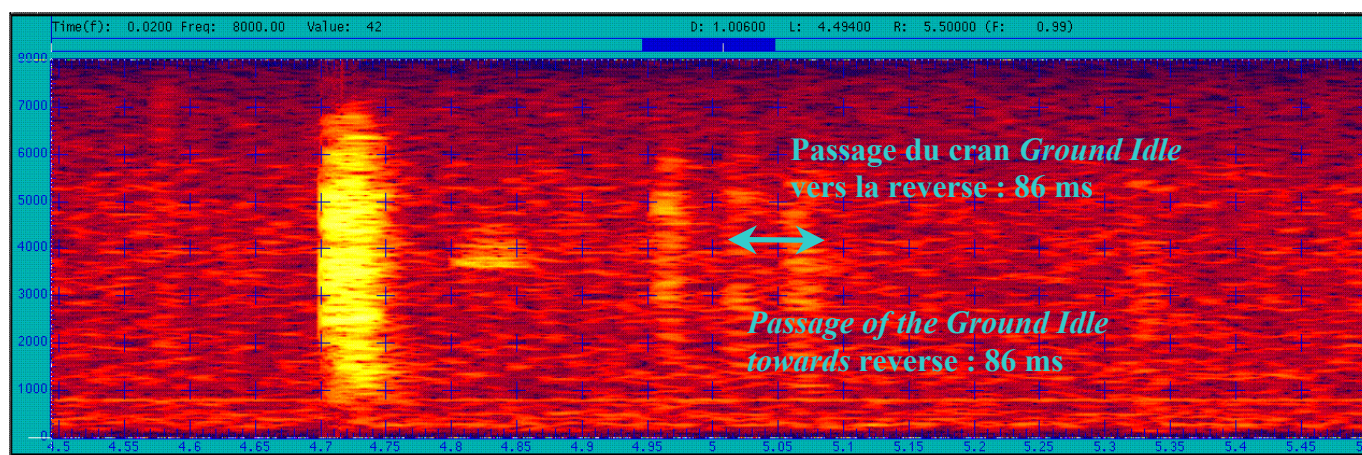
**Fig. 19:** Représentation Temps - Fréquence issue du mouvement de la manette des gaz mise en position « Reverse » depuis la position *Flight Idle*. **Time Frequency representation of the movement of the throttle from the Flight Idle position to the « Reverse » position.**

S'agissant d'un mouvement de manette, on retrouve encore la même décomposition du bruit. Dans le cas présent, ce bruit est plus long que celui transcrit, avec les causes connues décrites au paragraphe 3.4.2. Les comparaisons des spectres donnent :

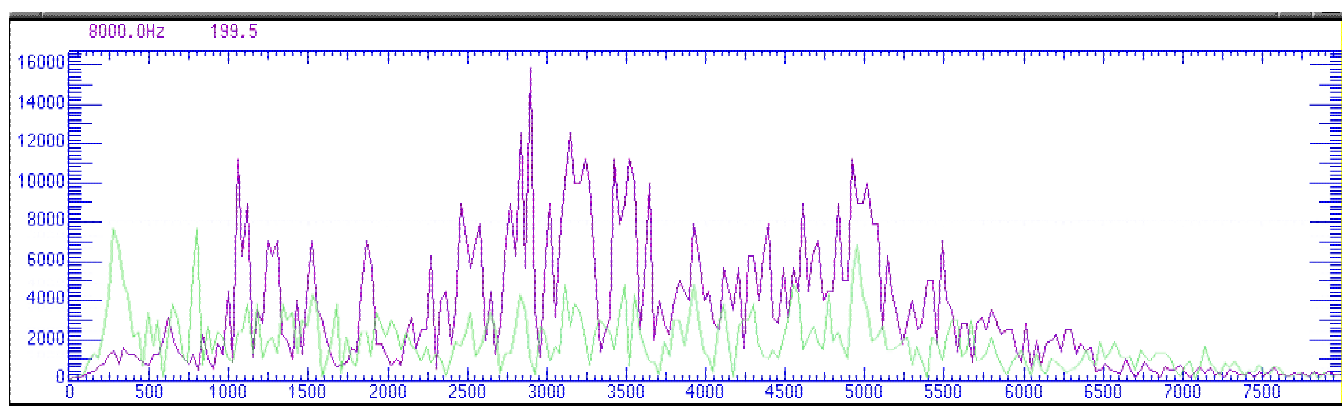
**Fig. 21: Comparaison des composantes fréquentielles entre les manettes poussées en position Flight Idle (en mauve) et en reverse (en vert). Spectrum comparison between the throttle set to Flight Idle position (in mauve) and Reverse position (in green)**

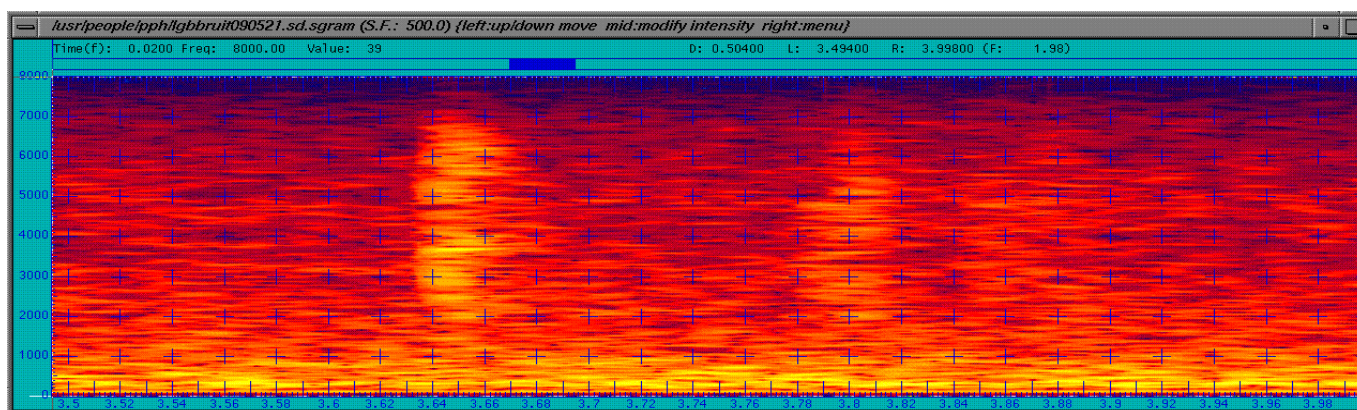
**09 h 05 min 21 s : "Bruit similaire à la manoeuvre de la commande des flaps" / "Sound similar to the operation of flaps control"**

**Fig. 22 : Représentation Temps – Fréquence du bruit. Time – Frequency representation of the noise.**

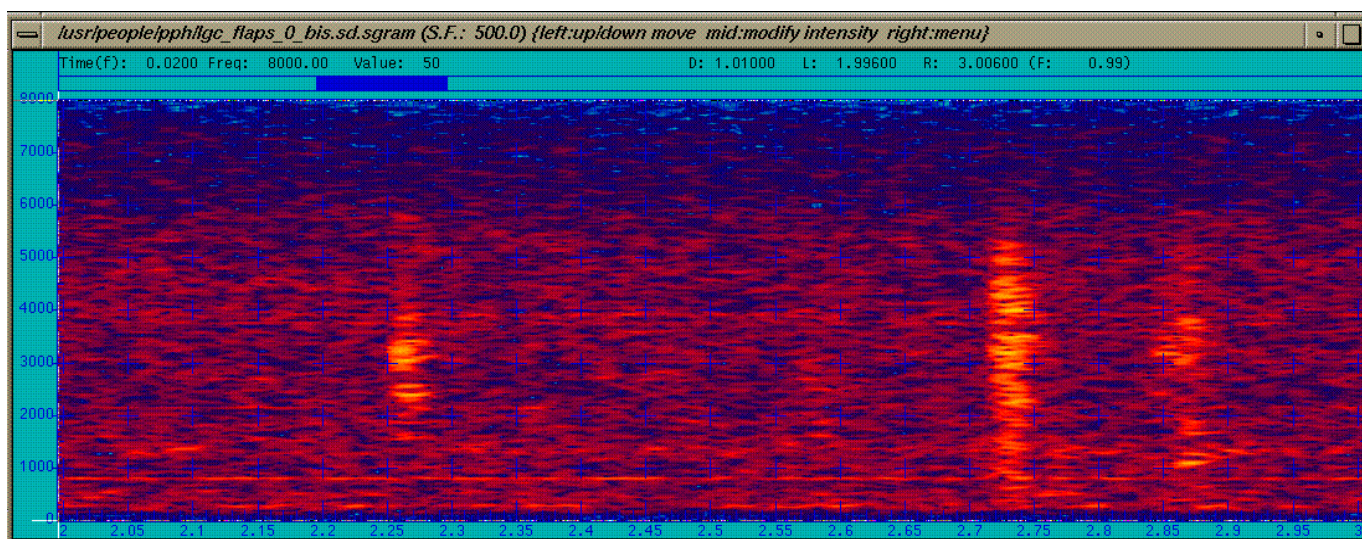
**Fig. 23 : Représentation Temps – Fréquence du bruit de la commande des volets ramenée en position 0°. Time – Frequency representation of the flaps command noise moved to 0°.**

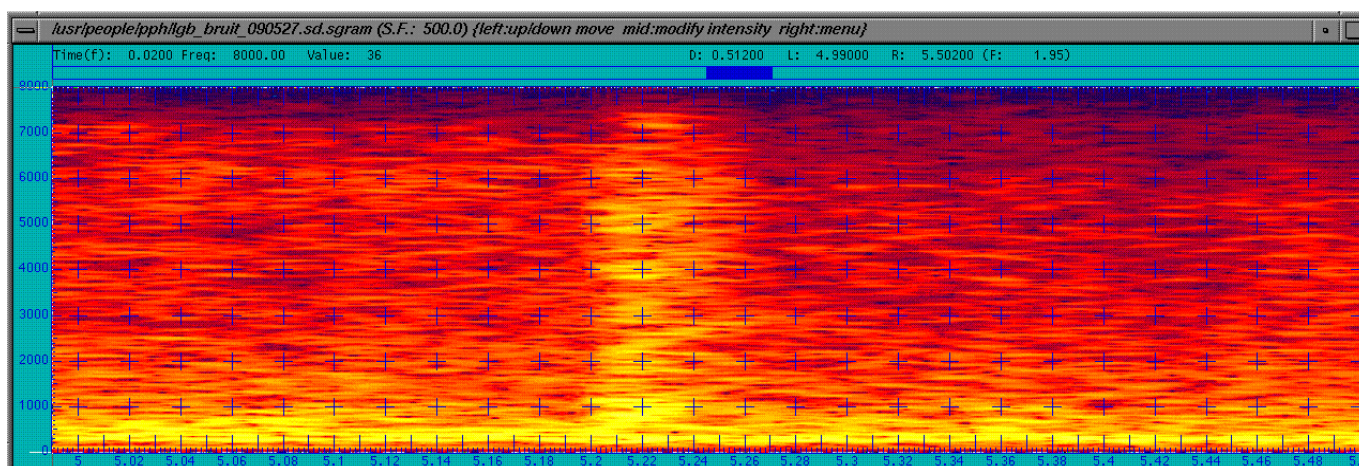
**09 h 05 min 27 s : "Bruit" / "Noise"**

**Fig. 23 : Représentation Temps – Fréquence du bruit. Time – Frequency representation of the noise.**

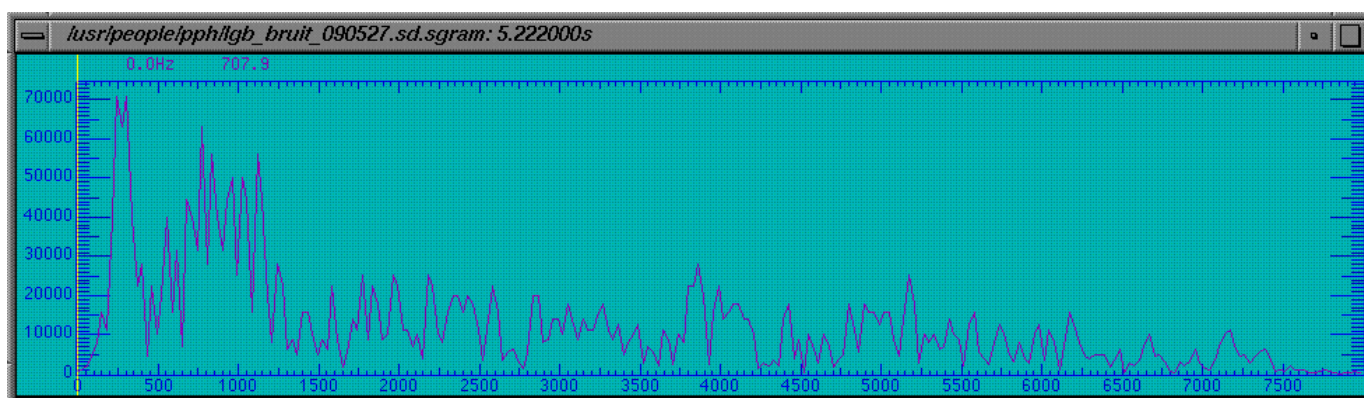
**Fig. 24 : Spectre du bruit inconnu. Spectrum of the unidentified noise.**
