**AIR ACCIDENT INVESTIGATION
& AVIATION SAFETY BOARD
(AAIASB)**

AIRCRAFT ACCIDENT REPORT

**HELIOS AIRWAYS FLIGHT HCY522
BOEING 737-31S
AT GRAMMATIKO, HELLAS
ON 14 AUGUST 2005**

Accident of the a/c 5B-DBY of Helios Airways,
Flight HCY522 on August 14, 2005,
in the area of Grammatiko, Attikis,
33 km Northwest Of Athens International Airport

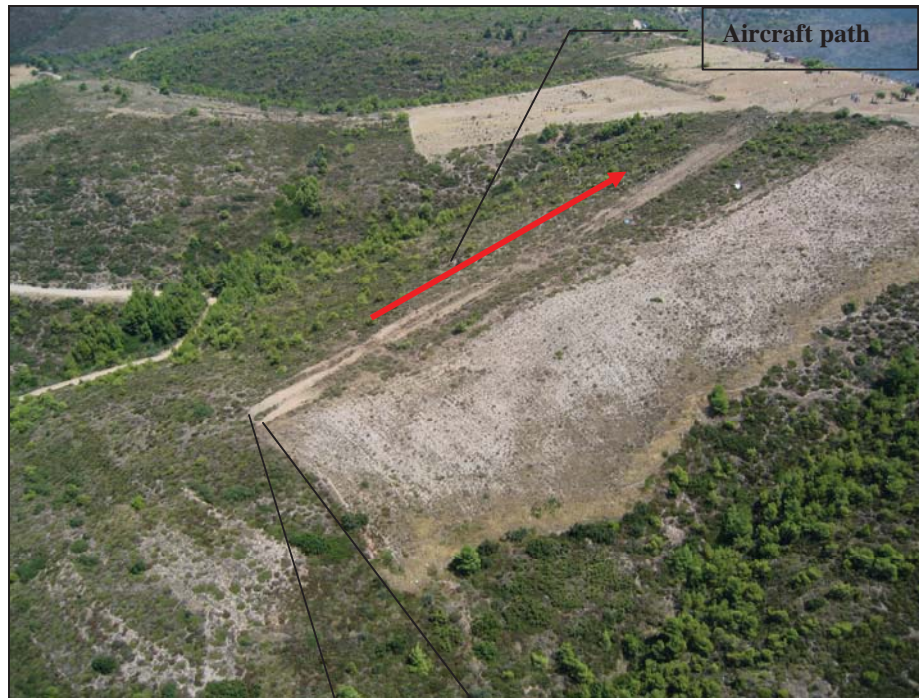
Two adjacent dirt paths (gouges) were found at the initial impact area, which matched the spacing of the fuselage to the right engine. The dirt paths passed through low vegetation on the first uphill slope (See photos on the next page). The wider path was found to be consistent with the 3.7 m width of the fuselage and the adjacent path to the right was consistent with the 2.4 m width of the engine. A third dirt path was found to the left, 10 m down-track from the initial contact of the fuselage and right engine. The location of this dirt path was consistent with the spacing of the left engine from the initial impact of the fuselage and right engine. A 35 cm wide slice through the vegetation began 9 m to the right of the fuselage centerline and 5 m down-track from the initial contact of the fuselage and right engine.

Photos – Initial impact area and first two contact paths on first uphill slope. The path with the width of the fuselage begins in the center of the photo and the path with the spacing and width of the right engine begins near the right side. The slope of the hill is visible as darkening of the path. For scale, the two people immediately beneath the peak of the hill are barely visible.

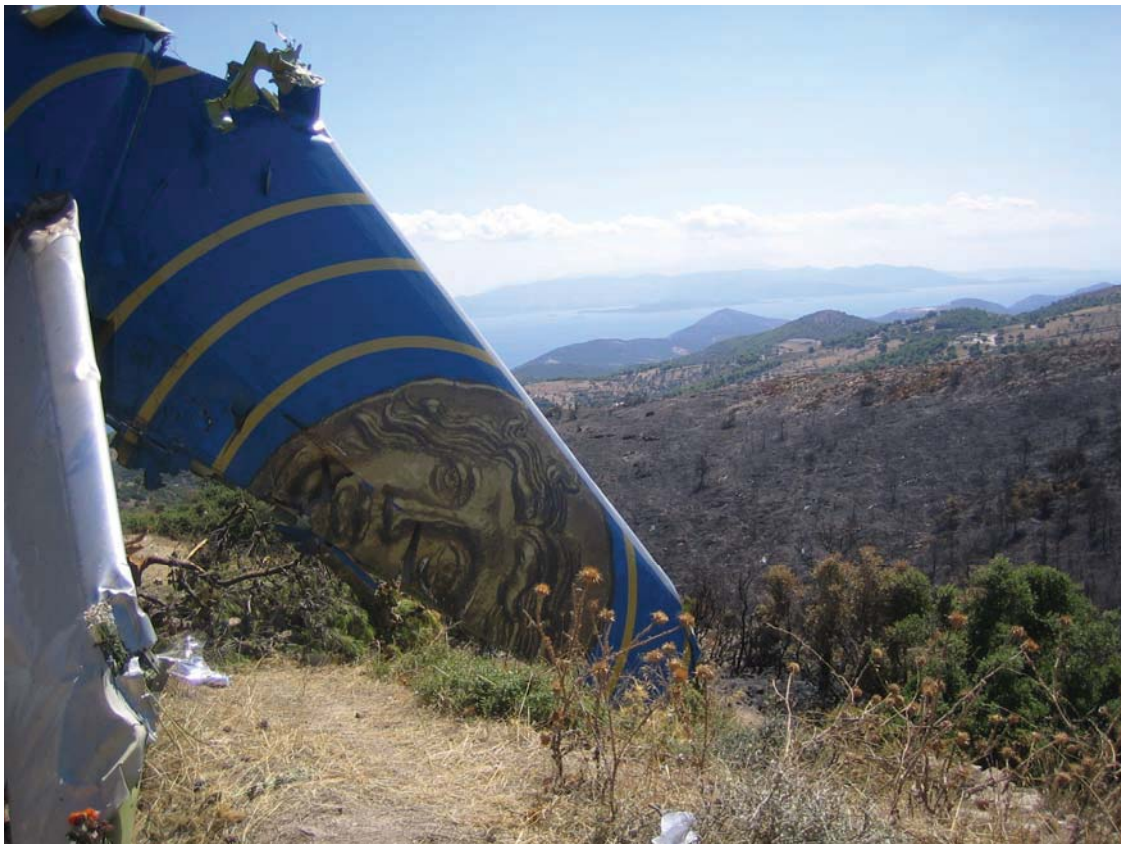
Photo – The tail assembly near the crest of the first hill, with the distant crest of the second hill in the background.

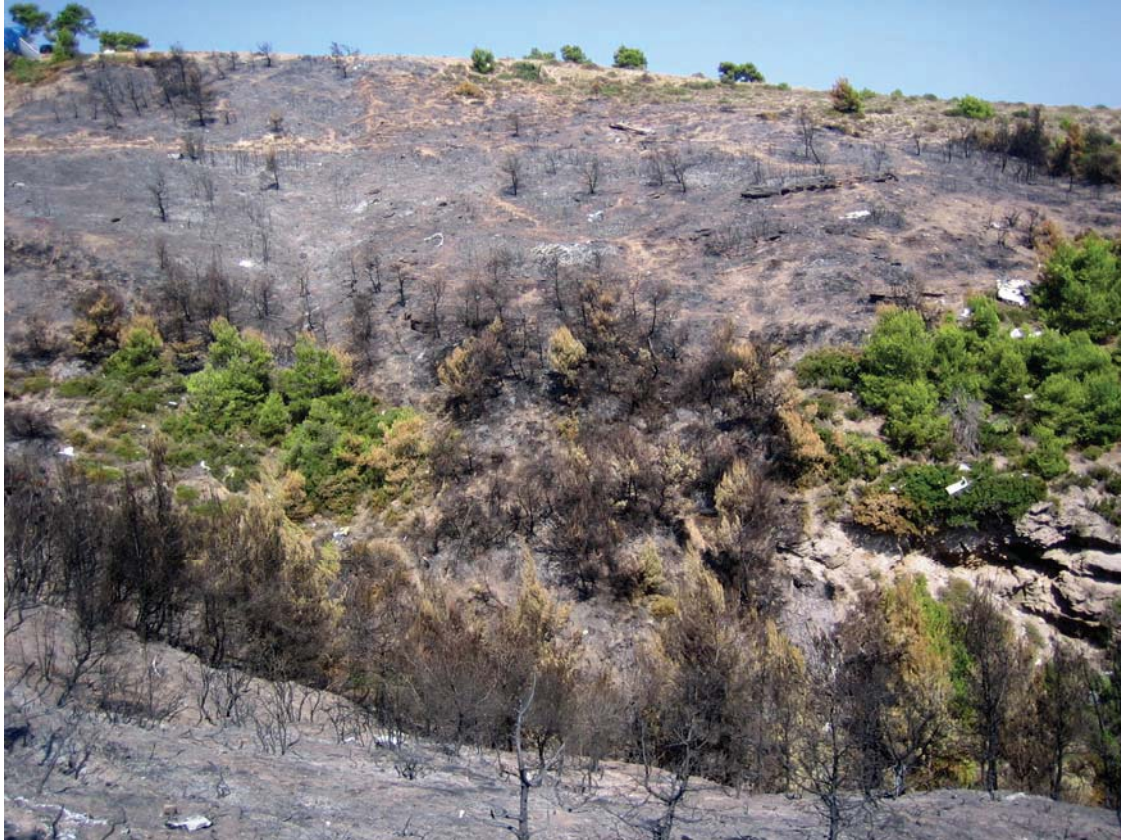
Photo – Viewed backward from the second hill, this photo looks at the downward slope of the first hill into a ravine. The tail assembly is at the extreme upper left corner, beneath the two trees. The skin of the right aft fuselage and top of fuselage is the white material at the right edge of the photo, above the green vegetation. The upper edge of the first ravine is visible along the bottom of the photo, which then drops out of sight.

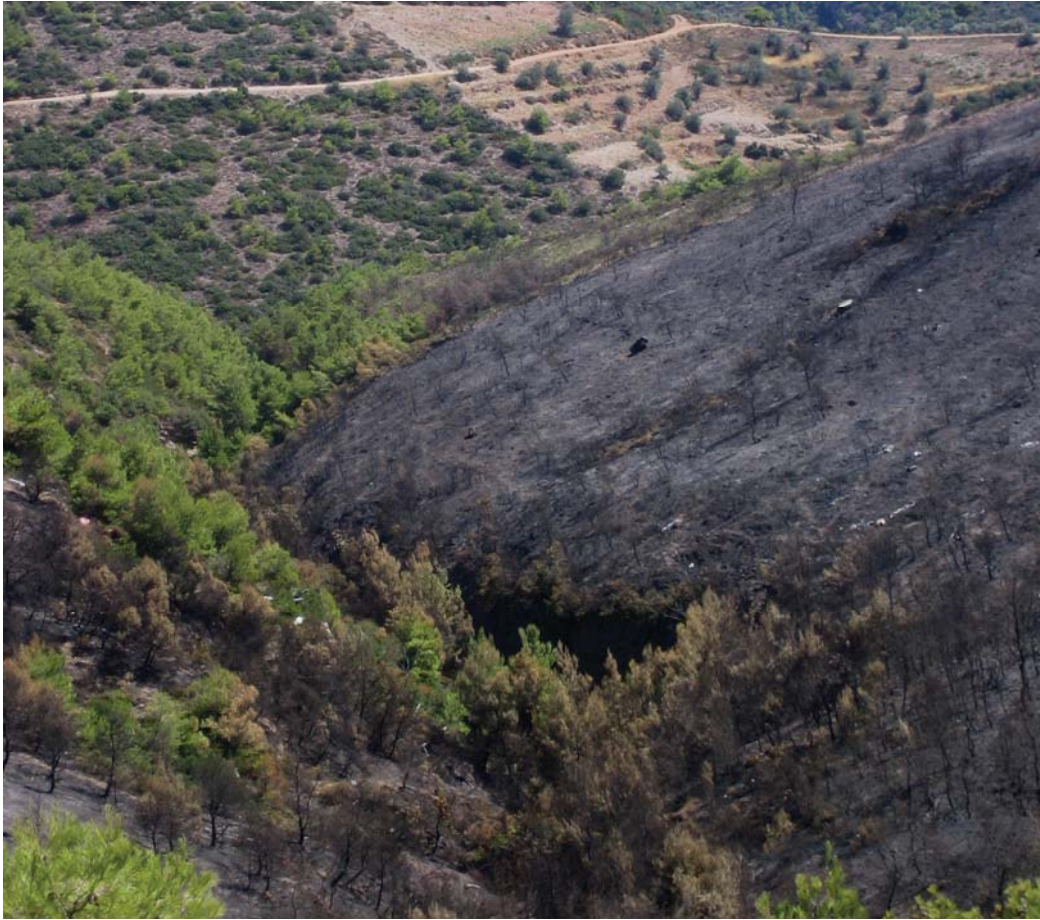
Photo – The downhill slope from the first peak is to the left and the upward slope to the peak of the second hill is to the right. The dark debris in the center of the upward slope to the right is half of the left engine.

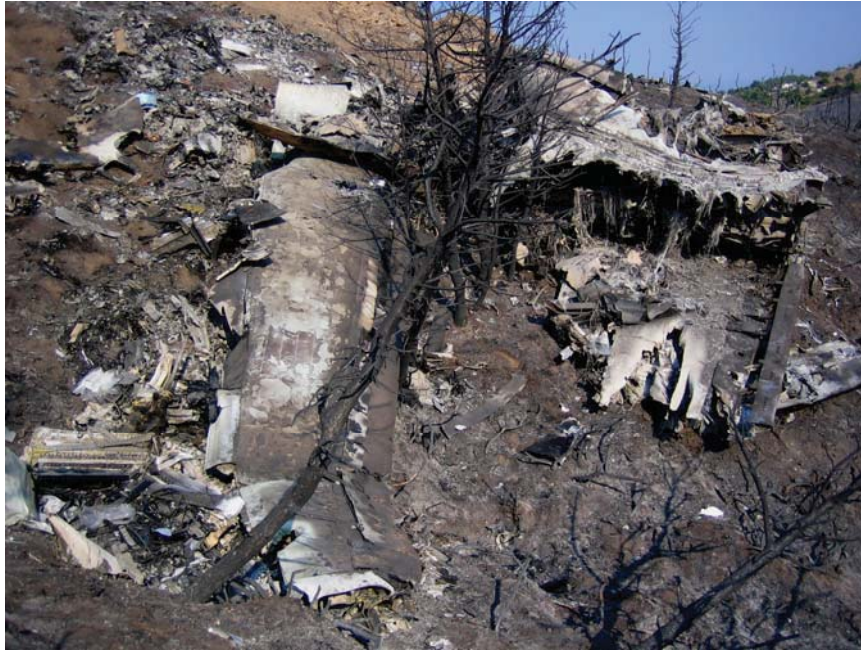
The nearly complete wings assembly was found about halfway down the second slope. The main landing gear well was burned out and was found about 12 m uphill from the wings. The wings were found folded so that the tips were downhill (See photo below).

Photo – The right wing tip is at the lower left and the left wing is at the right edge of the photo. The center section and main gear well is at top right.

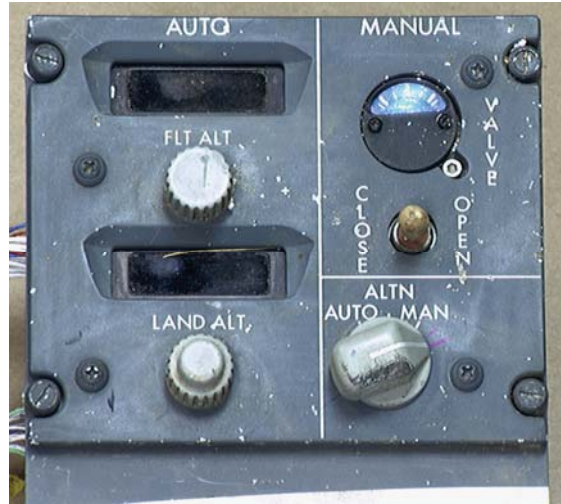
Photo – Pressurization Panel

The P5-5 cabin pressurization panel was found intact and remained in the P-5 overhead panel. The position indicator of the cabin pressure mode selector was found rotated past the MAN (manual) position (on the faceplate) by approximately 7.0 mm. It was later determined by the Boeing EQA that the damage was consistent with physical impact. The selector had an abrasion, in line with the selector line, on its right side at the lower corner. The panel face plate in the vicinity of the AUTO nomenclature had a 180 degree circular impression of the selector base. The center mark on the selector was about 10 degrees from the start of the circular impression (See photo below).

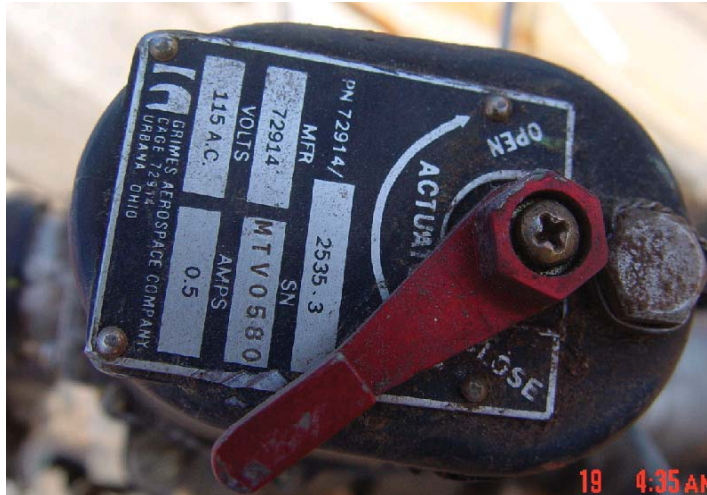
Photo - Forward Outflow Valve

The Forward Outflow Valve (photo below), manufactured by Grimes Aerospace Co., was found intact and connected to its ducting. The manufacturer Commercial and Government Entity (CAGE) code number on the actuator was 72914, which indicated that the actuator was made by Honeywell (the parent company of Grimes Aerospace Co.). The part number and serial number of the actuator were 2535-3 and MTV0580, respectively. The actuator was a subassembly of the Forward Outflow Valve, P/N 32-2684-007. The valve position indicator lever remained in the closed position, and an electrical connector remained connected to the valve assembly. A tag on the valve stated *“installation eligibility Boeing 747-200, 747-300, 747-400.”* According to Boeing, this valve is the *“approved 737 forward outflow valve as verified by part number 32-2684-007 ... the part is also approved for use on the 747.”* The butterfly valve contained within the assembly was in the closed position.

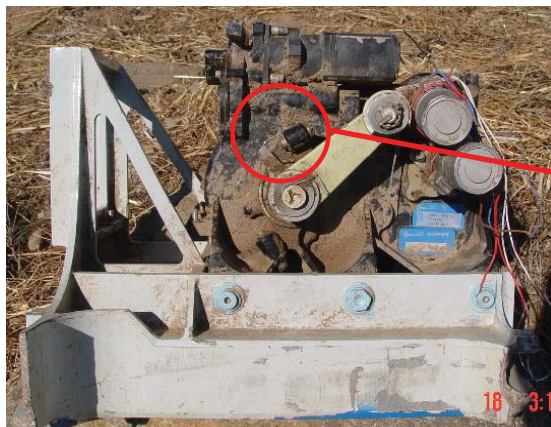
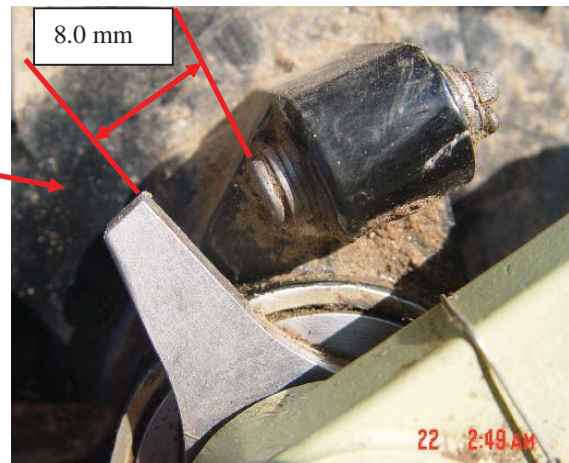
Photo - Aft Outflow Valve at accident site

The actuator/motor assembly and both the forward and aft door gates of the aft outflow valve (AOV) were found at the accident site (see diagram and photos below and next page). The actuator/motor assembly was separated from each of the door gates. The condition of the actuator/motor assembly was documented and photographed at the accident site. The control arm and position indicator remained attached to the motor assembly. Using hand pressure, a small force was applied to the control arm; it was physically locked in place and not able to rotate freely. At the storage facility, a measurement was taken between the closed position stop and the control arm position lever; the distance between the two was 8.0 mm (see photo in the next page).

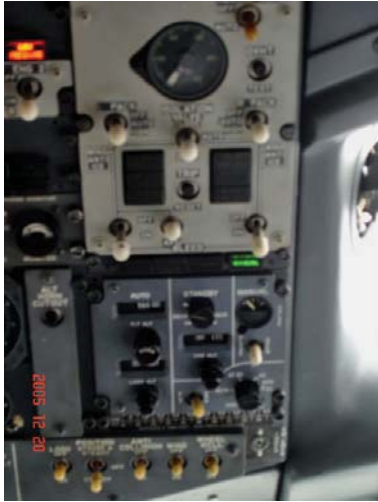
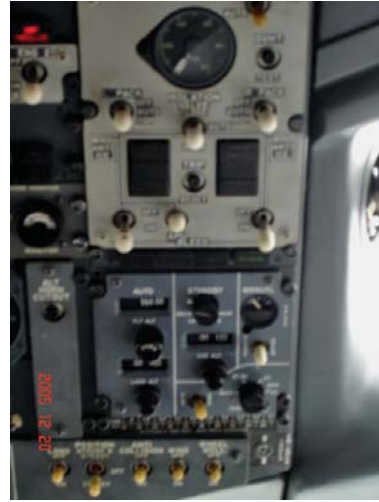
on DIM and looking up to the overhead panel from the First Officer's seat, the green annunciation MANUAL was not particularly obvious.
