# **NATIONAL TRANSPORTATION SAFETY BOARD**

**CONTROLLED FLIGHT INTO TERRAIN  
KOREAN AIR FLIGHT 801  
BOEING 747-300, HL7468  
NIMITZ HILL, GUAM  
AUGUST 6, 1997**

**National Transportation Safety Board. 2000. *Controlled Flight Into Terrain, Korean Air Flight 801, Boeing 747-300, HL7468, Nimitz Hill, Guam, August 6, 1997. Aircraft Accident Report NTSB/AAR-00/01. Washington, DC.***

NTSB/AAR-00/01  
PB00-910401  
Notation 6952B  
Adopted January 13, 2000

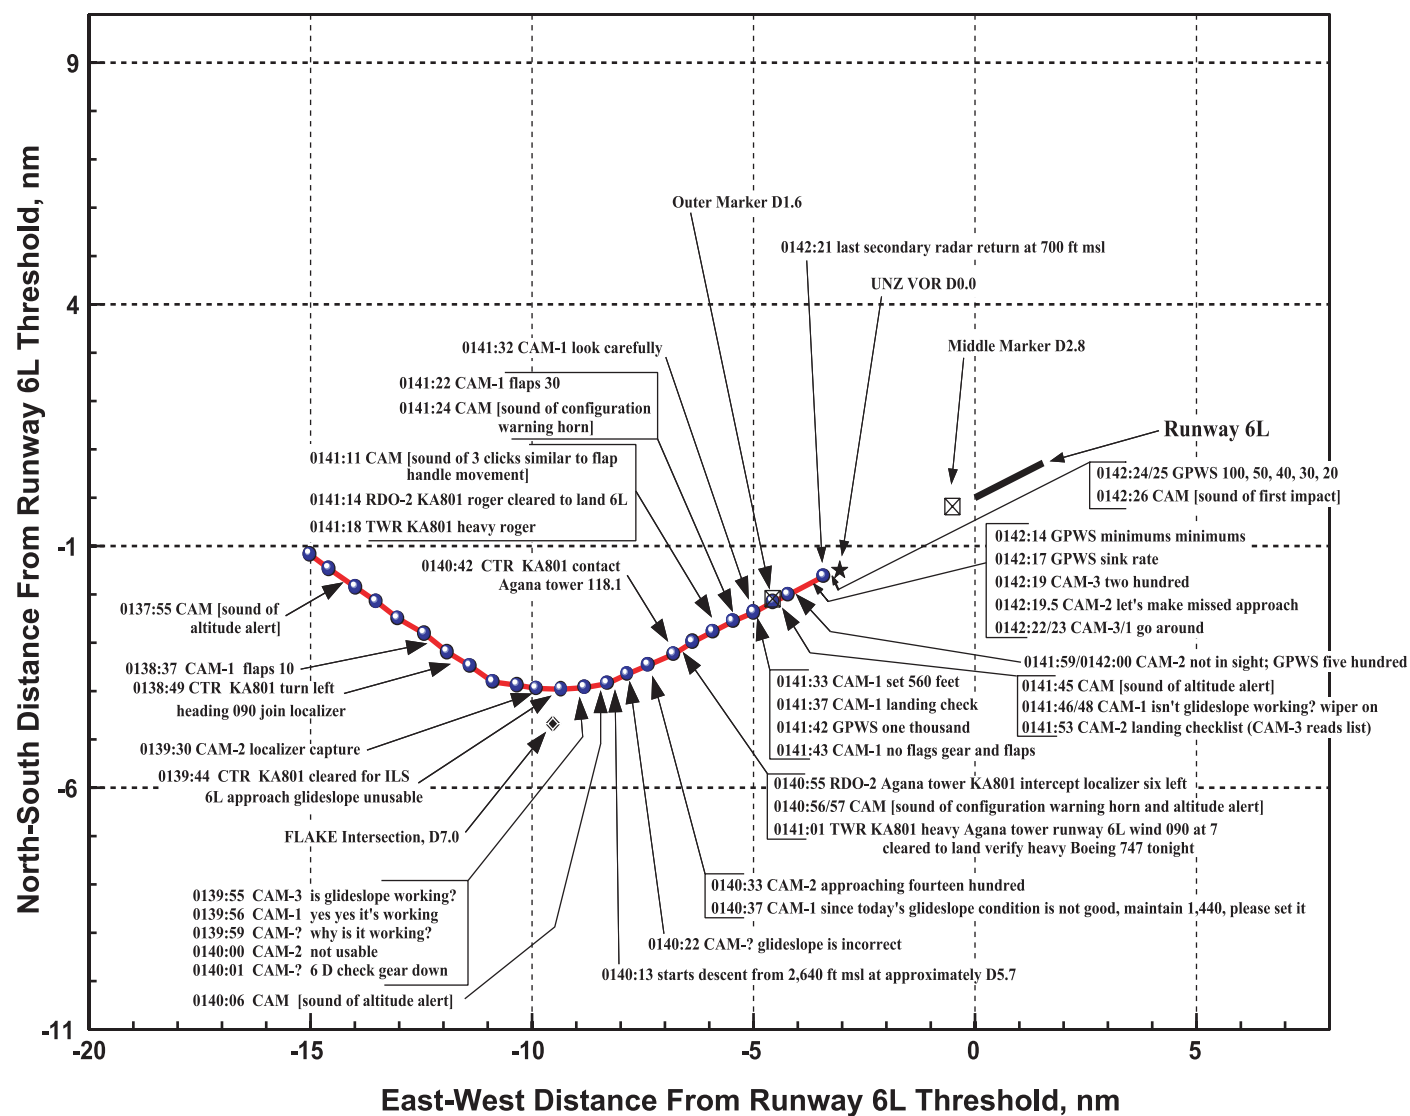
**Figure 3.** Overhead view of FAA radar data with selected ATC and CVR communication excerpts.

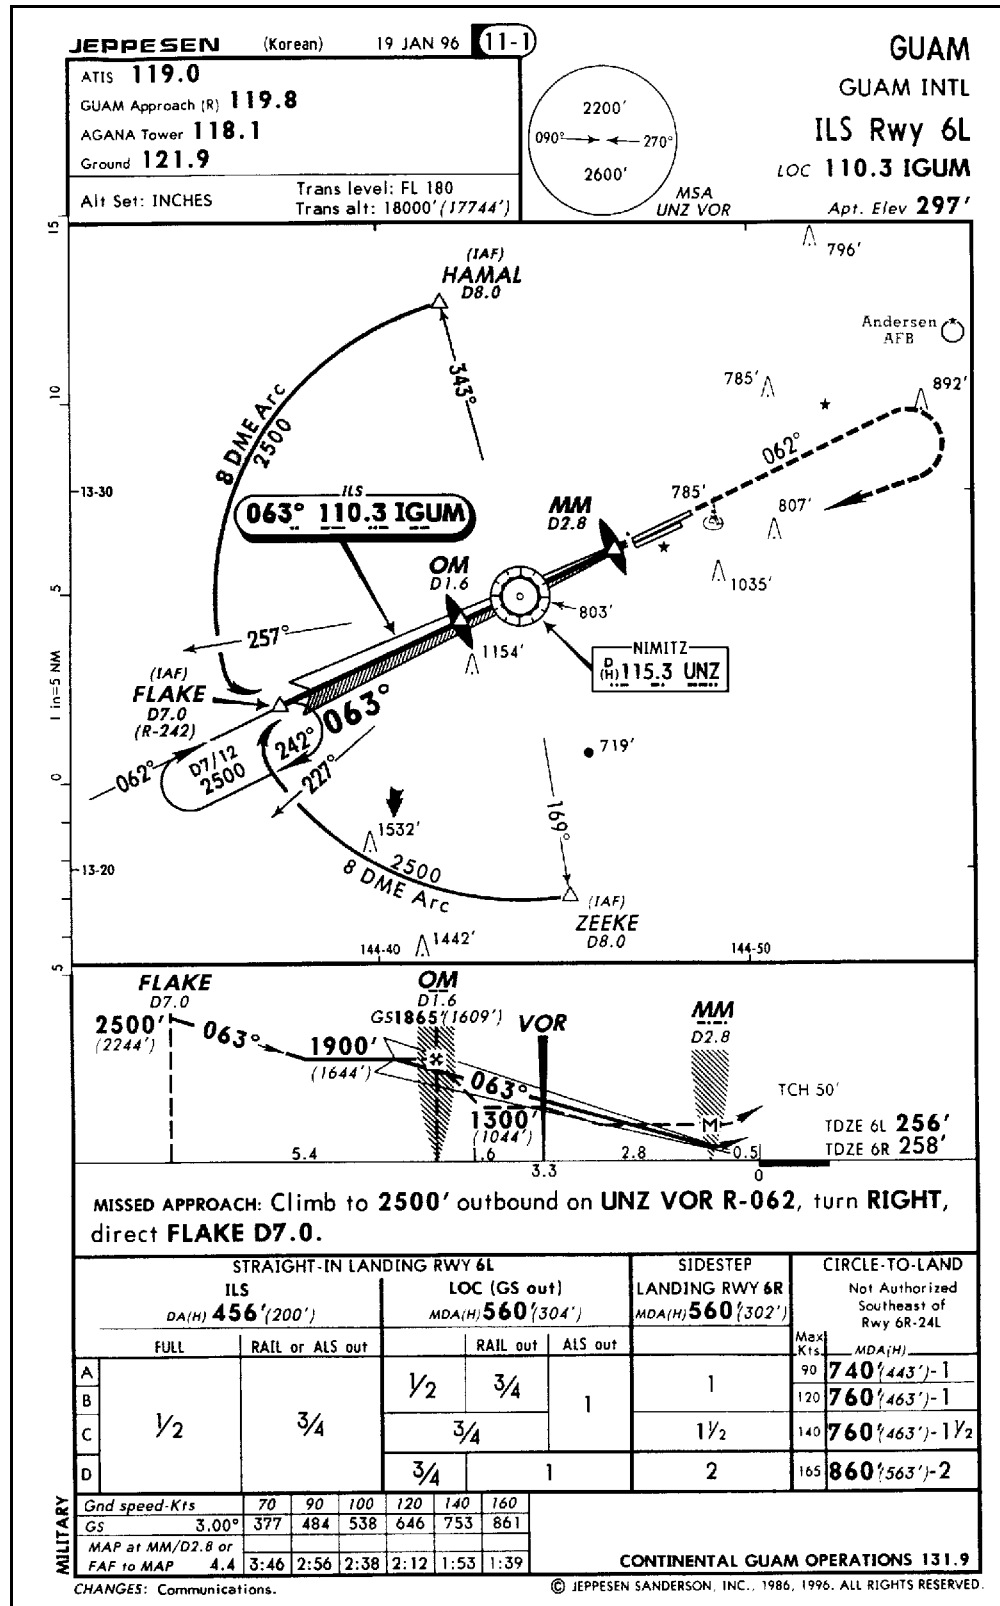
Charts 11-1 and 13-2 were found side by side and were visible through one face of the plastic sleeve. Chart 16-1 and the blank side of an approach plate were visible through the opposite face of the plastic sleeve. Chart 11-1, which is shown in figure 7, had the following items highlighted with a green fluorescent tint:<sup>62</sup>

Figure 7. The January 19, 1996, 11-1 ILS runway 6L instrument approach chart.

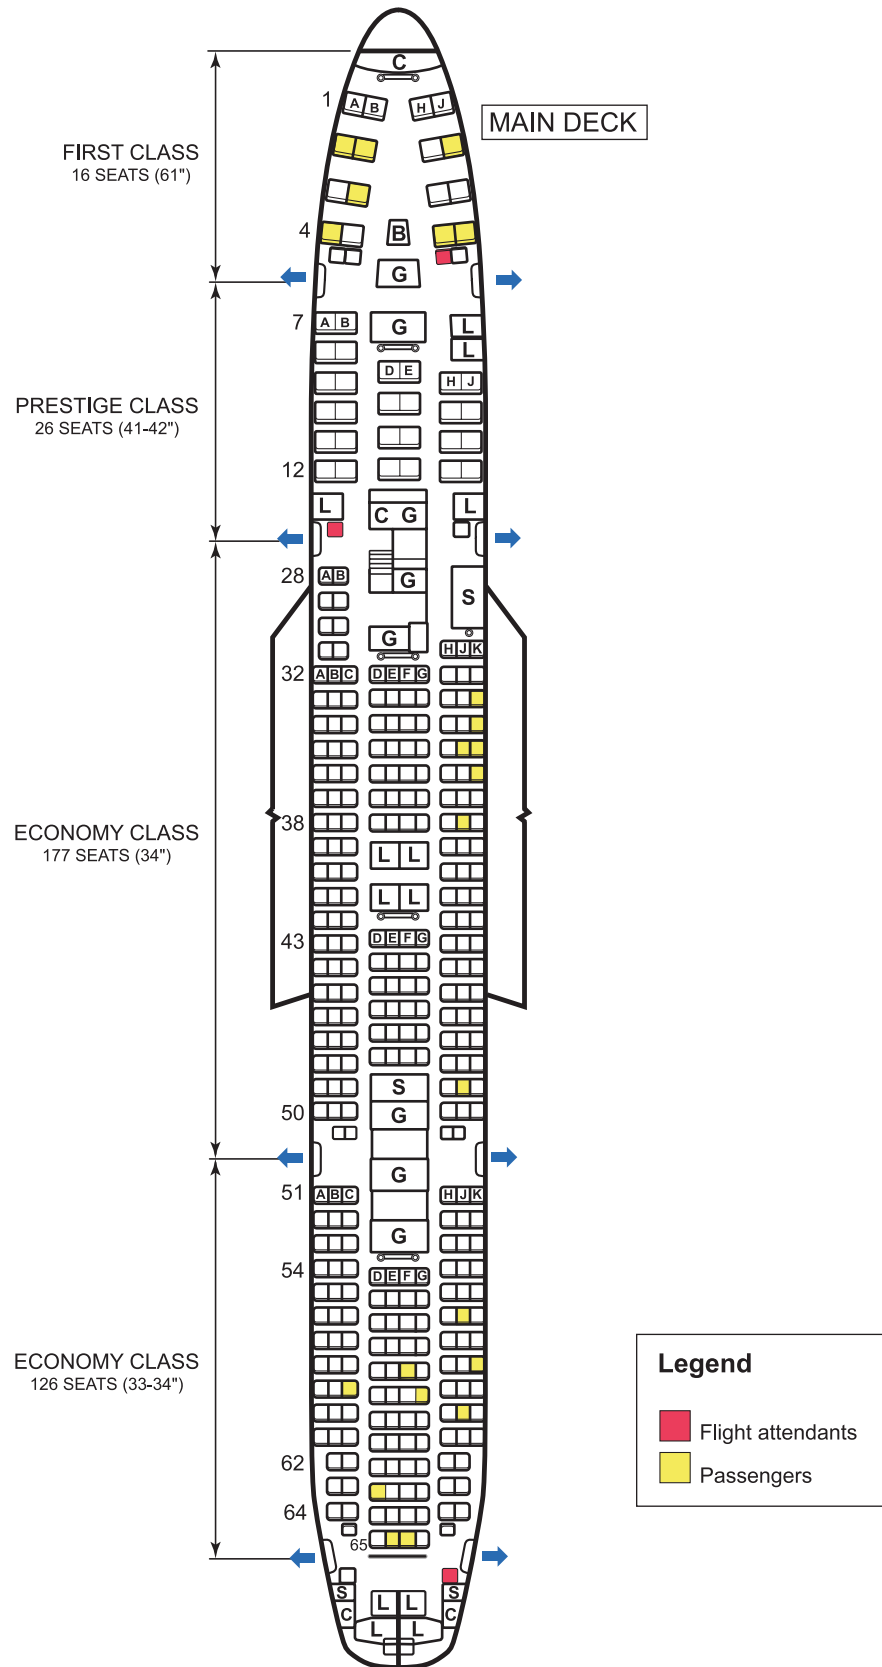
Of the 26 survivors of the accident, 7 passengers and 1 flight attendant were seated in the first class section, 1 flight attendant was seated in the prestige class section, 7 passengers were seated in the forward economy class section, and 9 passengers and 1 flight attendant were seated in the aft economy class section. Two of the surviving flight attendants and 13 of the surviving passengers were seated on the right side of the airplane; 6 of these 13 passengers were seated over the right wing. Figure 9 shows the 747-300 cabin configuration and the survivor seat locations.

**Figure 9.** Korean Air flight 801 cabin configuration and survivor seat locations.
