Attempted Takeoff From Wrong Runway  
Comair Flight 5191  
Bombardier CL-600-2B19, N431CA  
Lexington, Kentucky  
August 27, 2006

NTSB/AAR-07/05

# Aircraft Accident Report

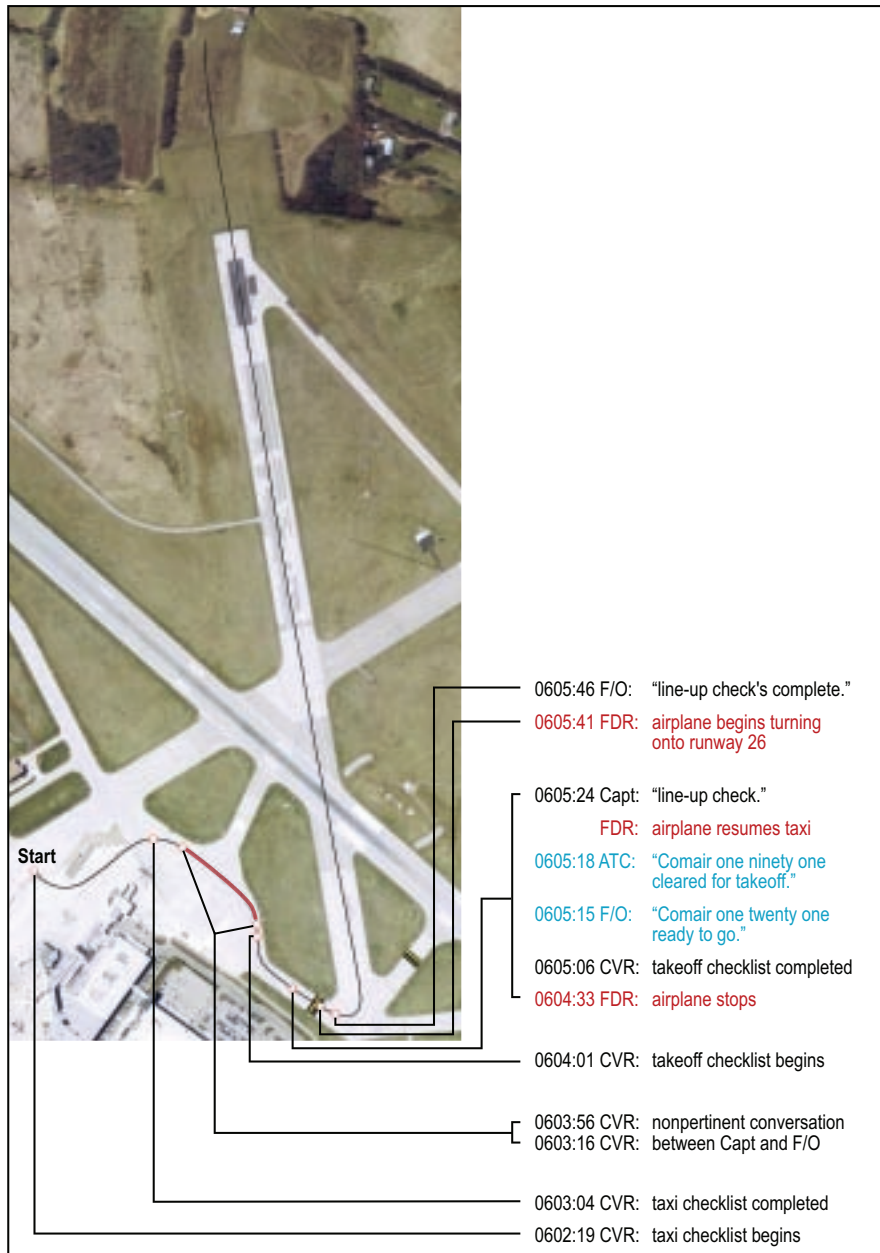
**Figure 1.** Groundpath Before Flight 5191 Aligned With Runway 26

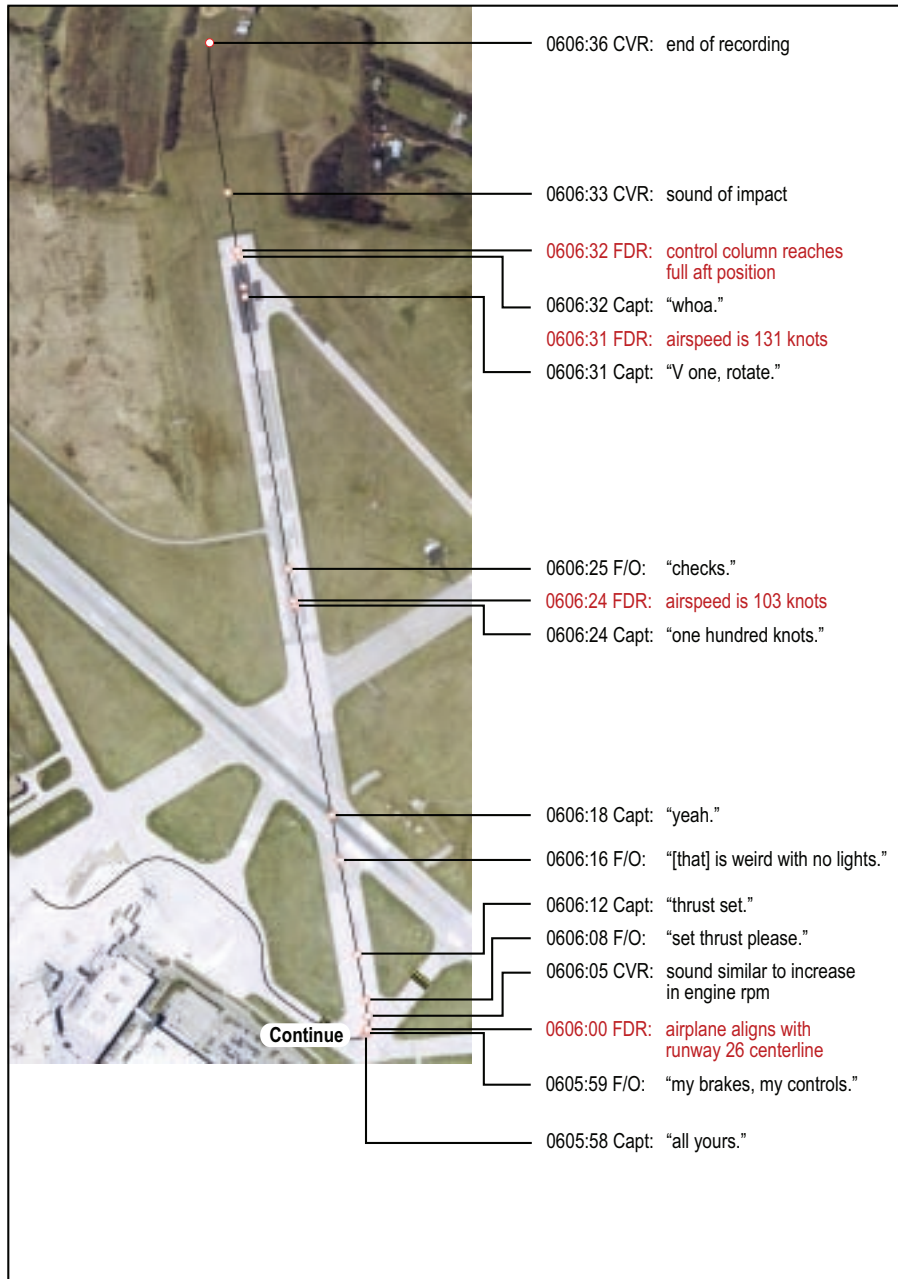
**Figure 1a.** Groundpath as Flight 5191 Aligned With Runway 26

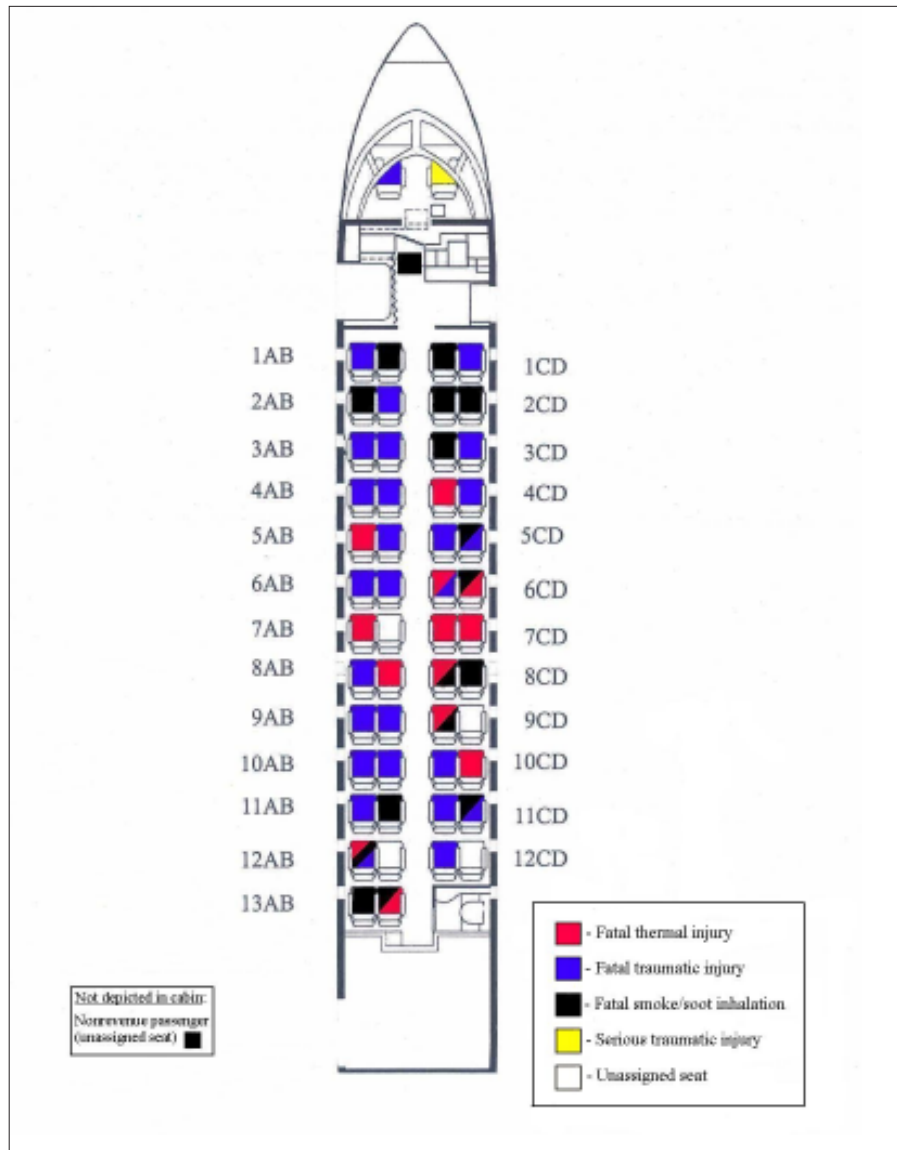
The Fayette County Coroner's office examined the remains of the captain, flight attendant, and passengers. Their cause of death was "multiple injuries sustained in a commercial aviation crash with subsequent fire." The major pathologic findings for these airplane occupants are shown in figure 4 along with injury information for the first officer.

**Figure 4.** Injury Information According to Seat Assignment

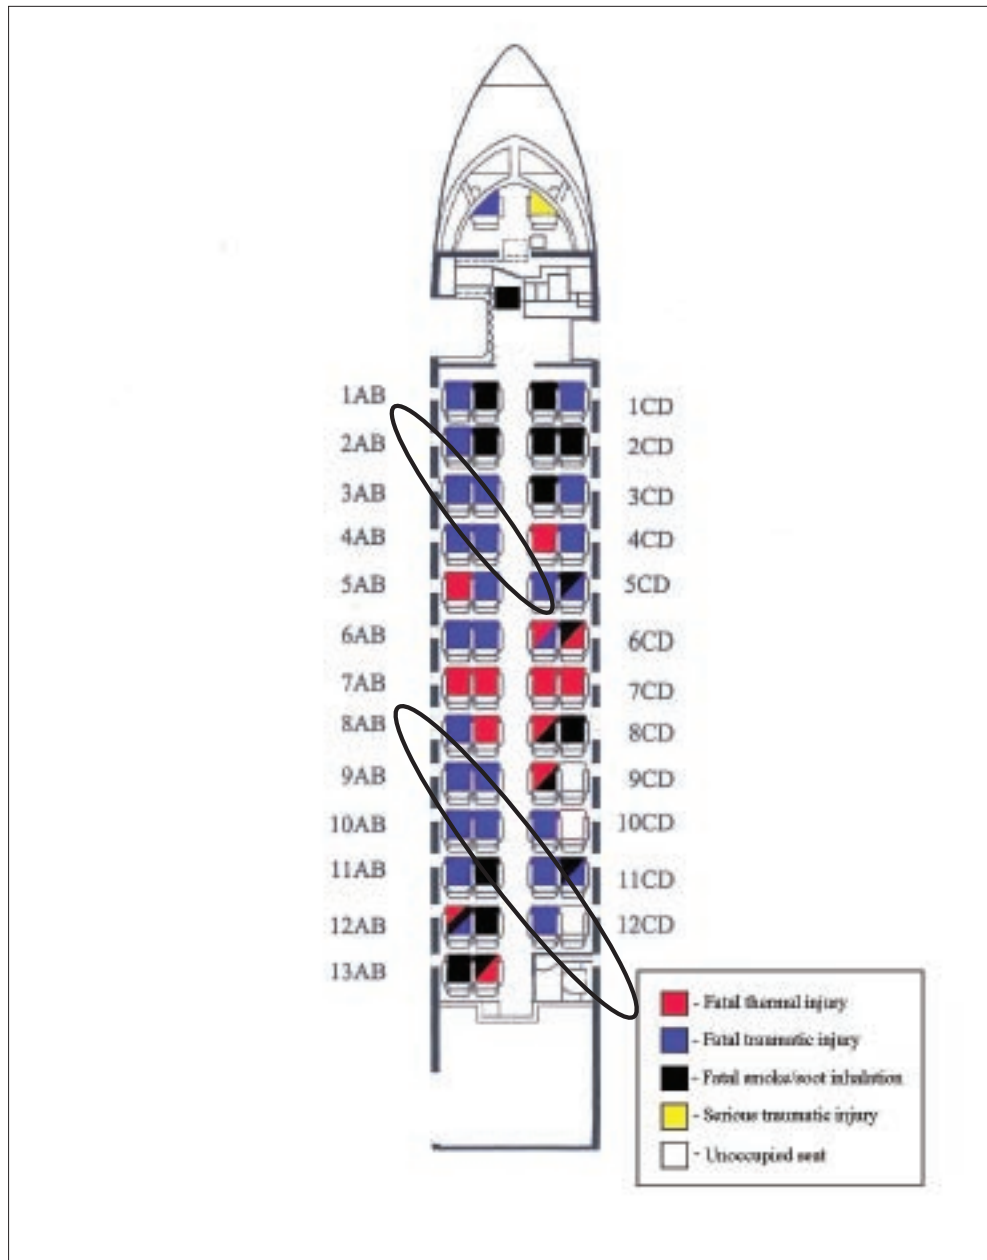
The simultaneous impacts with two large diameter trees caused numerous blunt force fatal injuries to passengers. One of these tree strikes occurred on the left side of the fuselage several rows aft of the main cabin door.<sup>209</sup> The other tree strike occurred in the area where the left inboard wing attached to the fuselage. This tree breached the left wing fuel tank and the cabin in the area of the left overwing exit, cut through the cabin as the airplane continued to slide, and exited the right side of the aft cabin. Figure 8 shows the approximate tree strike areas in the cabin.

**Figure 8.** Approximate Tree Strike Areas and Injury Information
