AIRCRAFT ACCIDENT REPORT

IN-FLIGHT ICING ENCOUNTER AND LOSS OF CONTROL
SIMMONS AIRLINES, d.b.a. AMERICAN EAGLE FLIGHT 4184
AVIONS de TRANSPORT REGIONAL (ATR)
MODEL 72-212, N401AM
ROSELAWN, INDIANA
OCTOBER 31, 1994

VOLUME 1: SAFETY BOARD REPORT

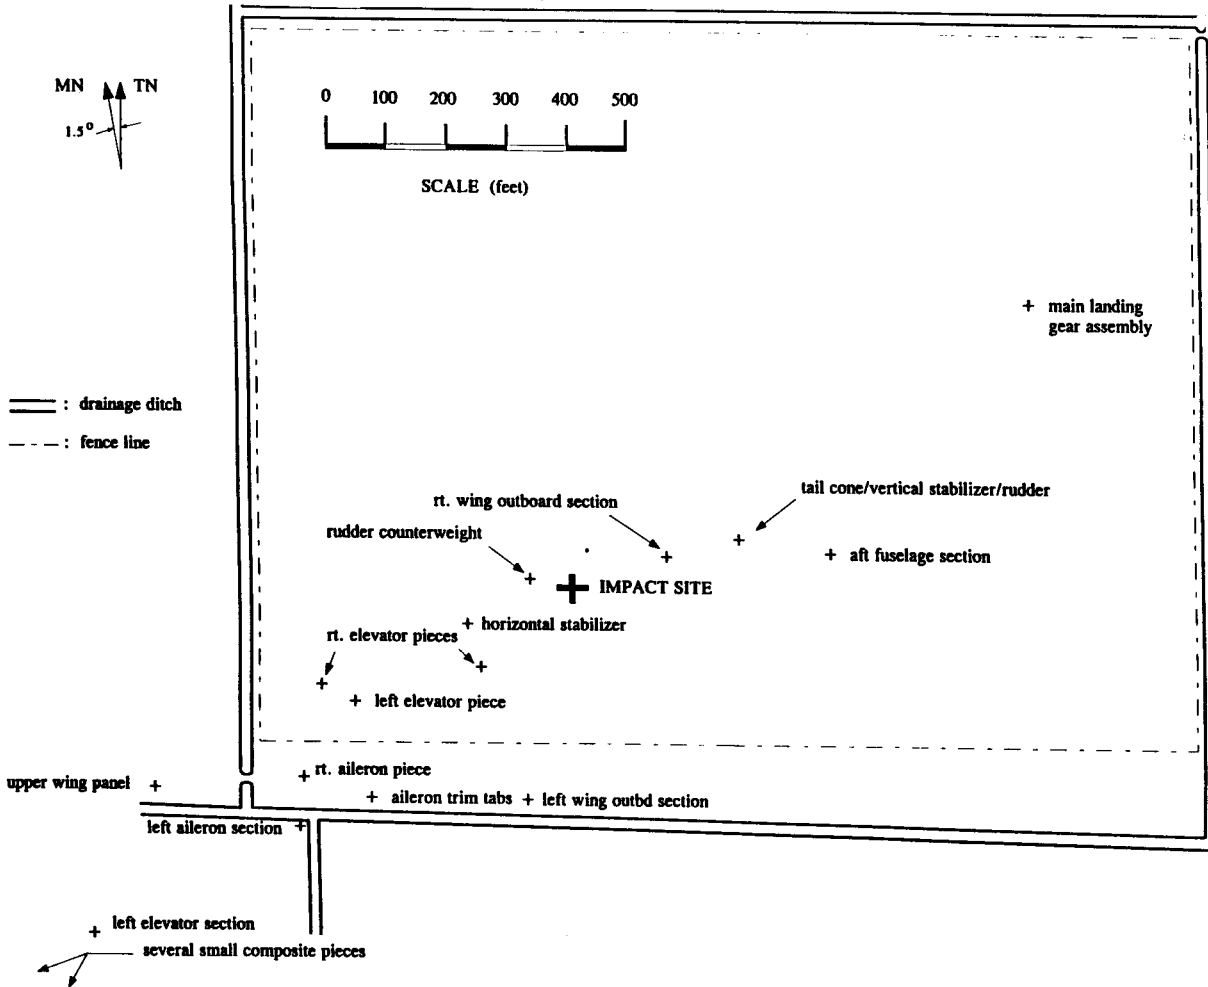
Figure 10a.--Wreckage distribution diagram.

Two smaller impact craters, consistent with the size of the left and right engines, were found on both sides of the larger, main impact crater (the size and orientation of the three craters, identified as crater 1, crater 2A, and crater 2B, are shown in Figure 10b). Most of the human remains, as well as portions of the

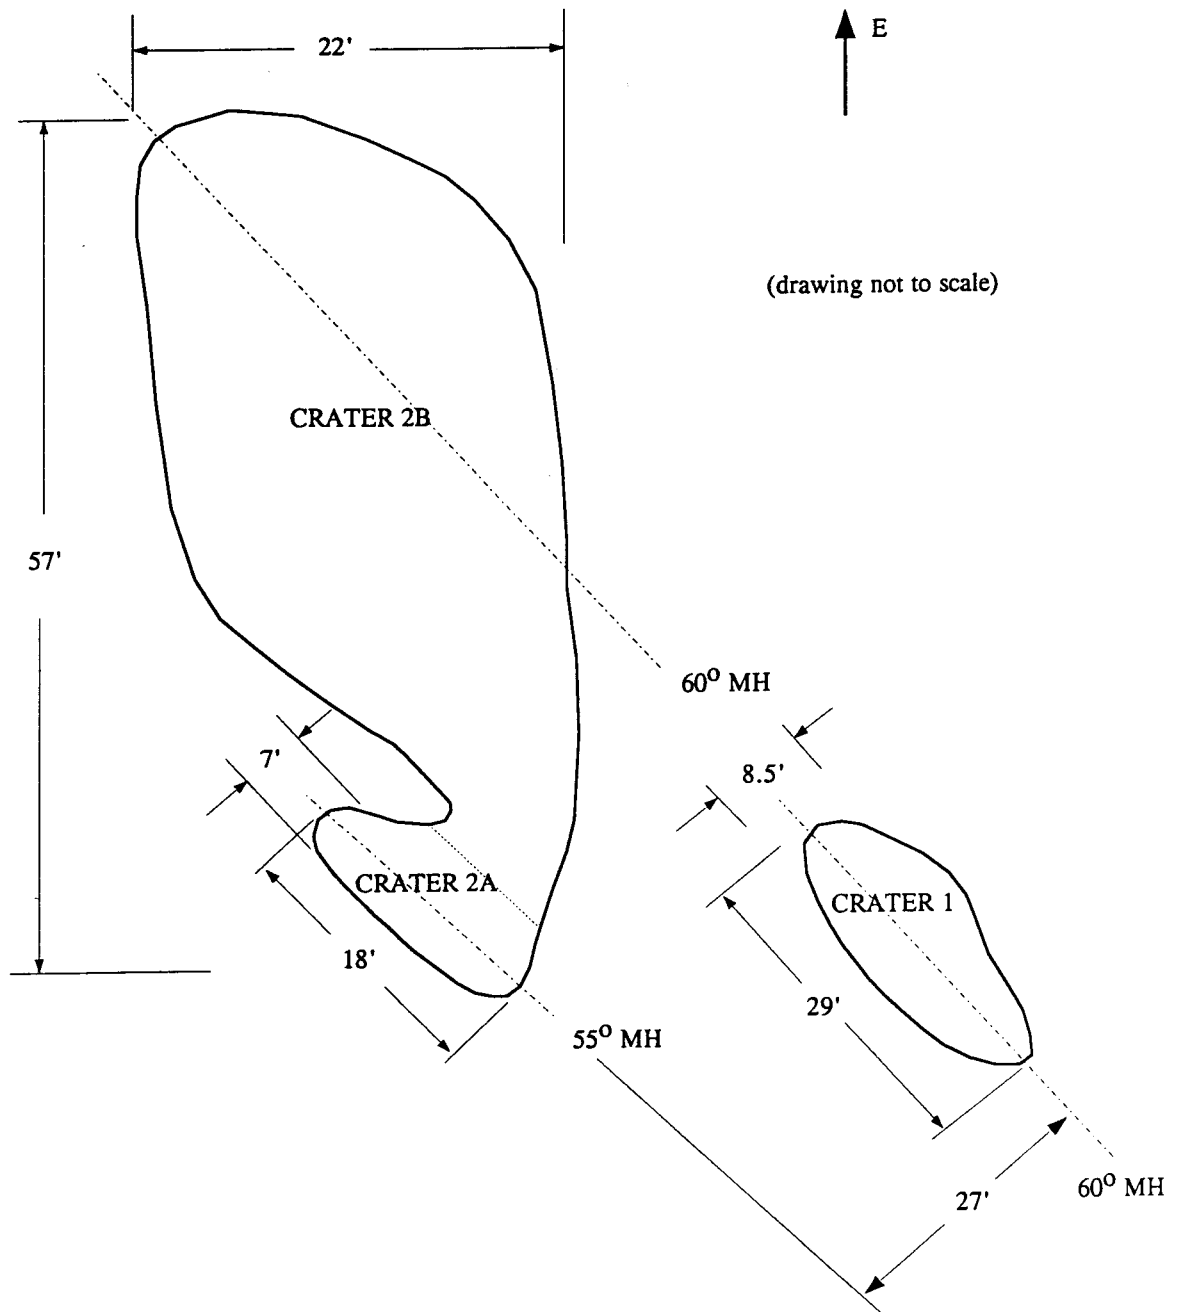
Figure 10b.--Impact craters.

airplane structure and components, were located to the east-northeast of the impact craters. Portions of the wings and empennage were found to the south and southwest of the craters. The first major airplane structure found in the debris field, located farthest southwest from the impact craters, was a portion of the left elevator. Numerous small lightweight pieces of composite material were found about 1,000 feet southwest of the elevator. The last pieces in the debris field, farthest northeast from the impact craters, consisted of a main landing gear assembly (main landing gear wheel and tire) a portion of the flightcrew/passenger oxygen bottle, and two hydraulic pumps located in the lower section of the airplane.

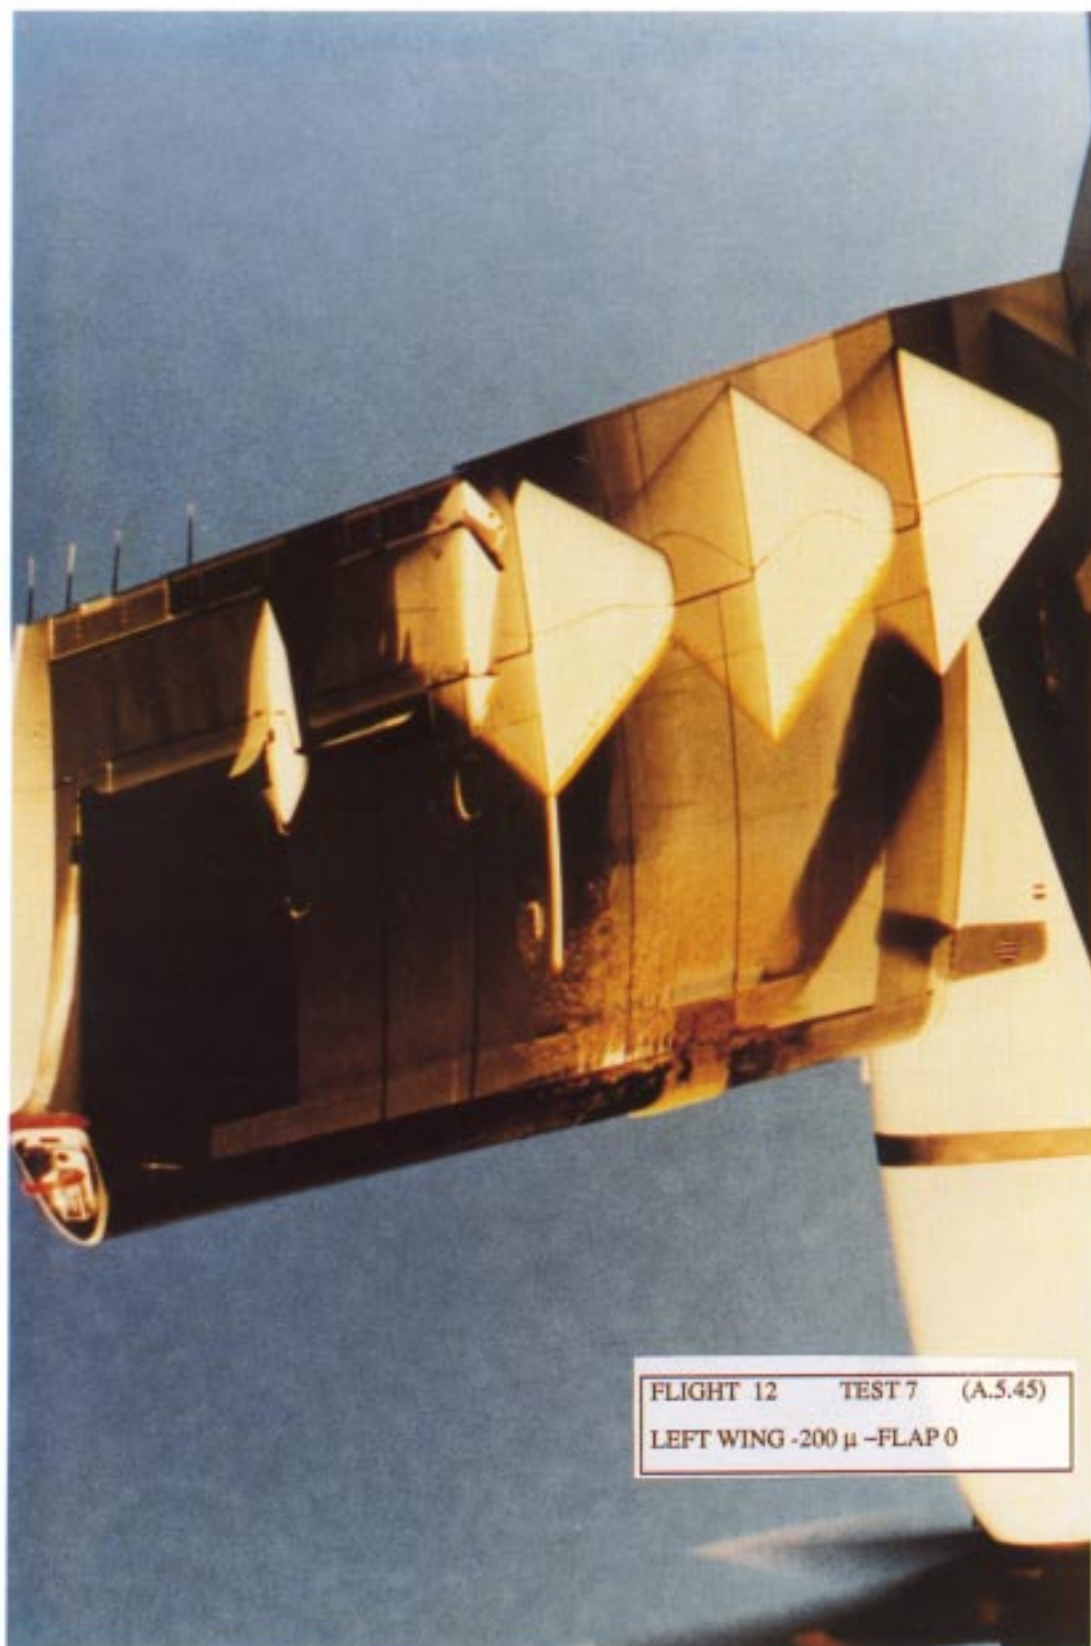
FLIGHT 12 TEST 7 (A.5.44)
LEFT WING -200 μ -FLAP 0
