AIRCRAFT ACCIDENT REPORT

IN-FLIGHT ICING ENCOUNTER AND LOSS OF CONTROL
SIMMONS AIRLINES, d.b.a. AMERICAN EAGLE FLIGHT 4184
AVIONS de TRANSPORT REGIONAL (ATR)
MODEL 72-212, N401AM
ROSELAWN, INDIANA
OCTOBER 31, 1994

VOLUME II: RESPONSE OF BUREAU ENQUETES-ACCIDENTS
TO SAFETY BOARD'S DRAFT REPORT

COMMENTS OF THE BUREAU ENQUETES ACCIDENTS (FRANCE)

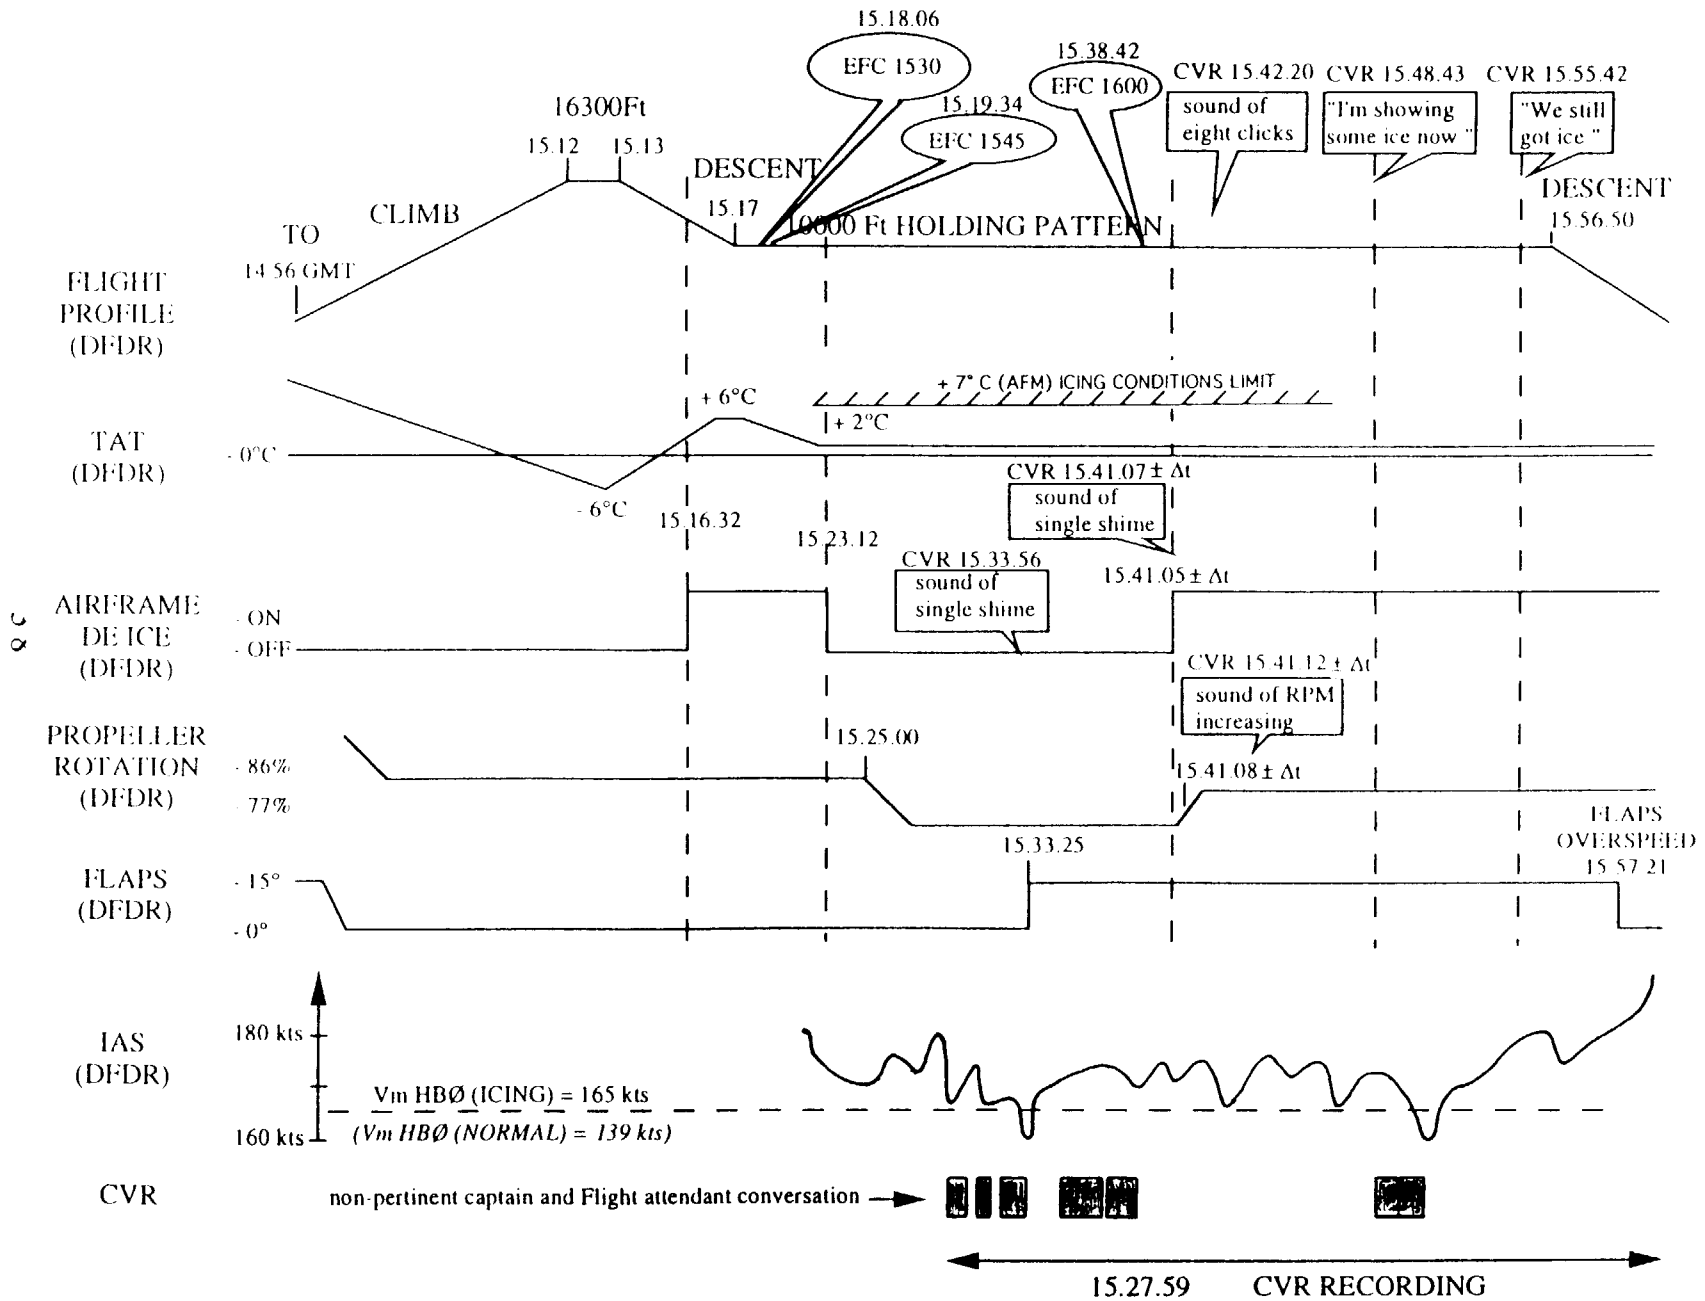
FIGURE 1 : FLIGHT 4184 PROFILE AND MAJOR DFDR EVENTS

The last seconds of DFDR data indicate a rapid, large input on the elevator.

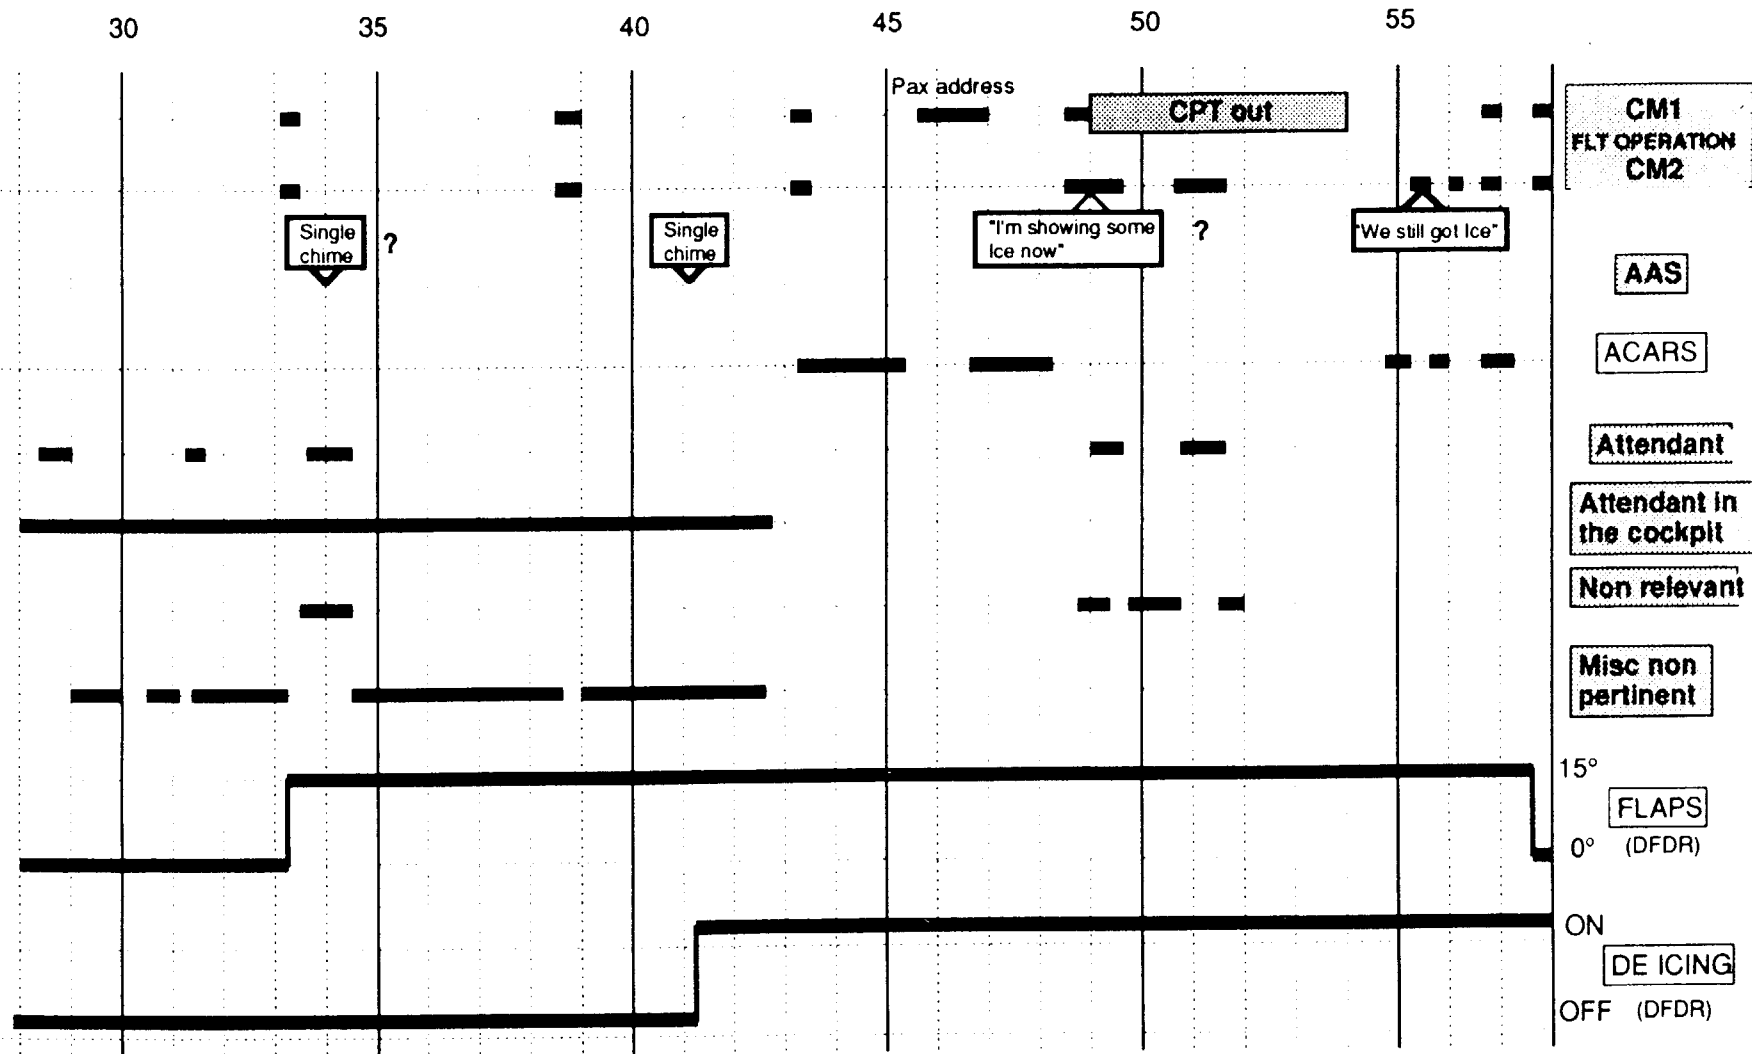
FIGURE 2 : FLIGHT 4184 CVR TIME HISTORY

Flight 4184 CVR transcript by NTSB was highly unedited

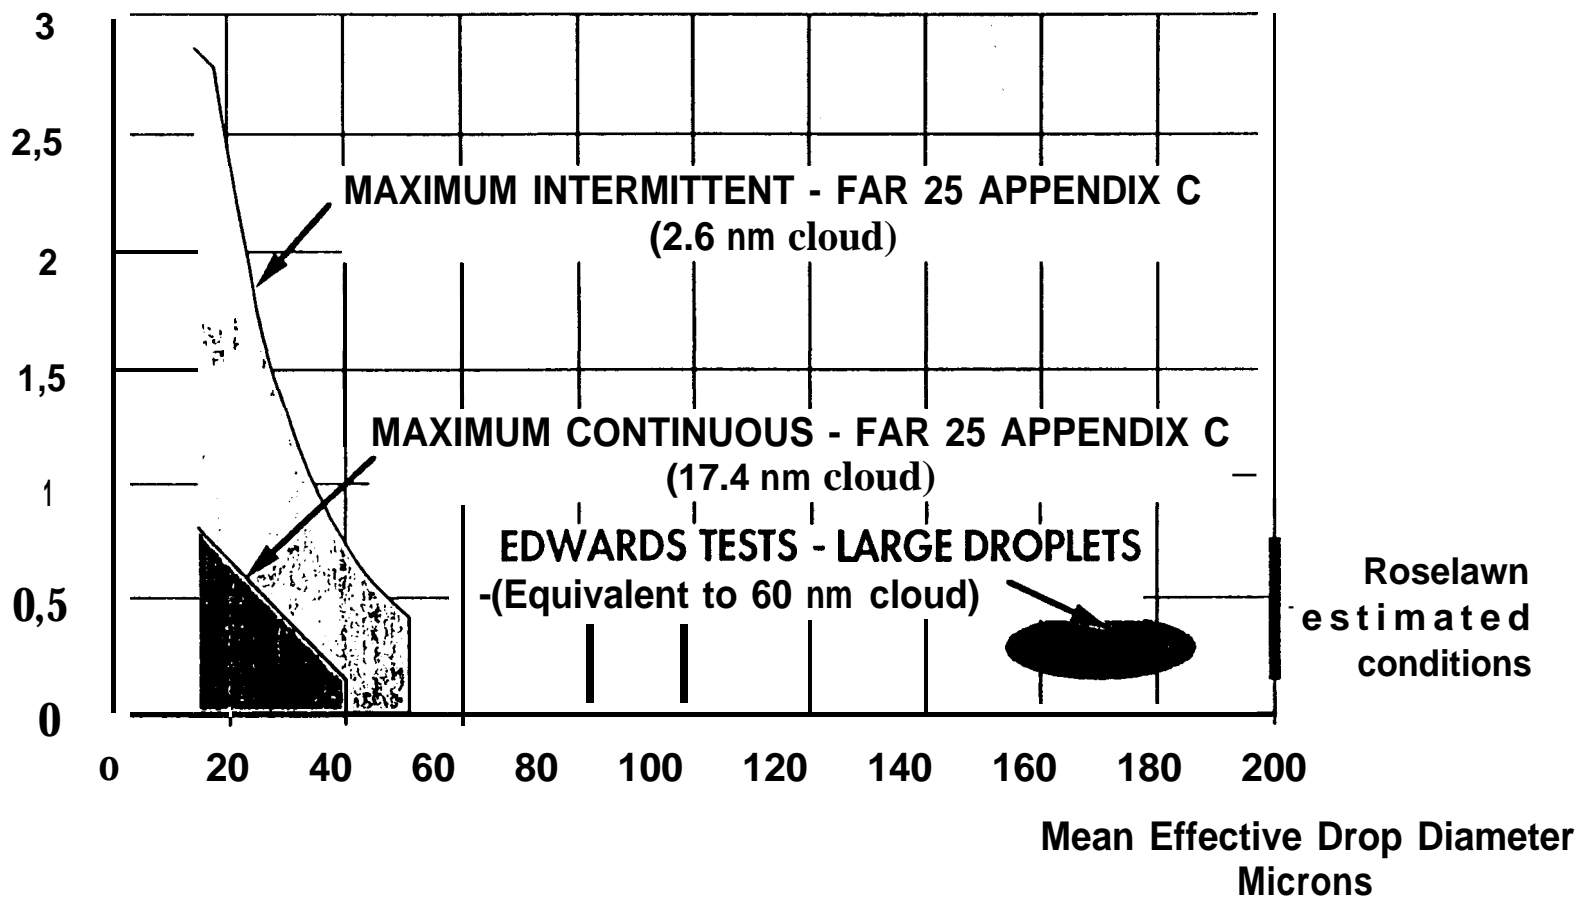
Liquid Water Content
(g per cu m)

ROSELAWN conditions were far outside App "C" certification envelope

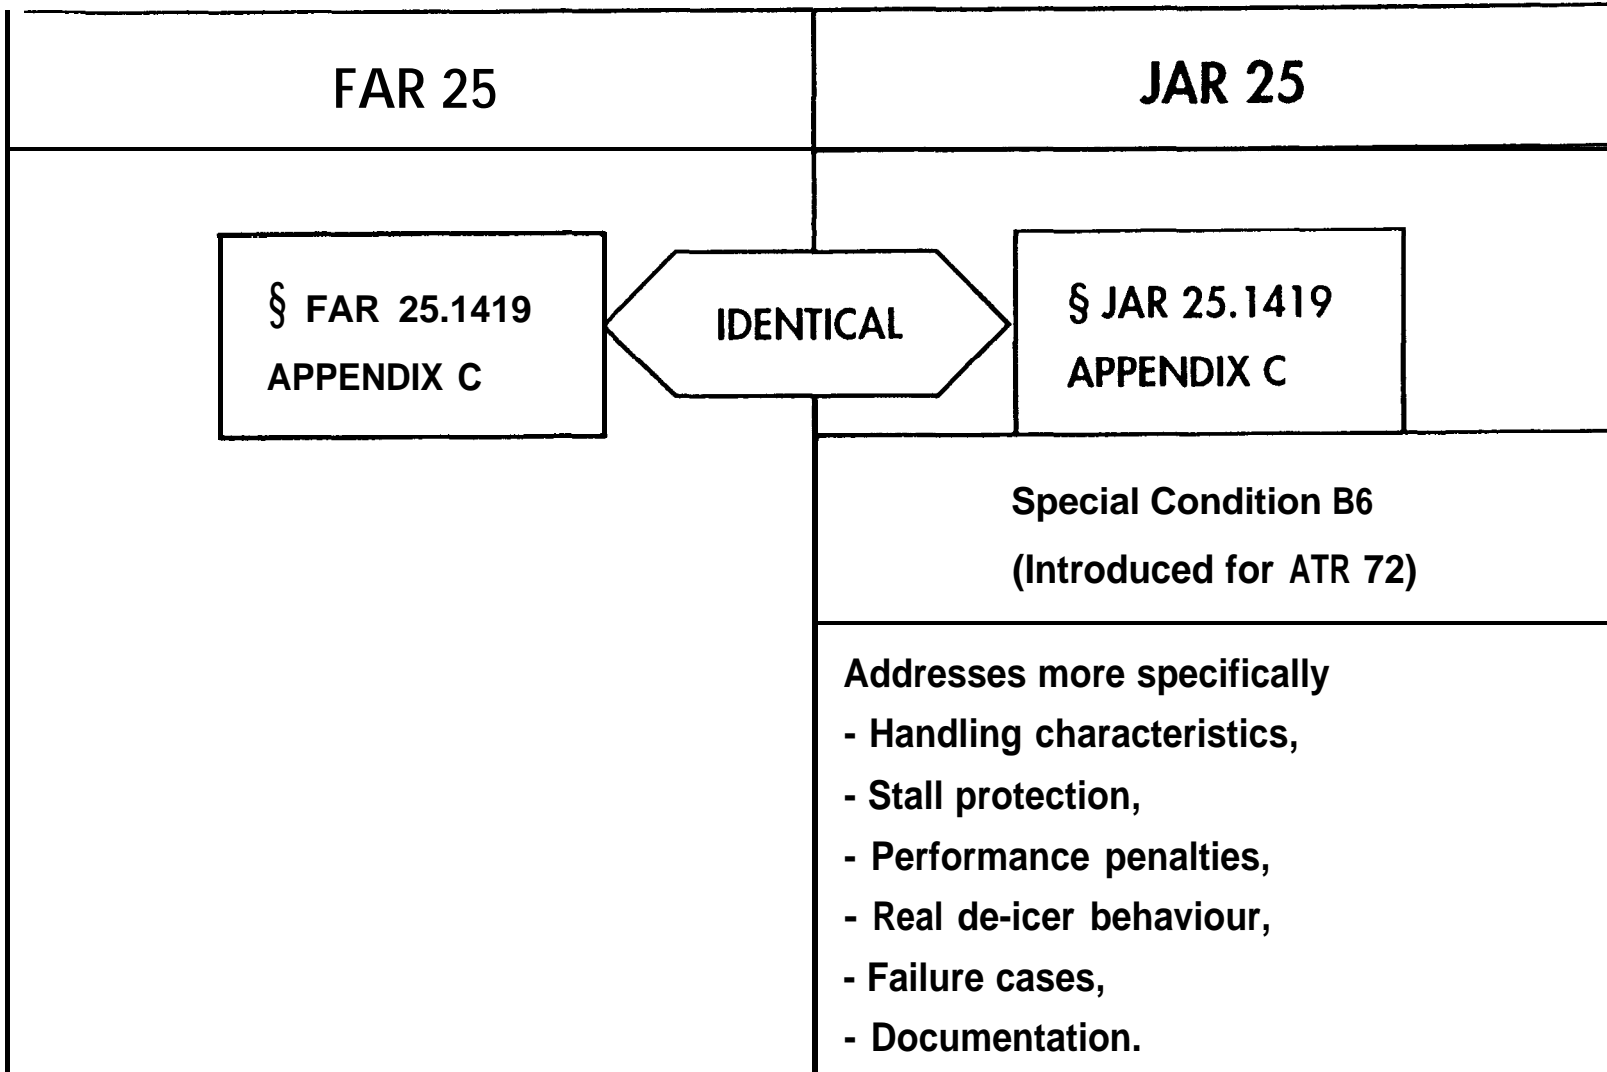
ATR 72 Icing Certification Standard encompassed current FAR 25.1419

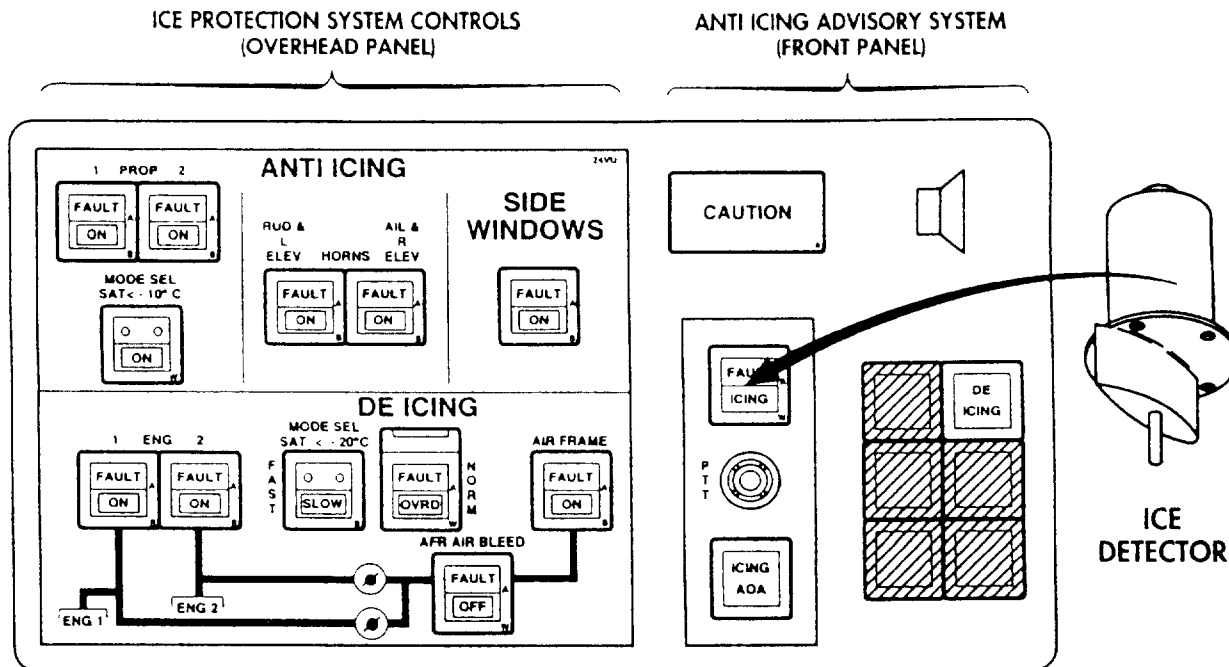
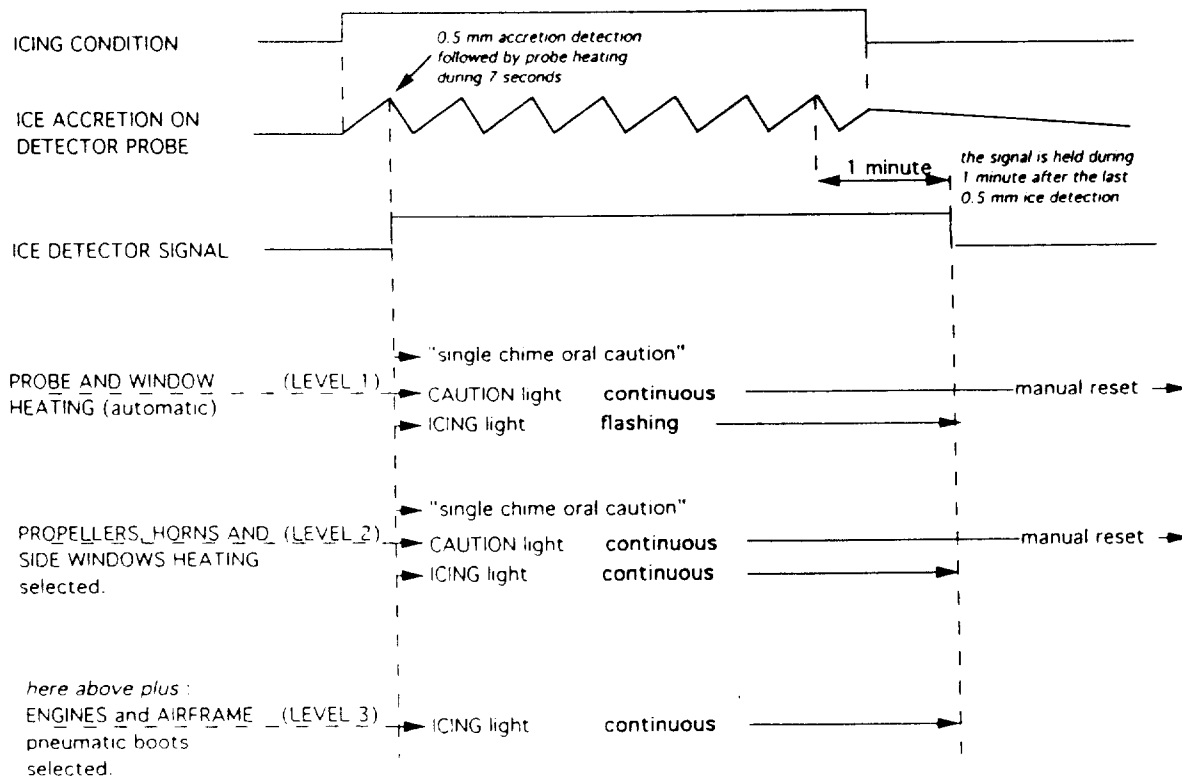
FIGURE 12 : ATR 72 ANTI-ICING ADVISORY SYSTEM (AAS)

The propeller rotation speed is not controlled nor monitored by the AAS. The normal procedure requires the increase in the propeller rotation speed, from 77% to 86%, as soon as and as long as icing conditions are present. This should be done when the propeller anti-icing is selected as part of the Level II procedure.

ATR 72 ANTI-ICING ADVISORY SYSTEM (AAS) : An effective warning logic to back up crew awareness

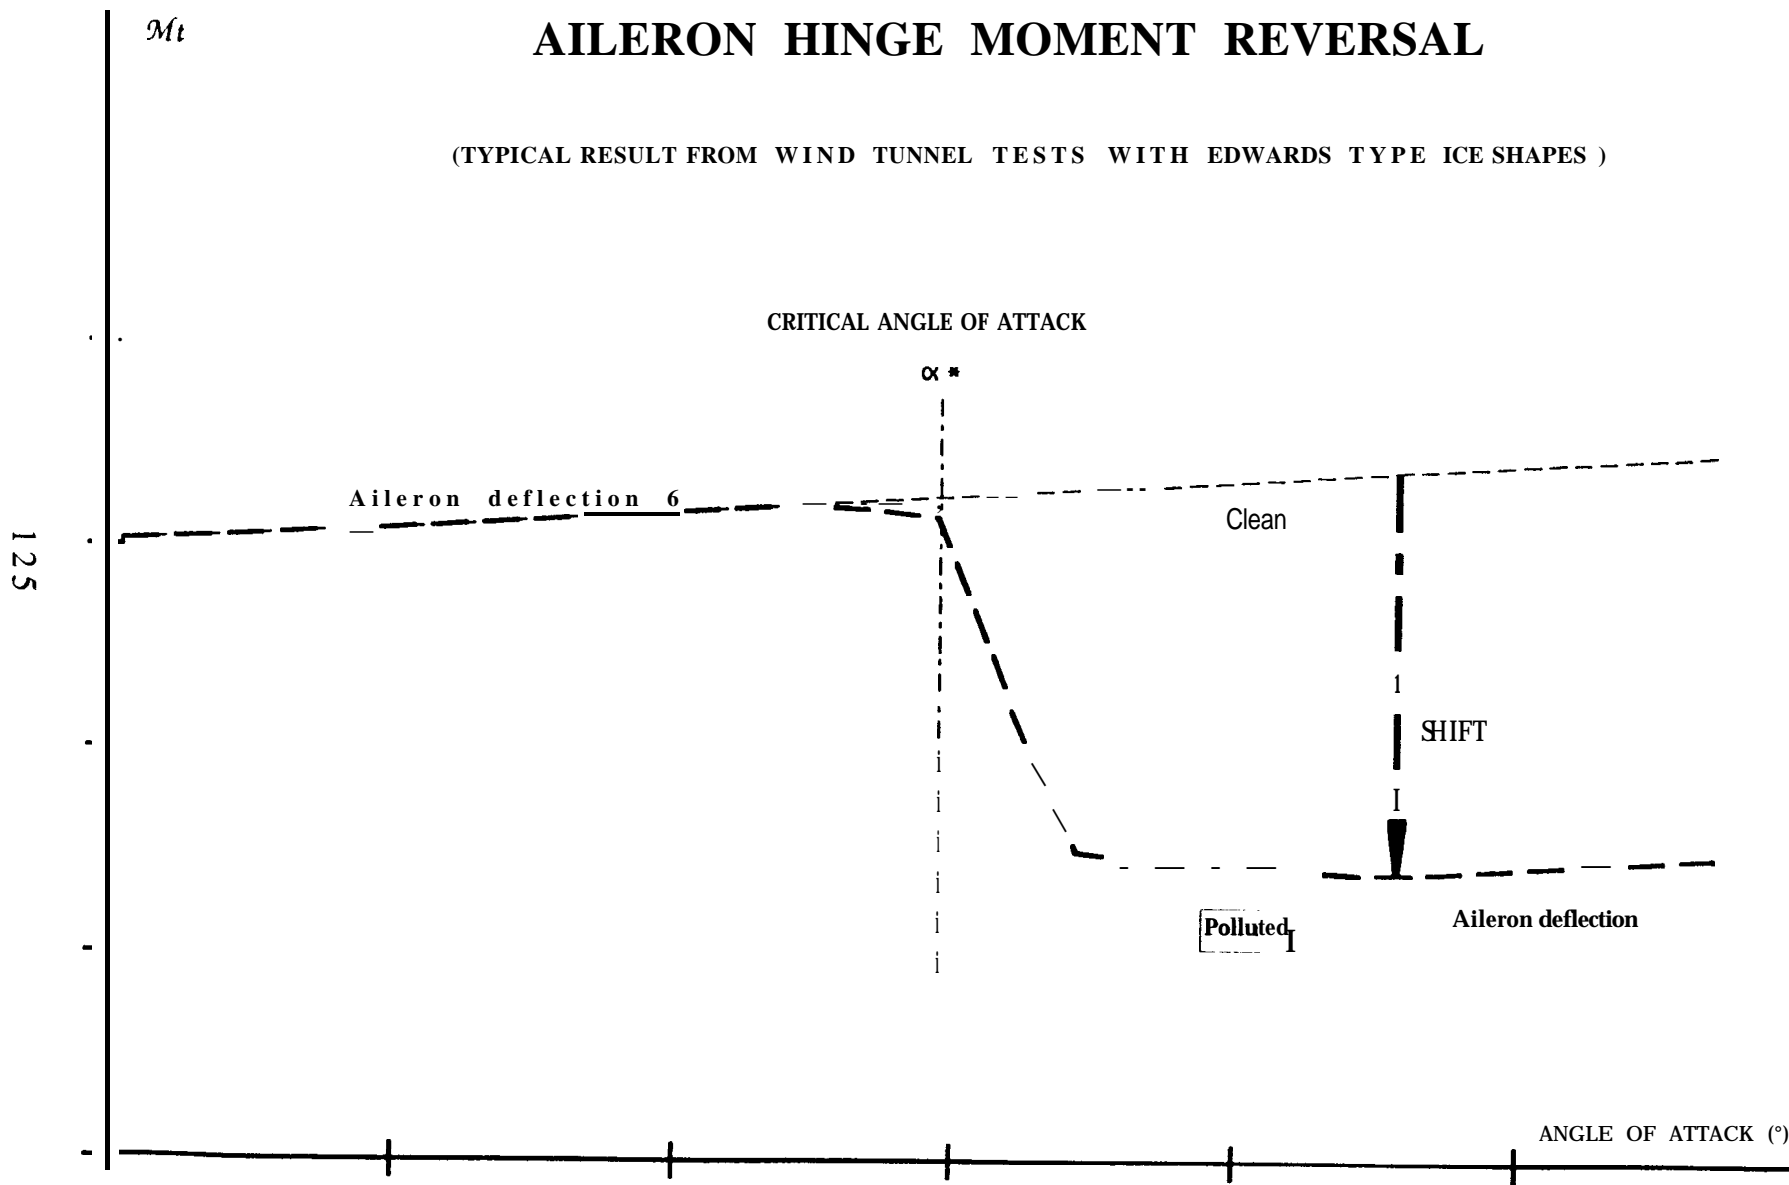
FIGURE 13 : HINGE MOMENT REVERSAL IDENTIFICATION

AILERON HINGE MOMENT REVERSAL

(TYPICAL RESULT FROM WIND TUNNEL TESTS WITH EDWARDS TYPE ICE SHAPES)

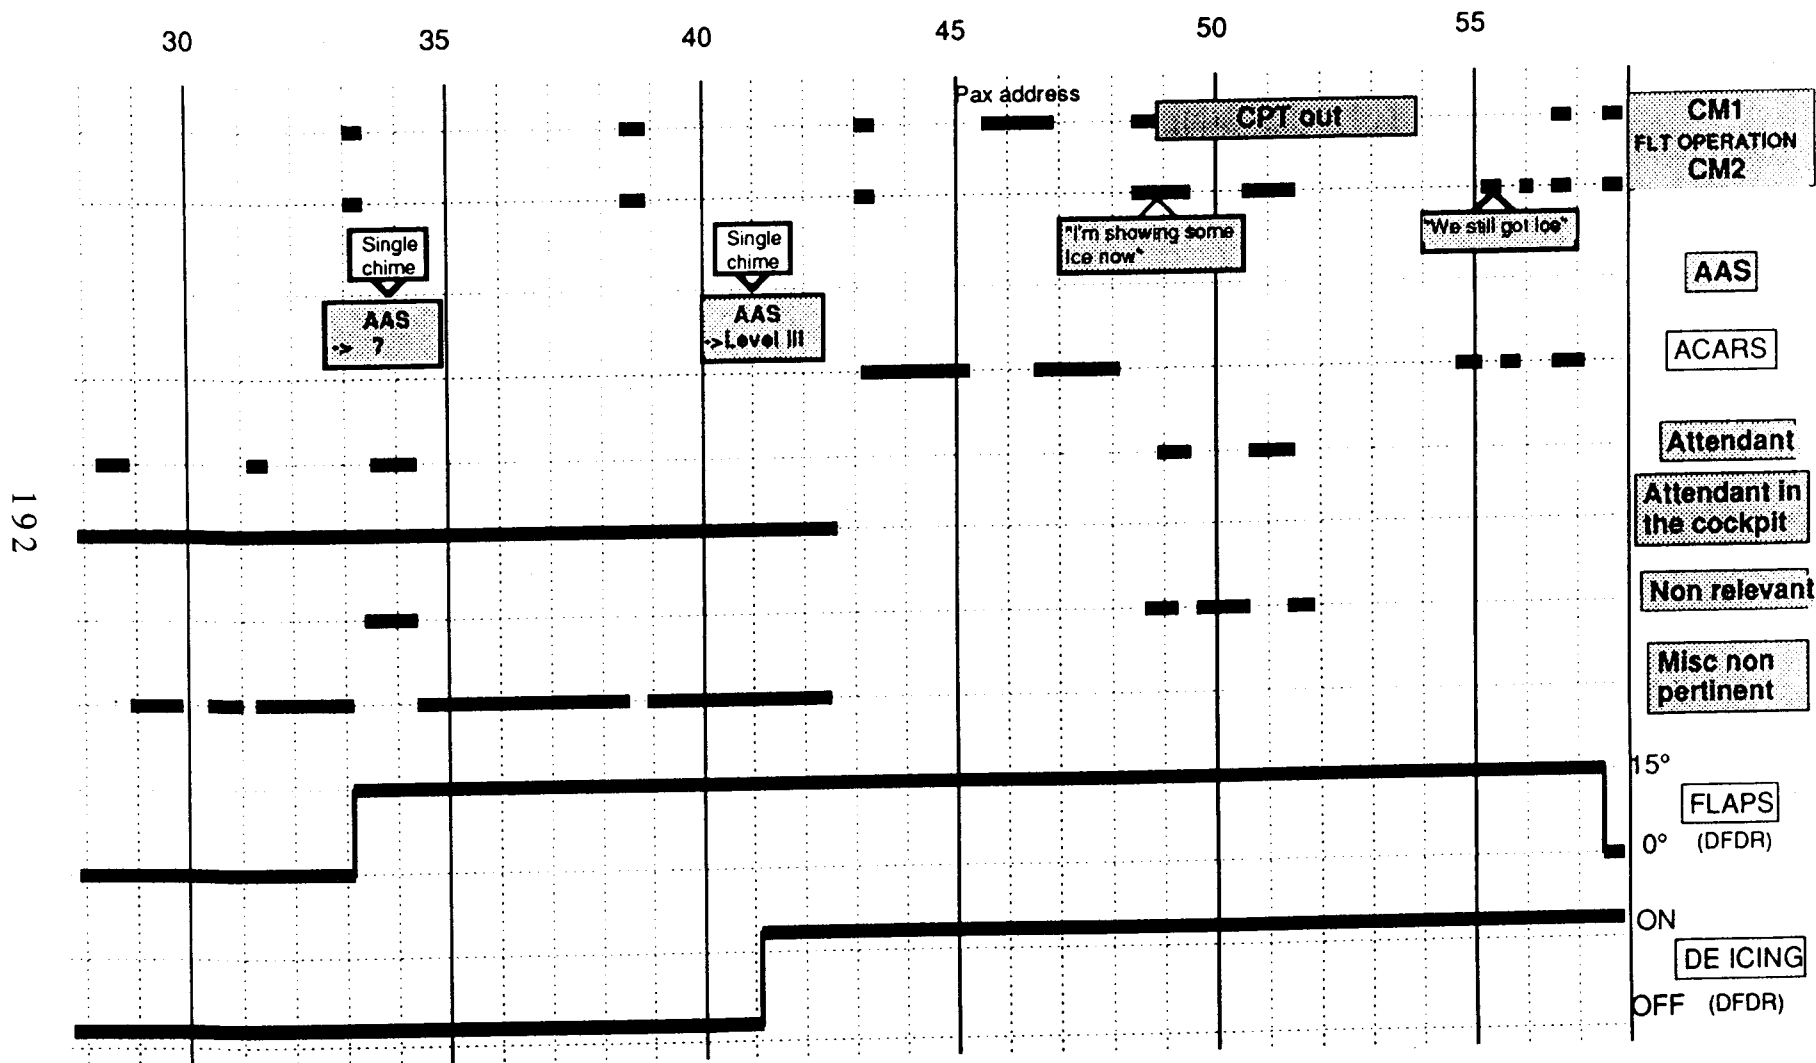
FIGURE 14 : FLIGHT 4184 CVR TIME ANALYSIS

More than 15 mn of Non Relevant & Non Pertinent conversations

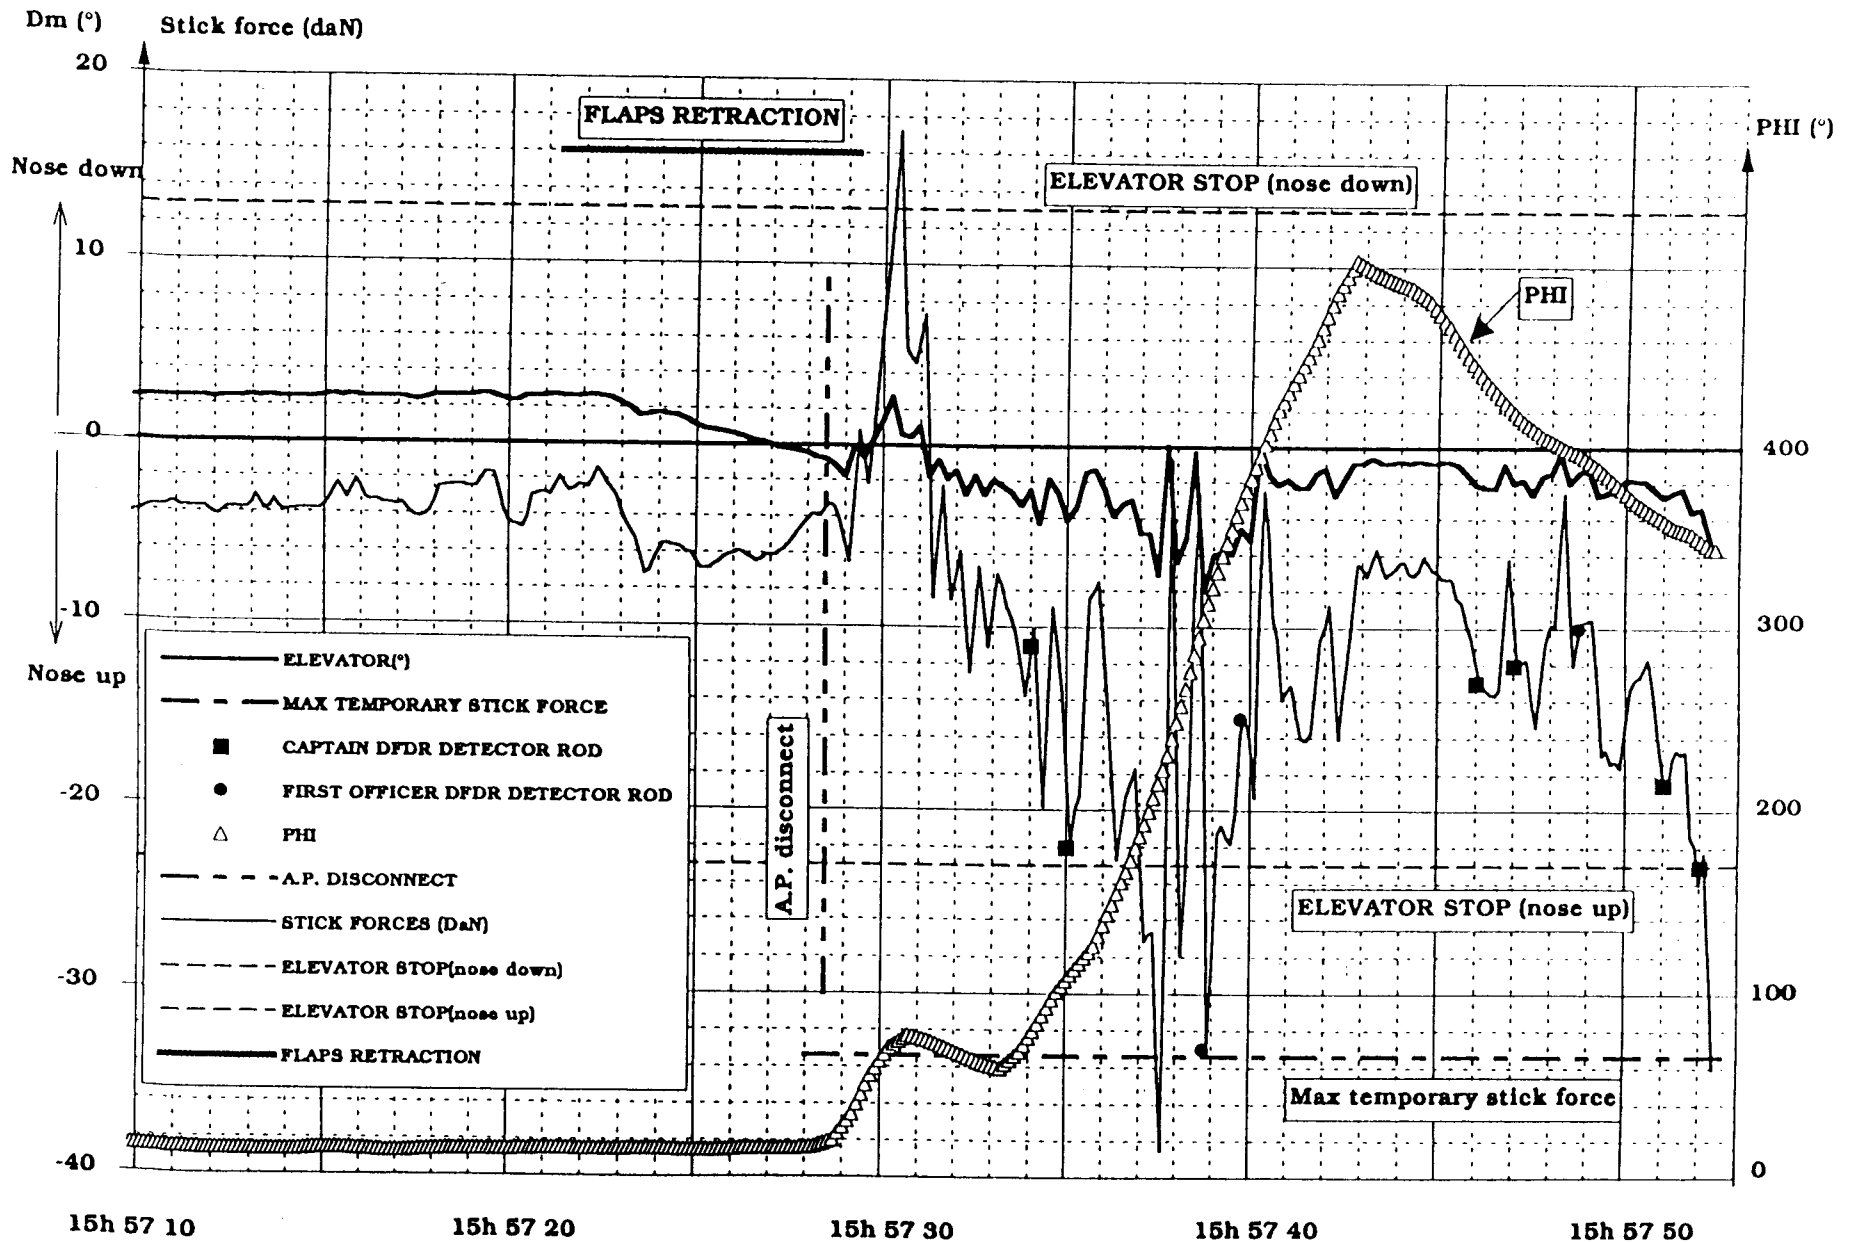
FIGURE 16 : PITCH CONTROL INPUTS / ACTIVITY AFTER ROLL UPSET

A limited control activity mainly during inverted flight

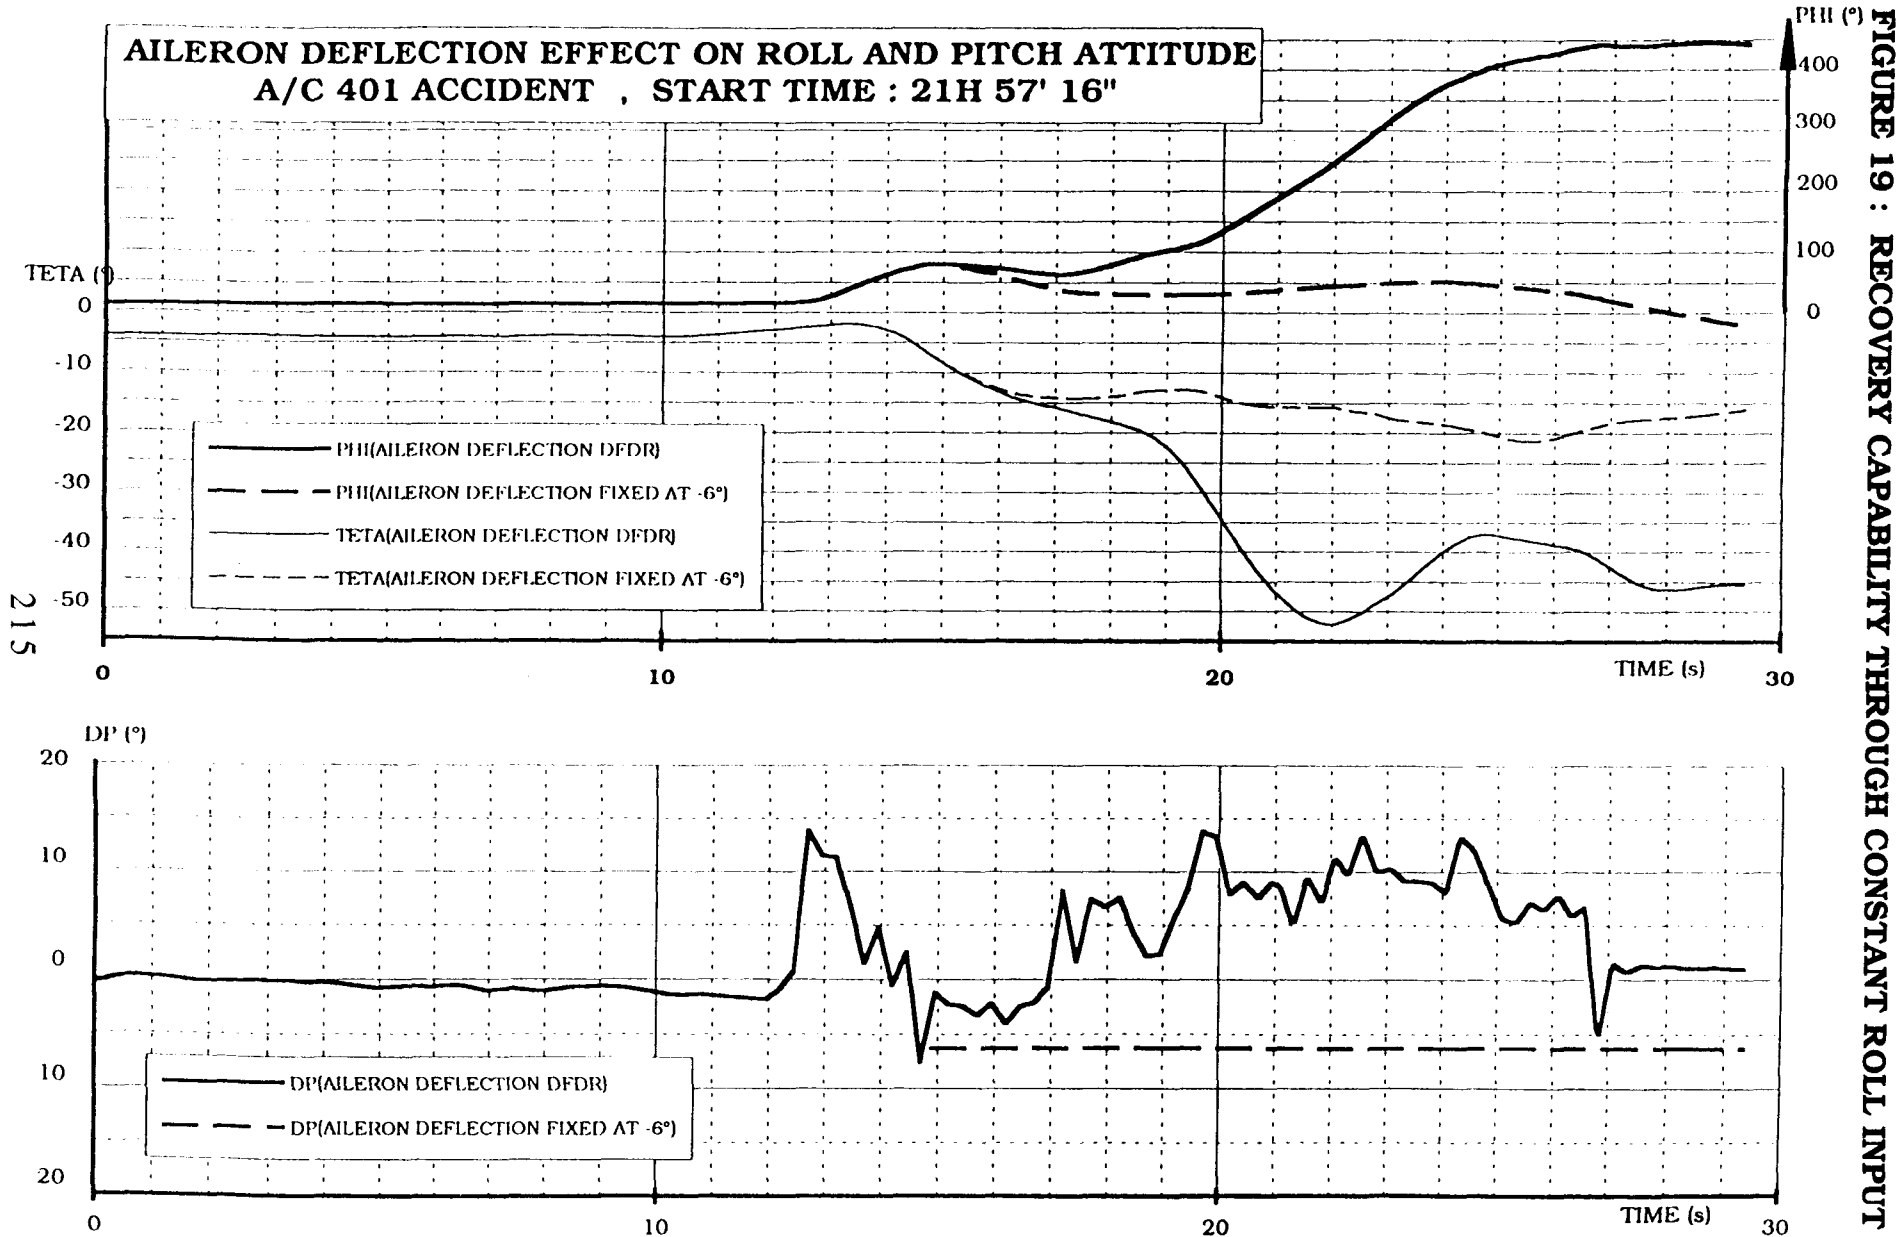
FIGURE 19 : RECOVERY CAPABILITY THROUGH CONSTANT ROLL INPUT

Moreover, assuming a counteracting steady deflection limited to 6° on the ailerons and applied after the maximum conventional crew reaction time used in cruise (3 seconds) after disconnection, the Flight path is rapidly controlled (fig. 19). The lateral attitude is kept close to wings level and the longitudinal attitude does not exceed 22° before returning to 0° .

A constant 6° roll input after 3 sec would allow for recovery
