National Transportation Safety Board

September 13, 2002

ATR 72-212, N401AM
Roselawn, Indiana
Notation 6486C,
Accident No. DCA-95-MA-001

RESPONSE TO PETITIONS FOR RECONSIDERATION

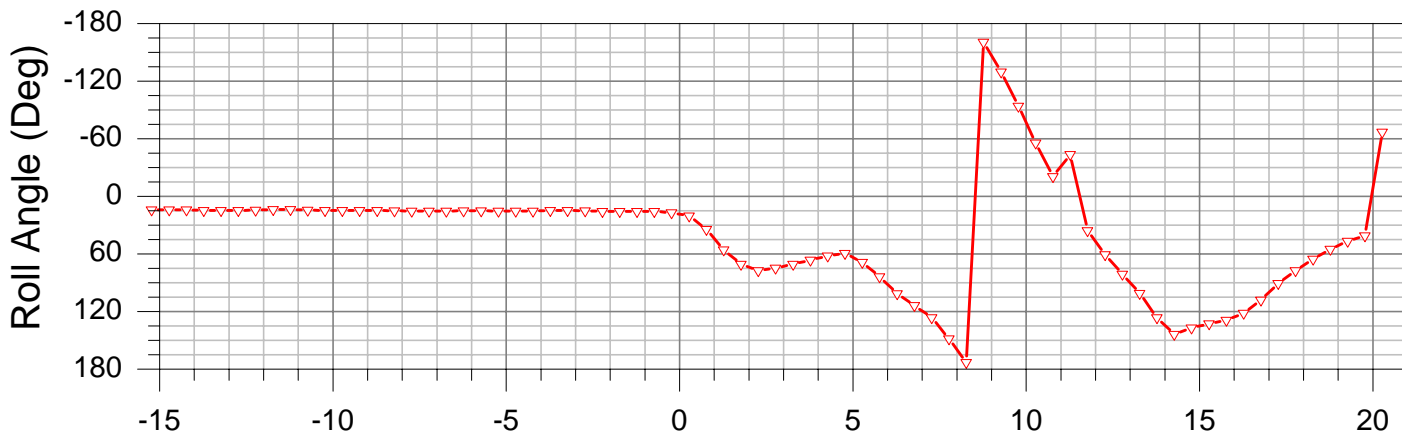
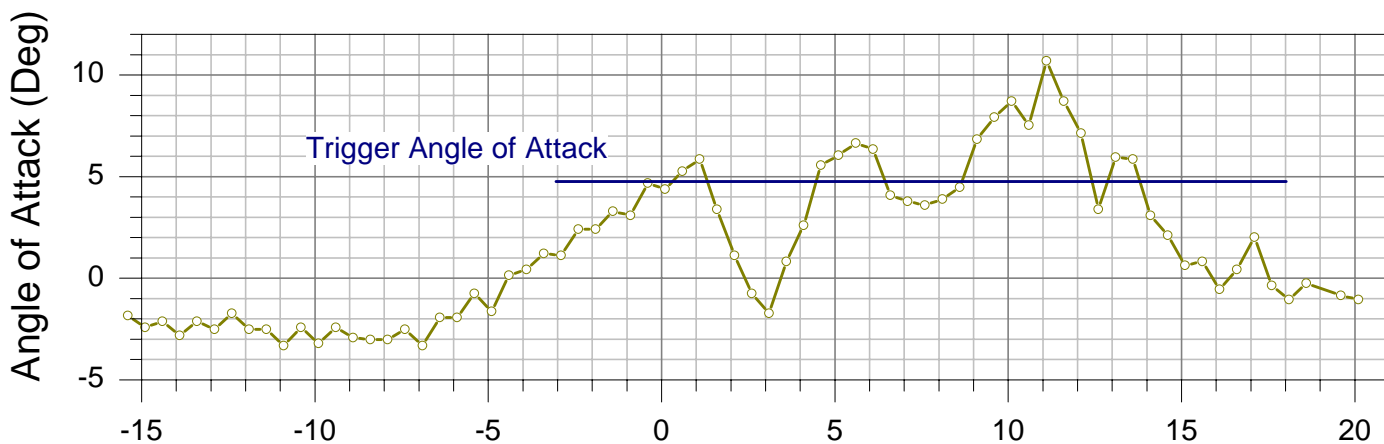
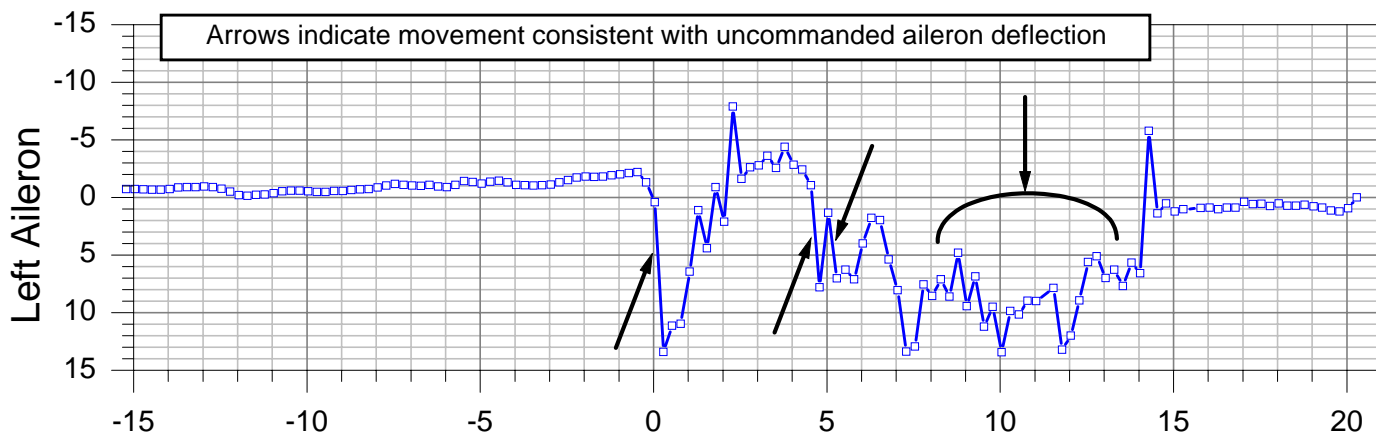
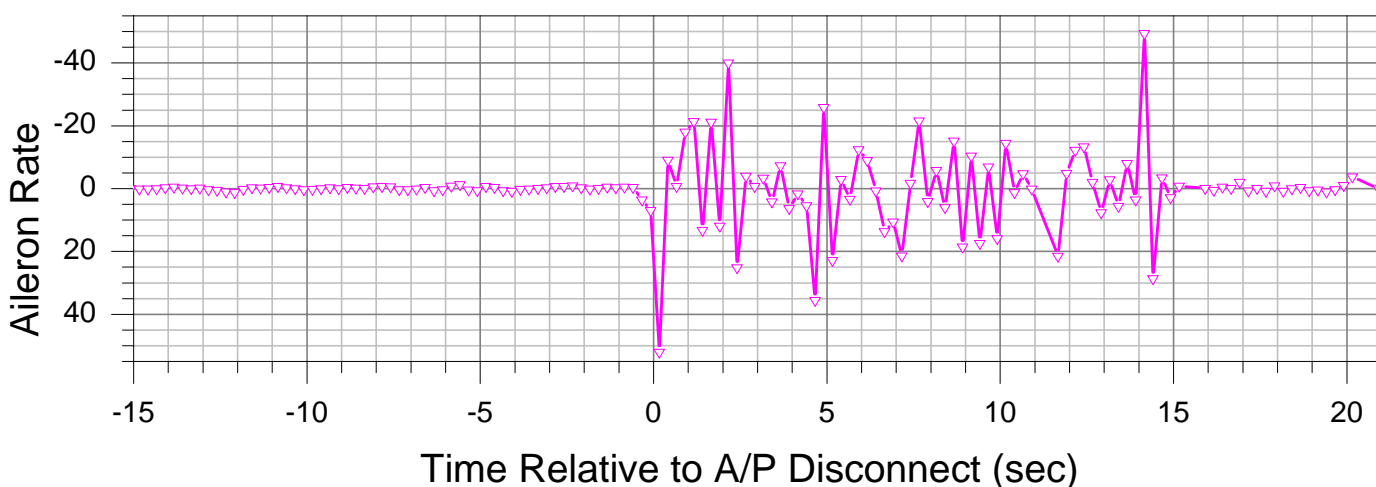
Roselawn FDR Data

the loss of control attributed to a sudden and unexpected aileron hinge moment reversal that occurred after a ridge of ice accreted beyond the deice boots because: 1) ATR failed to completely disclose to operators, and incorporate in the ATR 72 airplane flight manual, flightcrew operating manual and flightcrew training programs, adequate information concerning previously known effects of freezing precipitation on the stability and control characteristics, autopilot and related operational procedures when the ATR 72 was operated in such conditions; 2) the French Directorate General for Civil Aviation's (DGAC's) inadequate oversight of the ATR 42 and 72, and its failure to take the necessary corrective action to ensure continued airworthiness in icing conditions; and 3) the DGAC's failure to provide the FAA with timely airworthiness information developed from previous ATR incidents and accidents in icing conditions, as specified under the Bilateral Airworthiness Agreement and Annex 8 of the International Civil Aviation Organization.^[3]

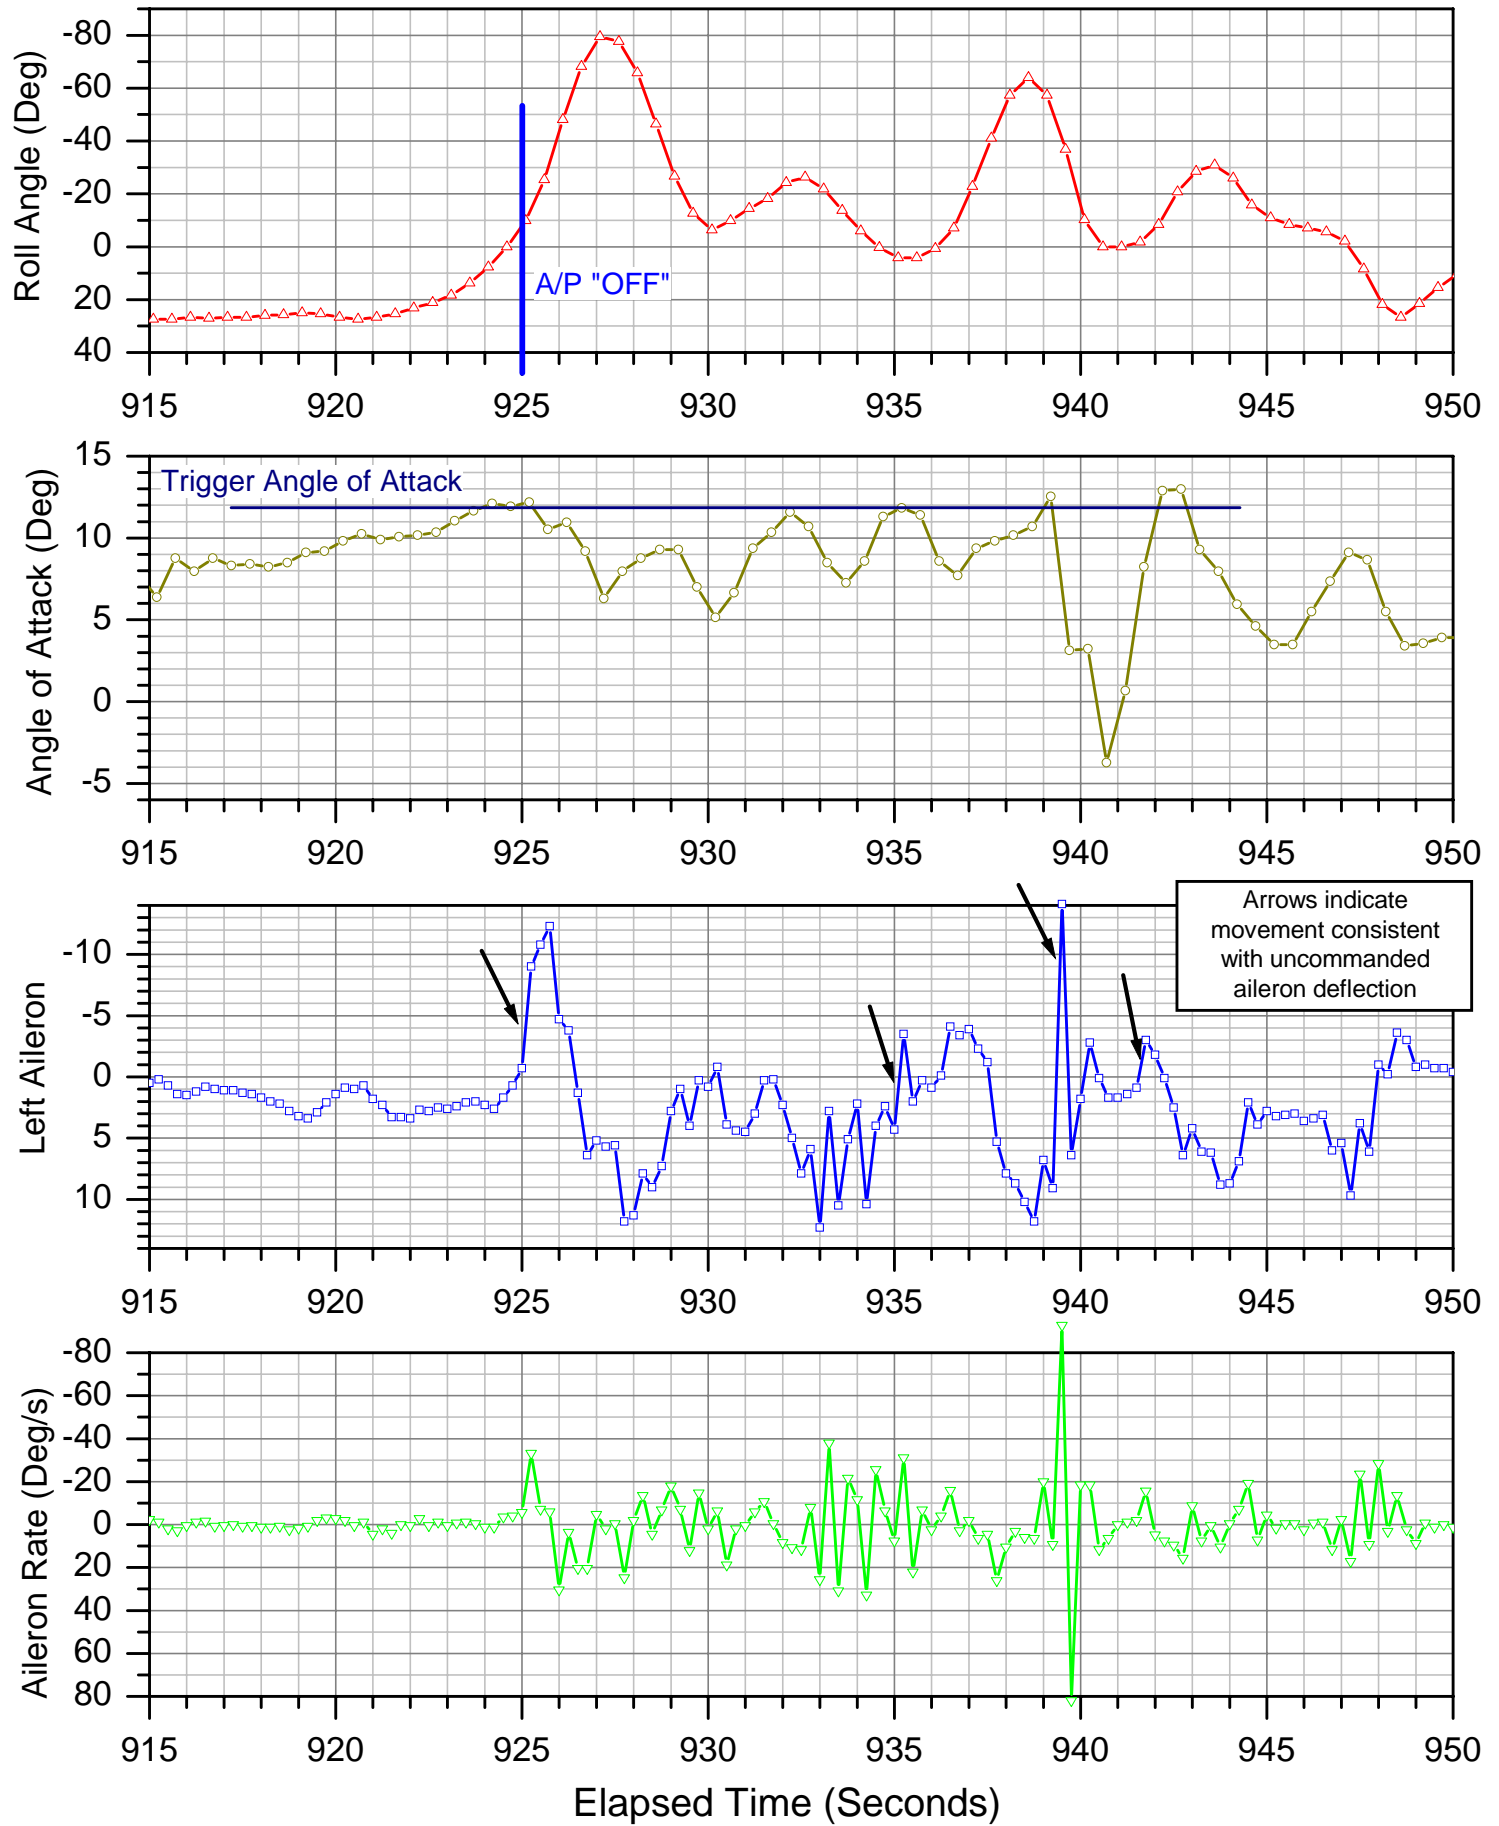
Mosinee FDR Data

¹⁷ For example, ATR's analyses of the Mosinee and Newark incidents refer to ice accretions aft of the deice boots. Further, in postaccident testing, aileron activity similar to what was observed at Roselawn and in the five prior incidents occurred when the airplane was flown with a simulated ice ridge aft of the deice boots in front of the ailerons.

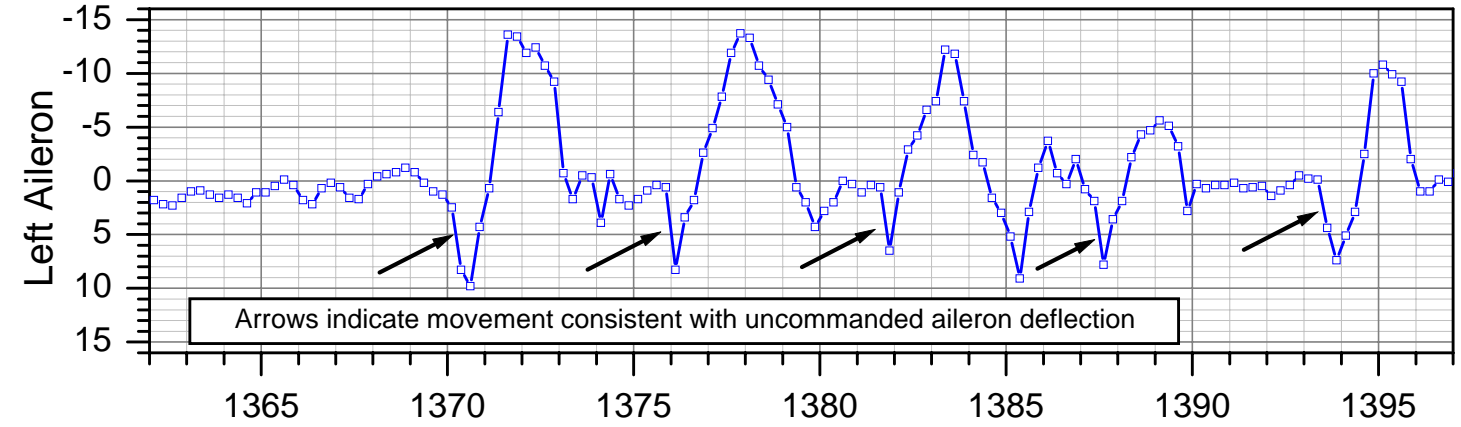
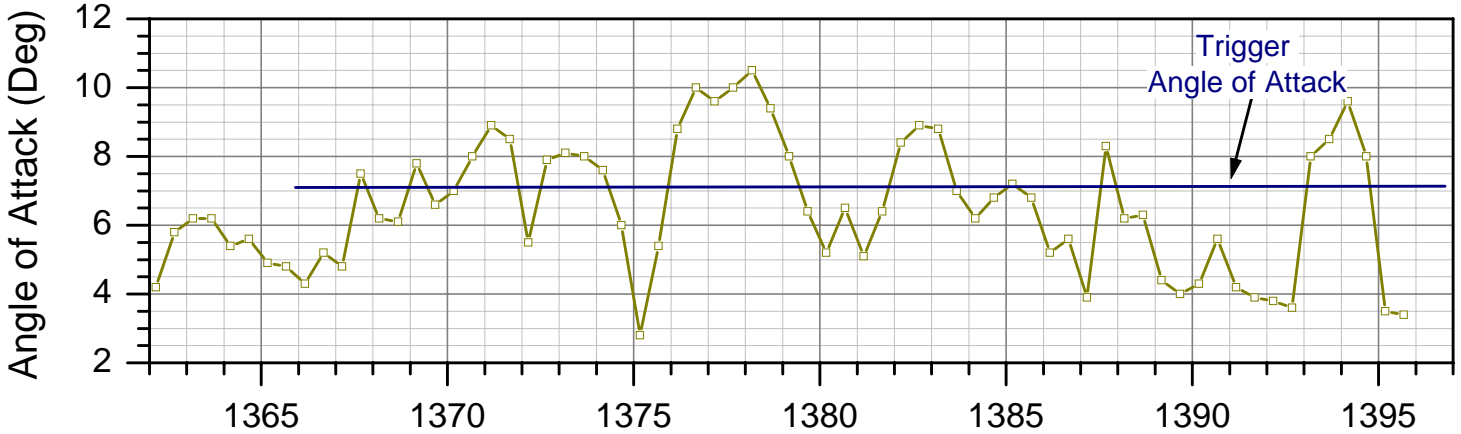
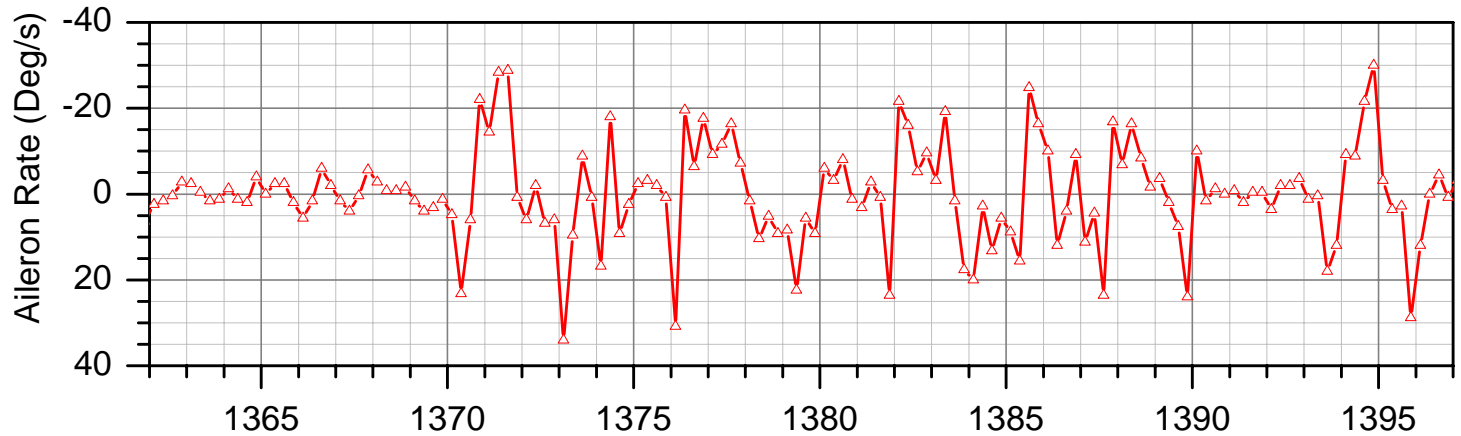
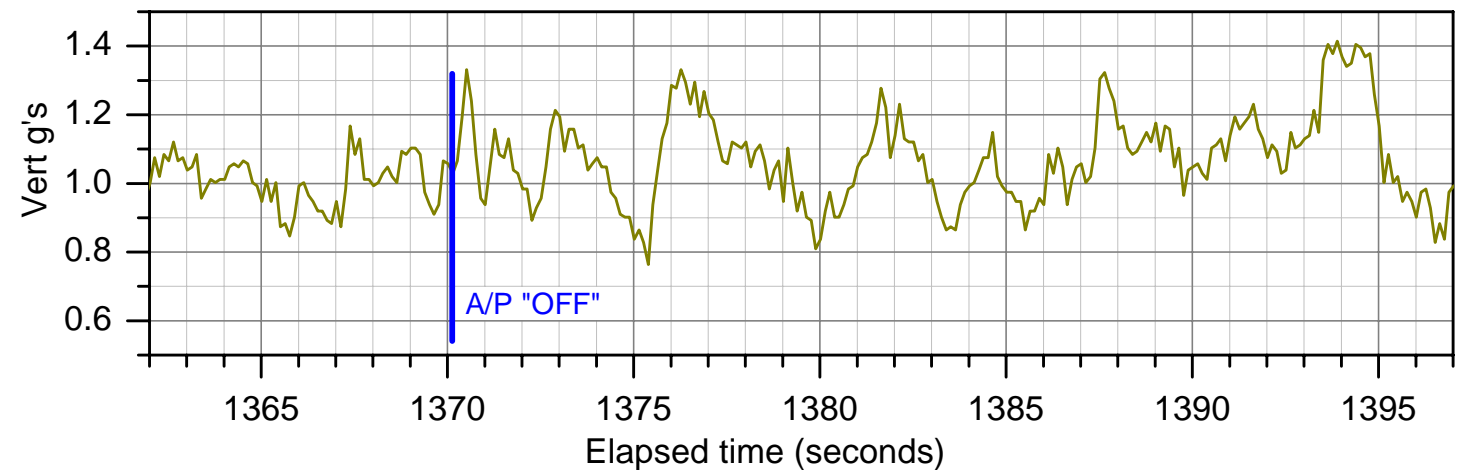
Newark FDR Data

¹² Even though weather reports indicated "severe turbulence" in the Newark area around the time of the incident, the Safety Board does not agree with the petitioners that the incident airplane was encountering severe turbulence during the incident. The FAA defines severe turbulence as turbulence that causes large, abrupt changes in altitude and/or attitude, and usually causes large variations in indicated airspeed. The FDR data from the Newark incident shows that the abrupt changes in aircraft attitude and roll excursions were predominantly caused by the aileron deflections, contrary to what would be expected if they had been caused by turbulence. Further, the FDR data shows changes in G forces of only $\pm .2$ Gs, which is much less than would be expected in severe turbulence. In addition, FDR data shows that the uncommanded aileron deflections occurred repeatedly at about the same angle of
