# **AIRCRAFT ACCIDENT INVESTIGATION REPORT**

**CHINA AIRLINES  
B 1 8 6 1 6**

**Japan Transport Safety Board**

CHINA AIRLINES (TAIWAN)  
BOEING 737-800, B18616  
SPOT 41 AT NAHA AIRPORT  
AUGUST 20, 2007, AT ABOUT 10:33 JST

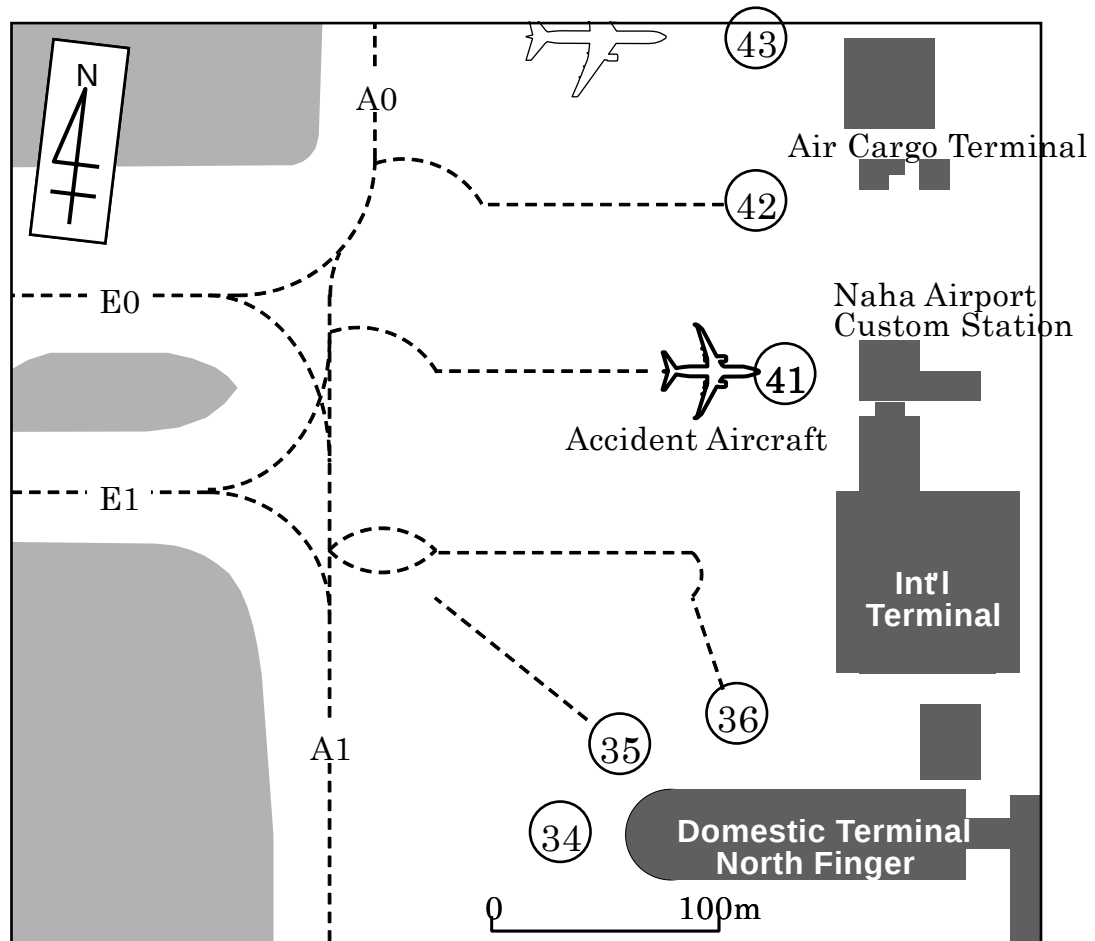
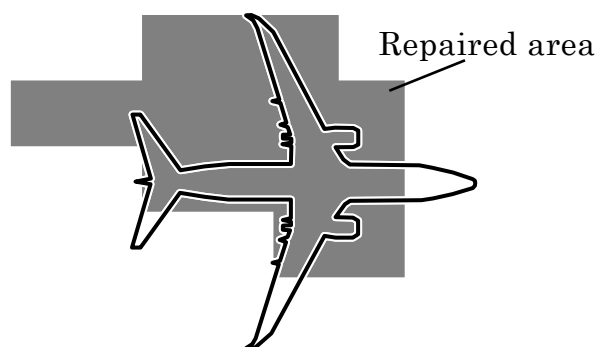
Figure 3      Parking Spot of the Aircraft and  
Damage to the Apron

The apron surface had numerous dents caused by broken pieces from the airframe bottom structure, which became detached from the airplane due to several explosions of the right- and left-wing fuel tanks and then hit the surface. Burning of the Aircraft also left a large pile of burnt residue on the apron. In the area between the right engine and the right wing joint to the fuselage, there were scattered pieces of cargo (fruit and fish), which had fallen out of the cargo compartment damaged by the fuel tank explosions.

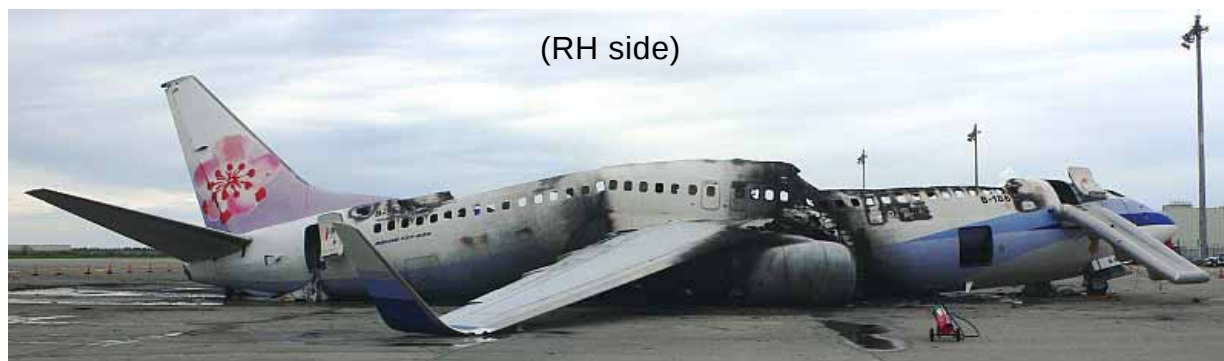
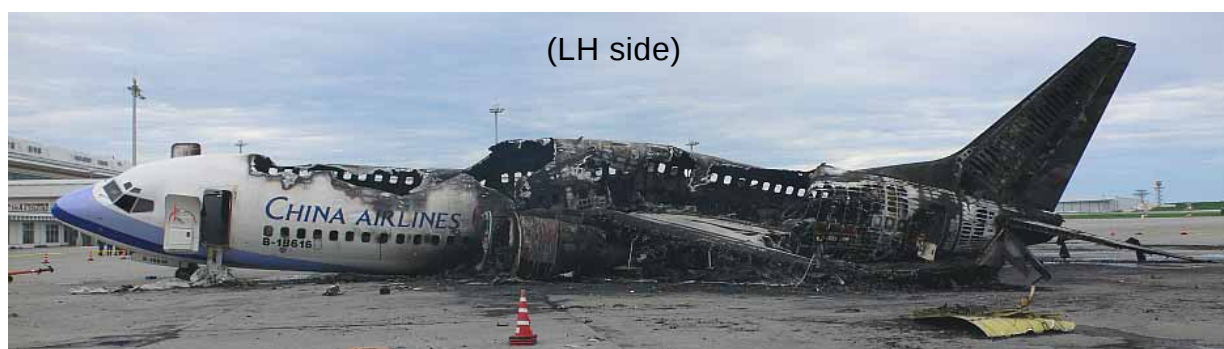
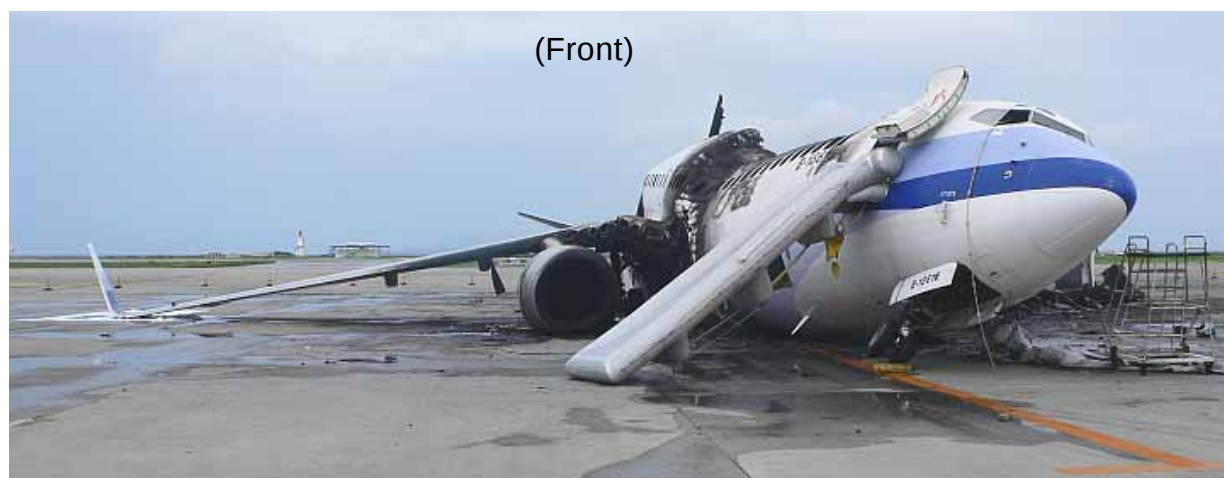
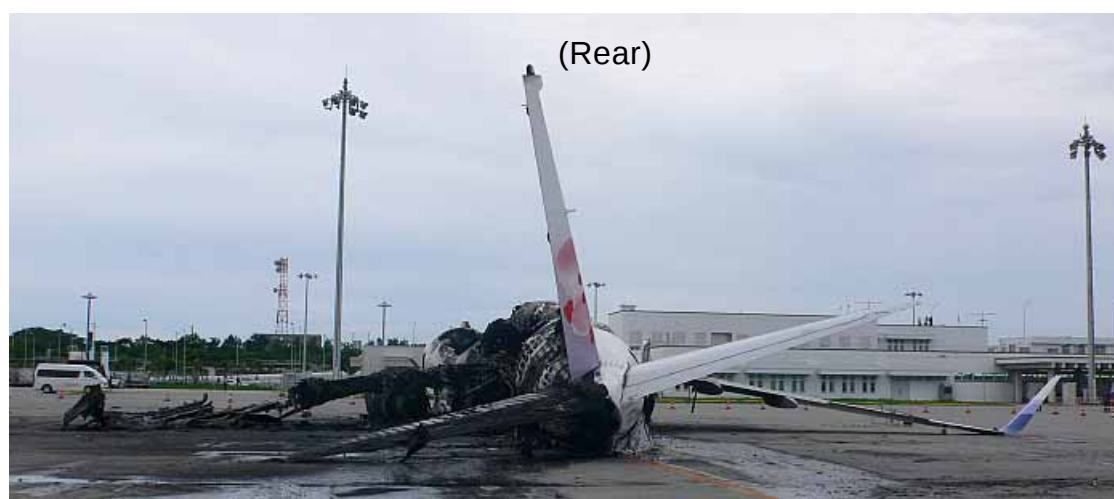
## Photograph 1 Accident Aircraft

- (1) Fuselage: The fuselage had broken off at the part immediately forward of the wing roots with the forward half largely tilted to the left and the bottom touching the

ground. The fuselage was longitudinally bent at the part immediately aft of the wing roots and its aft half lay tilted to the left with the tail touching the ground. The cockpit and nose landing gear were intact, but in the forward fuselage, the cabin interior was burned and the upper skin and floor in this area were consumed by fire. The lower fuselage near the wing roots was destroyed and burned by fire. The cabin interior in the aft half of the fuselage was entirely burned to the extent that there was no trace of the original shape, and the top and left-side skins as well as the floor in this section were lost in the fire. The aft galley remained intact.

- (2) Left wing: The left wing, which was almost entirely burned and had lost its original shape, lay over the engine resting on the ground. The wing portion between the engine and fuselage was destroyed by explosion of the fuel tank and the burnt main landing gear was tilted forward. The top skin of the wing between the fuselage and engine had been torn off and lay on the ground about 7 m to the left of the wing tip.

- (3) Right wing: The main landing gear was burned and stood upright, while both the engine and the wing tip were resting on the ground. The underside of the wing between the engine and fuselage was broken and burned due to the fuel tank explosion. The wing portion from the engine mounting area to the wing tip remained nearly intact.

- (4) Engines: The cowlings of the No. 1 (left) engine were consumed by the fire and the engine itself was entirely burned. The leading edge of the air intake that was made of a different material from that of the other part of the cowlings remained unconsumed. The fuselage-side cowlings of the No. 2 (right) engine were consumed by the fire and the engine itself was partially burned at the fuselage-side and fan sections. The pylons were burned on the outside surface but the interior was neither burned nor broken.

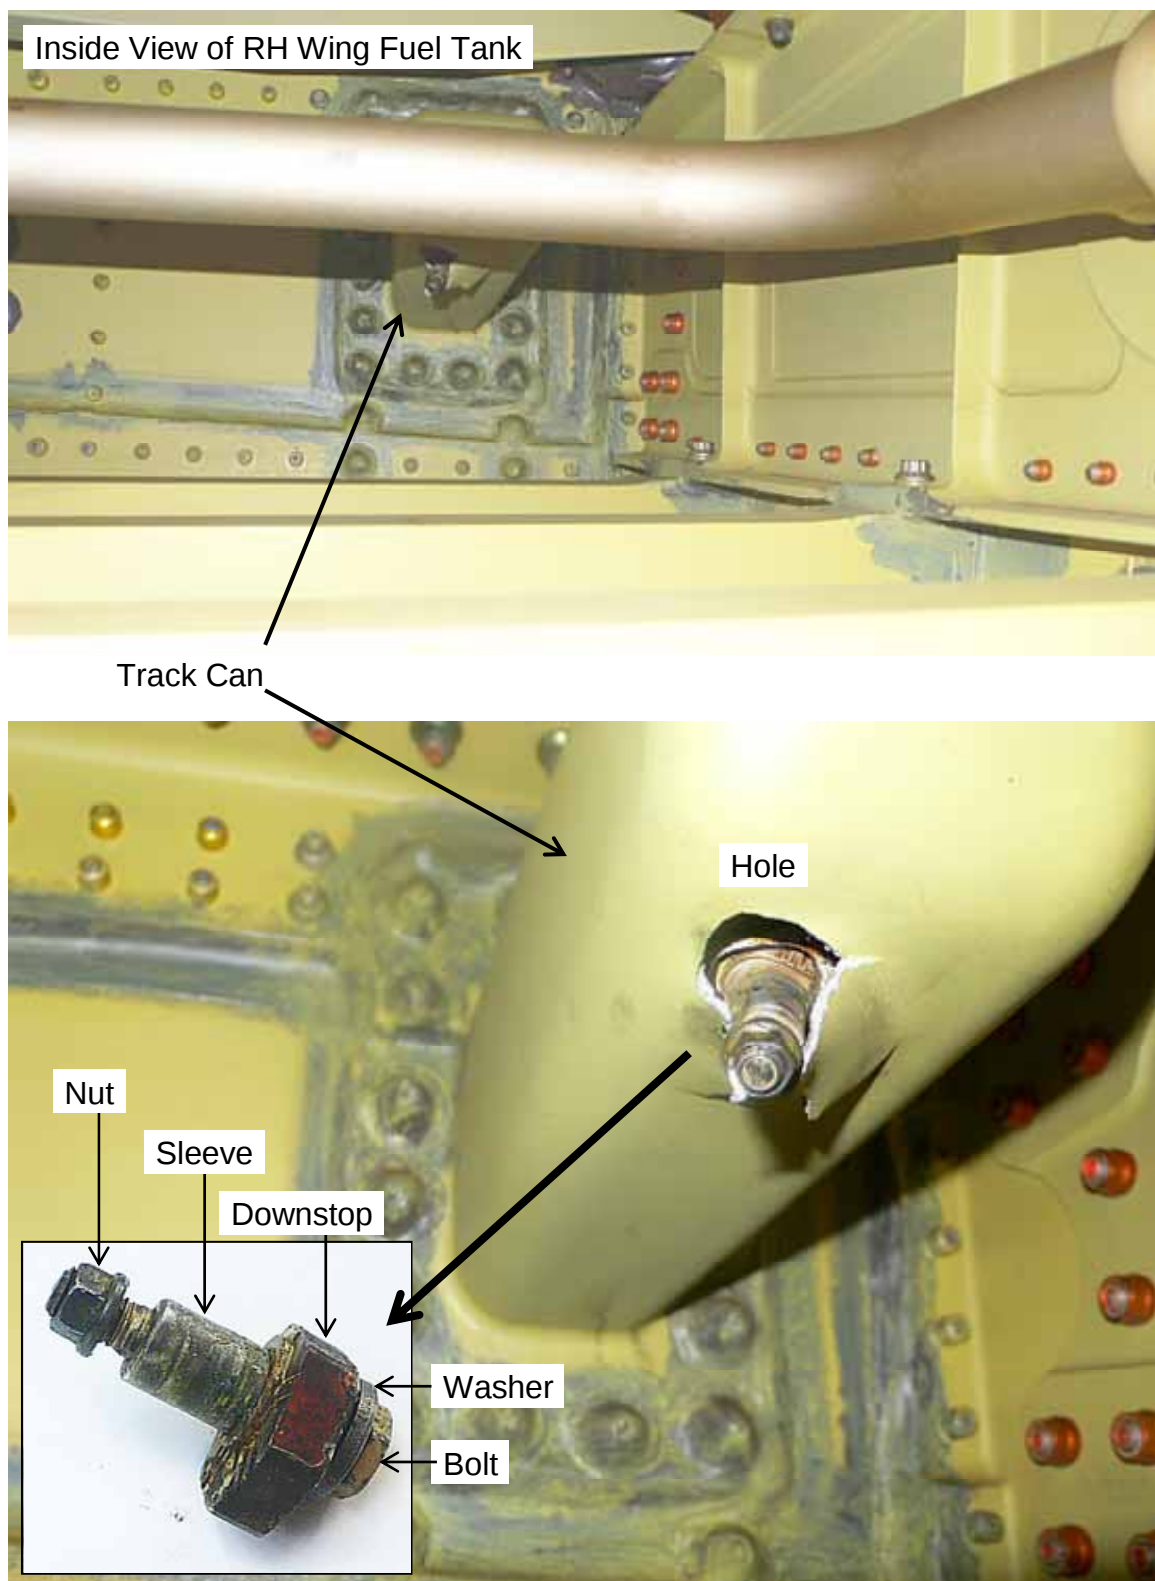
**Photograph 5      Damaged Inner Track Can of No.5 Slat**

- (a) The puncture hole was found on the bottom of the track can and extended from a point about 60 mm to a point about 100 mm, both from the aft end of the track can, showing signs of being pushed from inside.  
(The track can was made of aluminum alloy and measured 220 mm in length, 80 mm in height at the highest portion and 65 mm in width at the widest portion.)

- (b) The puncture hole including the cracks measured 41 mm in maximum length and 23 mm in maximum width.
- (c) A piece of hardware headed by a nut protruded through the puncture hole toward the inside of the fuel tank.

- (d) The inside of the track can was inspected using a borescope from the slat side. The inspection revealed that the hardware protruding toward the inside of the fuel tank was the downstop assembly consisting of a bolt, washer, downstop (on the bolt-head side), stop location, sleeve and nut. One flat of the bolt head was in contact with the bottom surface of the main track. One flat of the downstop (on the bolt-head side) was in contact with the inside surface of the track can. The downstop (on the nut side) was found lying inside the track can at a place close to the puncture hole but not in contact with the bottom surface of the main track.

The paint film on the inside surface around the puncture hole of the track can was found peeled off, and there were several traces of relatively deep damage in

that area that were located near the cracks that originated at two points. The fragment that had fallen off during the on-site investigation also had abrasion marks with missing paint, as well as an impression indicating that it would have received strong pressure from something.

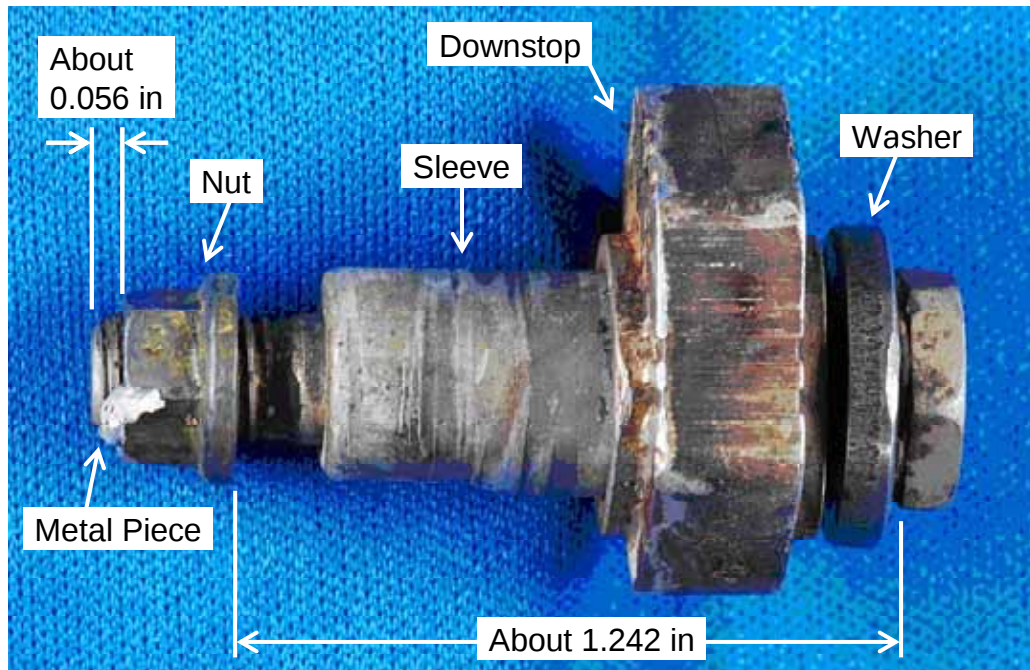
## Photograph 6 Downstop Assembly

A piece of metal was found sticking to the surface across the bolt's threaded end and the nut.

The nut was found tightened with a torque of 26.55 in-lbs when measured in the tightening direction.

The sleeve showed no major damage except for a number of friction marks on the surface.
