AIRCRAFT ACCIDENT REPORT

**PACIFIC SOUTHWEST AIRLINES, INC.,
B-727, N533PS AND**

**GIBBS FLITE CENTER, INC.,
CESSNA 172, N7711G**

**SAN DIEGO, CALIFORNIA
SEPTEMBER 25, 1978**

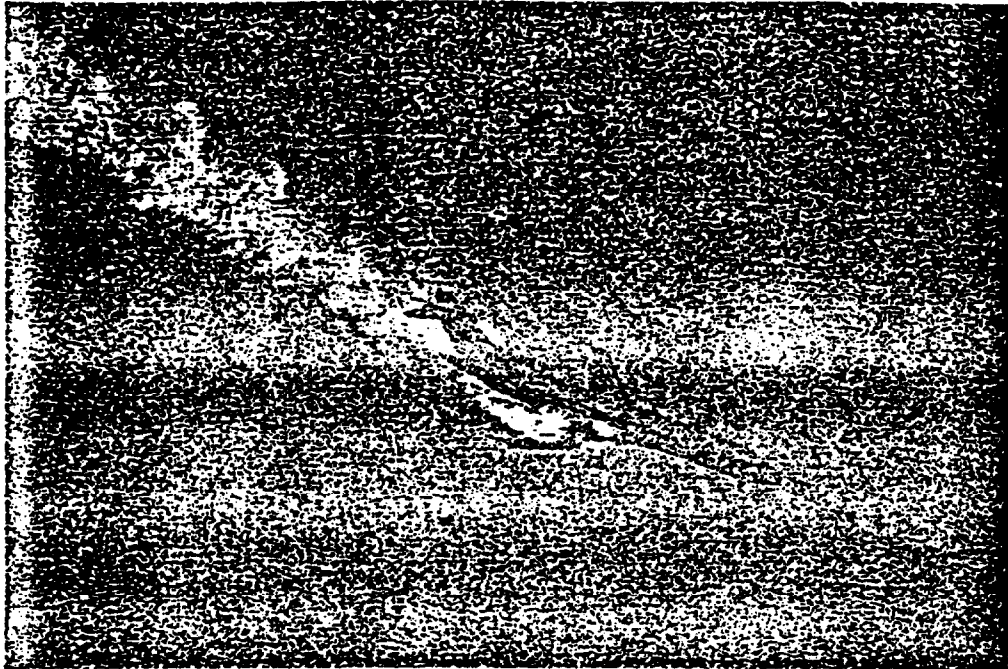
Enlargements of two postcollision photographs were used to try to determine the Boeing 727's flight control displacements and the condition of its fuel and hydraulic systems during the latter portions of the flight. (See Figures 1 and 2.)

Except for the upper and lower rudders, which were centered in the first photograph and positioned 10° left in the second, the deflections of the other control surfaces in both pictures were the same. The left wing flight spoilers were full up; the left wing ailerons were full up; the right wing outboard aileron was down; the elevators were almost full up; the trailing edge flaps were extended to 15°; and the leading edge devices were extended fully.

Figure 1. Flight 182 after colliding with the Cessna.

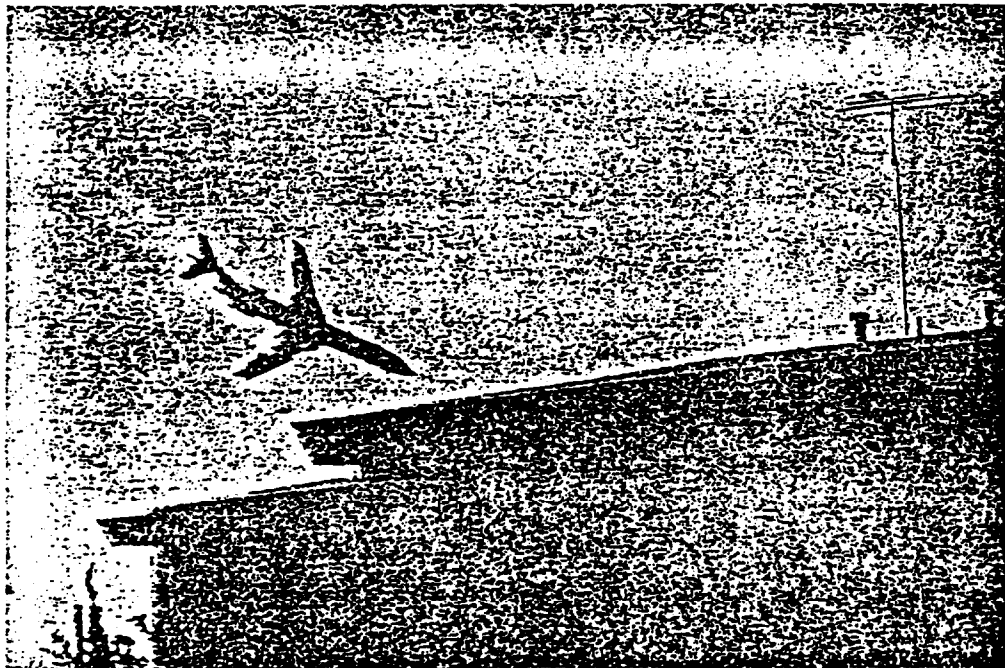
The right wing, as shown in Figure 2, was studied. The examination revealed that the Nos. 5 and 6 leading edge flaps were missing, a portion of the No. 5 leading edge slat was missing, and a large portion of the wing's leading edge back to about the front spar was peeled off the aircraft.

Hydraulic tubing from both the System A and the standby hydraulic systems was routed to the leading edge devices forward of the front spar. It was not possible to determine from the photographs if the tubes were broken or flattened. The B hydraulic system's tubing was located just aft of the rear spar of the wing. Because the extent of damage that could have existed in that area could not be determined, the status of the tubing could not be determined.

Fuel lines from the fuel pumps to the fuel pressure sensors were located immediately behind the leading edge flaps. These lines contain fuel under pressure and, if severed, would spray fuel out as long as the fuel pumps were operating. Because of fire which covered the aft section of the wing in the area of the inboard aileron, it was not possible to ascertain whether any of the surfaces in that area were missing.

Figure 2. Flight 182 descending. (Photo taken after Figure 1)

The study of the two photographs showed that the structural damage to the Boeing 727's right wing leading edge extended from the No. 4 inboard leading edge flap outboard to, and including, the No. 3 leading edge slat--a distance of 30 feet or more. The chordwise penetration of this damage appeared to extend rearward to the front spar of the wing. The calculated positions of the flight controls in Figure 2 show almost full deflection in the proper direction to arrest the abnormal attitude and to restore controlled flight. The deflected position of the flight controls and the left wing flight spoiler surfaces indicated that at least partial hydraulic pressure was available from system A and system B.
