*REPORT C 1993:57*

**Air Traffic Accident  
on 27 December 1991  
at Gottröra, AB county**

*Case L-124/91*

The Board of Accident Investigation (SHK) has investigated an aircraft accident which occurred on 27 December 1991 at Gottröra, AB county, involving an aircraft with registration OY-KHO.

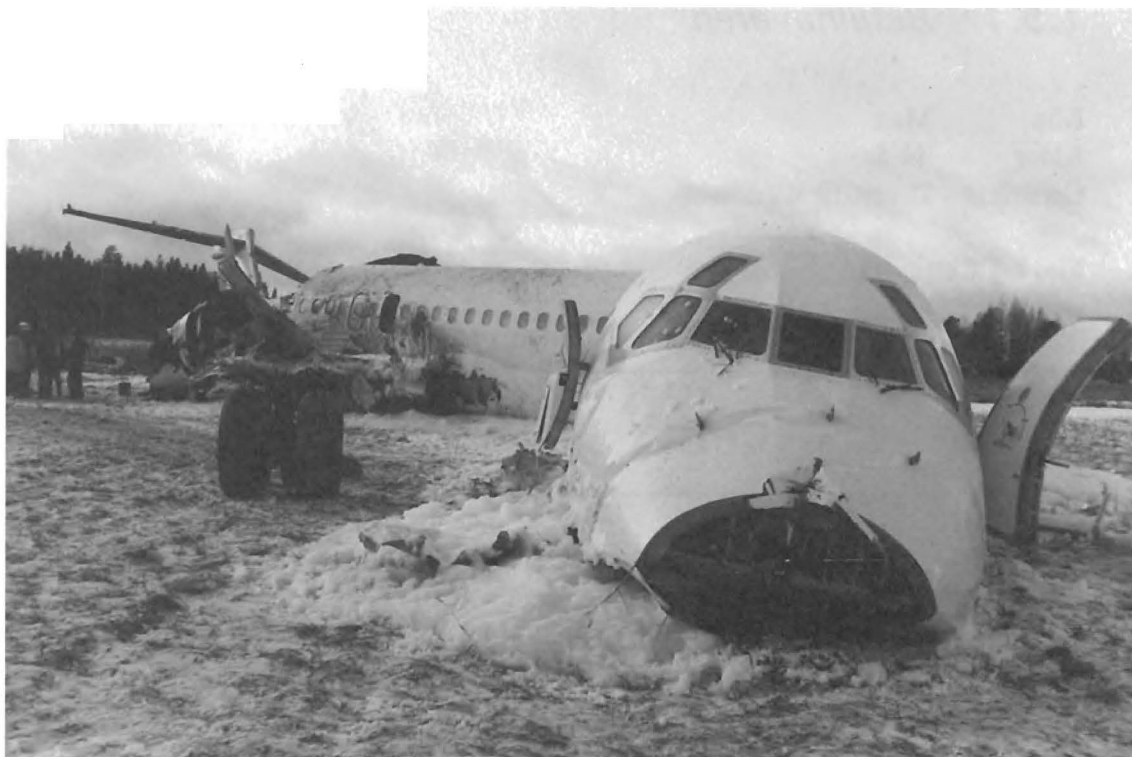
The aircraft was totally destroyed on impact.

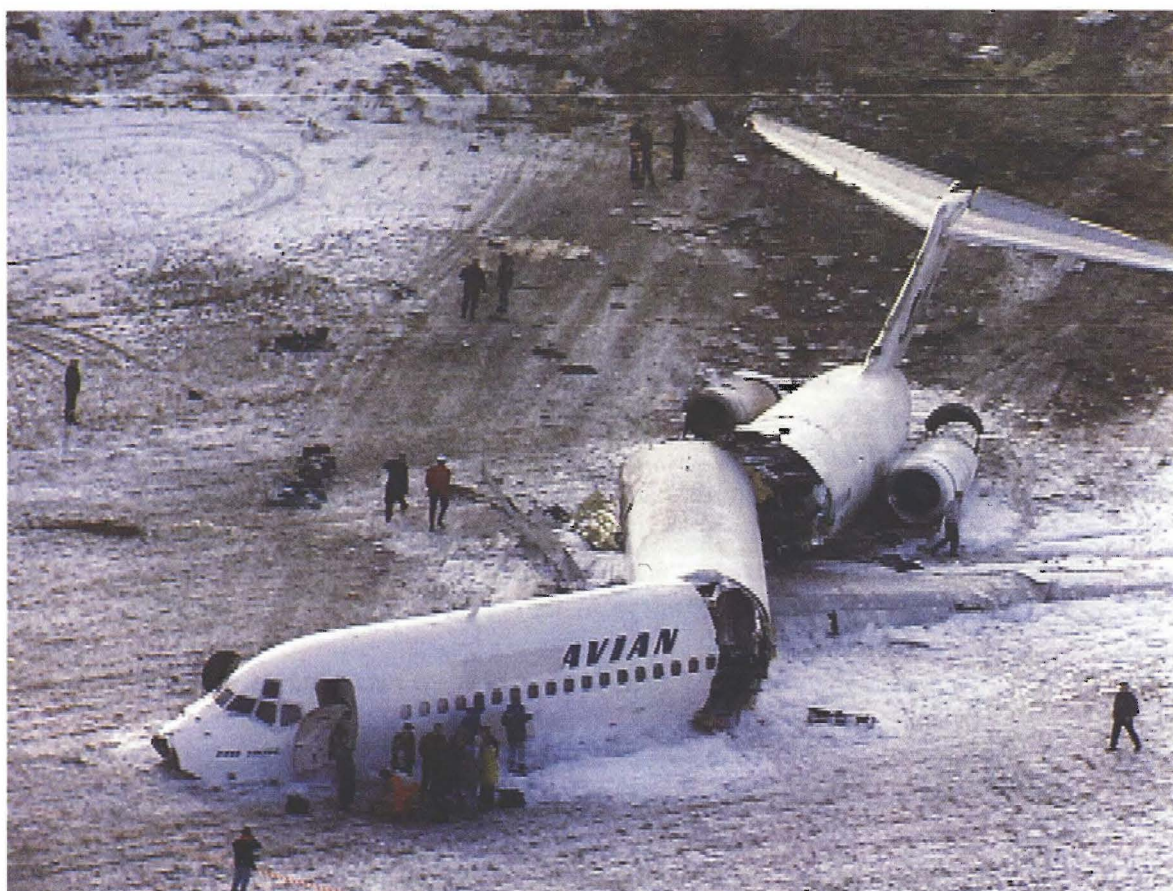
*The aircraft wreckage*

The underside structures were much damaged in the forward part of the wreck. The indentations were largest in the left of the front part – approx 80 cm – and smallest in the right rear part – approx 18 cm. Damage to the underside structure in the middle and rear parts was limited. The cabin floor had limited damage. Apart from damage in the areas of the breaks, the floor structure was ruptured only at row 5 on the right side.

The major part of the right wing had separated from the fuselage. Wing parts lay spread out along the path of the crash. The underside of the left wing was severely damaged.

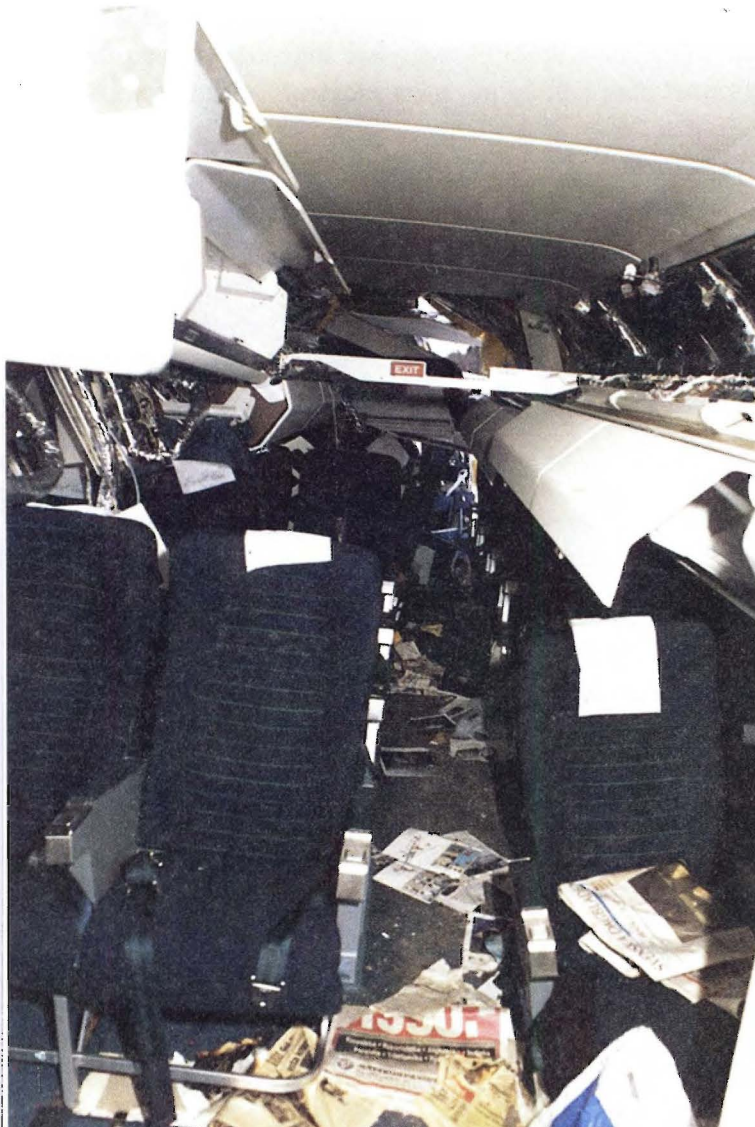
### ***Cabine damage***

In the forward portion of the passenger cabin the overhead bins and their mountings had been damaged. The two modules on the left had parted completely from their mountings and fallen down onto the backs of passenger seats. On the right side the modules had parted from their ceiling mountings but not from the wall mountings. The modules from row 3 and rearwards were resting on seat backs. A number of bin lid locks had broken and the lids had come open. The cabin divider – which was between rows 3 and 4 – had fallen down together with the bins. In the middle portion of the wreck the damage was limited to the break areas. At the forward break the forward part of the left bin had fallen. At the rear break the bins on both sides had fallen. A number of bin lid locks had broken. According to available information, the bins were not excessively loaded with baggage.

In all three parts of the wreck most of the PSUs had loosened from the bin structures and were hanging either by their outer hinges or by wiring. Many of the oxygen masks had been released from the PSUs and some had also been activated. Some of the cabin crew oxygen masks had also been released.

In the forward galley area the walls of galley 3 had been deformed in two places and one floor mounting had ruptured. The ceiling at galley 1 had been pressed downwards. The ceiling panel between galleys 2 and 3 had fallen in. The exit sign at galley 3 was missing. The door to the flight deck had broken off.

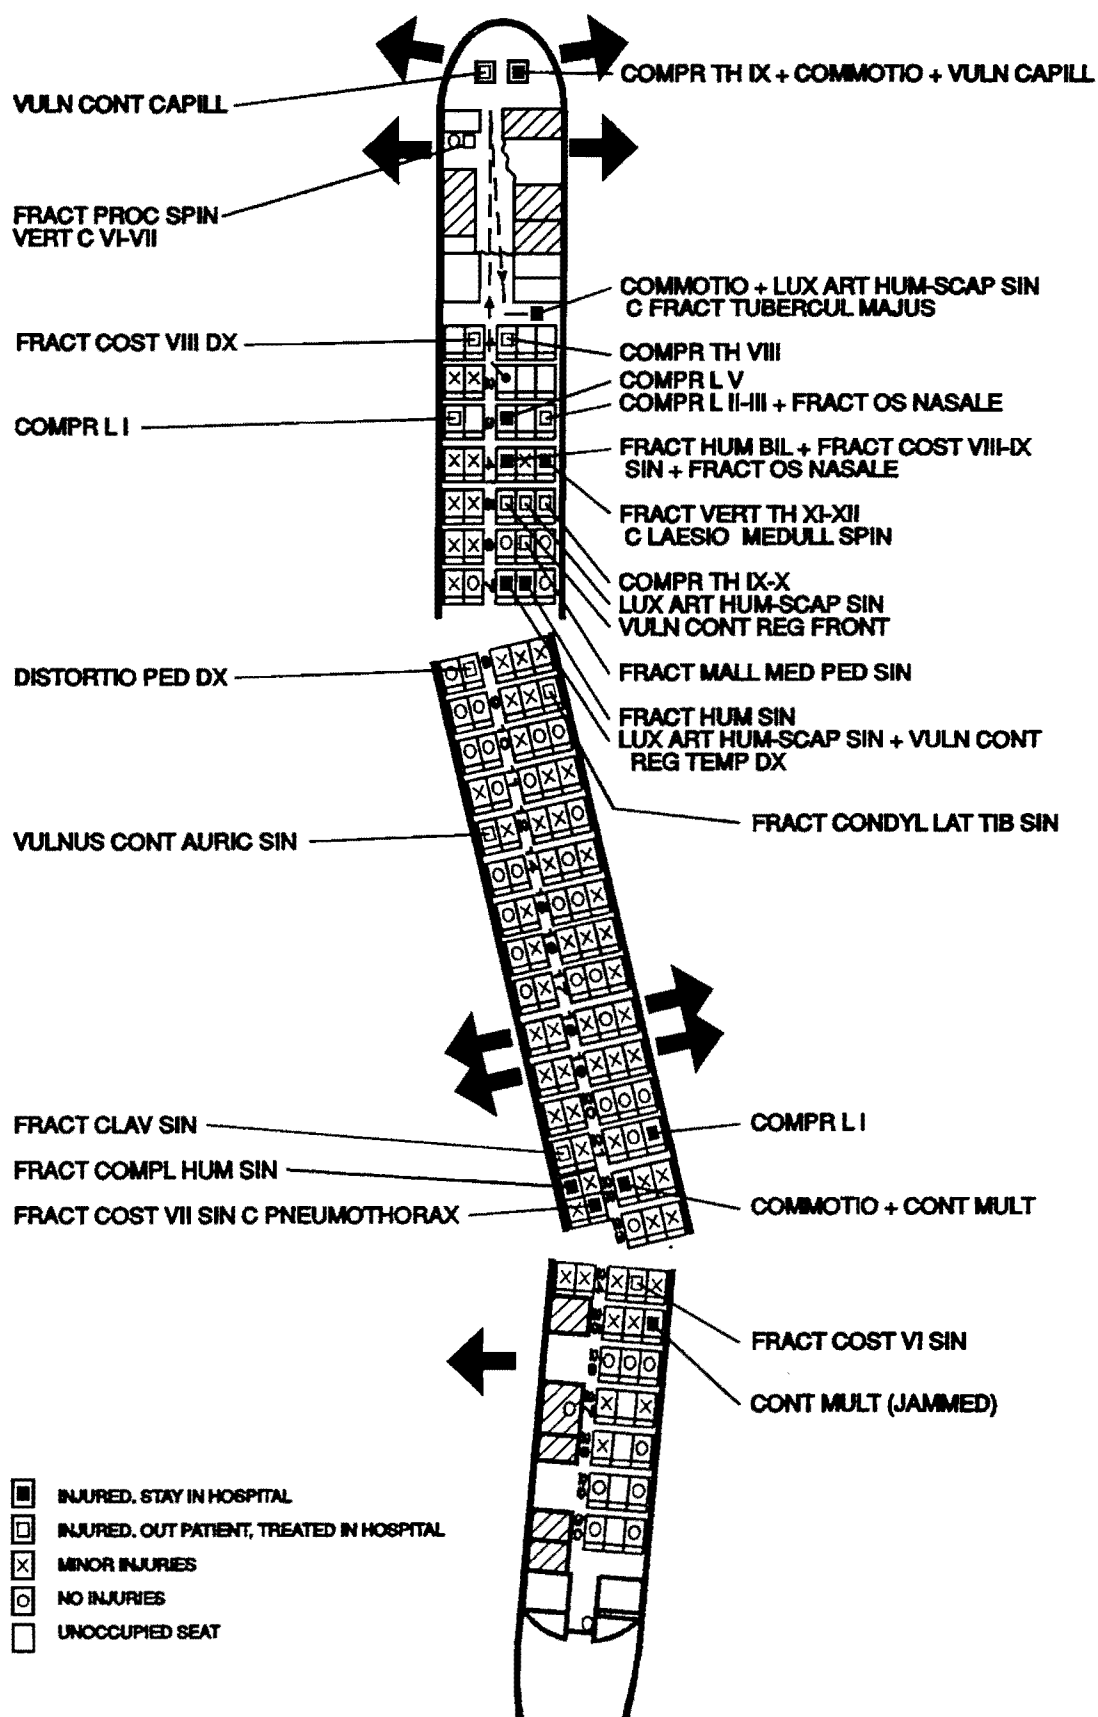
*Injury profile*

Most of those injured, and those with the most serious injuries, were sitting in the forward part of the aircraft, with a concentration to the right side. Here there were eight of totally nine cases of back injury and five of totally seven shoulder and arm injuries. Another concentration of injuries was among those sitting near the rear fuselage break. Those sitting in the middle and rear parts of the aircraft sustained slighter injuries or were uninjured.

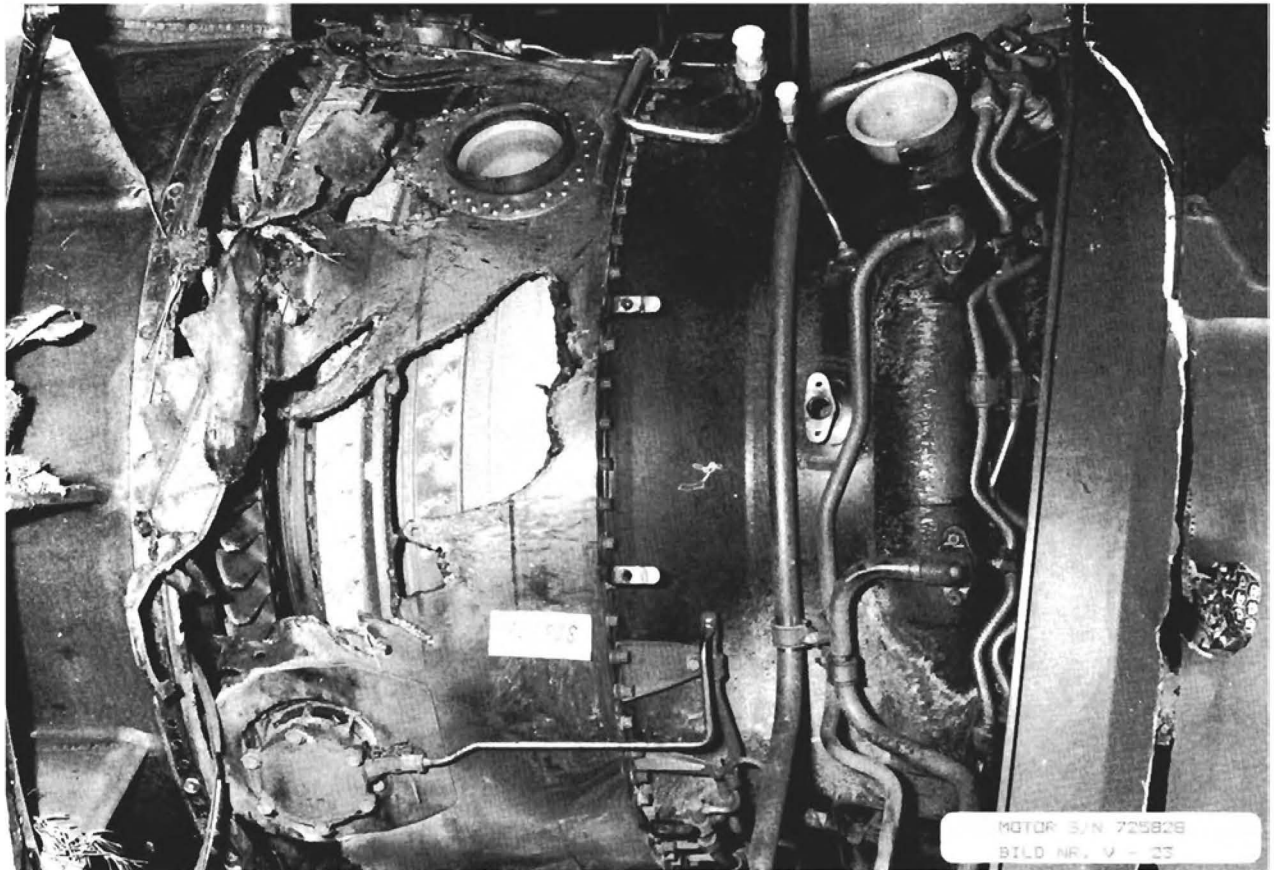
***Compressor cage damage***

The stg 7 stator had ruptured and left its original position between rotor stgs 7 and 8. Parts of its outer shroud with suspended vanes stuck out through the rear compressor case between the 9-o'clock and 1-o'clock positions. The inner shroud

with its seal had ruptured and projected from a hole in the rear compressor fan duct between the 4-o'clock and 7-o'clock positions. Of a total of 52 guide vanes in stg 7, 12 had left the engine.

The front part of the stg 8 stator outer shroud, which supports the stg 7 stator, had ruptured around its whole circumference.

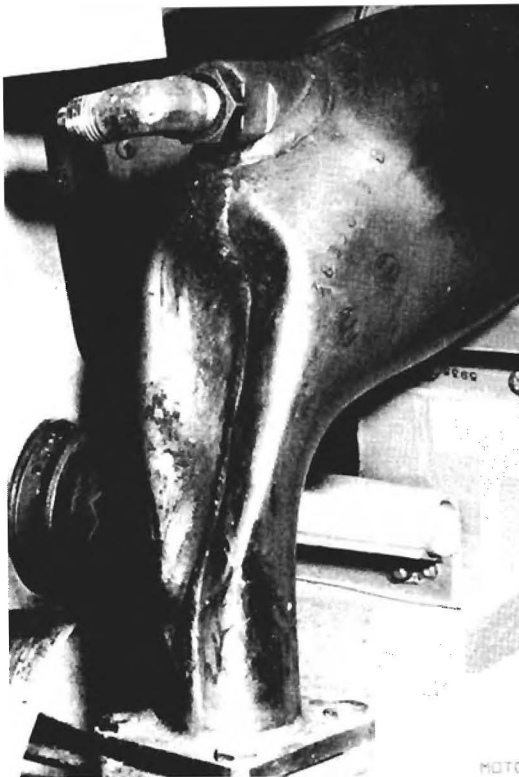
#### *Damaged fuel duct*

Fuel duct P/N 9938338-6 between the fire bulkhead towards the fuselage and the engine fuel regulator at compressor stg 7 had impact damage on the side facing the engine. On the opposite side of the fuel pipe approx 42 mm from its upper flange there was an approx. 22-mm-long fissure in a welded seam, with a maximum gap width of approx. 1.2 mm. In tests, the measured flow through the fissure was approx. 5 litres per min at a fuel pressure of 1 psig and approx 13 litres per minute at 15 psig.

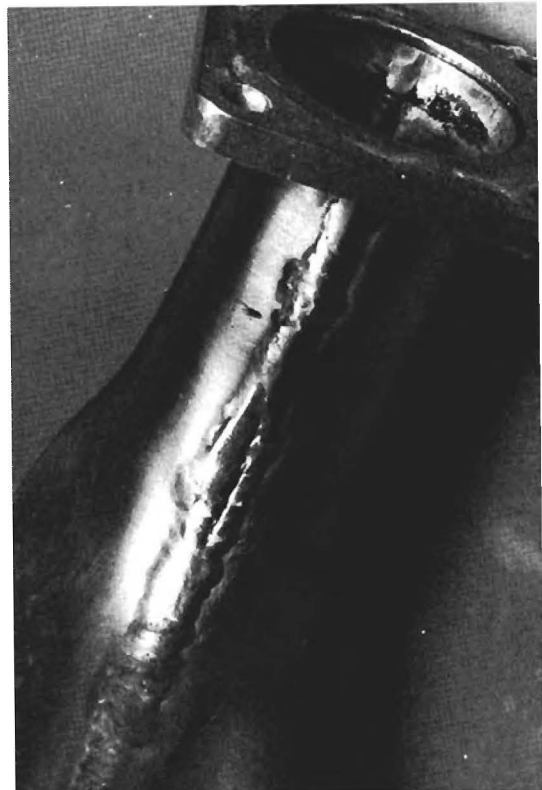
#### *Fissure in welded seam*

Metallurgical examination of the pipe revealed that there were manufacturing defects in the weld seam in the area where the fissure had occurred. The weld fissure is judged to have arisen in connection with the opposite side of the fuel pipe being subjected to the impact that caused the damage on that side. The impact created tensions in the defective weld joint which caused it to crack.

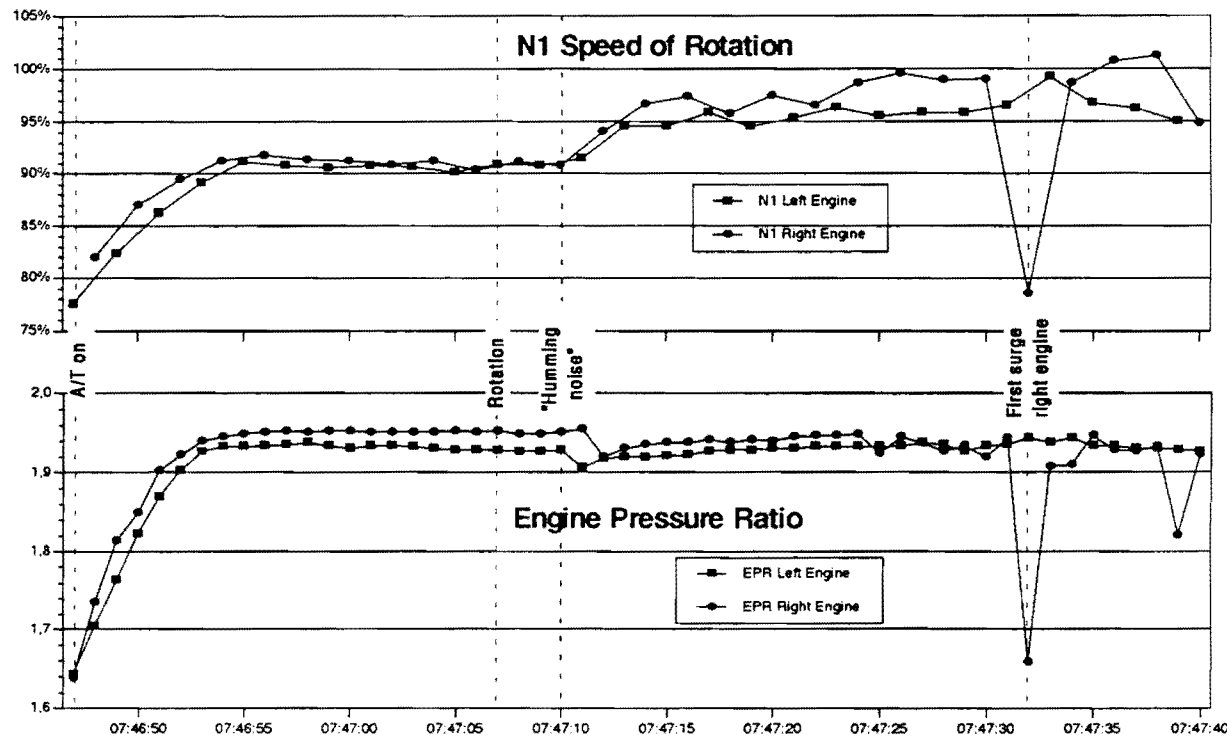
#### *Shift in $N_1$ and EPR at liftoff*

At liftoff an increase in engine  $N_1$  rotation speed by 4% in the left engine and 6% in the right engine was recorded in the QAR. At the same time EPR sank by 0.03 and 0.02 units respectively. These recordings have been compared with corresponding values from earlier takeoffs with OY-KHO and with other MD-81's. The comparison shows that the values at the relevant takeoff were not normal.

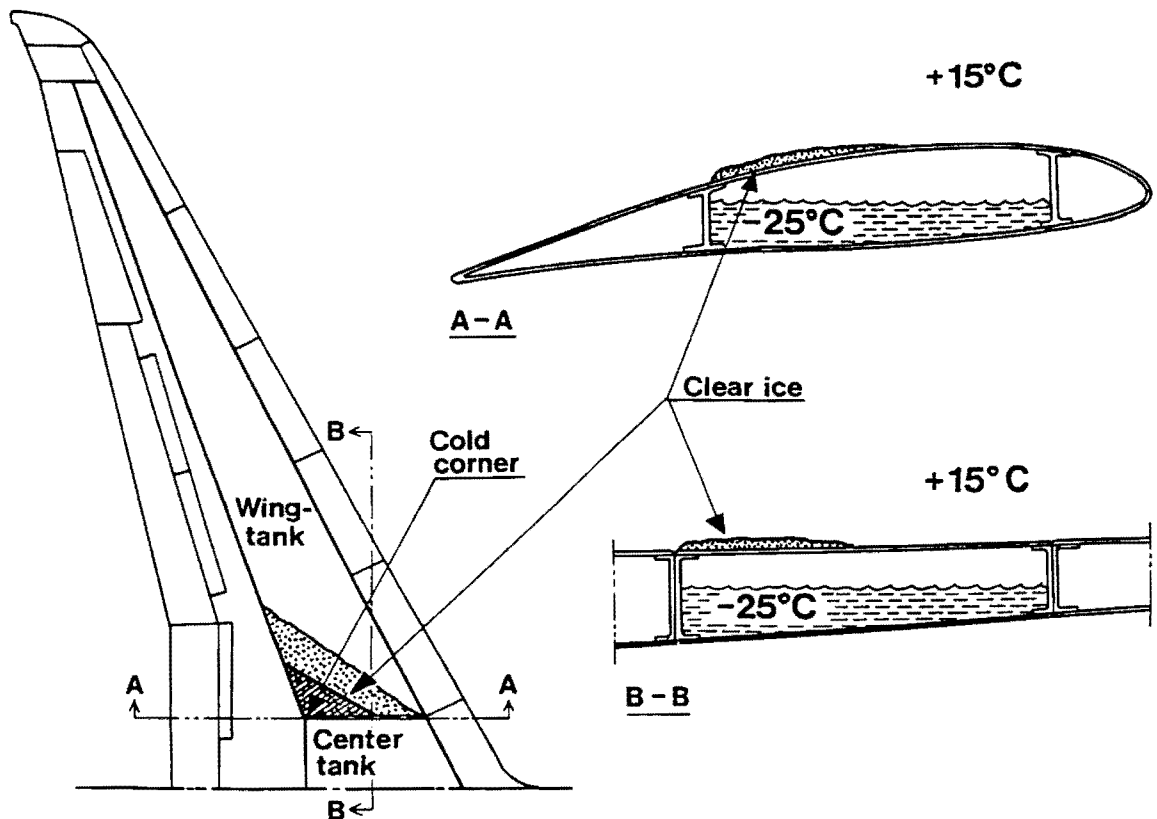
#### *Clear ice*

series the volume of the centre tank was increased by partly extending it into the enlarged wings. The innermost part of the neighbouring wing tanks, which contain the unused, often greatly chilled, remaining fuel, then came almost exactly in front of the engine air intakes.
