## 7.2 Subsequent safety actions

### **7.2.2 Release of non-conforming oil feed stub pipes into service**

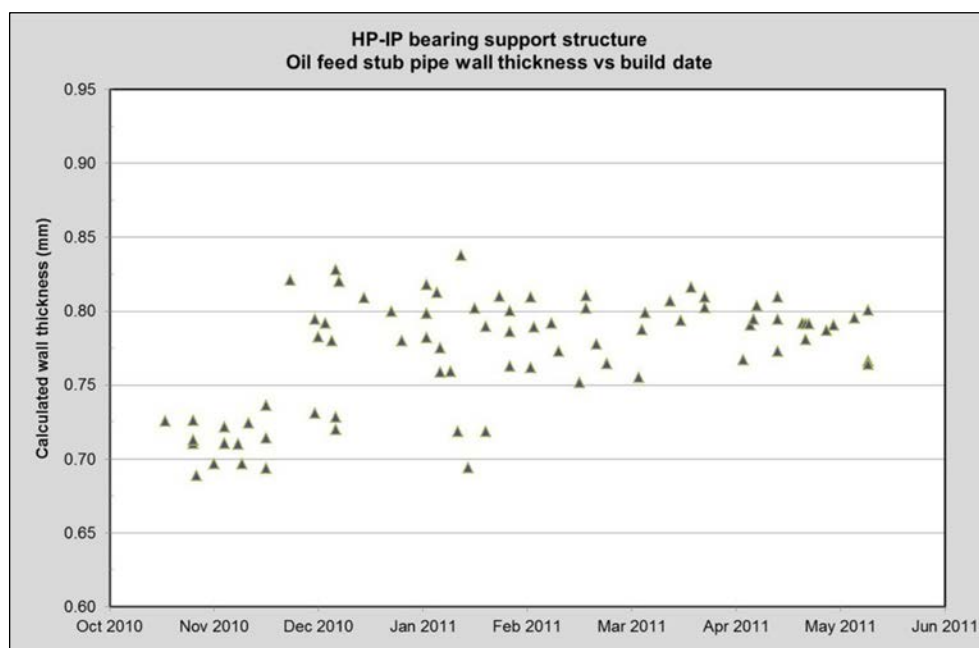
**Figure 93: Production data for the HP/IP bearing support structures that were manufactured at the Hucknall facility**

Following the occurrence, the stub pipe wall thickness production limit was restricted to 0.70 mm for all newly manufactured engines (Figure 93). The revised limit was introduced in December 2010, along with enhanced techniques for the measurement of critical dimensions within the counter bore region.

Rolls-Royce production data showed that, after the introduction of this revised limit in December 2010, the quality control of the manufacture of the HP/IP bearing support structure at the Hucknall facility had improved (Figure 93).
