Subject: Correction of the Report on the accident involving aircraft  
BOEING 747 PH-BUF of KLM and BOEING 747 N 736 PA of PANAM.

JOINT REPORT

COLISION AERONAVES

EN LOS RODEOS (TENERIFE)

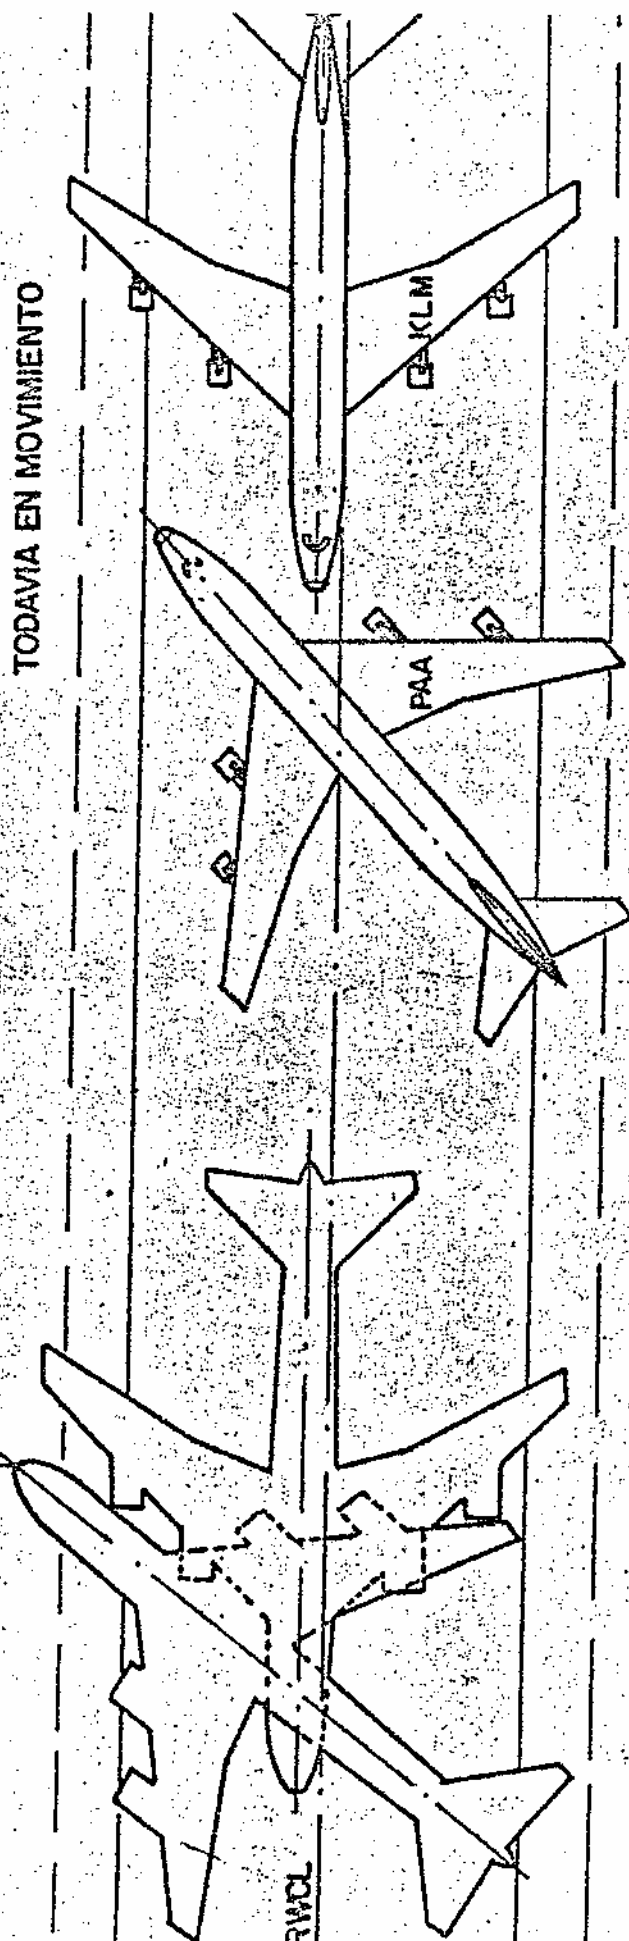
Damage to the planes was 100% due to the impact and post-impact fire.

1.4 Other damage
