## Aviation Investigation Report

### In-Flight Fire Leading to Collision with Water

Swissair Transport Limited  
McDonnell Douglas MD-11 HB-IWF  
Peggy's Cove, Nova Scotia 5 nm SW  
2 September 1998

Report Number A98H0003

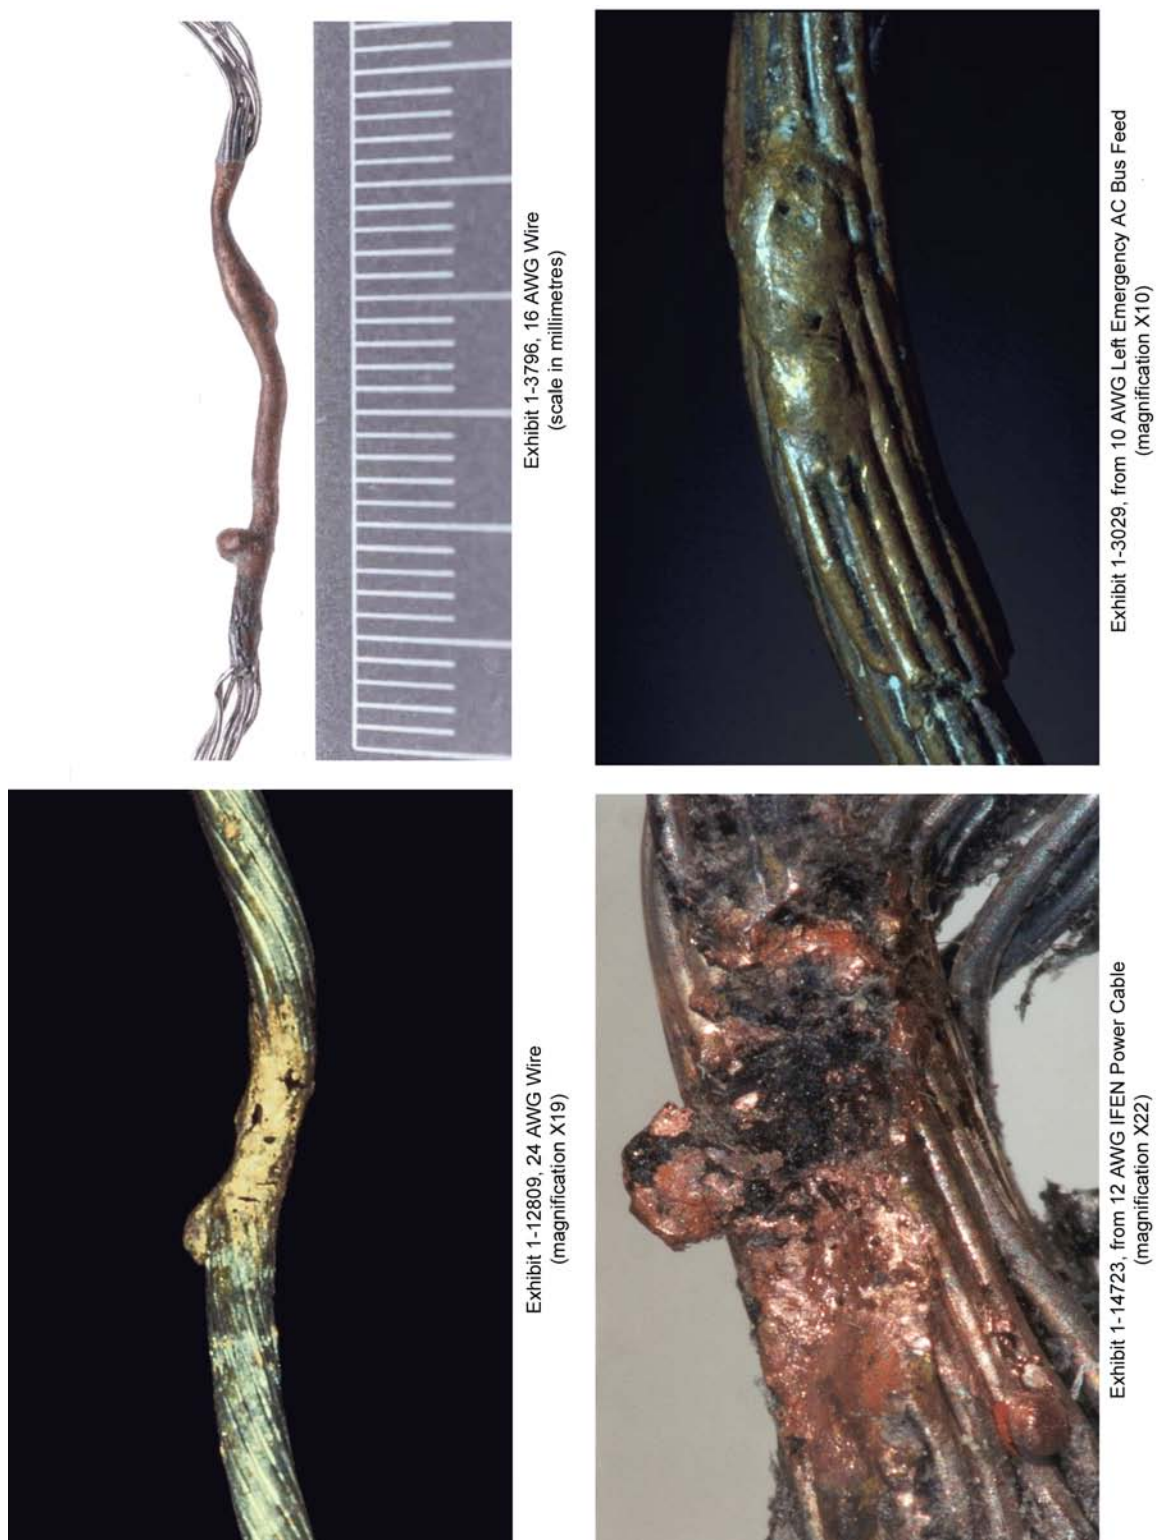
**Figure 20:** Wire segments with melted copper

All of the recovered wires were examined, primarily to identify any with signs of melted copper. As the fire did not reach temperatures high enough to melt copper,<sup>50</sup> any areas of melted copper would indicate that an electrical arcing<sup>51</sup> event had occurred.

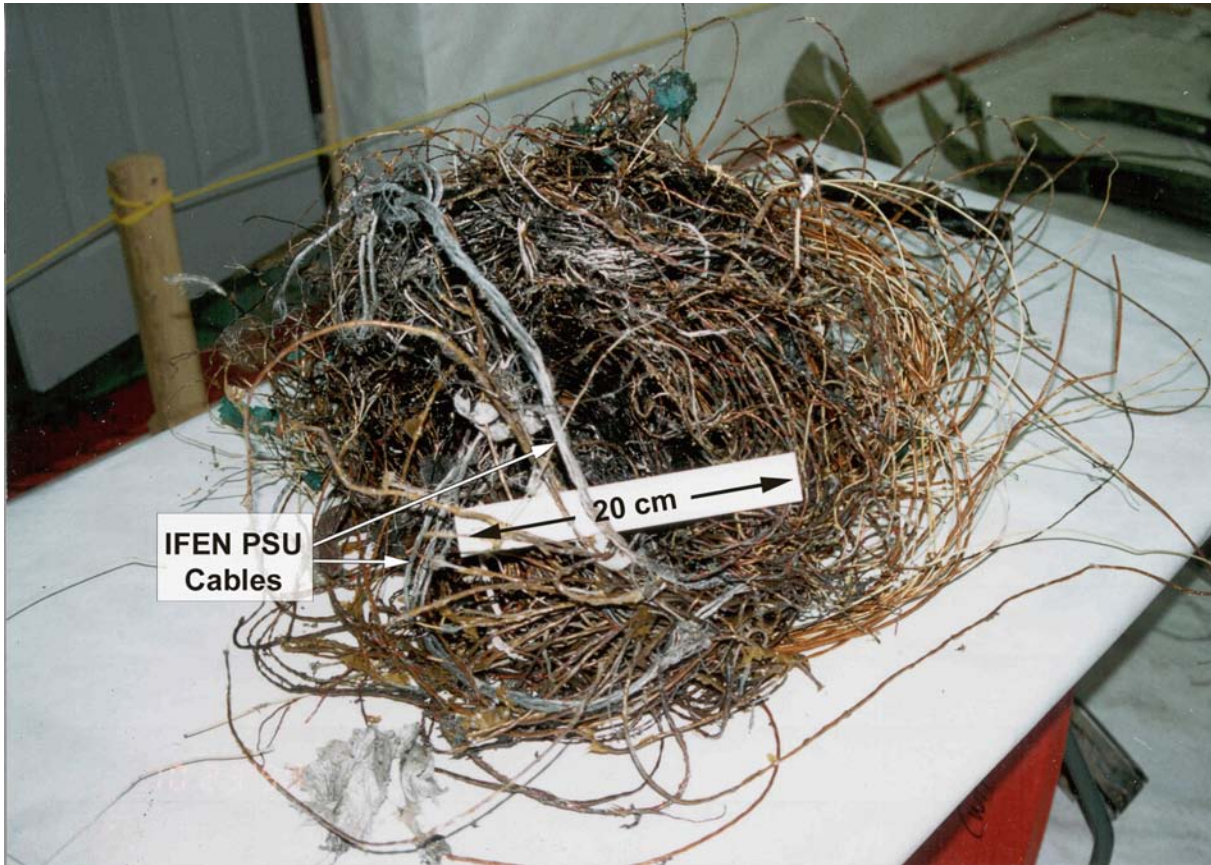
**Figure 21:** Exhibit 1-4372

Of the nine wire or cable segments with areas of melted copper that were recovered from Exhibit 1-4372, four were positively identified as being segments of the IFEN PSU cables (1-3790, 1-3791, 1-3792, and 1-3793) (see Figure 22). This identification was based on remnants of coloured ETFE insulation remaining attached to the wires. On each of these four segments, one end was heavily matted, or crushed together, and the opposite end was fractured and frayed. Exhibits 1-3790 and 1-3792 both had distinctive regions where the tin coating was missing from the wire strands on all three wires. Exhibits 1-3791 and 1-3793 did not have a similar region of missing tin.

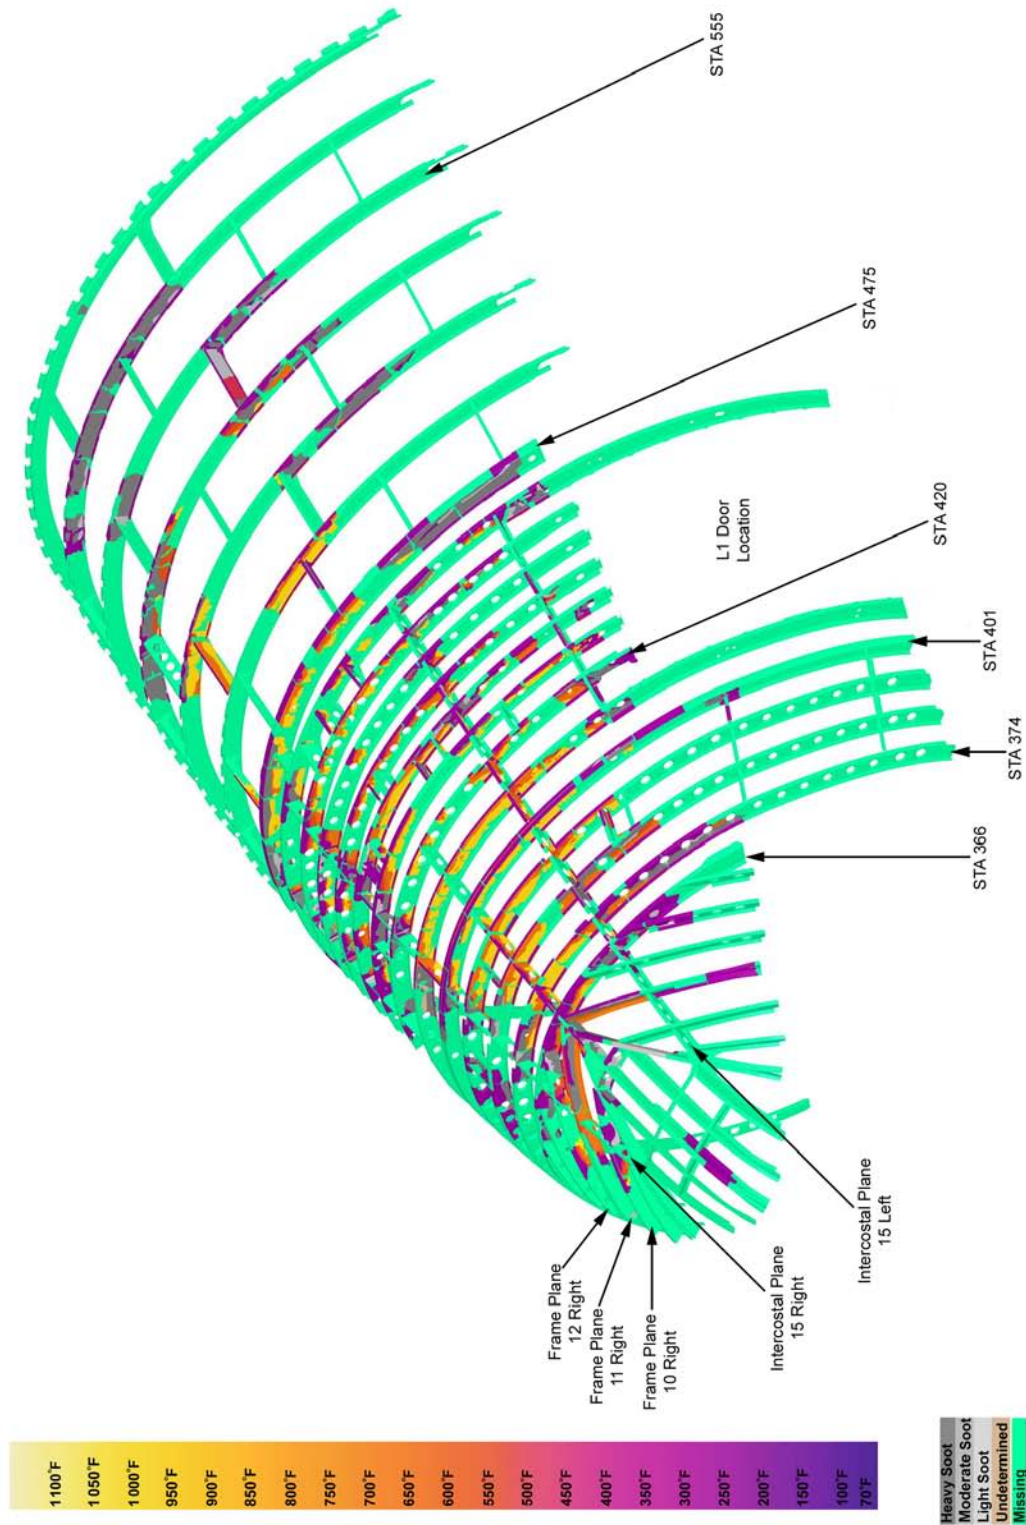
Figure 25: Heat damage – airframe structure

Damage to the riser duct assembly ranged from no heat damage to bare-metal heat damage. The vertical portion of this assembly had no heat damage. The first area of bare-metal damage to the riser duct assembly started at intercostal plane 15 right, where the lower surface had a region of bare-metal heat damage from  $X = -30$  inboard to the joint at  $X = -20$ . This was in the vicinity of the Galley 2 vent end cap. There was bare-metal damage from approximately STA 395 to STA 442 between  $X = 25$  and  $X = -10$ . A section of molded duct was installed in that area from STA 420 to STA 442 between  $X = 5$  and  $X = 25$ . No portions of this molded duct were identified in the wreckage.

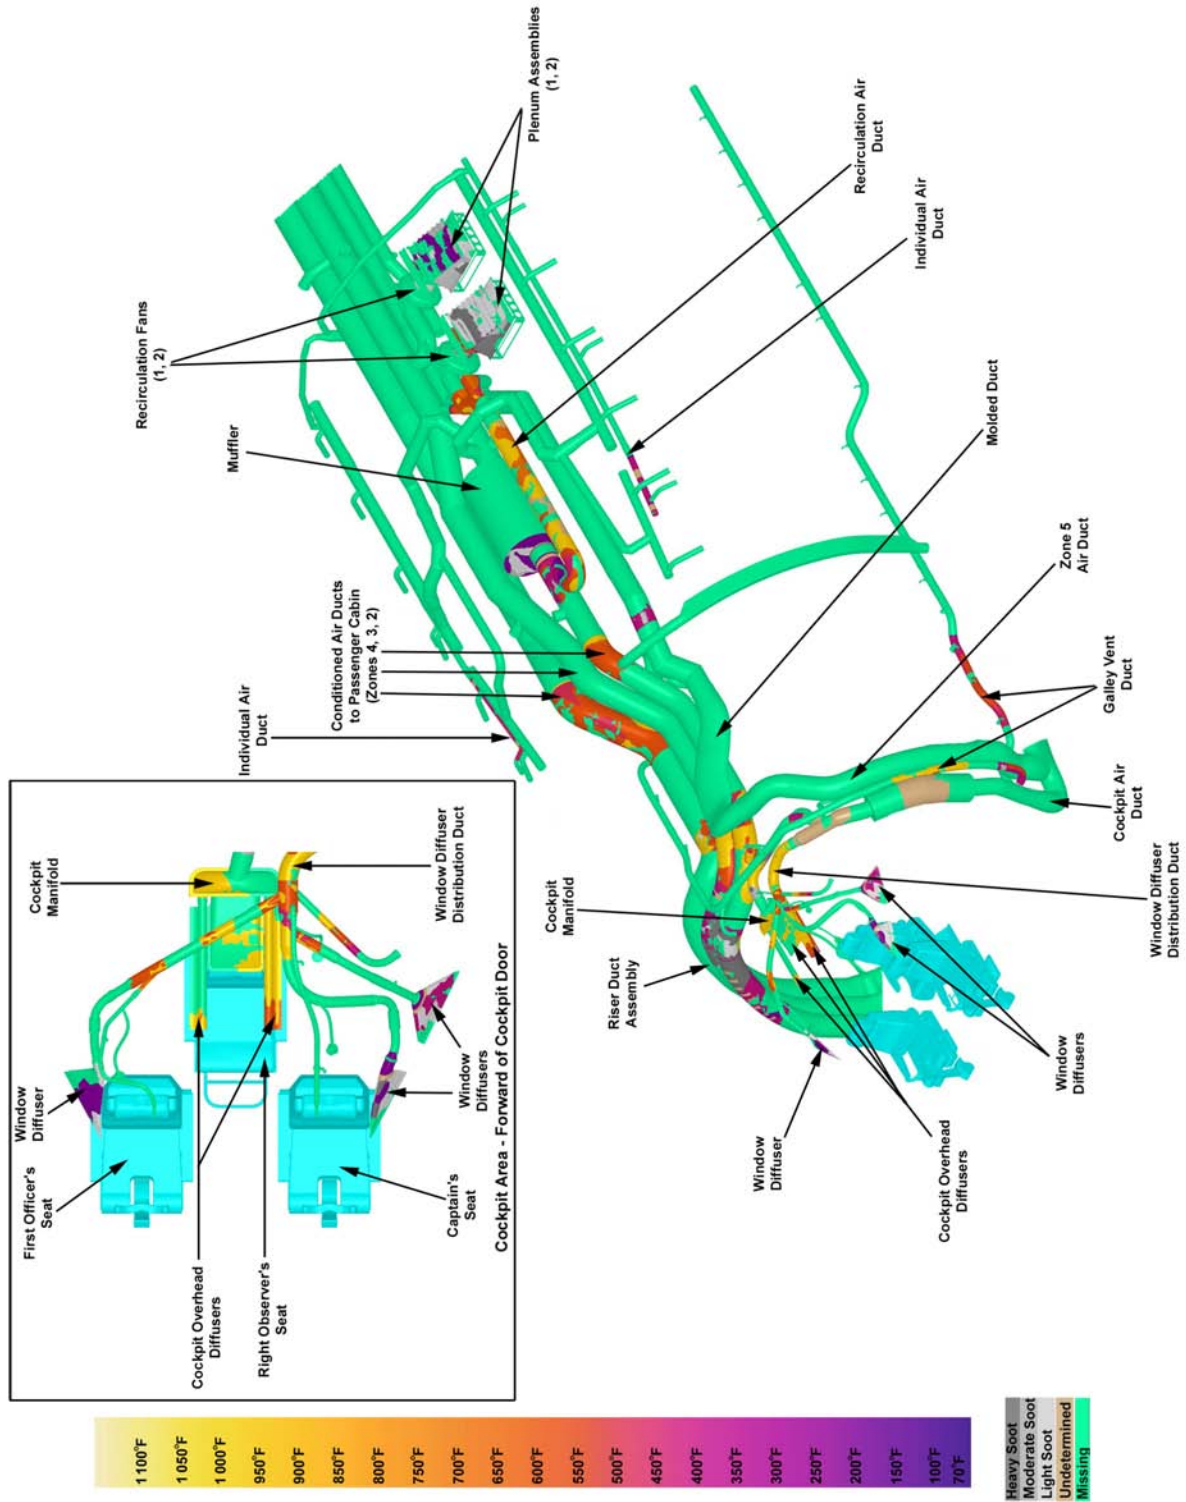
Figure 26: Heat damage – air distribution system

Between approximately STA 480 and STA 545, the main conditioned air ducts for zones 2, 3, and 4 transitioned from running near the top of the forward cabin drop-ceiling, upward to run near the crown of the aircraft. In this area there was bare-metal heat damage at places along the top of the ducts. The primer on the underside of these ducts was not damaged by heat. The recovered portions of two individual air ducts from approximately STA 555 to STA 595 at  $X = 70$  and  $X = -70$  had areas of light to moderate soot accumulation.

Forward passenger cabin individual air was supplied by a fan and plenum assembly identical to a recirculation air fan and plenum assembly. The fan was located at STA 990 at  $X = -24$ . The plenum assembly was between  $X = -40$  and  $X = -65$ . The recovered portions of the plenum had no heat damage or soot accumulation. The individual air ducts were uninsulated and ran forward from STA 990 to a "Y" (split) at STA 750 at  $Z = 91$ ,  $X = -21$ . One branch of the "Y" ran across the crown to the left side of the cabin at  $X = 76$ , and the other ran to the right side at  $X = -76$ . The recovered portions of these ducts had moderate to heavy soot accumulations on the exterior, with no heat damage. The aftermost section of individual air duct that was identified was from STA 934 to STA 955 at  $X = -22$  and had light soot accumulation on the exterior.

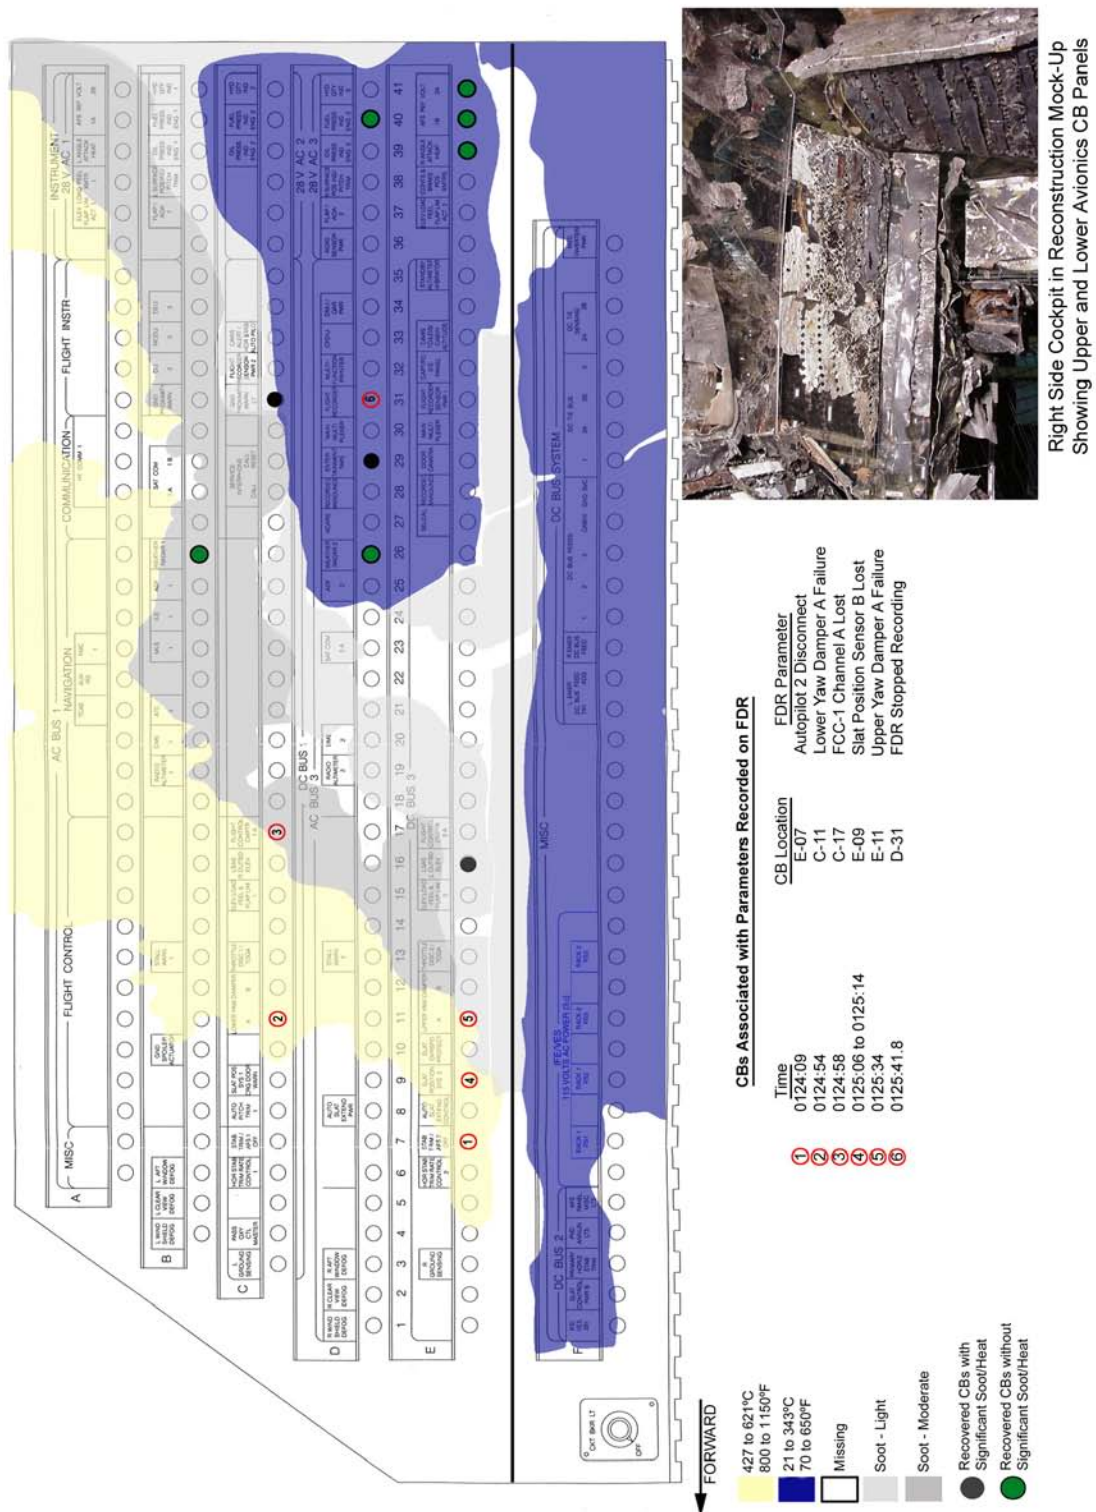
Figure 28: Heat damage – upper and lower avionics CB panels

side, particularly on those pieces near the forward end of the panel where the front side of the panel showed considerably more heat damage than the back side. Individual CBs showed soot on the white indicator ring; soot could only have been deposited if the CB had tripped and subsequently been exposed to combustion by-products. Details concerning the CBs on the avionics CB panel and wiring in the vicinity are included in separate sections of this report.

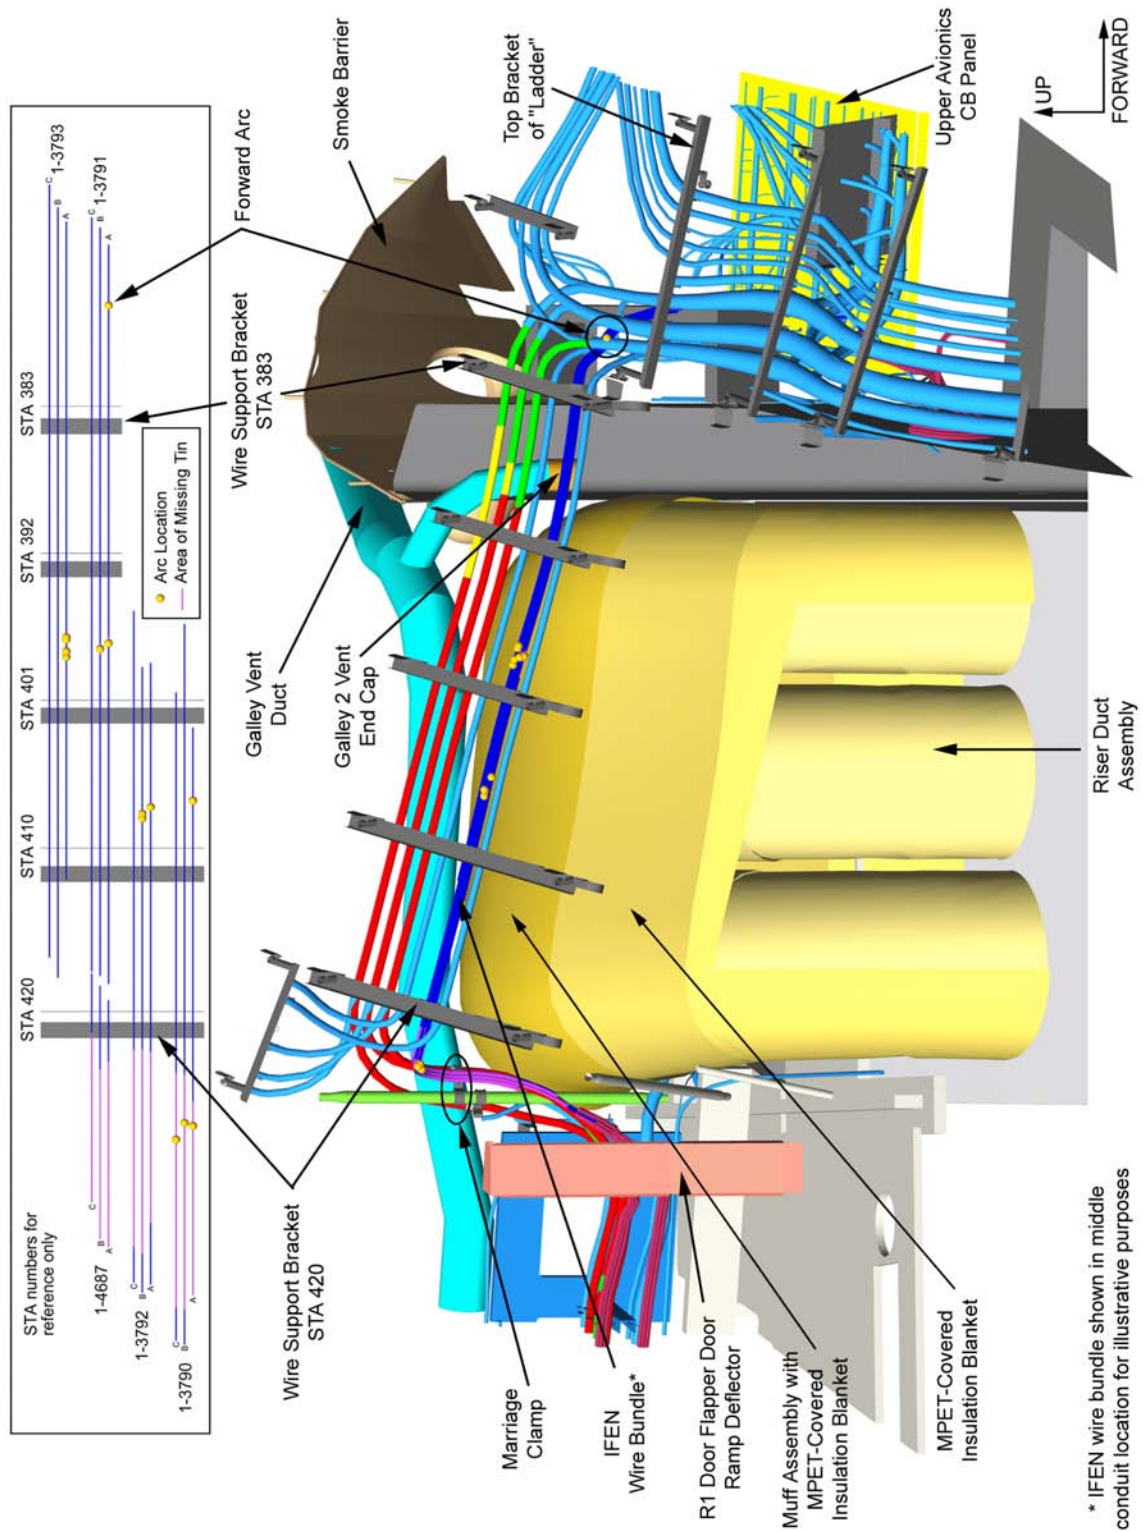
**Figure 31:** Position of recovered IFEN wires – middle conduit

The region of missing tin represented an area of higher heat. If this had been an earlier event, it is strongly suspected that all three cables would exhibit similar arcing events in the vicinity of 1-3790 outside the aft end of the conduit. With the cables and control wire laid out as described above, all of the regions of melted copper could be attributed to arcing events between phases on the same cable, between the cables and the control wire except for the arc event that took place at the forward end of 1-3791, or both. There was no matching arc damage on cable 1-3793 in this area. However, the continuation of exhibits 1-3790/1-3792 from approximately STA 401, along with the 16 AWG control wire forward, were not identified. Therefore, no determination could be made with respect to exactly what the single wire from 1-3791 had come in contact with at the forward end.
