AAIS Case Reference: 13/2010

AIR ACCIDENT INVESTIGATION REPORT

**Uncontained Cargo Fire Leading to Loss of Control
Inflight and Uncontrolled Descent Into Terrain**

Boeing 747-44AF
N571UP
Dubai
United Arab Emirates
03 September 2010

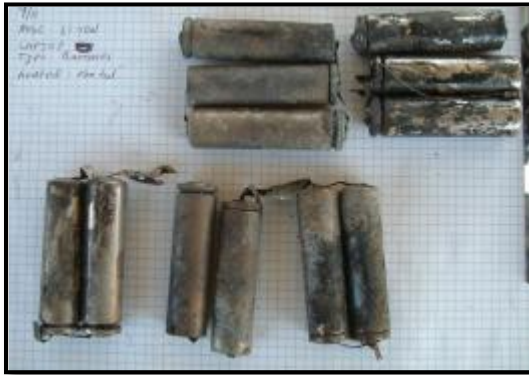
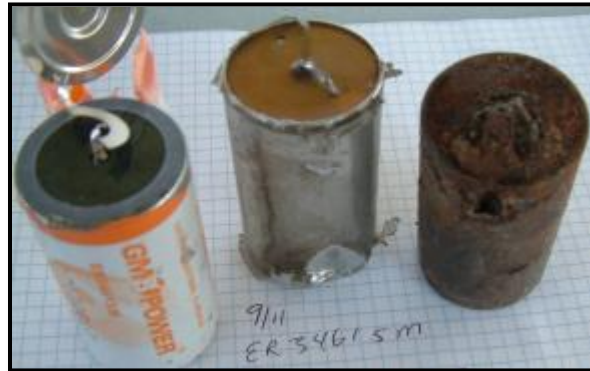
Additional battery pack remains [LH]/D-Cell size lithium primary batteries. Photo shows fire damaged and undamaged batteries [RH]

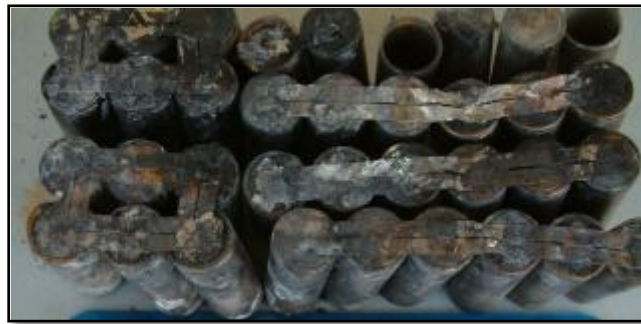
36-cell lithium-ion battery pack with multiple vented cells

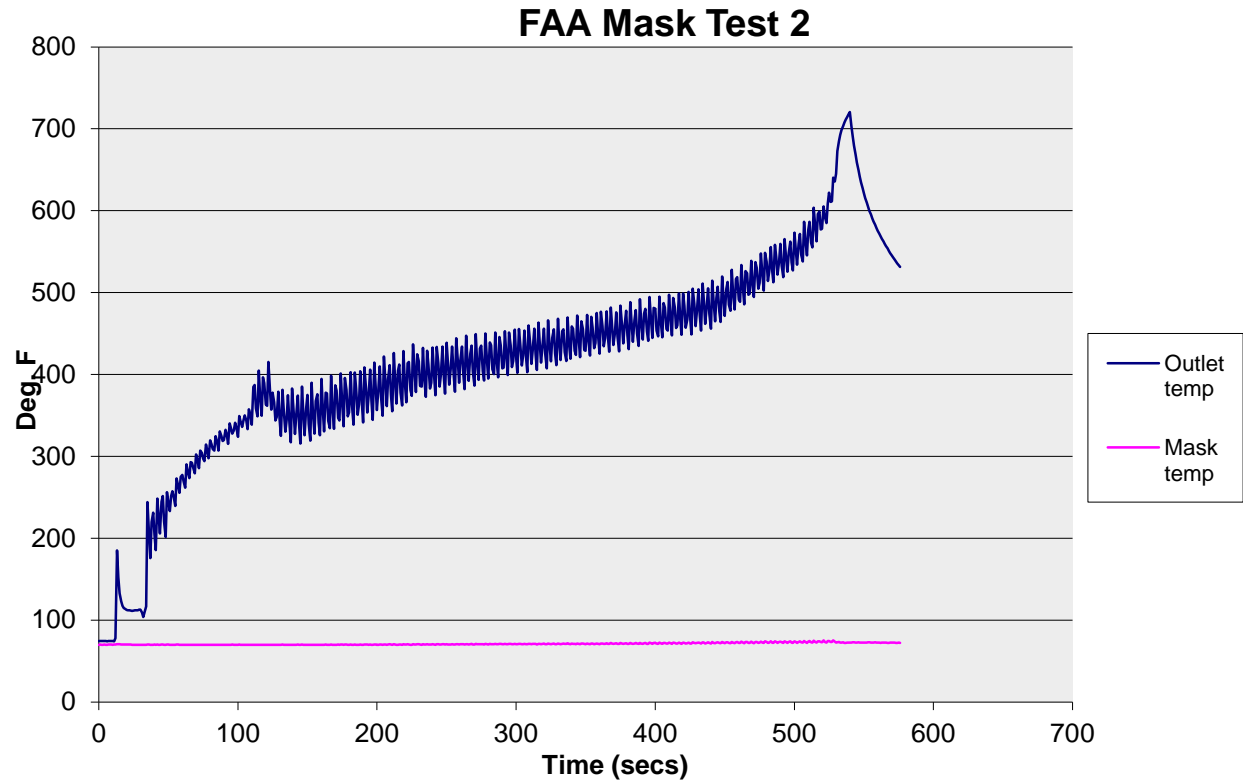
Mask Test #2 Flex Hose 60B50059 hose failure
