AIRCRAFT ACCIDENT REPORT

**IN-FLIGHT FIRE AND IMPACT WITH TERRAIN
VALUJET AIRLINES FLIGHT 592**

DC-9-32, N904VJ

EVERGLADES, NEAR MIAMI, FLORIDA

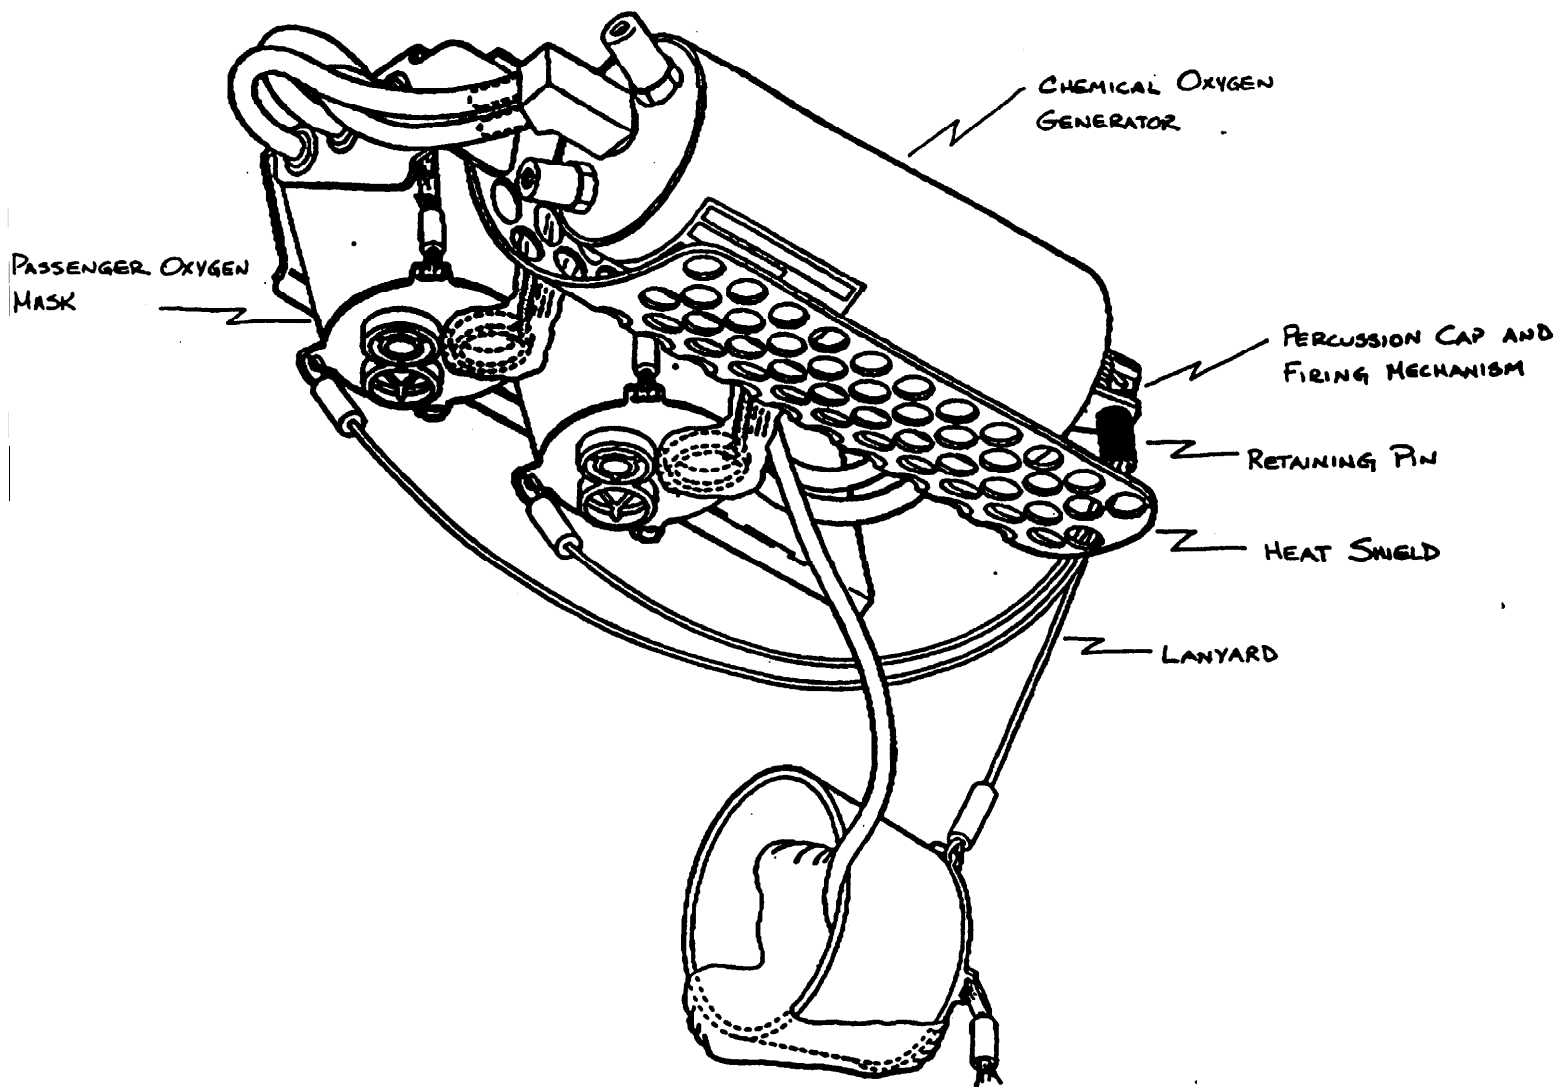
Figure 2a—Diagram of passenger oxygen generator/mask installation

The chemical reaction is exothermic, which means that it liberates heat as a byproduct of the reaction. This causes the exterior surface of the oxygen generator to become very hot; the maximum temperature of the exterior surface of the oxygen generator during operation is limited by McDonnell Douglas specification to 547 °F when the generator is operated at an ambient temperature of 70 to 80 °F. Manufacturing test data indicate that when operated during tests, maximum shell temperatures typically reach 450 to 500 °F.

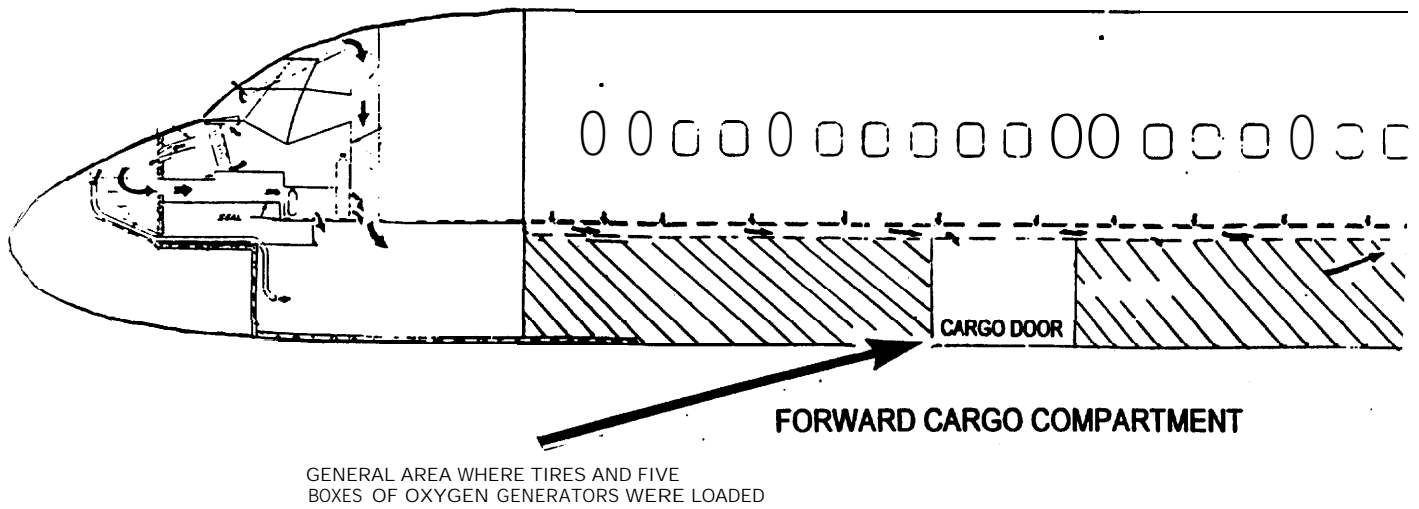
Figure 3—Forward cargo compartment

The accident airplane was equipped with two class D cargo compartments. (See figure 3—forward cargo compartment.) The volume of the forward cargo compartment in the DC-9 airplane is about 560 cubic feet.

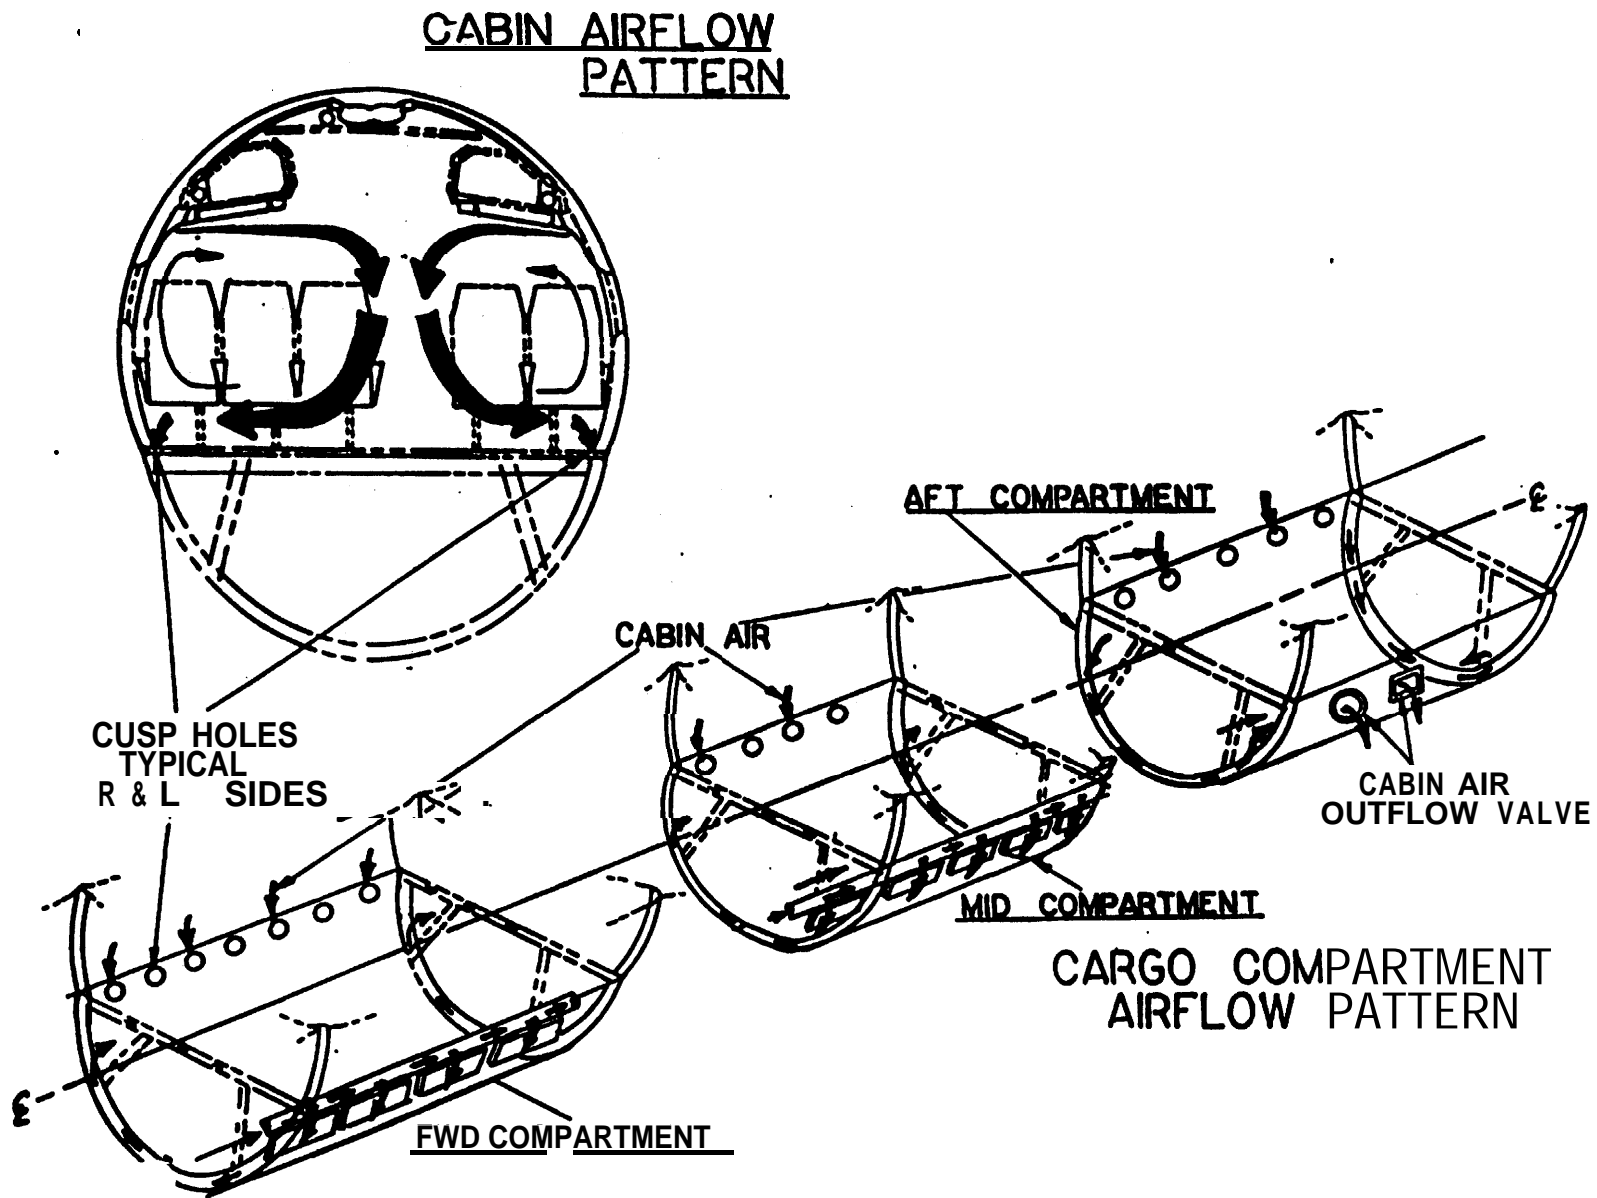
Figure 4—Cabin/cargo airflow pattern

According to the DC-9 electrical and wiring diagram manual, the DC-9 electrical wiring bundles are routed along the left, right, and top of the forward lower cargo compartment (between the fuselage and the cargo liner such that the bundles remain within the pressurized

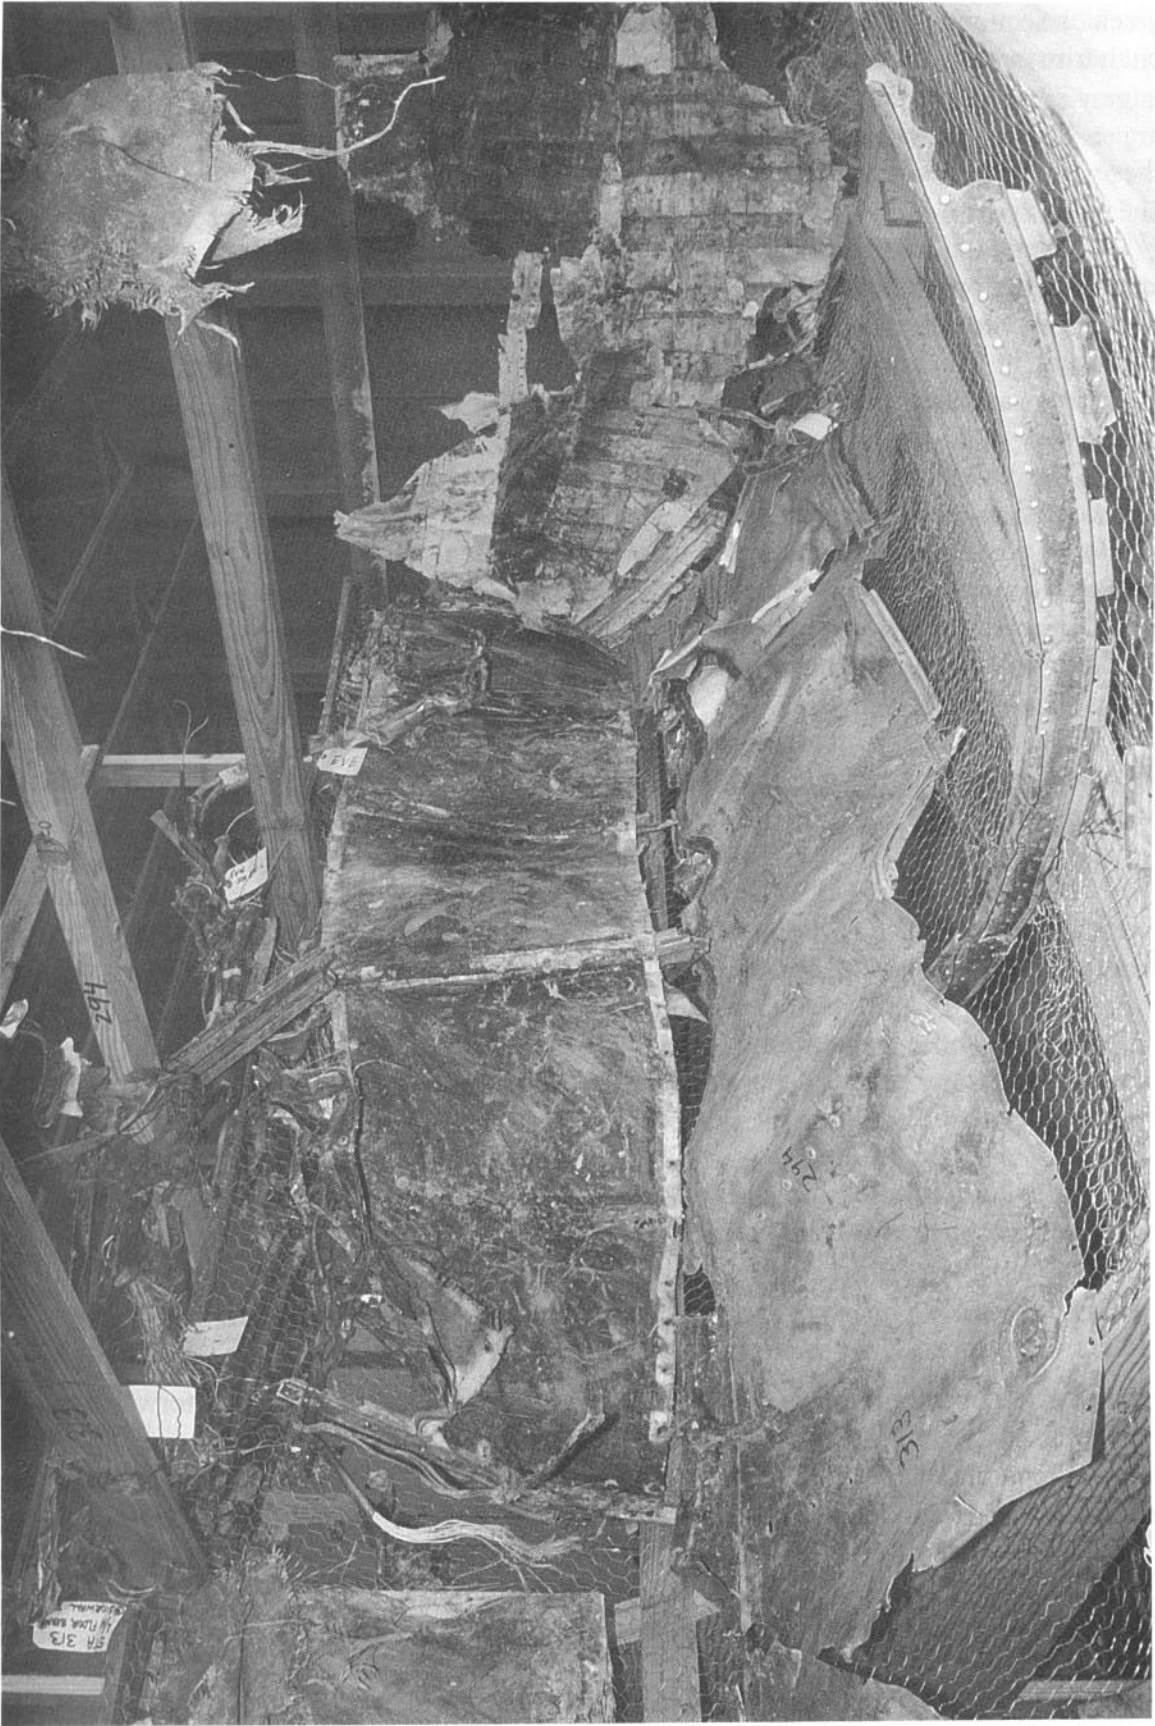
Figure 5—Cargo compartment mockup

All recovered wreckage identified as being from the area of the forward cargo compartment was assembled into a full-scale, three-dimensional mockup. (See figure 5.) The forward cargo compartment extended from fuselage station (FS) 218 to 581. The forward edge of the forward cargo door was located at FS 373 and the aft edge was located at FS 425. Most of

these pieces, which included the cargo floor, cargo liners, and fuselage structure, exhibited soot and heat damage.

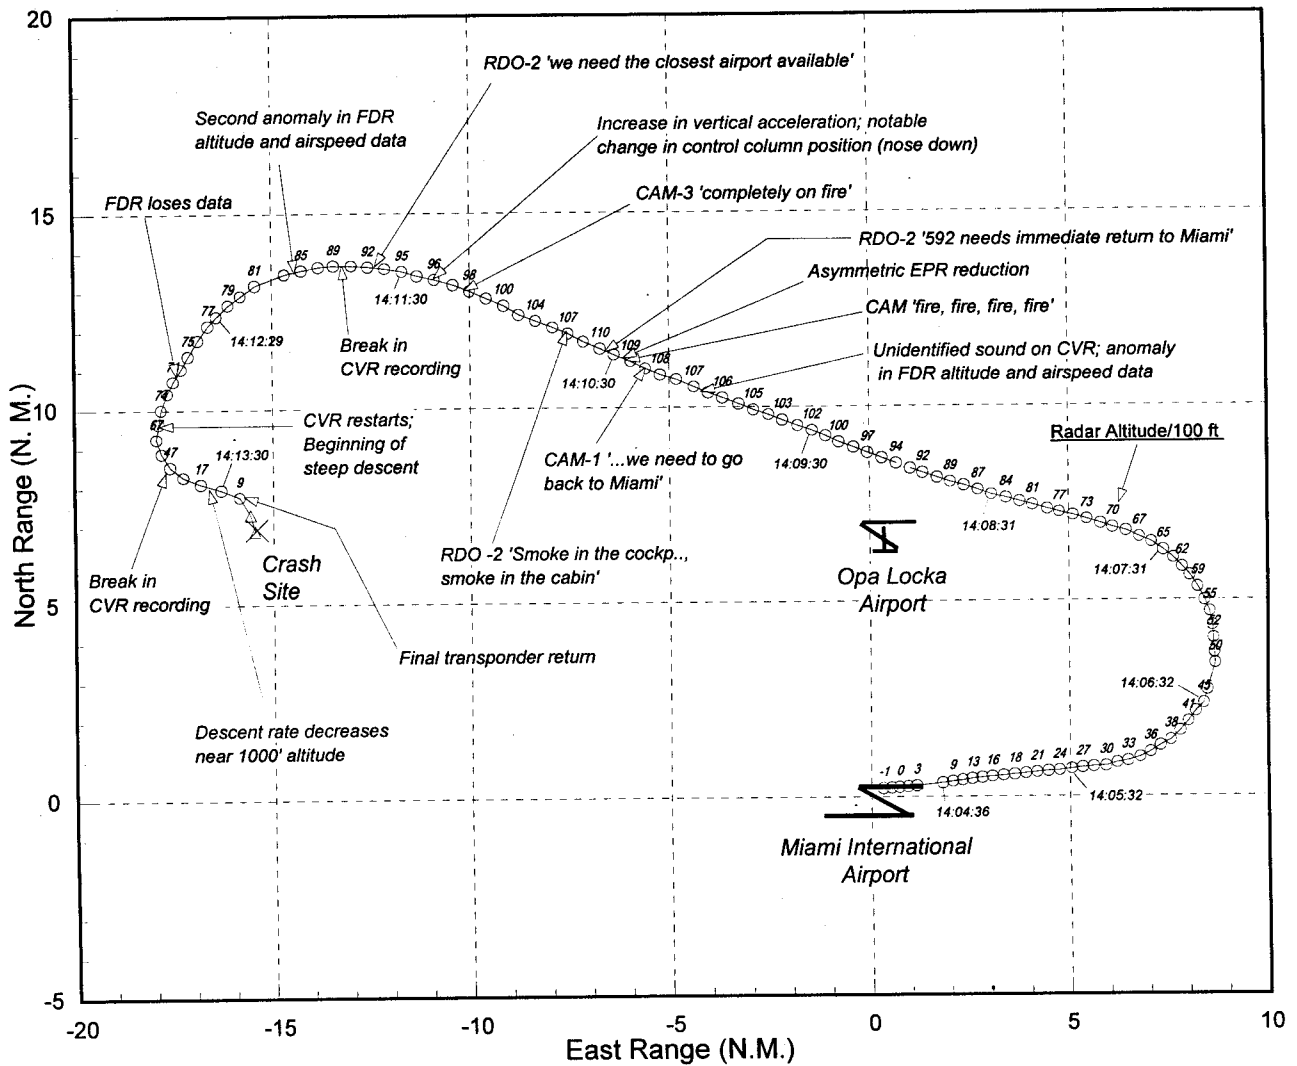
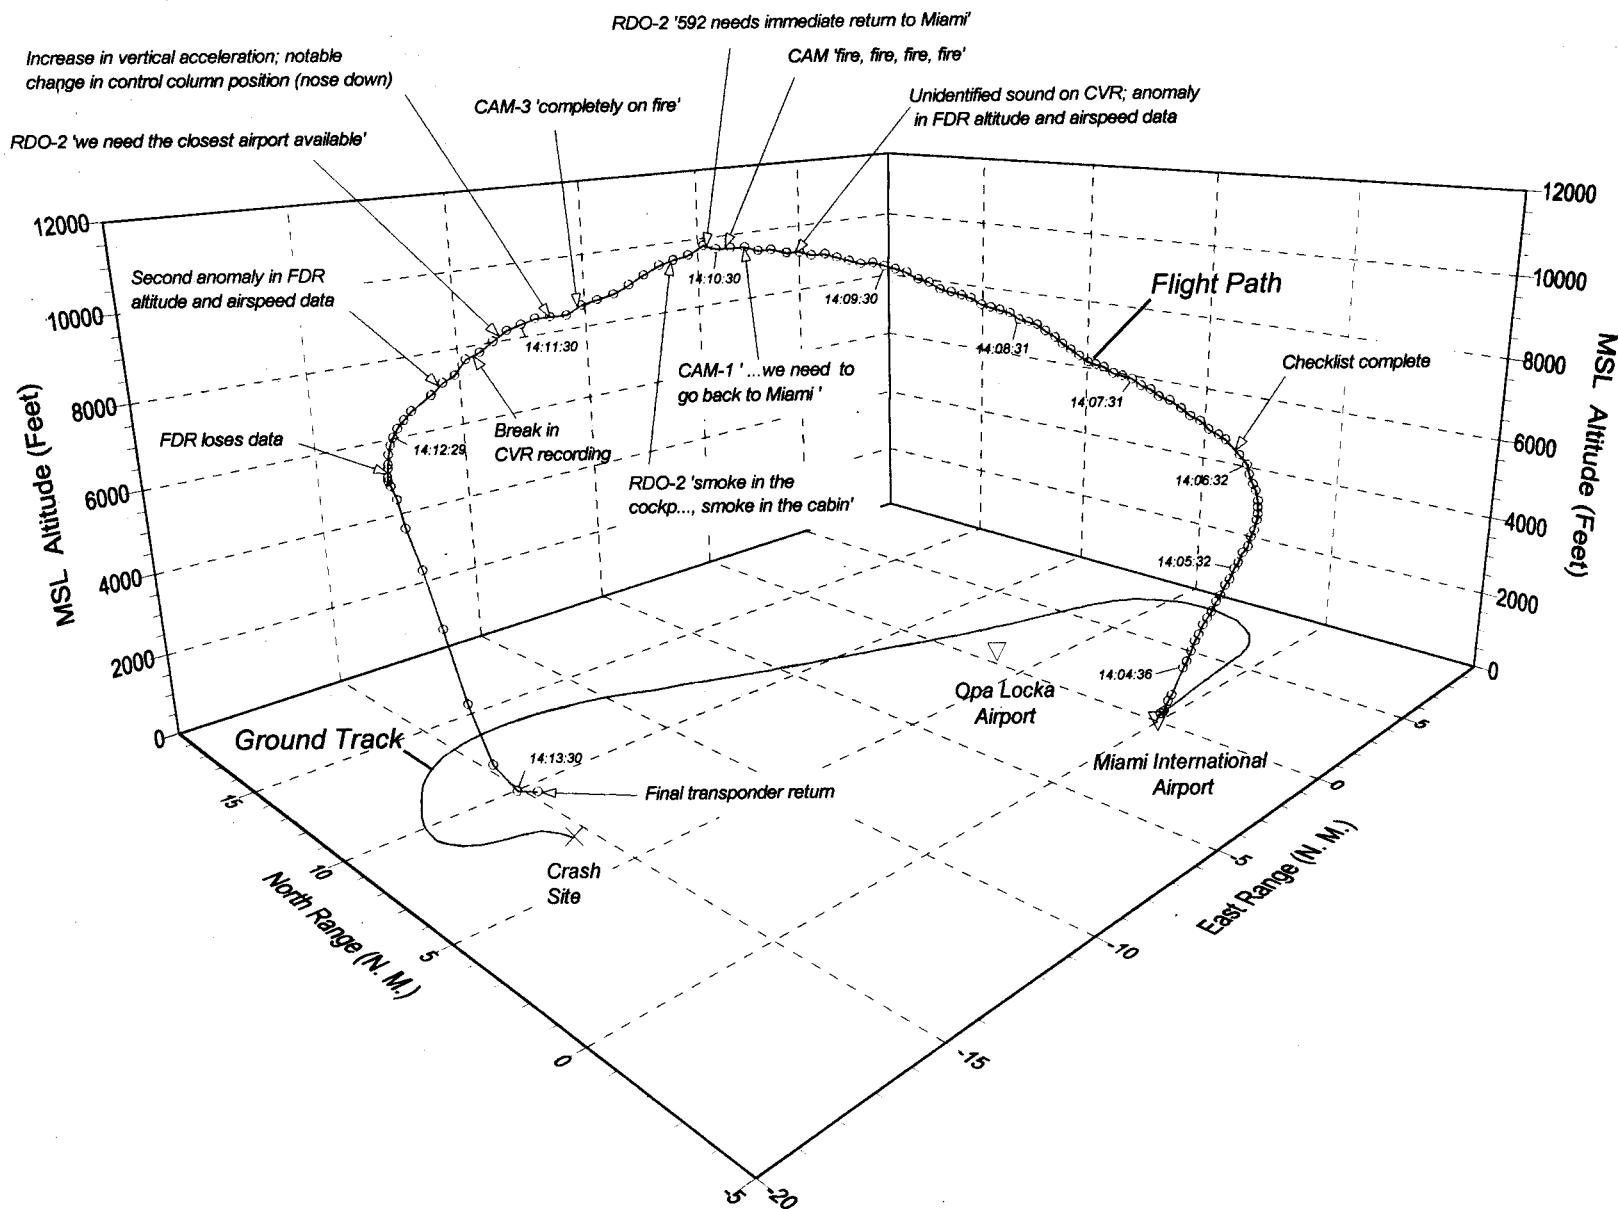
Figure 6b—Ground track of flight 592 (3-dimensional)

The FDR and radar data indicated that flight 592 began to change heading to a southerly direction about 1411:20. Shortly thereafter, the FDR recorded increases in vertical acceleration to a maximum of 1.43 Gs and an approximate 5° reduction in control column position from 1.54° to –3.8° (i.e., nose down); the vertical acceleration decreased to about 1.0 G.

FDR and radar data indicate that the airplane remained at an altitude of about 9,500 feet msl over the next 15 seconds, while airspeed decreased from 302 KIAS to 283 KIAS.
