## SPECIAL AIRWORTHINESS INFORMATION BULLETIN

SAIB: NE-16-19

**SUBJ:** Turbine Engine Compressor Section – Stator Nozzle Distress

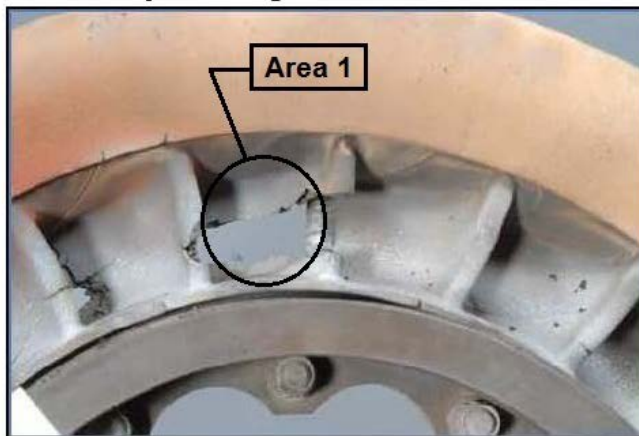
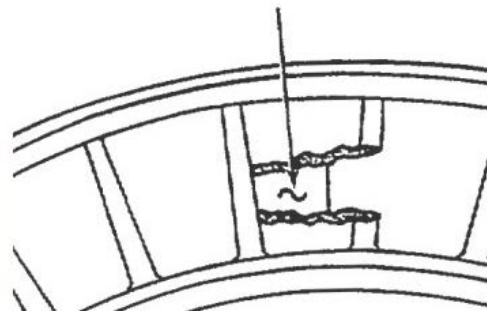
**Figure 2. 1<sup>st</sup> Stage Turbine Stator Nozzle with Nozzle Vane Burn-through**

**BURN THROUGH**

**Area 1: Stator nozzle vane burn-through; unacceptable and unserviceable**

1. The FAA recommends a BSI at every fuel nozzle inspection interval when the fuel nozzle manifold is removed from the engine, not to exceed 450 hours since last inspection.
2. We also recommend BSI viewing through 4 fuel nozzle boss openings to obtain full inspection coverage of the 1<sup>st</sup> stage nozzle.
3. We also recommend using an RF Systems videoscope with a 3.9 mm or 6.9 mm flex insertion tube or equivalent.

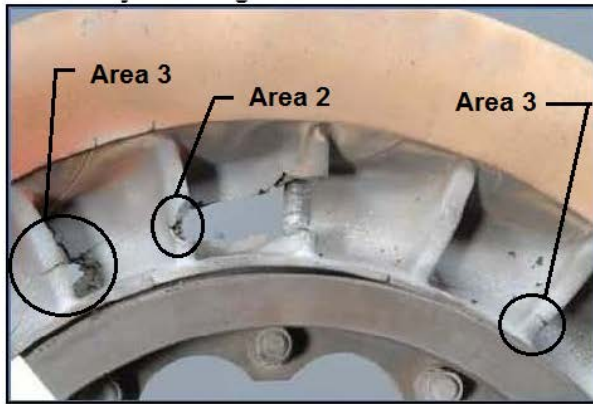
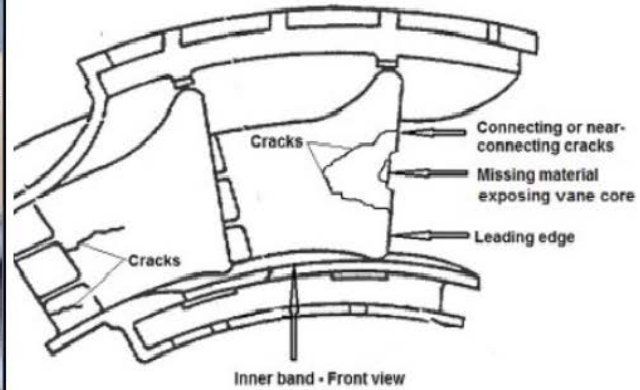
**Figure 3. 1<sup>st</sup> Stage Turbine Stator Nozzle with Nozzle Vane Distress**

**Area 2:** Missing material exposing vane core; acceptable, but re-inspect at next fuel nozzle inspection interval

**Area 3:** Blisters, leading or trailing edge cracks, or connecting or near-connecting cracks; acceptable, but re-inspect at next fuel nozzle inspection interval

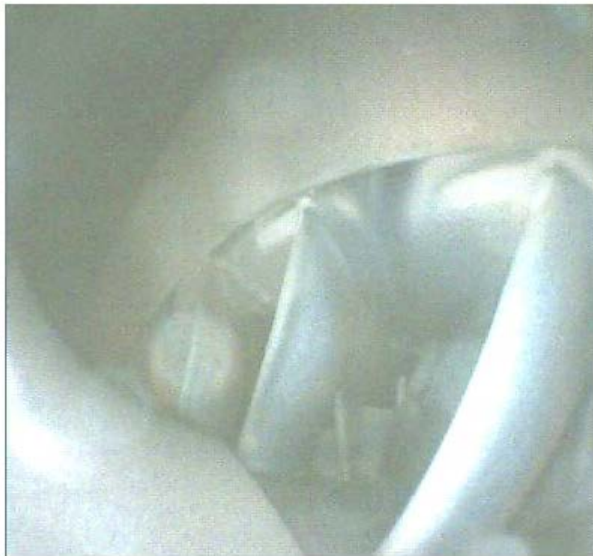
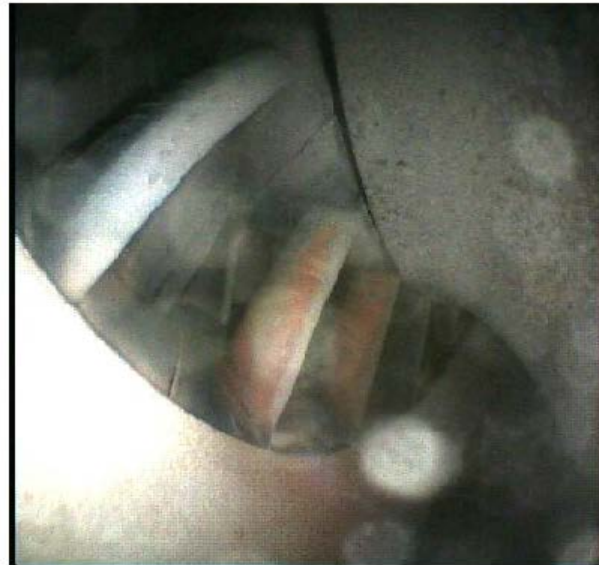
**Figure 4. 1<sup>st</sup> Stage Turbine Stator Nozzle with Acceptable Nozzle Vanes**
