AIRCRAFT ACCIDENT REPORT 2/2014

Report on the accidents to Eurocopter EC225 LP Super Puma

**G-REDW
34 nm east of Aberdeen, Scotland
on 10 May 2012**

**G-CHCN
32 nm southwest of Sumburgh, Shetland Islands
on 22 October 2012**

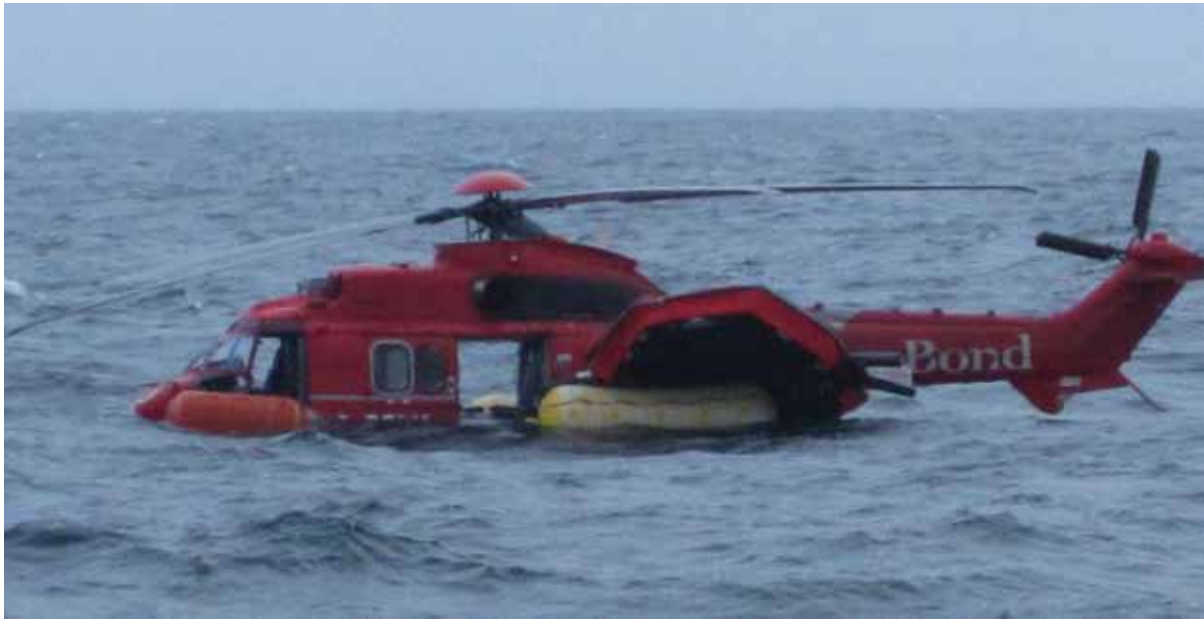
Figure 1

G-REDW afloat, approximately 8 hours after ditching

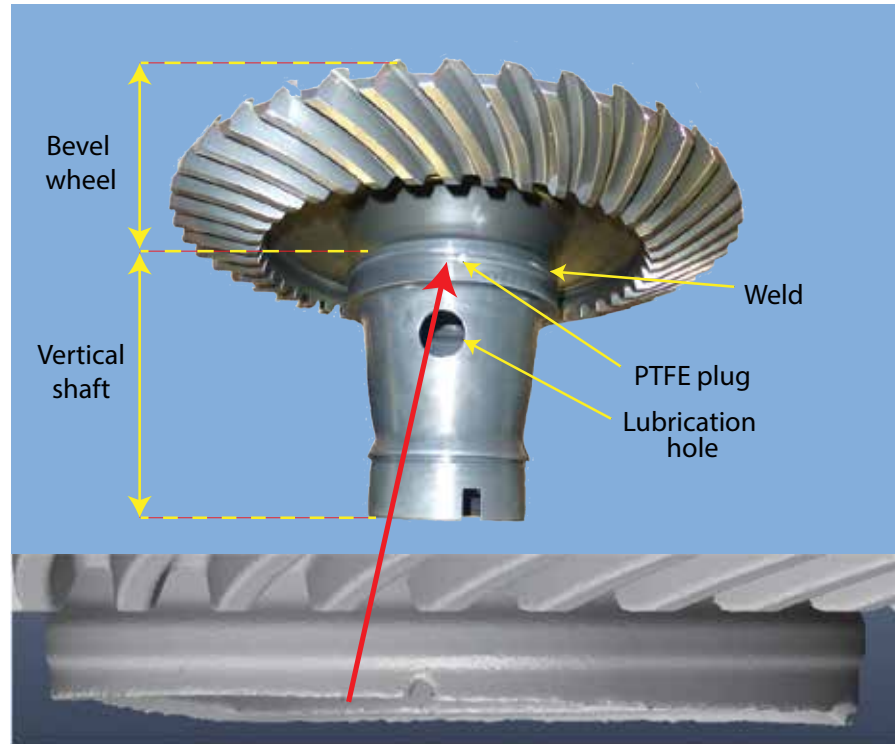
Figure 24

The bevel gear vertical shaft on G-REDW failed as a result of a 360° circumferential crack that initiated at the inner countersink of the 4.2 mm hole in the weld. A representation of the location of the crack is at Figure 24.

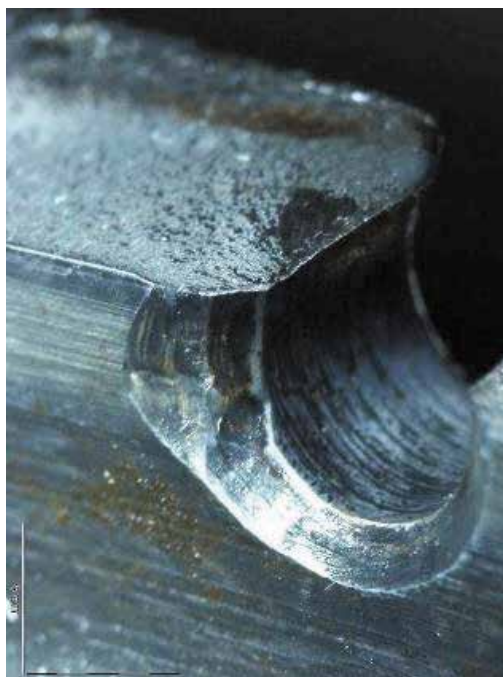
Figure 25

From an examination of the weld using a Scanning Electron Microscope (SEM), a review of the x-rays and results of the inspections performed during manufacturing, it was established that the weld had been correctly formed. The weld was within the design tolerances. While the 4.2 mm hole was of the correct size, and correctly aligned in the weld, there was evidence of tooling marks and a spiral scratch that ran along the length of the bore. The geometry of the countersinks was found to be outside the design specifications; there were also a number of 'scoops' in the inner countersink (Figure 25).

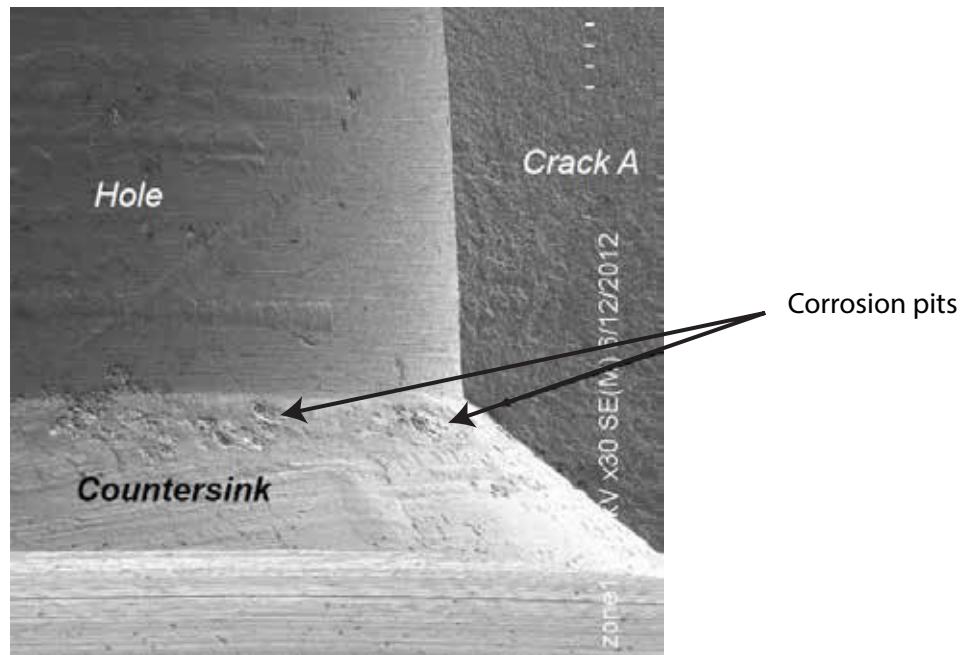
**Figure 26**

There were patches of very small corrosion pits in the walls of the hole and around the inner countersink, in the area where there is a gap (crevice) between the PTFE plug and the countersink. These corrosion pits were only initially detected using a SEM (Figure 26).

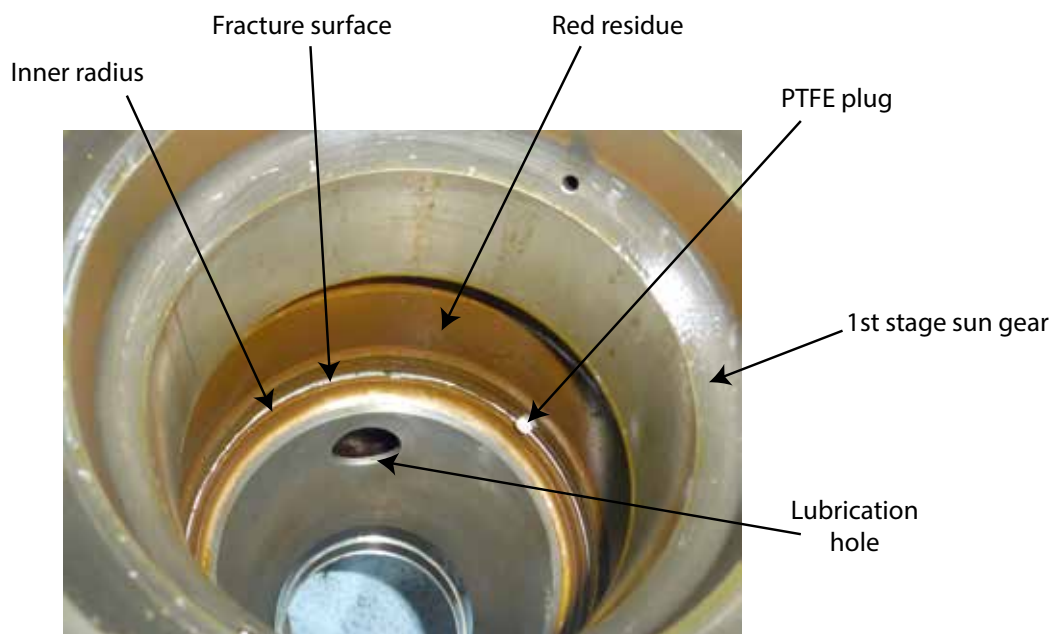
Figure 27

A red deposit was present on the inside of the bevel gear²⁸ part of the shaft which appeared to be slightly more concentrated on the inner radius and above and below the splines (Figure 27). Apart from on the inside of the first stage sun gear and in the fluid found in the gearbox sump, this deposit was not seen on any other part of the bevel gear vertical shaft or in the MGB. The deposit was found to contain iron oxide that had most probably been generated as a result of wear debris from the splines that drive the first stage sun gear.

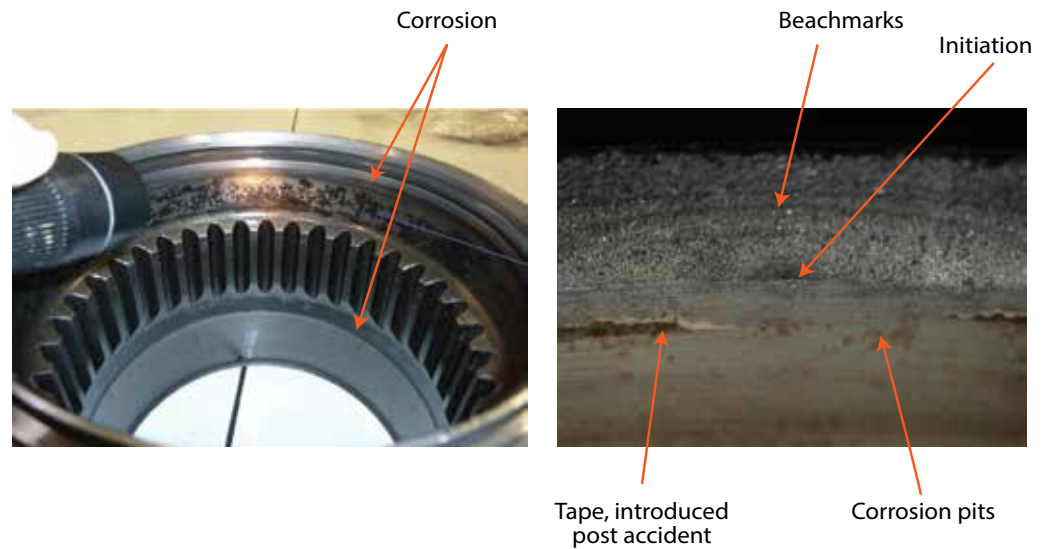
**Figure 28**

Evidence of corrosion pits on G-CHCN

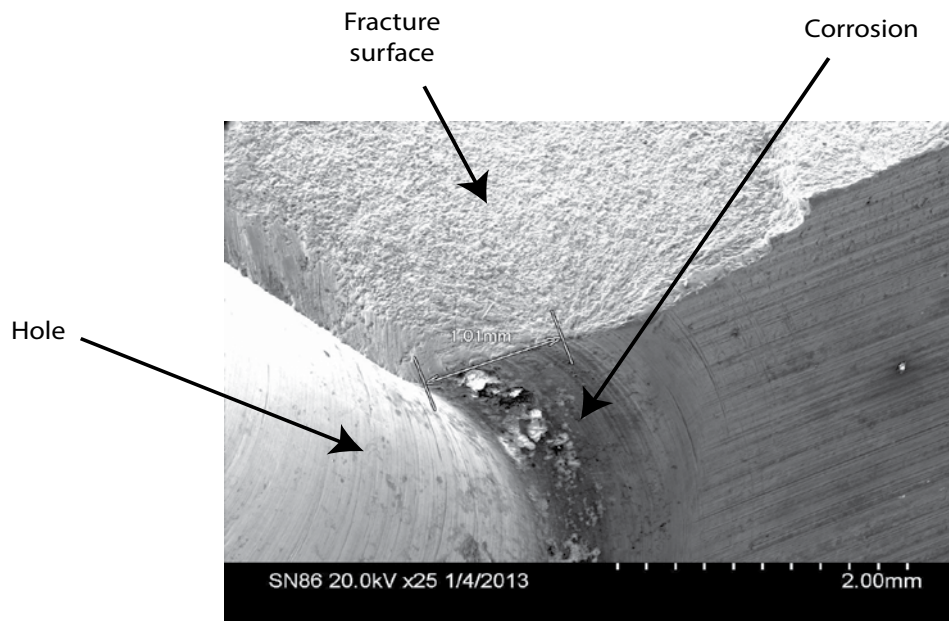
Figure 30

Corrosion similar to that seen on G-REDW was also found on the inner countersink of the 4.2 mm hole in the weld (Figure 30). There was no evidence of corrosion elsewhere on the shaft.

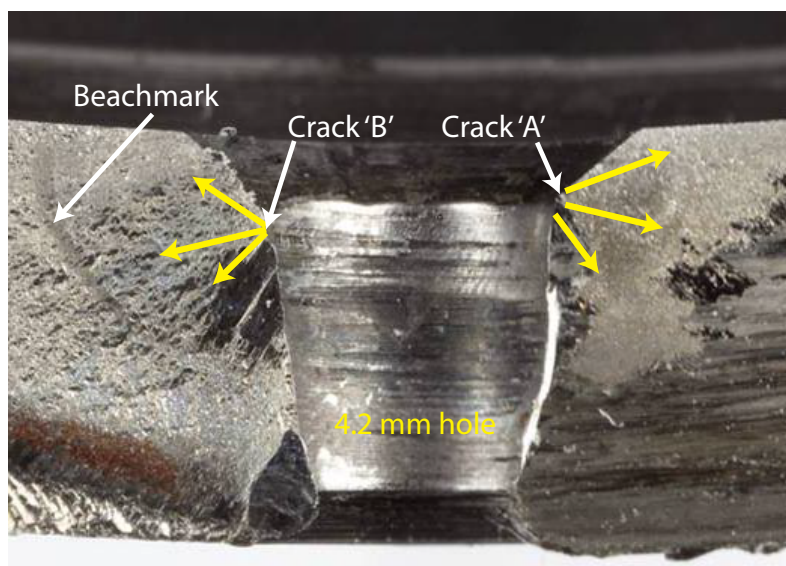
Figure 31

to the fusion line, on the inside of the shaft, up to a minimum of 61 mm and was observed to be in the parent material at a distance of 135 mm from the point of initiation. A second crack, Crack 'B', then initiated at a small defect in the internal surface of the hole. The propagation of Crack 'A' may have caused the initiation of Crack 'B' and the deviation of Crack 'A' into the HAZ may have been as a result of the propagation of Crack 'B'. Crack 'B' ran into a third crack identified as Crack 'C' (Figures 31 and 32).

Location of cracks 'A' and 'B' on G-REDW

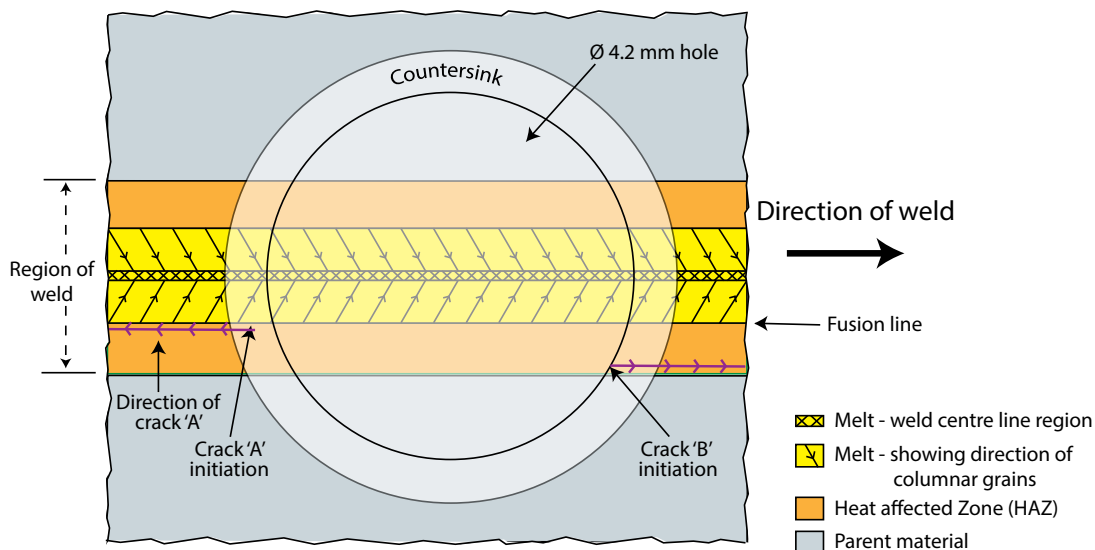
Crack A initially propagates close to the fusion line in the HAZ.

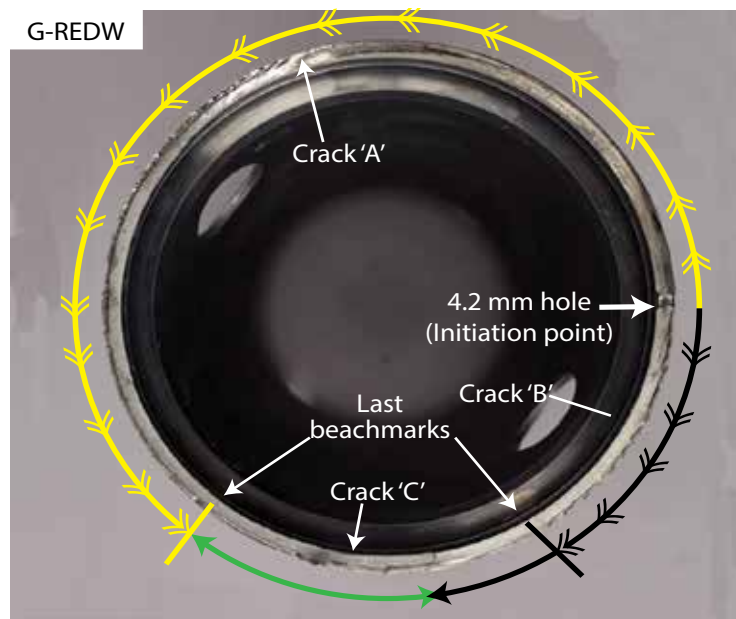
Figure 33

Crack 'A' extended around the circumference for approximately 250°, Crack 'B' extended in the opposite direction to crack 'A' along an arc of approximately 80° (Figure 33). Crack 'C', which showed no evidence of beachmarks, ran between Crack 'A' and 'B' along an arc of approximately 30°. The inner part of the fracture surface was flat and perpendicular to the axis and what appeared to be a 45° shear lip ran around the outer edge. Striations²⁹ were also detected, by the use of a SEM, on the fracture surfaces of Crack 'A' and 'B'.

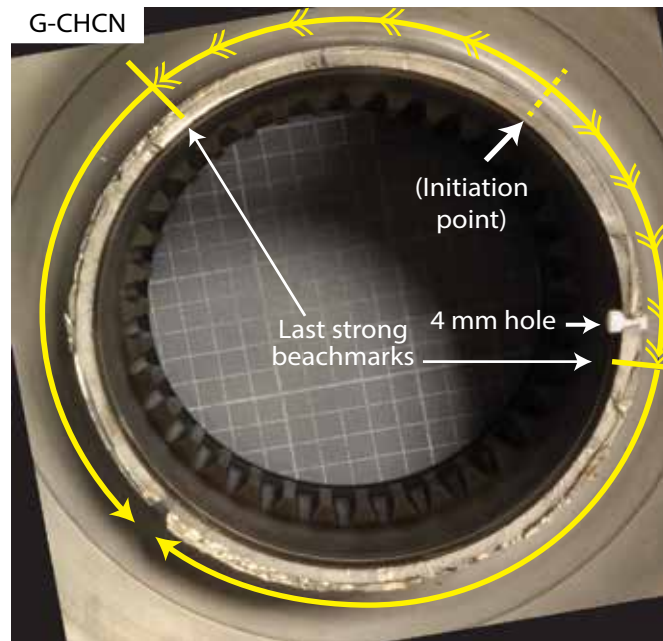
**Figure 34**

G-CHCN fracture surface

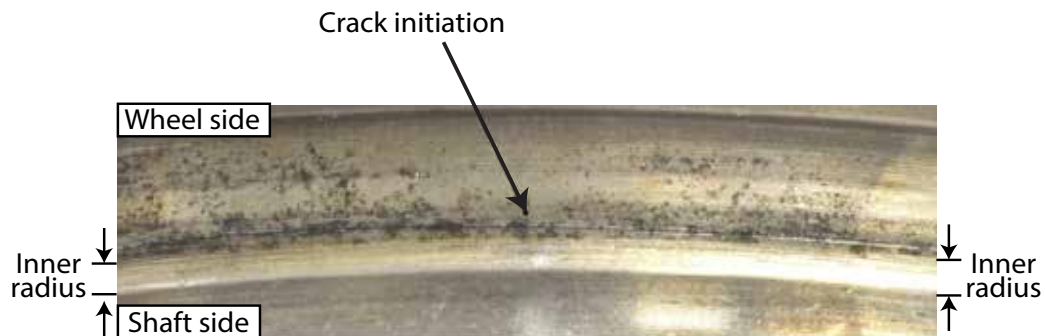
**Figure 36**

The machining marks on the inner flange of the shaft, in the area of the weld, appeared to be more pronounced than the marks left on other parts of the shaft. Additionally, there were numerous small tears in the surface consistent with a machine tool vibrating as it cut the metal during the manufacturing of the shaft. Localised pits of corrosion were also present in this area, particularly in the inner radius, and appeared to have developed in the crevices of the machining marks in this location (Figure 36).

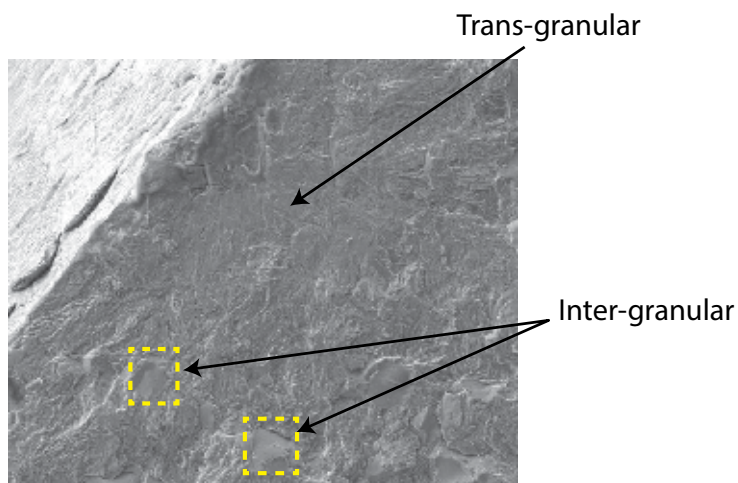
**Figure 37**

The fracture surfaces on the bevel gear vertical shafts fitted to G-REDW and G-CHCN displayed trans-granular fracture which is typical of high cycle fatigue. There was a small amount of inter-granular fracture on G-REDW, which may be associated with the weld; however, there was no evidence of inter-granular fracture on G-CHCN. There was no evidence of corrosion on any of the fracture surfaces.

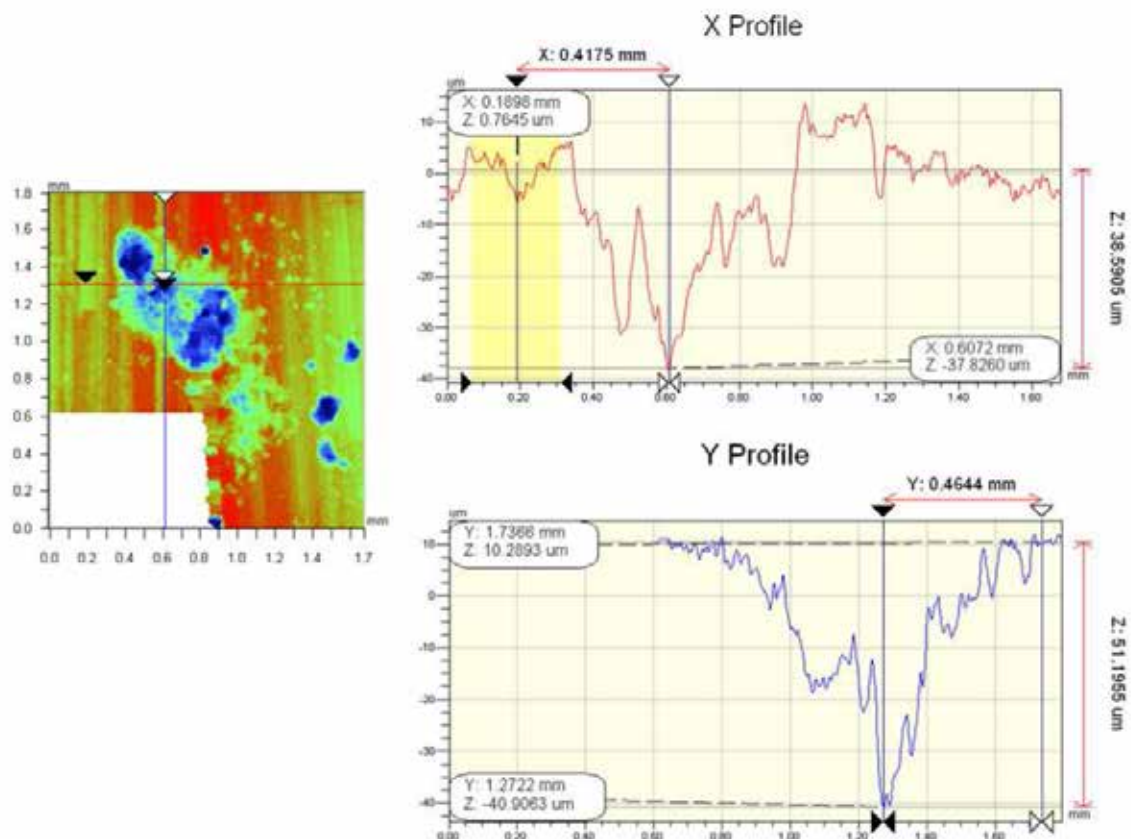
**Figure 38 (a)**

Profile of a corrosion pit on the shaft fitted to G-CHCN
(Note the scale of the horizontal and vertical axis is different)

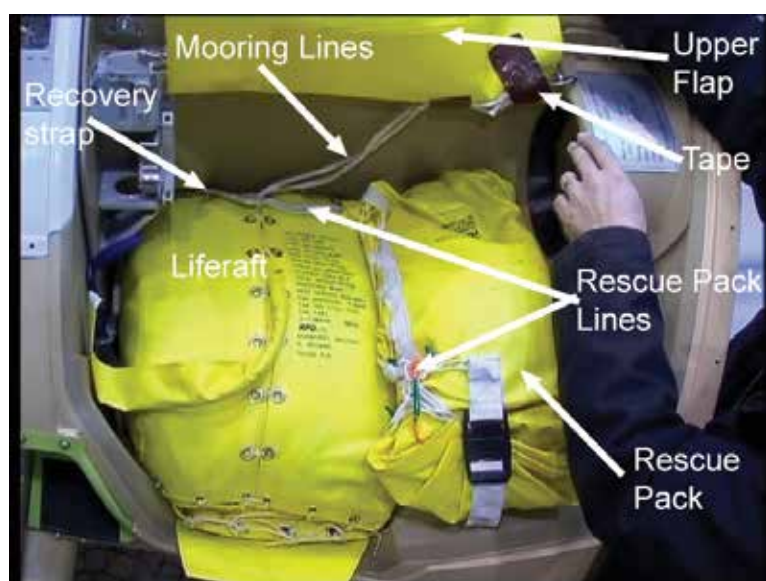
**Figure 41**

The EC225 LP aircraft maintenance manual (AMM) contains a procedure in workcard 25-66-01-061 (version 2012.06.14) for installing the liferaft, inflation bottle and rescue pack. The procedure calls for the liferaft to be installed first and then it states to '*Attach mooring lines (3) to spring-loaded hook (1) and bind them to upper flap (2) using Commercial Adhesive tape.*' These items are shown in Figure 3 of the procedure, reproduced in Figure 40 of this report. There is a spring-loaded hook secured to the end of the mooring lines and the intention of this instruction is for this hook to be attached to the bracket fixed to the sponson at position (1) in Figure 40. The figure does not show how to tape the mooring lines to the upper flap and the lines are shown to pass in front of the flap, when they should pass behind it as shown in Figure 41. This tape is removed after the inflation bottle is installed. The rescue pack is installed last. Figure 40 also shows the mooring lines (3) routing behind and below the liferaft which is different from the routing of the lines in an installation test carried out by the helicopter manufacturer (Figure 41).

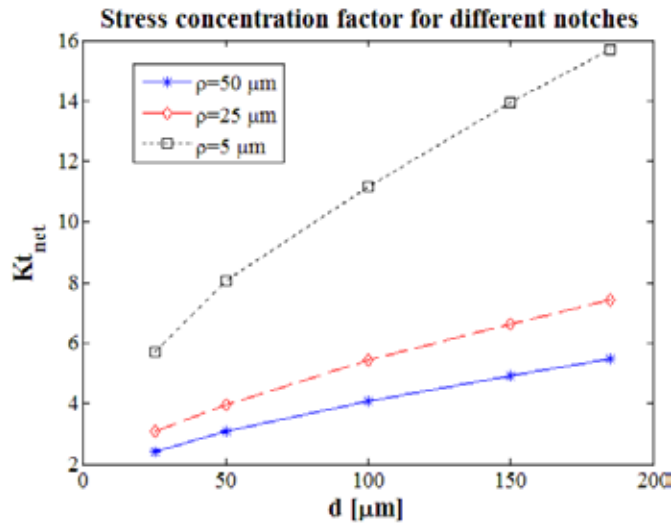
Figure 64

A similar corrosion pit, close to the initiation of the crack on G-REDW, had a depth of 44 μm and a tip radius of up to 5 μm .

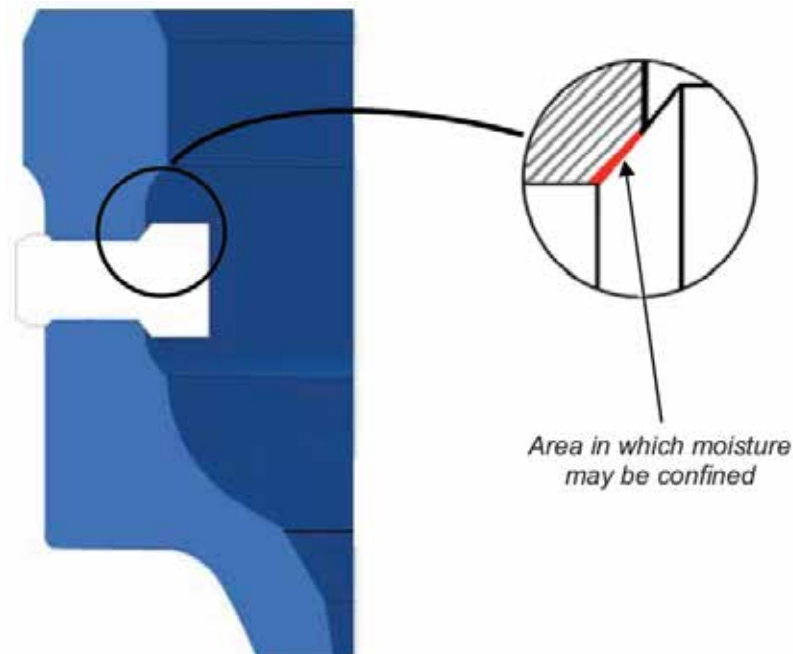
Figure 66

However, the geometry of the countersink, which was outside the design specification, should have allowed oil, during the normal operation of the gearbox, to flow into this gap and inhibited the corrosion mechanism. This gap would also have provided a path for other contaminants to enter this area in the countersink during normal operation of the gearbox.
