Loss of Control at Takeoff
Air Methods Corporation
Airbus Helicopters AS350 B3e, N390LG
Frisco, Colorado
July 3, 2015

NTSB/AAR-17/01
PB2017-101425

Aircraft Accident Report

Loss of Control at Takeoff

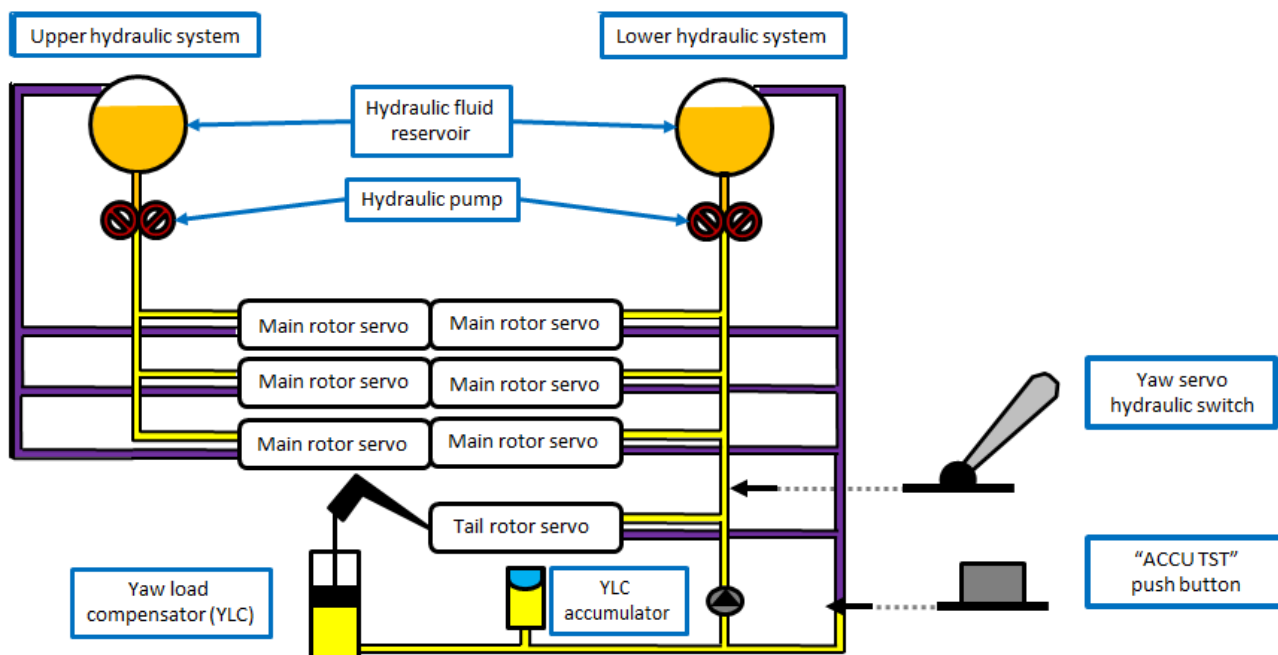
Figure 3. AS350 B3e dual hydraulic system.

As previously stated, the AS350 B3e is equipped with an upper and a lower hydraulic system.²³ The dual hydraulic setup provides hydraulic assistance redundancy to the main rotor servo controls in case one of the hydraulic systems were to fail.²⁴ The tail rotor servo control, yaw load compensator, and its accumulator are powered only by the lower hydraulic system. The yaw load compensator and its accumulator comprise a closed-loop system that would provide continuous hydraulic power assistance to the pedal controls in the event of a depressurization of the lower hydraulic system.²⁵ (The yaw load compensator is biased toward the right pedal because a right pedal input is needed to counteract the main rotor torque effect.) Figure 3 shows the hydraulic system configuration of the accident helicopter.

The hydraulic isolation electrovalve, installed on the transmission deck, provides a means to isolate the tail rotor hydraulic circuit from the lower hydraulic system in the event of a tail rotor servo control malfunction. Actuation of the hydraulic isolation electrovalve is controlled by a yaw servo hydraulic switch located on a control block installed at the forward end of the collective stick (see figure 4 in section 1.3.5.1). During normal operation, the hydraulic isolation electrovalve is in the open position, and the yaw servo hydraulic switch is on.

The yaw load compensator assembly contains an accumulator test electrovalve that allows hydraulic pressure to discharge from the yaw load compensator and accumulator when the “ACCU TST” push button, located on the cockpit center console, is depressed. Operating procedures for the AS350 B3e at the time of the accident indicated that the “ACCU TST” push button should be depressed during a ground check of the yaw load compensator accumulator (see section 1.3.5.1) or as part of emergency procedures for a tail rotor control failure. During normal operations, the accumulator test electrovalve is in the closed position, and the “ACCU TST” push button is raised.

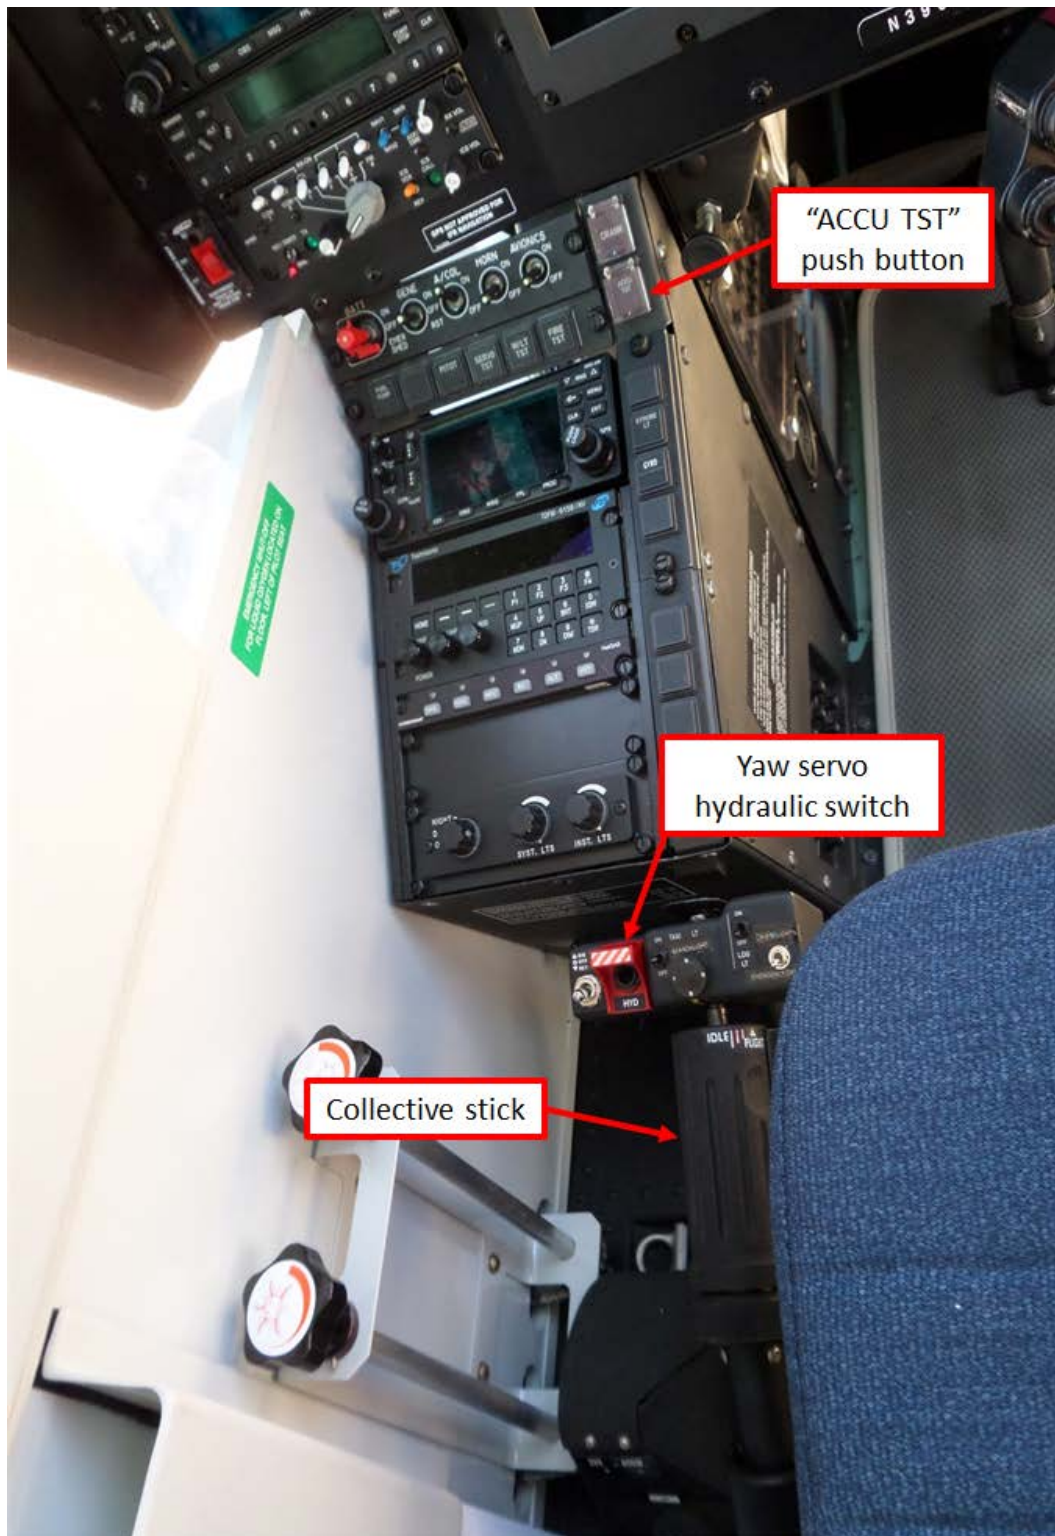
Figure 4. Yaw servo hydraulic switch and “ACCU TST” push button.

²⁹ The "HYD TEST" and "ACCU TST" push buttons, as noted in steps b and c of the procedure, perform the same function. For the AS350 B3e variant, the push button is labeled "ACCU TST."

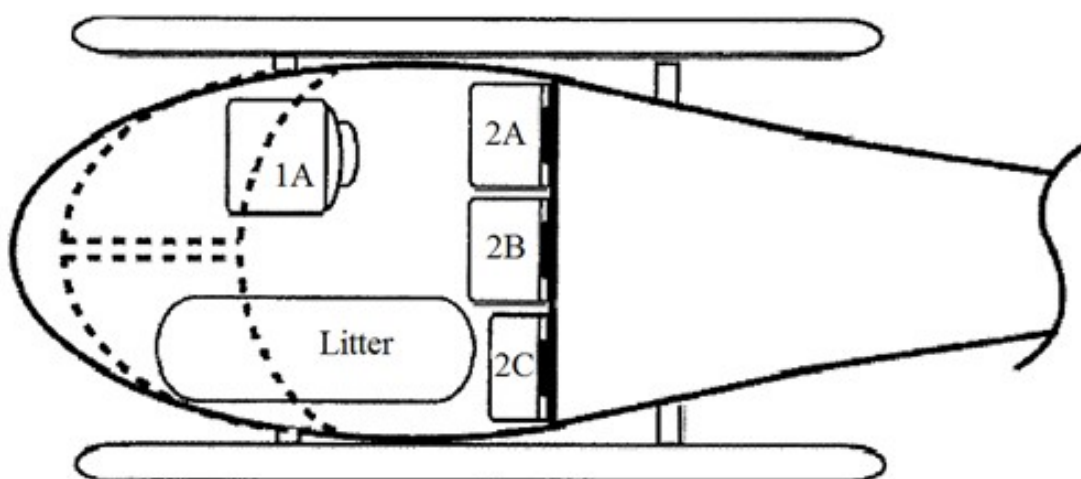
Figure 5. Occupant seating positions on N390LG.

The helicopter was equipped with four occupant seats and one patient litter, as shown in figure 5. The pilot's seat was located at the front of the cabin on the right side. The litter was adjacent to the pilot's seat on the left side of the helicopter next to an emergency exit door. The three forward-facing medical crewmember seats were mounted to the aft bulkhead.

Note: The pilot was in seat 1A, the flight nurse who sustained blunt force injuries only was in seat 2A, and the flight nurse who sustained blunt force and thermal injuries was in seat 2C.

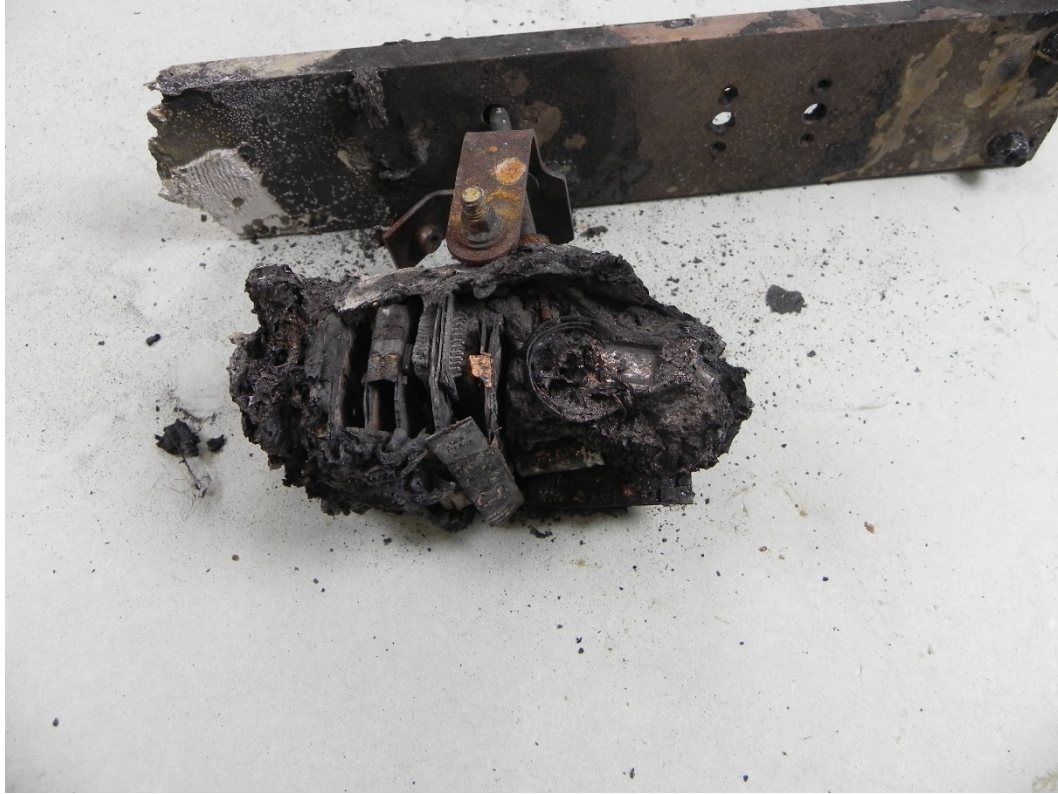
Figure 6a. Postaccident condition of onboard image recorder.

Postaccident examination of the helicopter's Appareo device showed that the device sustained extensive heat damage. Figure 6a shows the condition of the Appareo device upon arrival at the NTSB's vehicle recorders laboratory, and figure 6b shows an exemplar Appareo Vision 1000 onboard image recorder for comparison purposes. The SD memory card was removed from the Appareo device. The silicon memory device (internal to the SD card) was cracked and fractured throughout, so data recovery from the SD card was not possible. The Appareo device's internal NVM module was then removed, and the two NVM chips were removed from the internal memory device chassis. One chip (referred to as NVM chip 1) exhibited bubbling on, and cracking along, its plastic packaging surface. The other chip (referred to as NVM chip 2) exhibited heavy bubbling on its plastic packaging surface. The bubbling and cracking were indicative of high-temperature heat damage.

X-ray images of both NVM chips revealed a region of broken bond wires in the upper left portion of NVM chip 1 and no visible defects in NVM chip 2. A binary readout attempt of NVM chip 2 was performed but failed; an error message that is typically associated with failures due to internal damage to the chip was displayed. No further attempts were made to read out either NVM chip.
