# **AIRCRAFT ACCIDENT INVESTIGATION REPORT**

**CHINA AIRLINES  
B 1 8 6 1 6**

**Japan Transport Safety Board**

CHINA AIRLINES (TAIWAN)  
BOEING 737-800, B18616  
SPOT 41 AT NAHA AIRPORT  
AUGUST 20, 2007, AT ABOUT 10:33 JST

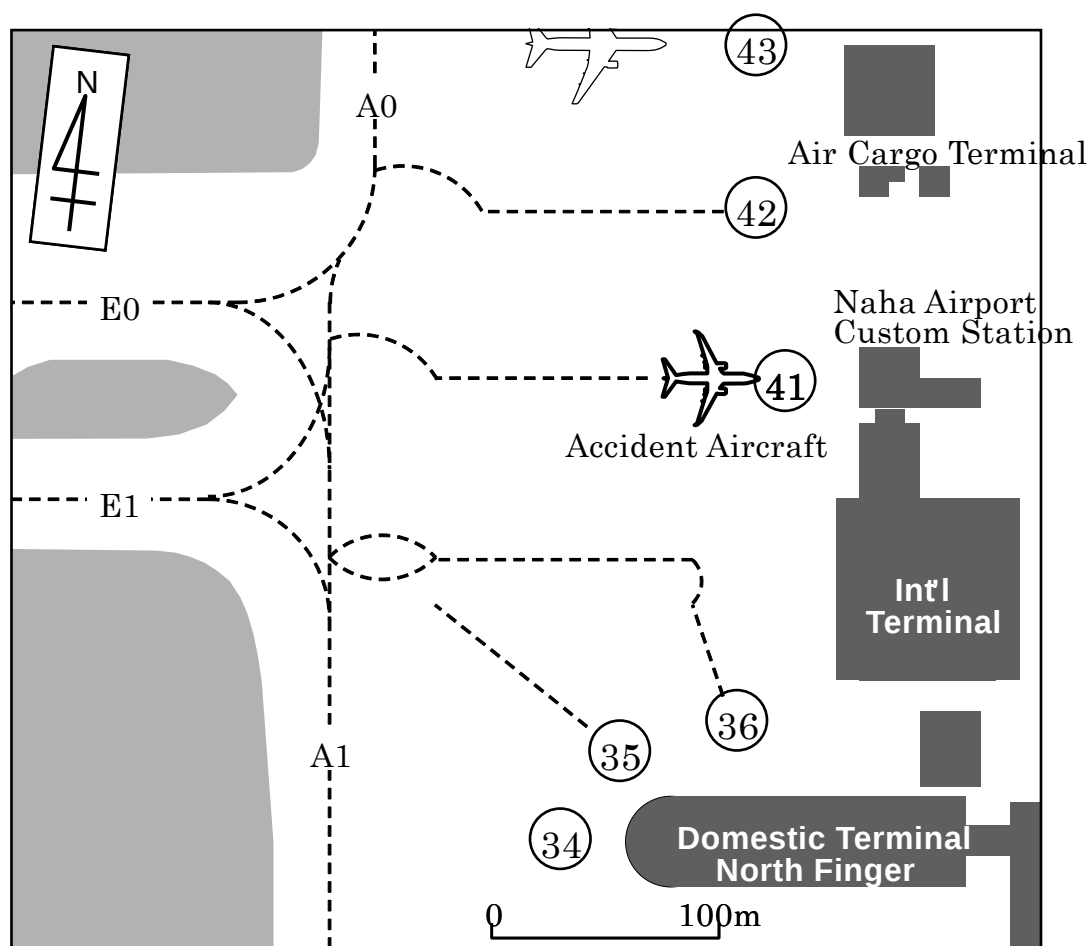
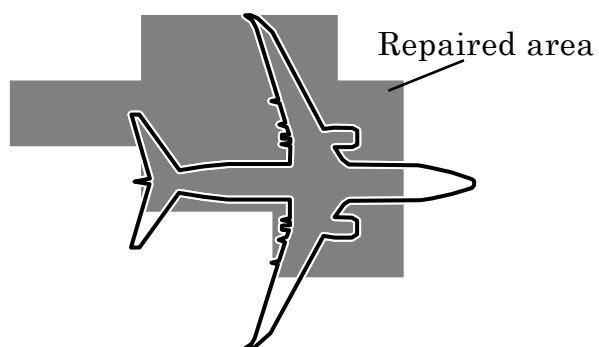
Figure 3      Parking Spot of the Aircraft and  
Damage to the Apron

The apron surface had numerous dents caused by broken pieces from the airframe bottom structure, which became detached from the airplane due to several explosions of the right- and left-wing fuel tanks and then hit the surface. Burning of the Aircraft also left a large pile of burnt residue on the apron. In the area between the right engine and the right wing joint to the fuselage, there were scattered pieces of cargo (fruit and fish), which had fallen out of the cargo compartment damaged by the fuel tank explosions.

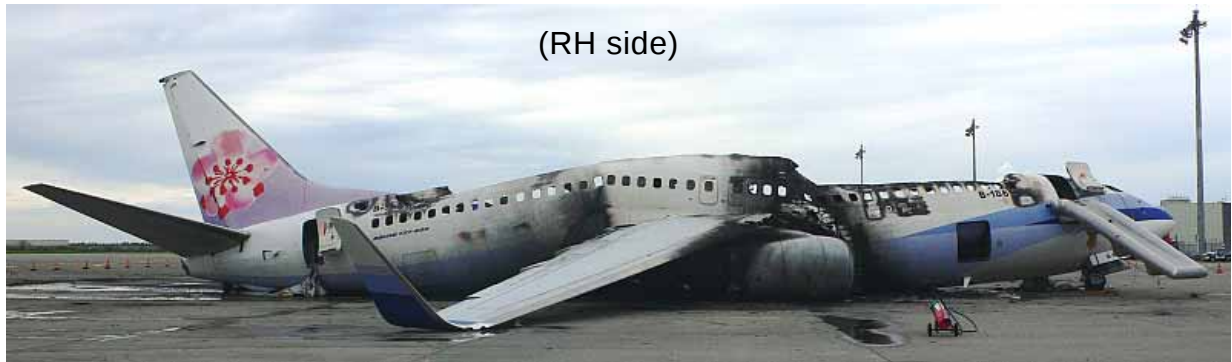
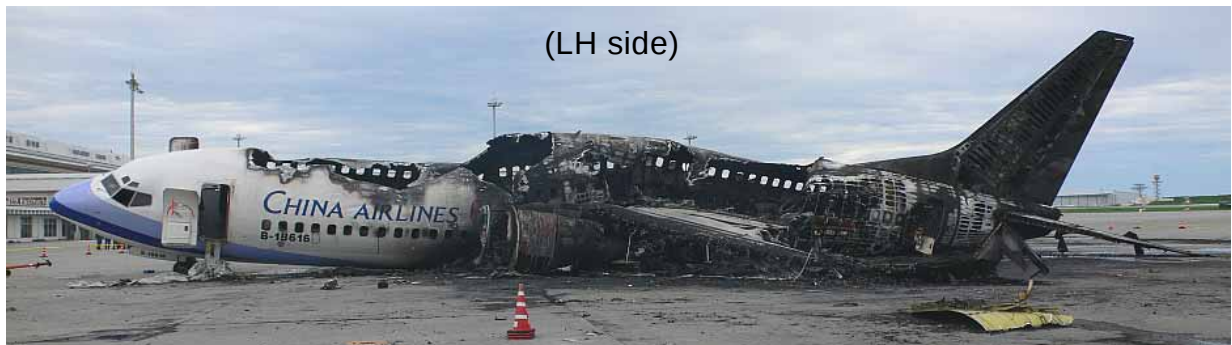
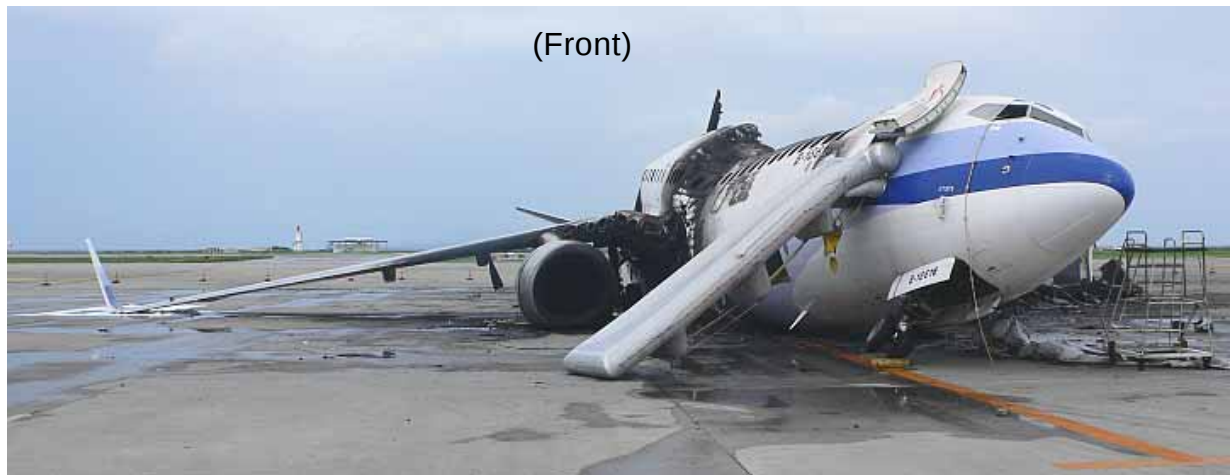
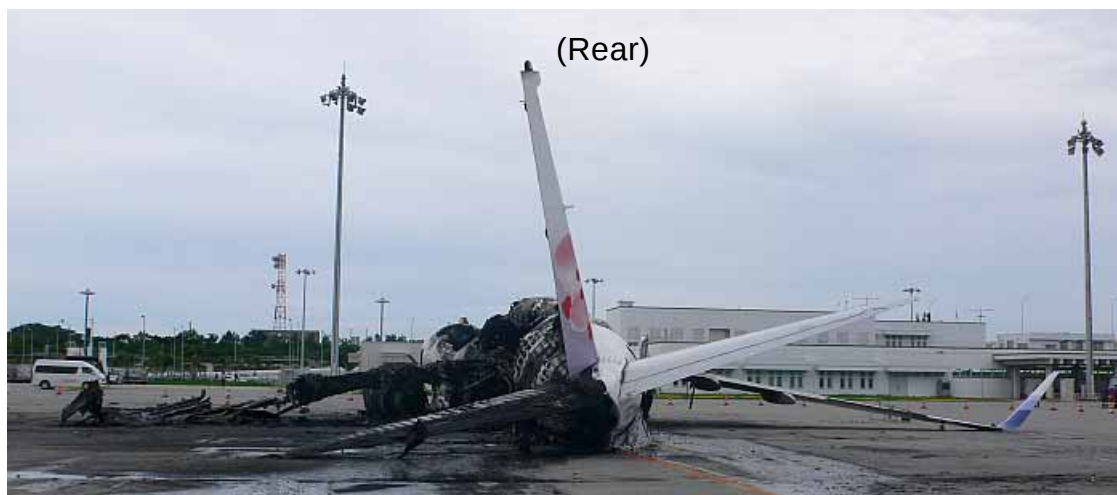
## Photograph 1 Accident Aircraft

- (1) Fuselage: The fuselage had broken off at the part immediately forward of the wing roots with the forward half largely tilted to the left and the bottom touching the

ground. The fuselage was longitudinally bent at the part immediately aft of the wing roots and its aft half lay tilted to the left with the tail touching the ground. The cockpit and nose landing gear were intact, but in the forward fuselage, the cabin interior was burned and the upper skin and floor in this area were consumed by fire. The lower fuselage near the wing roots was destroyed and burned by fire. The cabin interior in the aft half of the fuselage was entirely burned to the extent that there was no trace of the original shape, and the top and left-side skins as well as the floor in this section were lost in the fire. The aft galley remained intact.

- (2) Left wing: The left wing, which was almost entirely burned and had lost its original shape, lay over the engine resting on the ground. The wing portion between the engine and fuselage was destroyed by explosion of the fuel tank and the burnt main landing gear was tilted forward. The top skin of the wing between the fuselage and engine had been torn off and lay on the ground about 7 m to the left of the wing tip.

- (3) Right wing: The main landing gear was burned and stood upright, while both the engine and the wing tip were resting on the ground. The underside of the wing between the engine and fuselage was broken and burned due to the fuel tank explosion. The wing portion from the engine mounting area to the wing tip remained nearly intact.

- (4) Engines: The cowling of the No. 1 (left) engine was consumed by the fire and the engine itself was entirely burned. The leading edge of the air intake that was made of a different material from that of the other part of the cowling remained unconsumed. The fuselage-side cowling of the No. 2 (right) engine was consumed by the fire and the engine itself was partially burned at the fuselage-side and fan sections. The pylon was burned on the outside surface but the interior was neither burned nor broken.

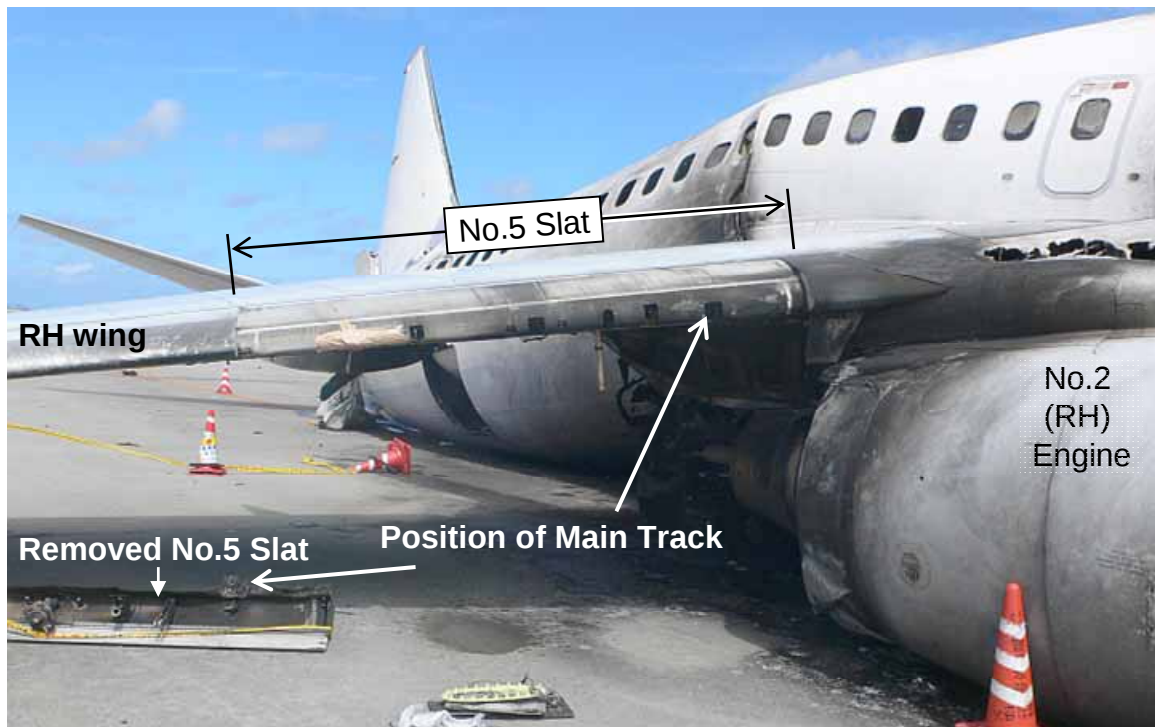
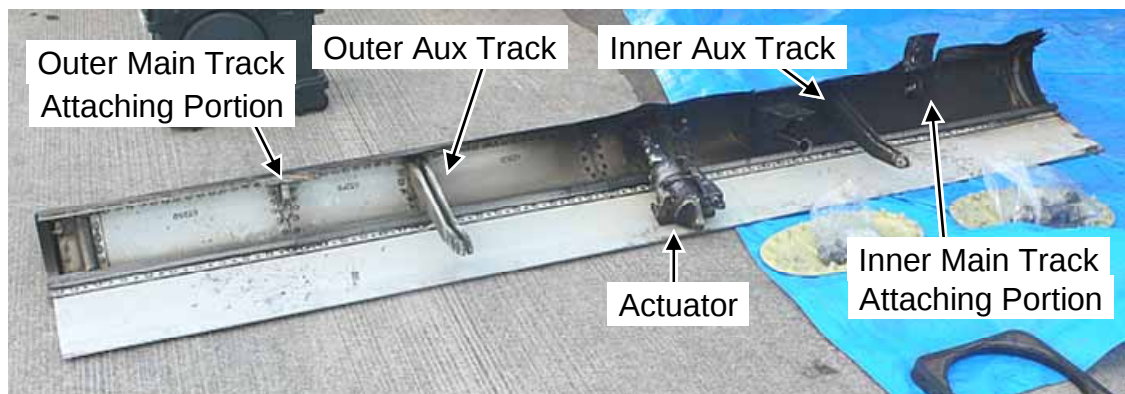
Photograph 2 No.5 Slat

Through the inspection conducted based on the eyewitness statements described in 2.1.4 and other information, indicating that fuel had been leaking from the right engine area and the wing leading edge near the engine immediately before the breakout of the fire, a puncture hole was found in a slat's track can on August 22, 2007, two days after the accident. The track can housed the inboard main track of the No. 5 slat on the right wing leading edge and protruded inside the fuel tank from the wing forward spar.

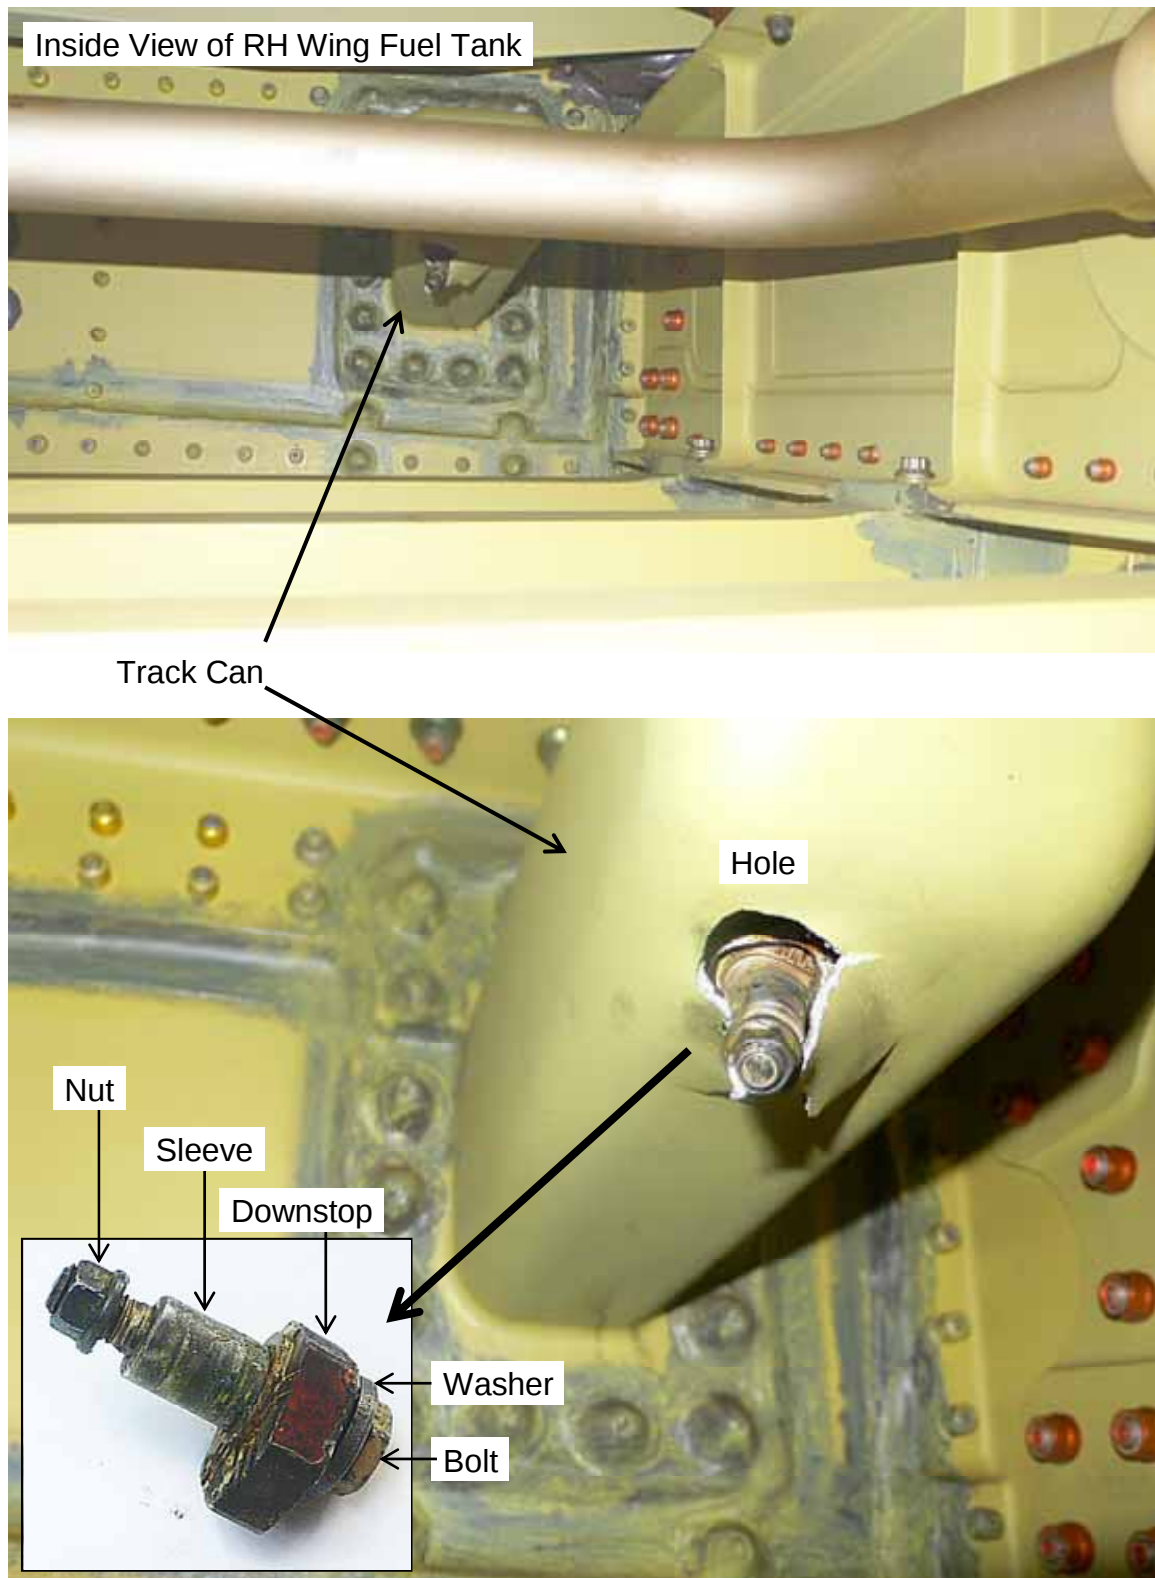
**Photograph 5      Damaged Inner Track Can of No.5 Slat**

- (a) The puncture hole was found on the bottom of the track can and extended from a point about 60 mm to a point about 100 mm, both from the aft end of the track can, showing signs of being pushed from inside.  
(The track can was made of aluminum alloy and measured 220 mm in length, 80 mm in height at the highest portion and 65 mm in width at the widest portion.)

- (b) The puncture hole including the cracks measured 41 mm in maximum length and 23 mm in maximum width.
- (c) A piece of hardware headed by a nut protruded through the puncture hole toward the inside of the fuel tank.

- (d) The inside of the track can was inspected using a borescope from the slat side. The inspection revealed that the hardware protruding toward the inside of the fuel tank was the downstop assembly consisting of a bolt, washer, downstop (on the bolt-head side), stop location, sleeve and nut. One flat of the bolt head was in contact with the bottom surface of the main track. One flat of the downstop (on the bolt-head side) was in contact with the inside surface of the track can. The downstop (on the nut side) was found lying inside the track can at a place close to the puncture hole but not in contact with the bottom surface of the main track.

The paint film on the inside surface around the puncture hole of the track can was found peeled off, and there were several traces of relatively deep damage in

that area that were located near the cracks that originated at two points. The fragment that had fallen off during the on-site investigation also had abrasion marks with missing paint, as well as an impression indicating that it would have received strong pressure from something.

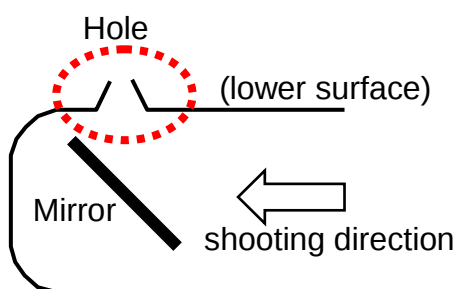
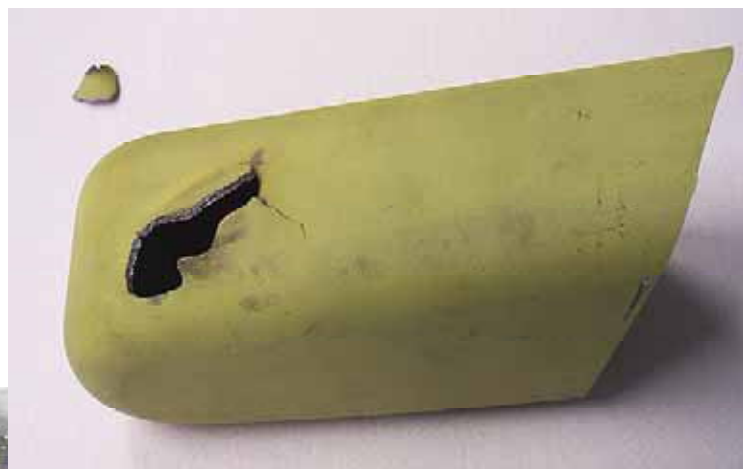
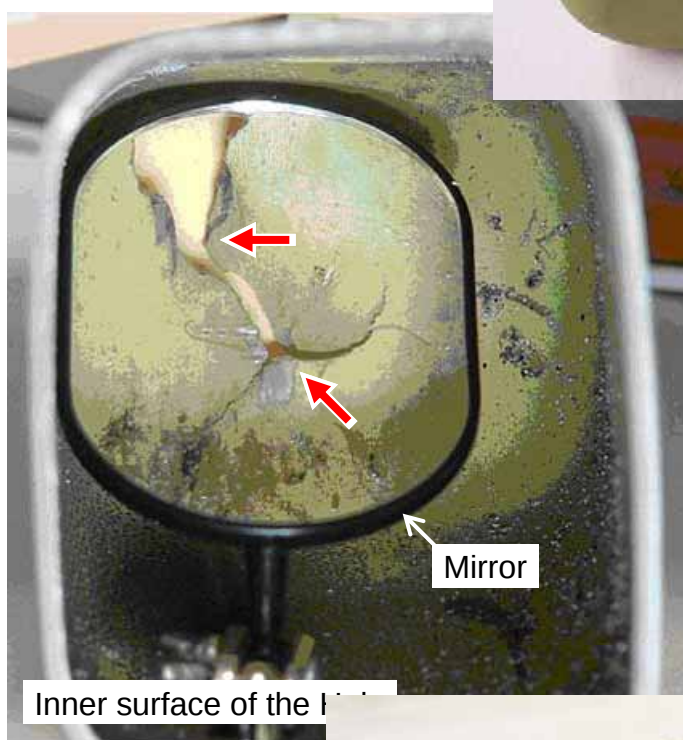
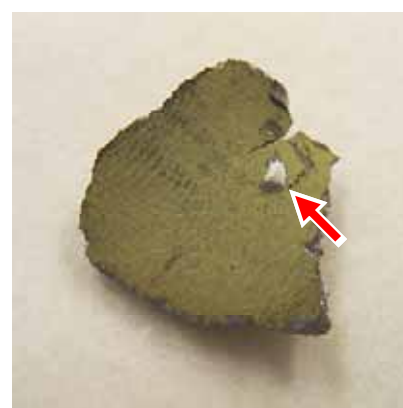
Photograph 7    Track Can and Main Track

During recovery of the downstop assembly, which had been protruding from the track can, and the downstop, which had been lying inside the track can, the stop location came off the bolt and fell inside the track can and a loose piece of the track can near the puncture hole became detached from the track can.
