Aviation Investigation Preliminary Report

Location:	Freeland, WA	Accident Number:	DCA22MA193
Date & Time:	September 4, 2022, 15:09 Local	Registration:	N725TH
Aircraft:	DEHAVILLAND DHC-3	Injuries:	10 Fatal
Flight Conducted Under:	Part 135: Air taxi & commuter - Scheduled

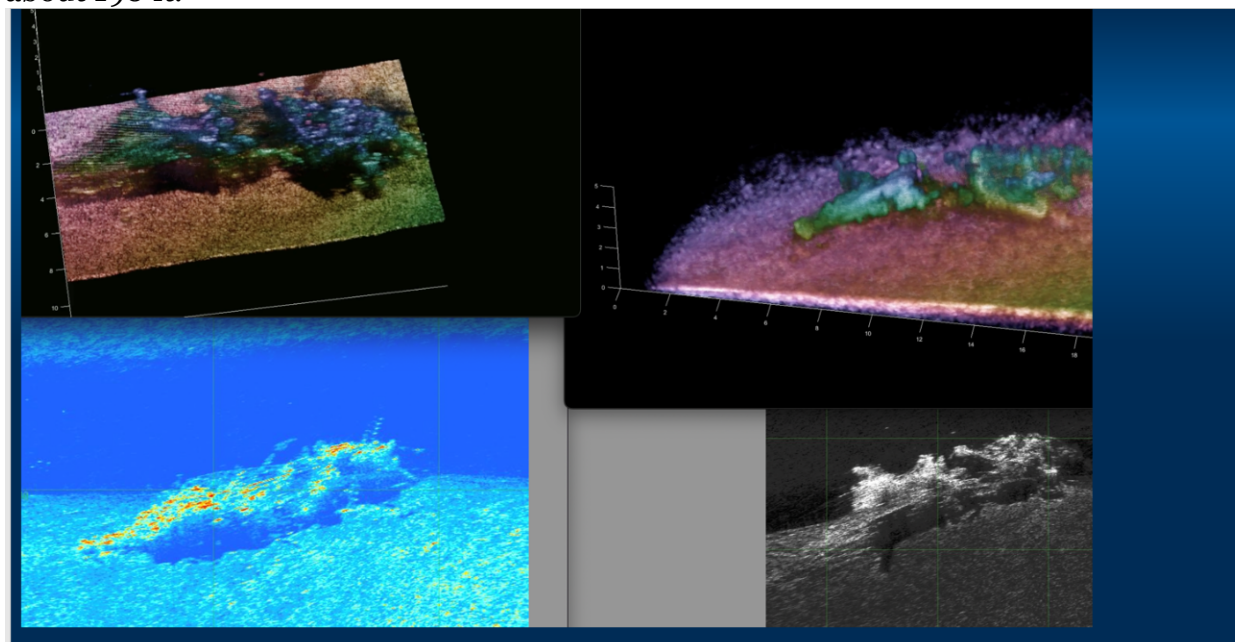
A sonar survey of the accident area located the main wreckage and debris field at a depth of about 190 ft.

Figure 3: Images from University of Washington Applied Physics Lab Multi-Sensor Towbody (MuST) – including 3D processed data of main wreckage
