# National Transportation Safety Board (

## Aviation Accident Final Report (

<b>Location:</b>	Daytona Beach, Florida	<b>Accident Number:</b>	ERA18FA120
<b>Date &amp; Time:</b>	April 4, 2018, 09:53 Local	<b>Registration:</b>	N106ER
<b>Aircraft:</b>	Piper PA28R	<b>Aircraft Damage:</b>	Destroyed
<b>Defining Event:</b>	Aircraft structural failure	<b>Injuries:</b>	2 Fatal
<b>Flight Conducted Under:</b>	Part 91: General aviation - Instructional

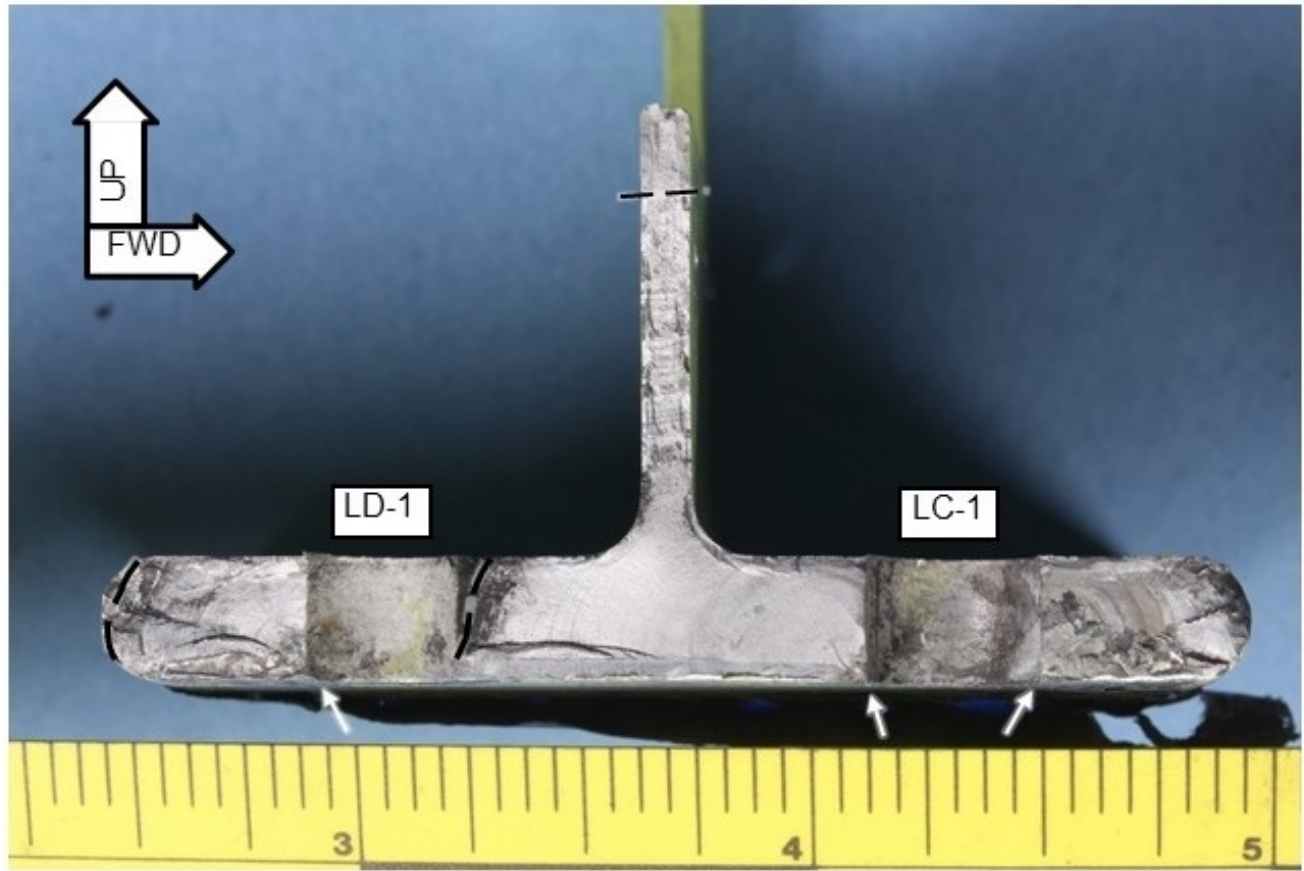
Metallurgical examination of the accident airplane's left-wing main spar lower cap found that it exhibited fracture features consistent with fatigue through more than 90% of the cross-section, reducing its residual strength capabilities almost completely. The examination identified three fatigue cracks in the left-wing main spar lower cap (see figure 1). One fatigue crack initiated near the lower forward corner of the outboard forward wing attachment bolt hole (designated as bolt hole LC-1) and propagated forward to the forward edge of the cap. A second fatigue crack initiated near the lower aft corner of bolt hole LC-1 and propagated aft toward the lower aft wing attachment bolt hole (designated as bolt hole LD-1) and up the cap web almost to the edges. A third fatigue crack initiated near the lower aft corner of bolt hole LD-1 and propagated aft almost to the aft edge of the cap. Fatigue cracks also originated in the forward and aft doublers from both sides of the bolt holes (see figure 2).

Figure 1. Close view of the fracture surfaces in the left-wing main spar lower cap. Unlabeled arrows indicate fatigue origin areas and dashed lines indicate approximate fatigue boundaries

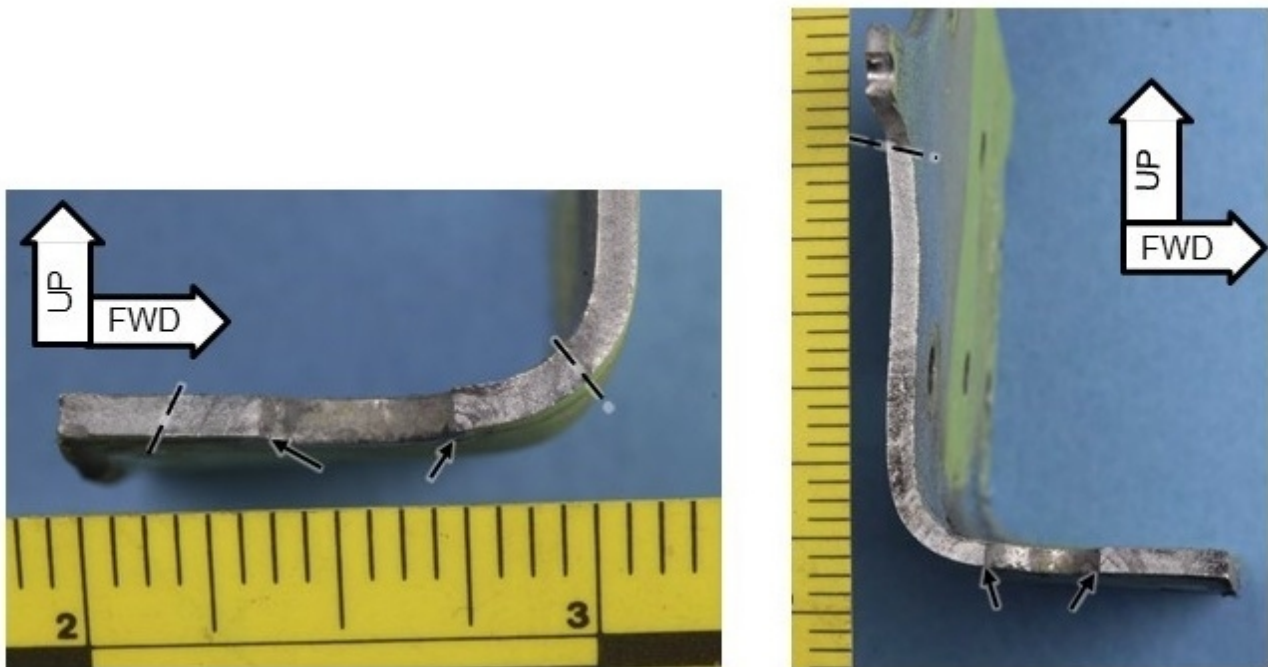
Figure 2. Close views of the fracture surfaces in the aft (left) and forward (right) doublers. Unlabeled arrows indicate fatigue origin areas and dashed lines indicate approximate fatigue boundaries

In the doublers, fatigue origins were noted on the lower sides of the doublers both forward and aft of the attachment holes. The fatigue region in the forward doubler was larger than in the aft doubler, extending to the forward edge of the doubler and upward about 1.25 inches from the aft side of the hole. In the aft doubler, the fatigue regions extended from each side of the hole to where they were about 0.88 inch apart.

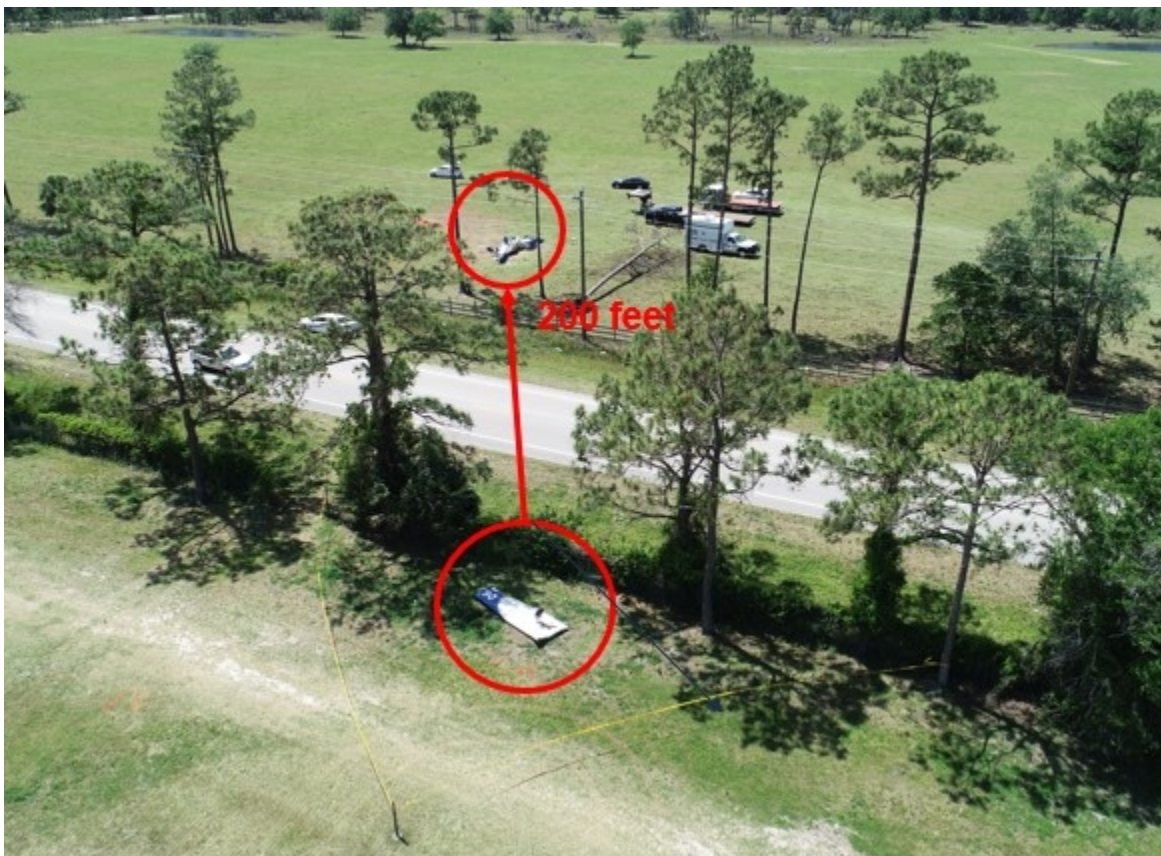
The debris path was about 570 ft long and began about 2 sm southwest of the departure end of runway 25L. The first items discovered along the debris path were a rubber wing root seal and fractured window plexiglass; the left wing was discovered 270 ft farther southwest adjacent to a road and tree line. About 200 ft from the wing on a magnetic heading of about 230°, the main wreckage rested in an adjacent field on the opposite side of the road (see figure 2).

Figure 2. Photograph (looking toward the southwest) showing the separated left wing in foreground and main wreckage in background #

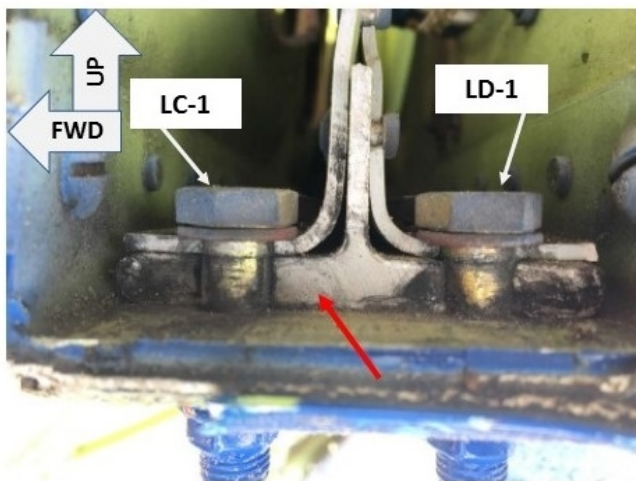
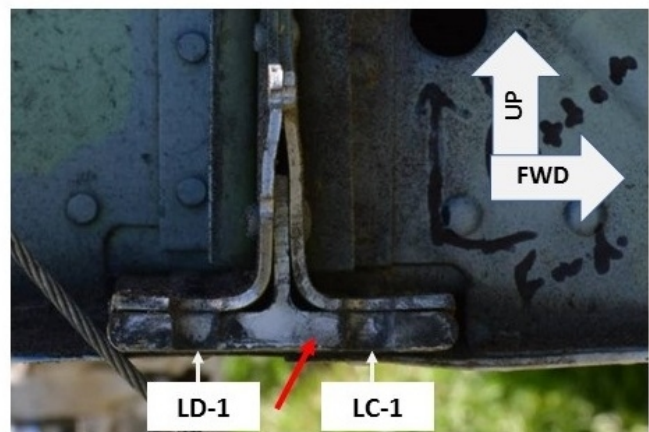
On-scene visual examination of the left-wing main spar found indications of a significant fatigue crack. Further analysis at the NTSB's Materials Laboratory found that more than 90% of the main spar lower cap and portions of the forward and aft spar web doublers exhibited fracture features consistent with metal fatigue (see figure 3). The remainder of the main spar lower cap, spar web doublers, and upper spar cap displayed fracture features consistent with overstress fracture. The fatigue features originated at or near the outboard forward wing main spar attachment bolt holes LC-1 and LD-1.

Figure 3. Left-wing main spar lower cap inboard side of the fracture (left frame) and outboard side of the fracture (right frame) with red arrows highlighting areas visually inspected on scene that showed fatigue regions

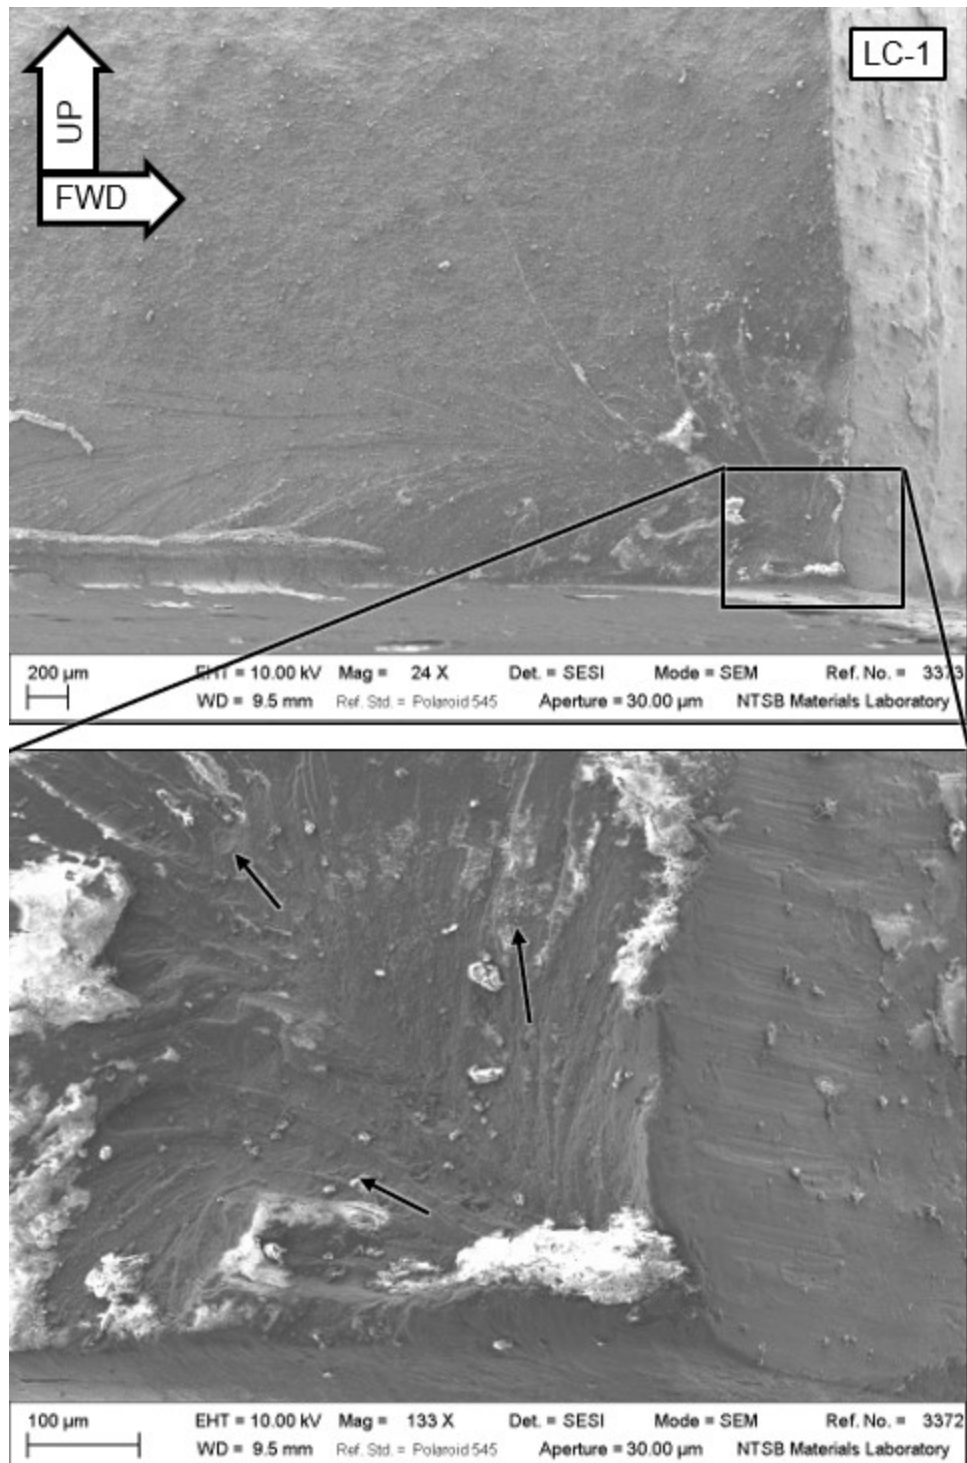
The left-wing main spar lower cap was examined using a scanning electron microscope (SEM). SEM images of the origin areas at the forward and aft sides of attachment bolt hole LC-1 are shown in figure 5. Arrows indicate local directions of fatigue crack propagation based on available fracture features in the images. Fracture features appeared to emanate from origins at the lower surface of the spar cap adjacent to attachment bolt hole LC-1.

Figure 5. SEM images of fracture features at the aft side of hole LC-1 with a view of the origin area shown at higher magnification (lower image). Unlabeled arrows indicate local directions of fatigue crack propagation
