Aviation Investigation Final Report

Location:	Iliamna, Alaska	Accident Number:	ANC15FA071
Date & Time:	September 15, 2015, 06:06 Local	Registration:	N928RK
Aircraft:	DEHAVILLAND DHC 3T	Aircraft Damage:	Substantial
Defining Event:	Loss of control in flight	Injuries:	3 Fatal, 5 Serious, 2 Minor
Flight Conducted Under:	Part 91: General aviation - Other work use

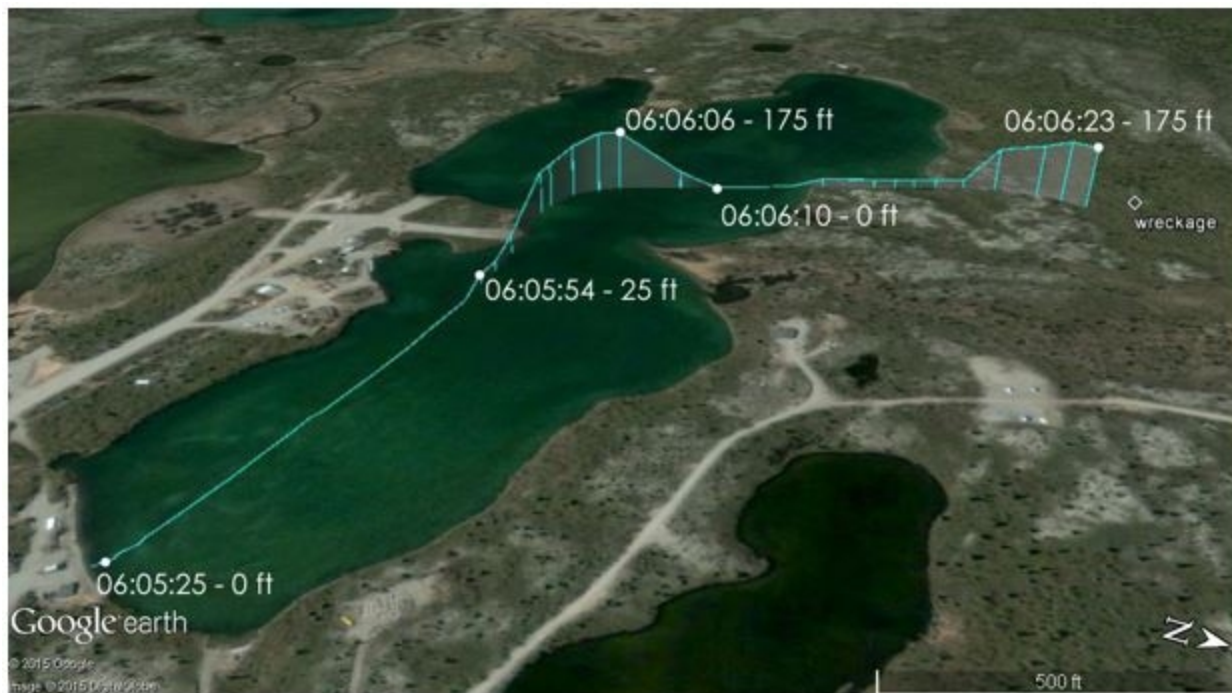
Figure 1. Airplane's flightpath from ADS-B data.

Data from the accident airplane's ADS-B, as shown in figure 1, show the airplane's flightpath. Airspeeds were calculated using the ADS-B position data and the reported wind information. Airplane orientation was calculated from these data and a basic aerodynamic model of the airplane. Calculations made from ADS-B and weather data are subject to uncertainty; therefore, airspeeds and attitude values should not be considered exact.

During the initial climb, the airplane remained below the recommended airspeed per the Texas Turbine Conversions, Inc., AFM. The data show the airplane initially gaining altitude at 0605:54 and reaching 56 mph, as recommended in the AFM. After the initial climb with a 10° bank angle, the airplane made a descending right turn at 57 mph and lost 175 ft of altitude, which placed the airplane at or near the water's surface. Subsequently, the airplane began regaining altitude with a 30° bank angle, and then it made another right turn at less than 57 mph. The airplane's stall speed is 57 mph at a 0° bank angle, 59 mph at a 20° bank angle, and 65 mph at a 40° bank angle.
