Aviation Investigation Report AIR-23-01

# Abrupt Loss of Pitch Control and Water Impact West Isle Air dba Friday Harbor Seaplanes de Havilland DHC-3, N725TH

Mutiny Bay, Washington  
September 4, 2022

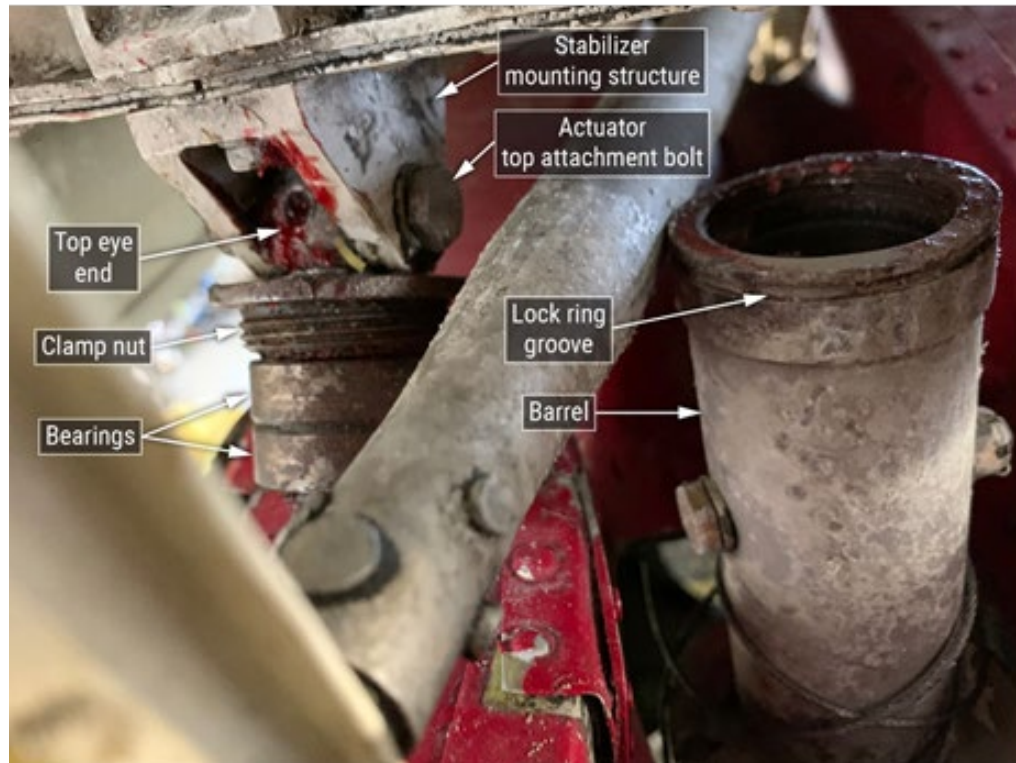
The horizontal stabilizer trim actuator's top eye end and bearing assembly clamp nut were found unscrewed from the actuator's upper housing with no obvious damage to the threads. The top eye end and bearing assembly remained connected to the horizontal stabilizer mounting bracket by the upper actuator attachment bolt (see figure 7) and could pivot freely about this bolt. The clamp nut could spin about

the top eye end. The lower actuator housing could rotate freely fore-aft about the lower attachment bolt.

**Figure 7.** Photograph of the clamp nut and barrel separation on the accident airplane.

When the barrel assembly was rotated full forward about the lower attachment bolt, the barrel contacted structure (which was bent inward and downward in this location). The lower center skin of the horizontal stabilizer was punched through at a 90° angle directly above the actuator when it was in the full-forward position. The punch-through was round and left a circular grease imprint on the contact surface that was consistent with the top of the actuator barrel assembly without the top eye end and bearing assembly present. The lock ring was not present in the lock ring groove of the upper barrel assembly. The through-hole in the lock ring groove was mostly clean, and light could be seen through it. The area below the actuator, as well as inside the horizontal stabilizer in the area of the punch-through, was searched for the lock ring both visually and with a magnet, but the lock ring was not found.<sup>19</sup>

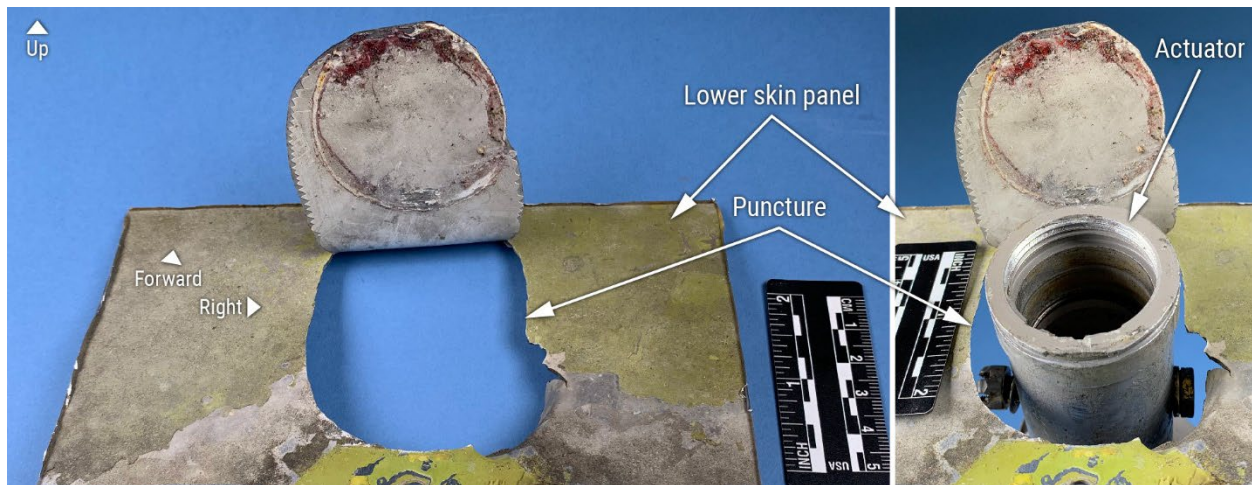
A lower skin panel from the horizontal stabilizer was examined at the NTSB Materials Laboratory. The panel contained a puncture with the ruptured flap portion that was deformed upward. The bottom face of the punctured skin exhibited a deformed curved pattern that was consistent with the shape and size of the horizontal actuator barrel outer diameter when the top eye end and bearing assembly was not present (see figure 11). The bottom surface of the flap was covered with translucent red grease (around and within the impression mark).

**Figure 11.** Photographs of the lower skin panel for the horizontal stabilizer.

Note: The left side of the image shows the puncture, and the right side of the image shows the barrel portion of the horizontal stabilizer trim actuator inserted into the open end of the puncture.

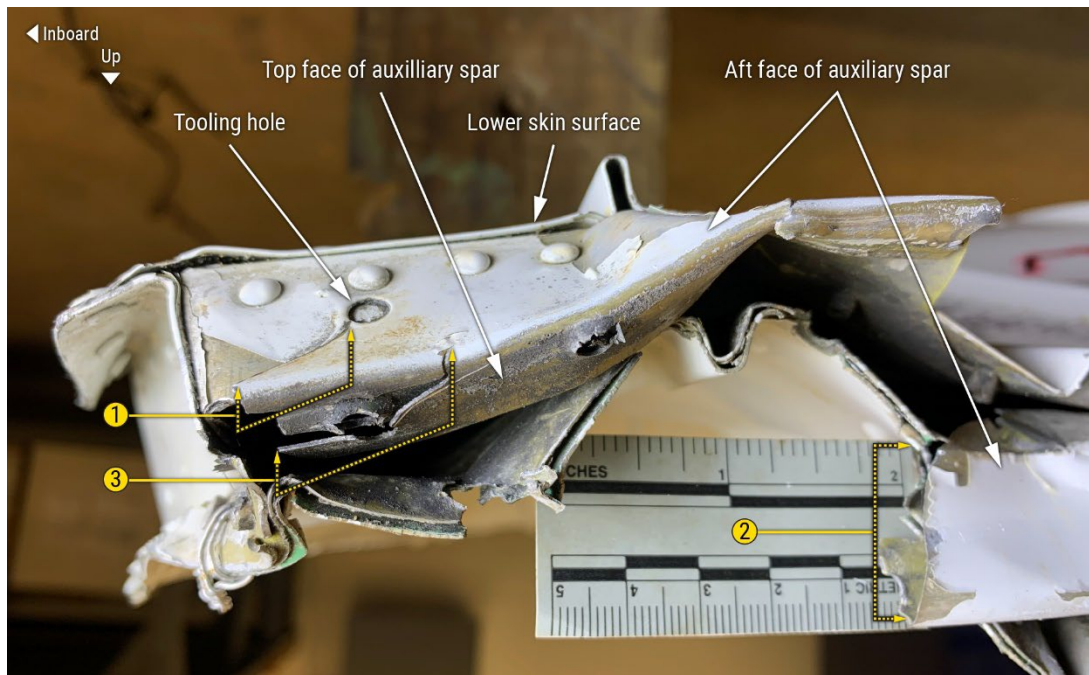
Examination of the left elevator assembly revealed the inboard end of the auxiliary spar contained three cracks (arbitrarily referred to as cracks "1", "2", and "3") (see figure 12). Cracks "1" and "3" were located in the same area that contained a

2-inch-long repair doubler (installed at the inboard end on the forward face of the auxiliary spar).<sup>31</sup>

**Figure 12.** Photograph of the auxiliary spar for the left elevator, after the tab was removed, showing cracks "1", "2" and "3" (view looking forward).

The cracks were examined by bench binocular microscope and scanning electron microscope. Cracks "1" and "3" revealed fracture features consistent with fatigue cracking, and crack "2" revealed evidence of overstress separation with no evidence of fatigue cracking. The repair doubler was intact, and no cracking was noted on it. The outboard end of the auxiliary spar was disassembled (de-riveted) from the left elevator to expose all surfaces of the auxiliary spar. The remaining portion of the auxiliary spar contained no evidence of cracks.
