SERVICE BULLETIN

TBM AIRCRAFT

SB 70-226

SUBJECT : GAS CONTROLLER UPGRADE

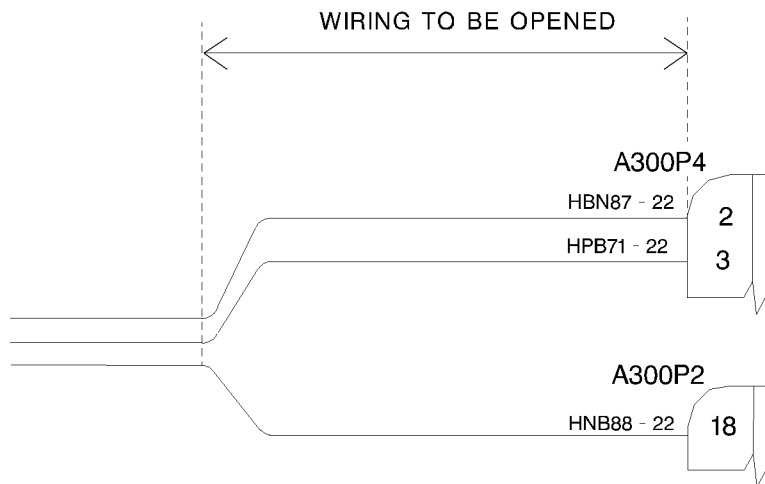
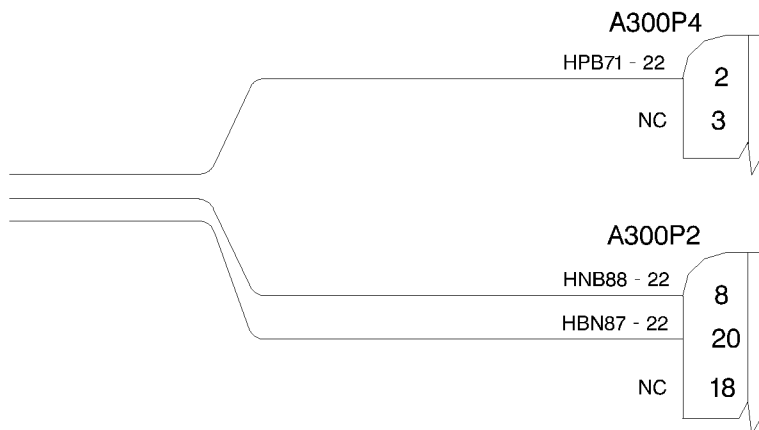
Figure 2 – S/N 687 to 1097 – A300 Calculator wiring modification

- 2) Open A300–P2 and P4 connectors.
- 3) In accordance with Figure 2, cut the sheath and open A300–P2 and P4 wirings.
- 4) From the wiring harness, retain the wire(s) removed from the connector, then remove heat-shrinkable sleeve used to isolate the contact.

- HPB71-22 into stud 2,
- HNB88-22 into stud 8,
- HBN87-22 into stud 20.

5) Using insertion/extraction tool, remove and relocate as follows :

6) Recondition the wiring harness with tie-wraps.

7) Close A300-P2 and P4 connectors.
