Midair Collision Over Hudson River  
Piper PA-32R-300, N71MC  
and Eurocopter AS350BA, N401LH  
Near Hoboken, New Jersey  
August 8, 2009

**Aircraft Accident Summary Report**

NTSB/AAR-10/05  
PB2010-910405

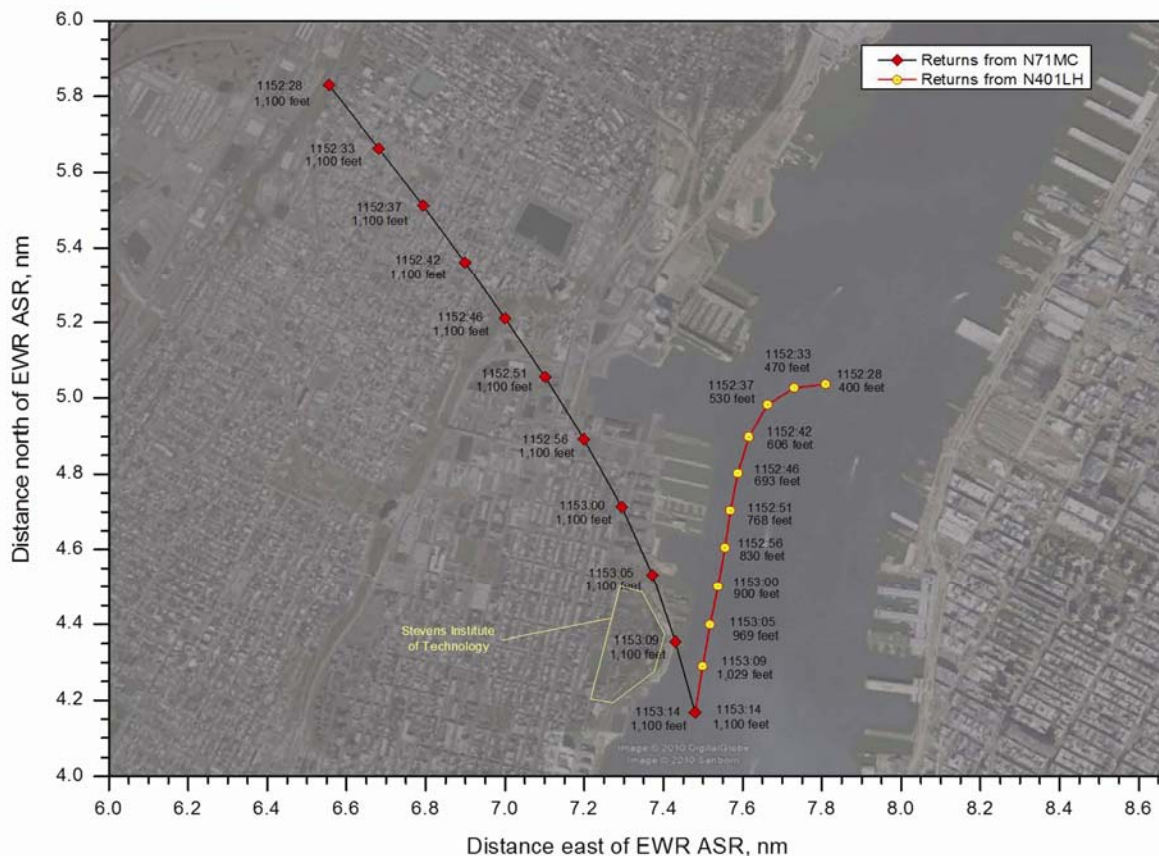
**Figure 1.** Accident aircraft ground tracks.

calculate the position and orientation of each aircraft in the minutes preceding the accident.<sup>22</sup> Figure 1 shows the ground tracks of the accident aircraft and the collision location over a Google Earth™ image of the Hudson River Class B exclusion area along with each aircraft's mode C-reported altitudes at each data point. This information was used to estimate the approximate location of each aircraft during the same time as viewed from the other aircraft's windscreen and the traffic information that could have been presented on the navigation display in each aircraft, as discussed in section 2.2. Figure 2 shows the Class B exclusion area in relation to the surrounding Class B airspace. The accident aircraft ground tracks just before the collision are also depicted.

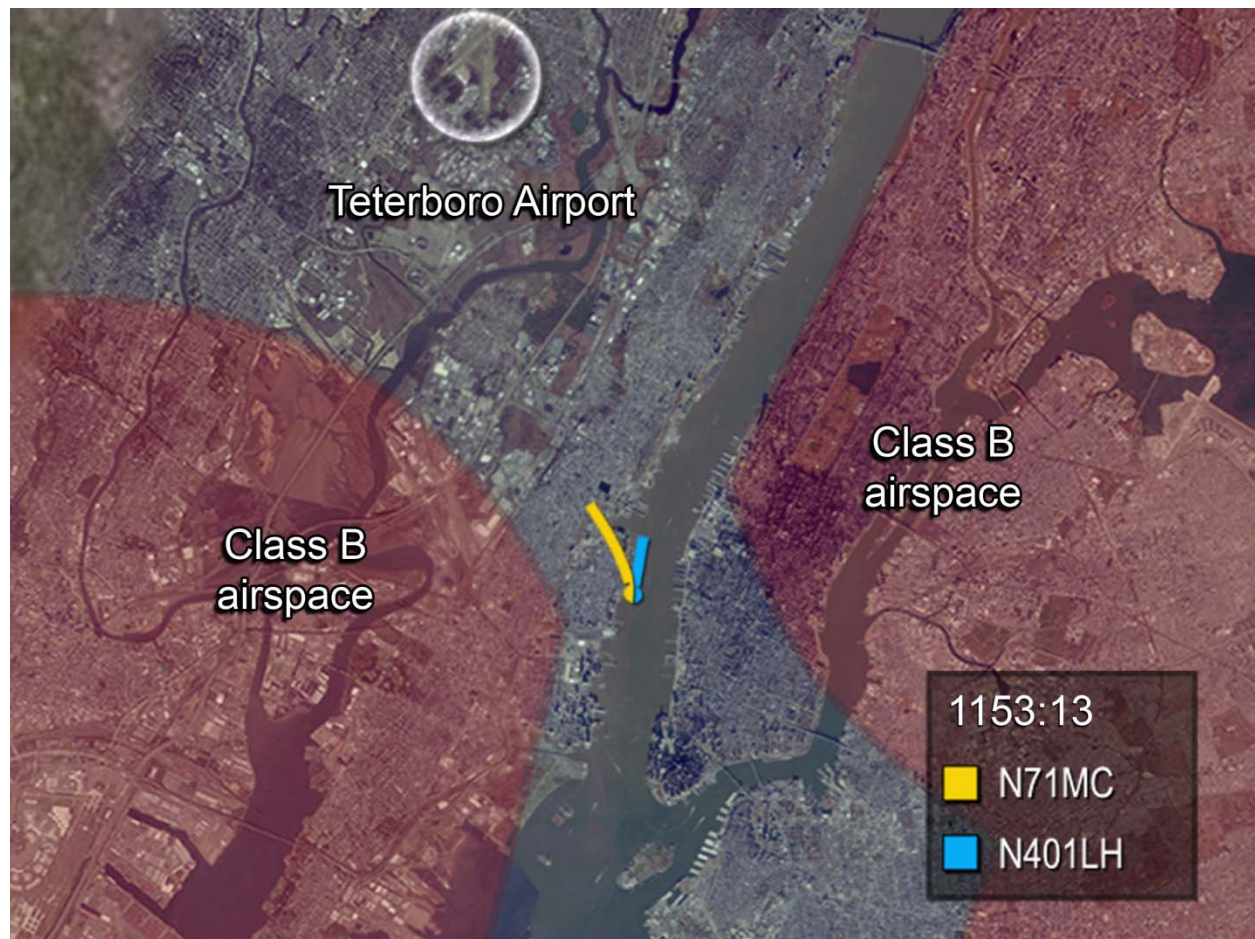
**Figure 2.** Hudson River Class B exclusion area.

Note: The Class B airspace over EWR, shown on the left, extends from 500 to 7,000 feet. The Class B airspace over LaGuardia Airport, shown on the right, extends from the surface to 7,000 feet.

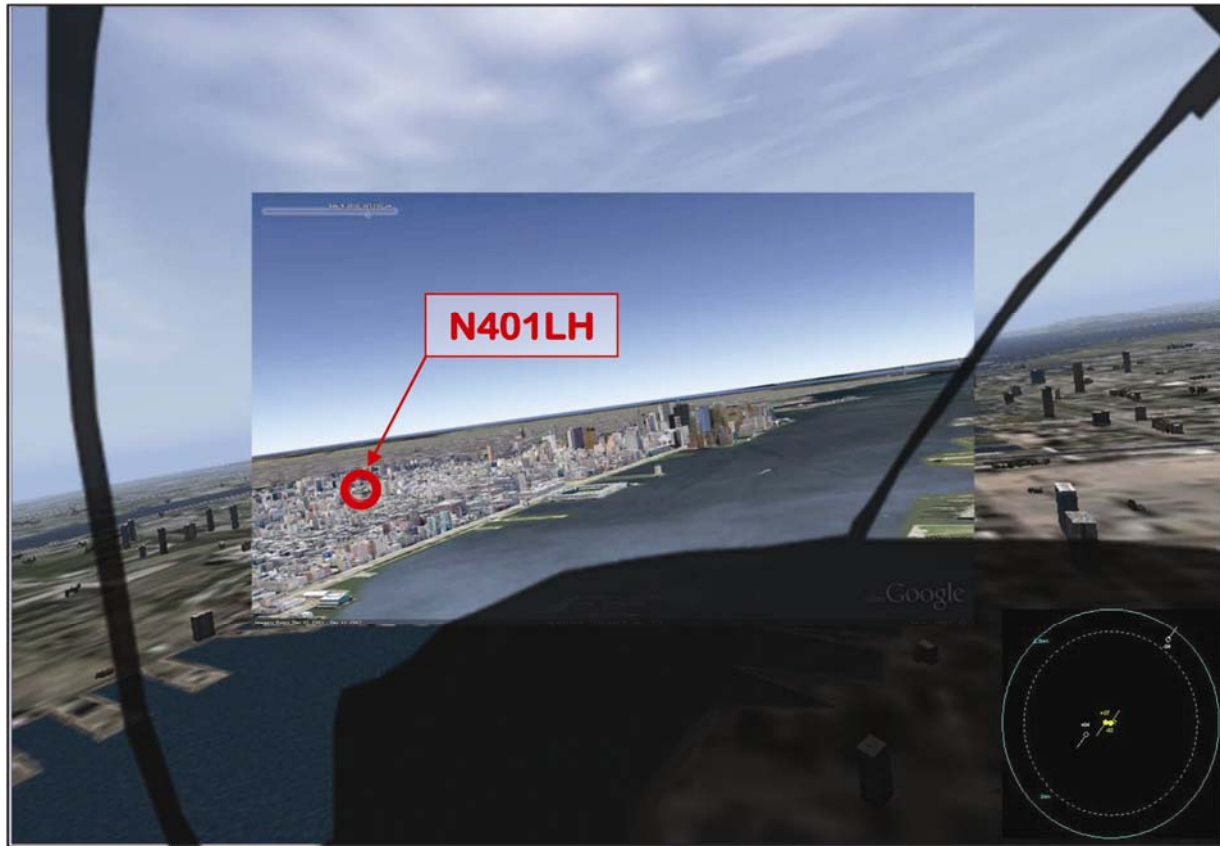
**Figure 3.** View of helicopter from airplane cockpit about 9 seconds before collision.

**1153:05**

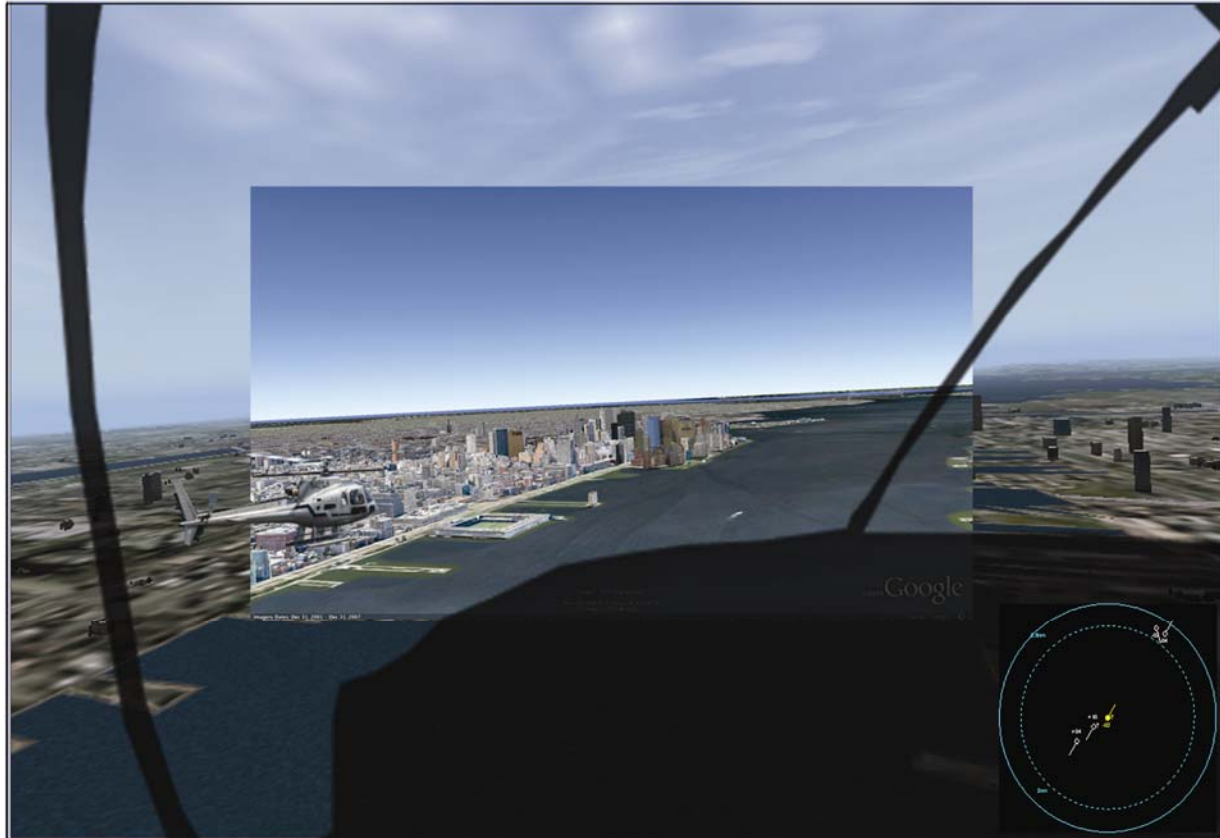
**Figure 5.** View of helicopter from airplane cockpit about 1 second before collision.

**1153:13**

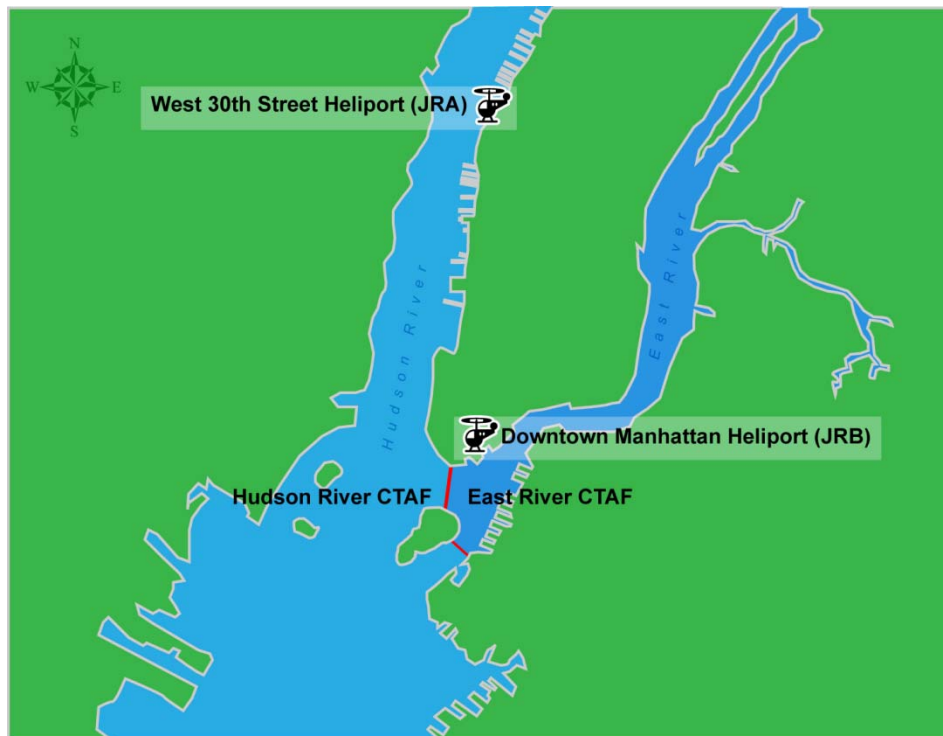
**Figure 6.** Location of West 30th Street and Downtown Manhattan Heliports and Boundary Between Hudson River and East River common traffic advisory frequencies.

The NTSB concludes that pilots operating air tour helicopters to and from JRB may not be fully aware of other aircraft operating over the Hudson River because the CTAF used for such flights is for the adjacent East River area. Therefore, the NTSB recommends that the FAA redefine the boundaries of the East River CTAF so that JRB will be located in the area that uses the Hudson River CTAF.
