## HCL No 62/96 (accident)

<b>Aircraft:</b>	Ecureuil AS350 B1, OY-HEC	Year of Manufacture: 1987
<b>Date and time:</b>	13 September 1996 at 1515 UTC	
<b>Location:</b>	Mouth of the Ice Fjord, Ilulissat, Greenland	6910.23N 05109.87W
<b>Nature of damage:</b>	Destroyed	
<b>No &amp; type of engines:</b>	1 Turbomeca Arriel 1D	
<b>Type of flight:</b>	Other commercial operation (photography), VFR	
<b>Commander:</b>	48 years of age, BH licence	
<b>Flying experience:</b>	9876 hours of which 712 hours were on type	
<b>Persons on board:</b>	Crew - 1	Passengers - 1
<b>Injuries:</b>	Crew - Serious	Passengers - Fatal
<b>Source of information:</b>	Telephone information from the company, report (HCL FORM 1) submitted by the pilot and the investigations made by the Aircraft Accident Investigation Board

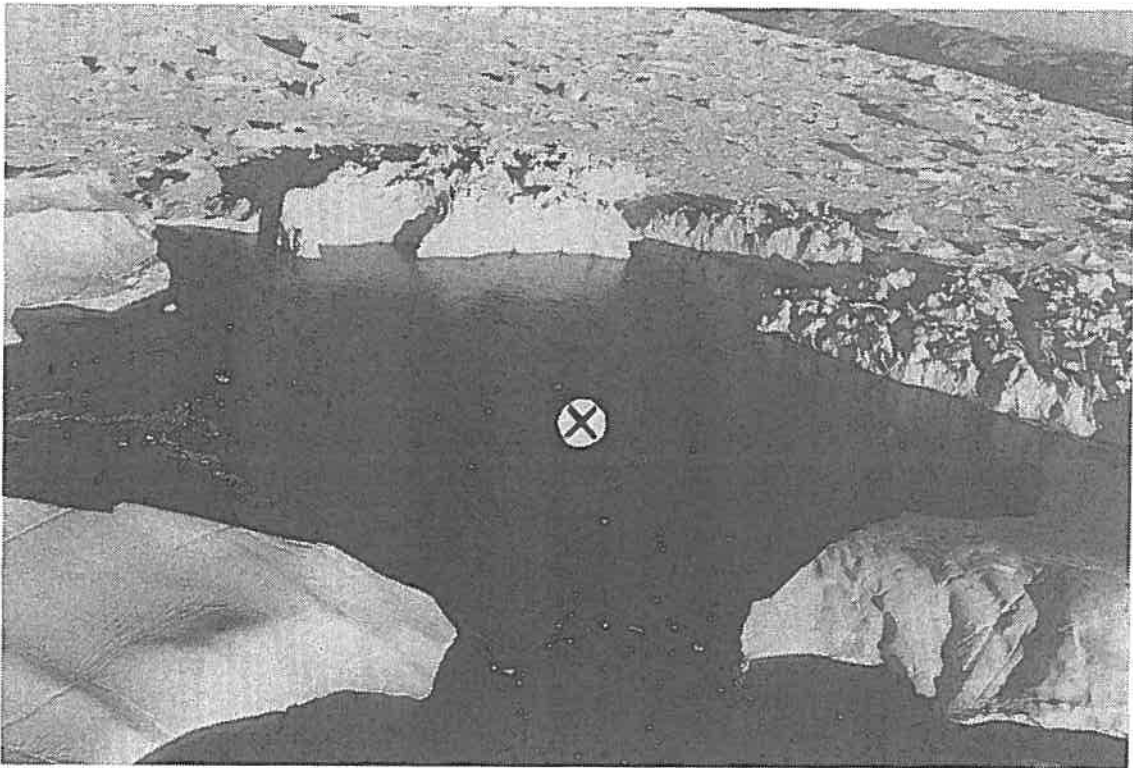
The site of the accident

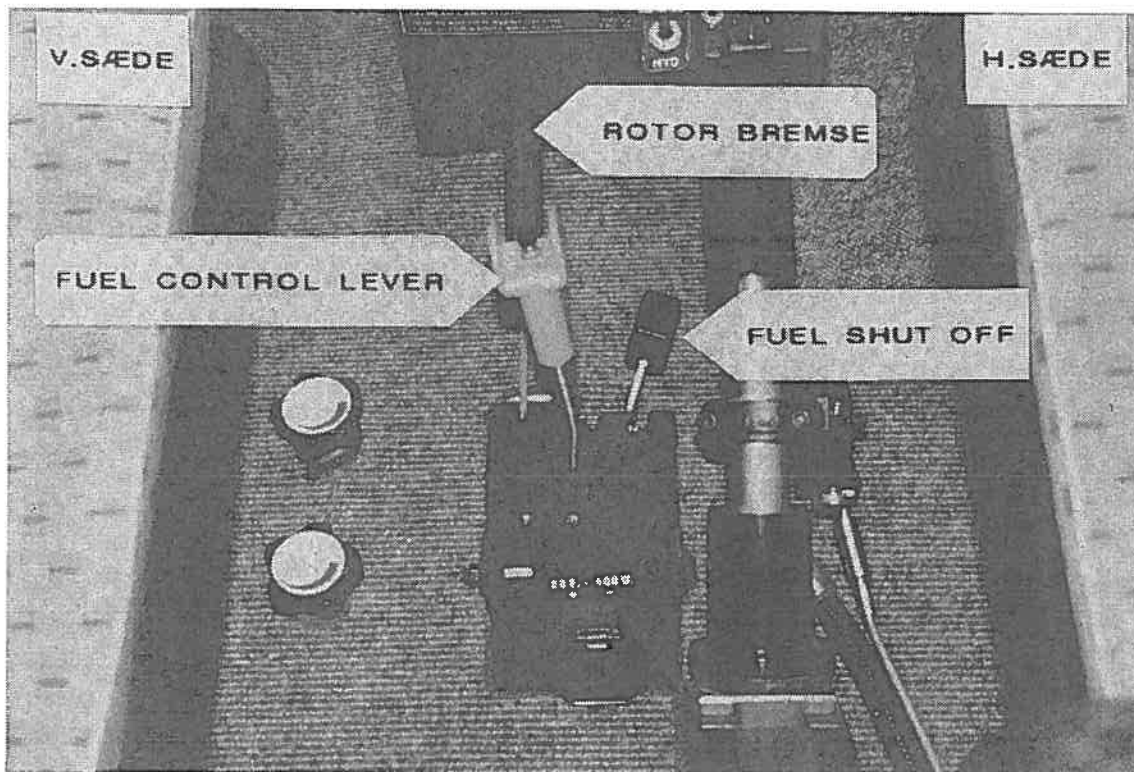
When full power is required, the lever is steadily moved approx. 25-30 mm further down to the next notch, where it is held in place by a slight spring-load. In this position the lever is unprotected at an angle of approx. 45° to the floor (as mentioned the rotor brake lever and the emergency fuel shut off lever are level with the floor).

The fuel control lever console

it is the opinion of the Aircraft Accident Investigation Board that during his movements in and around the left-hand seat the photographer may unintentionally have pushed the fuel control lever out of the notch and up towards idle/shut down. A distance equal to approx. 25-30 mm in the cut-out.

On inspection of a similar helicopter the Aircraft Accident Investigation Board attempted to duplicate the sequence of events and found that the position of the lever in normal operations may easily be disturbed by an accidental action by a person in the left-hand seat.

In connection with the investigations into the accident with OY-HEC at Ilulissat on 13 September 1996 it has been ascertained that there are various aspects concerning the construction of the helicopter type AS350 B which make it possible that during flight the fuel control lever may be unintentionally touched and moved to a position that jeopardizes the safety of the helicopter and the persons on board.

The situation arises when the left-hand front seat is occupied by a passenger, for instance a photographer, and the flight controls, collective, cyclic and pedals have been removed on the left-hand side. In the opinion of the Aircraft Accident Investigation Board in these circumstances it is quite easy to "happen to" push against the unprotected fuel control lever either with the right foot/heel or with equipment placed on the floor.

**The Civil Aviation Administration consider implementation of a system to protect the fuel control lever on the AS350 B helicopter types when during flight the lever is in the normal flight operation position in which it is unprotected at an angle of approx. 45° to the cockpit floor.**

**The protection shall prevent a passenger in the left-hand seat from unintentionally touching and moving the fuel control lever, thereby jeopardizing the safety of the helicopter.**

**The protection system must be easy to install as it shall only be in place when the left-hand front seat is occupied by a passenger. (REC-11-96).**
