Aviation Investigation Final Report

Location:	North Fork, Idaho	Accident Number:	CEN22FA331
Date & Time:	July 21, 2022, 16:42 Local	Registration:	N388RA
Aircraft:	Columbia Helicopters CH-47D	Aircraft Damage:	Destroyed
Defining Event:	Loss of control in flight	Injuries:	2 Fatal
Flight Conducted Under:	Public aircraft

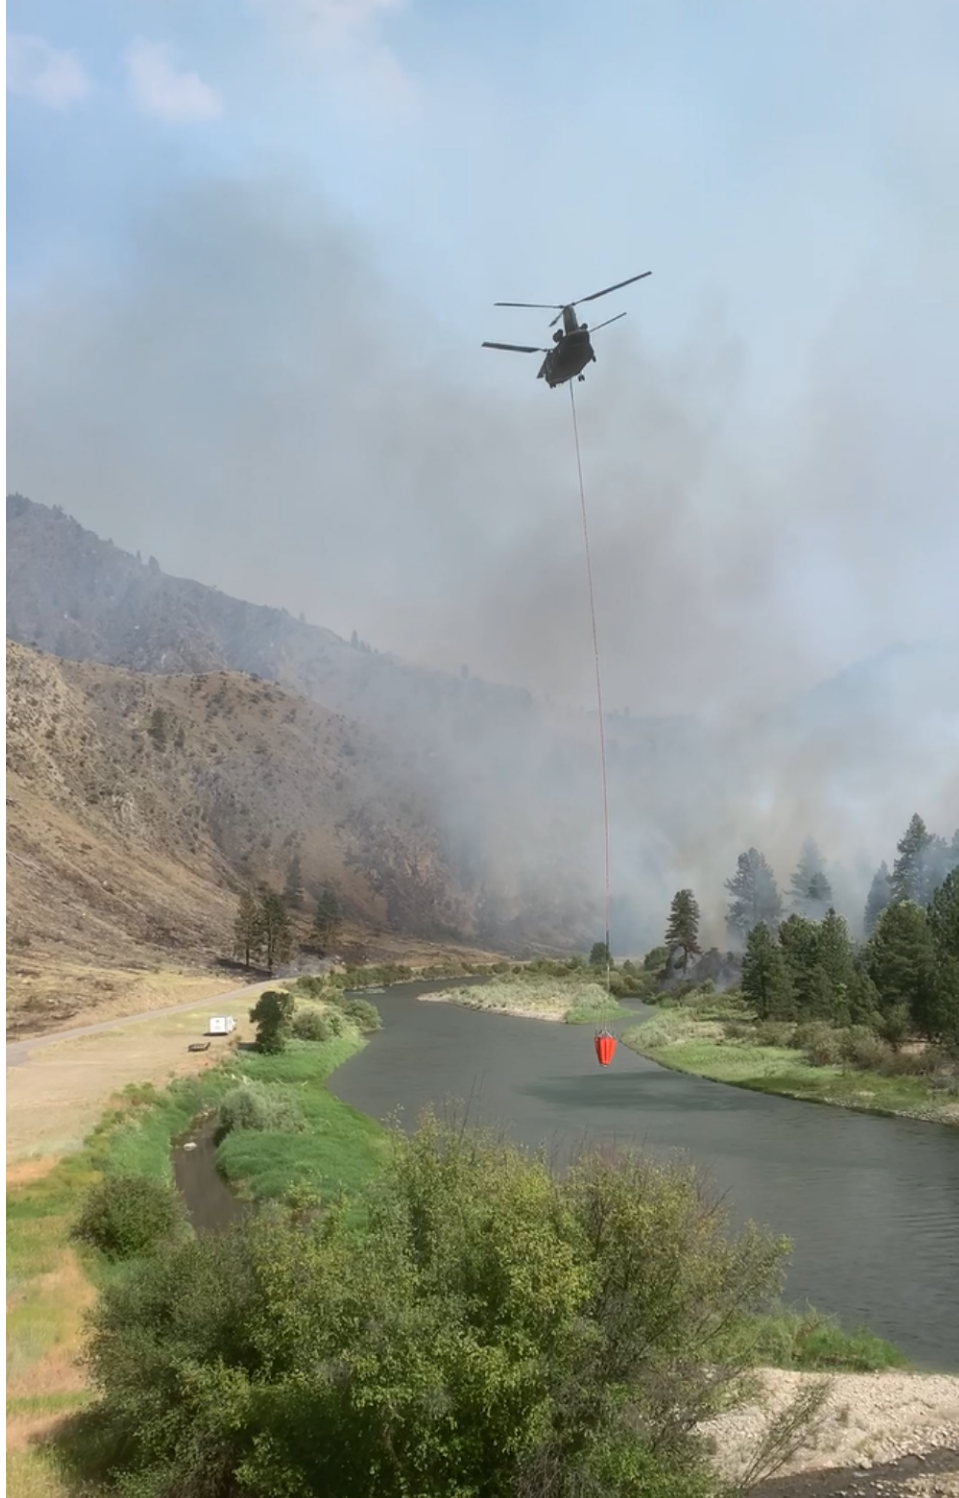
A 38-second video of the accident flight recorded by a local resident showed the helicopter setting up to dip the water bucket into the Salmon River. At the start of the video, the helicopter was hovering about 200 ft above ground level (agl) over the river with its empty water bucket, at the end of the long line, swinging close to the surface of the river. (See figure 1.) The helicopter then climbed to about 325 ft agl over a period of 8 to 9 seconds; its heading remained generally the same throughout the ascent. Next, the helicopter began to yaw to the left, and once it had turned about 180°, the helicopter suddenly pitched down, continued to yaw left, and descended. The left yaw continued through the descent until the helicopter impacted the river and riverbank.

Figure 1. This still image from the accident video shows the helicopter hovering above the river with the empty orange water bucket just above the water (source: witness video).
