Inadvertent Activation of the Fuel Shutoff Lever  
and Subsequent Ditching  
Liberty Helicopters Inc., Operating a FlyNYON Doors-Off Flight  
Airbus Helicopters AS350 B2, N350LH  
New York, New York  
March 11, 2018

NTSB/AAR-19/04  
PB2020-100100

# Aircraft Accident Report

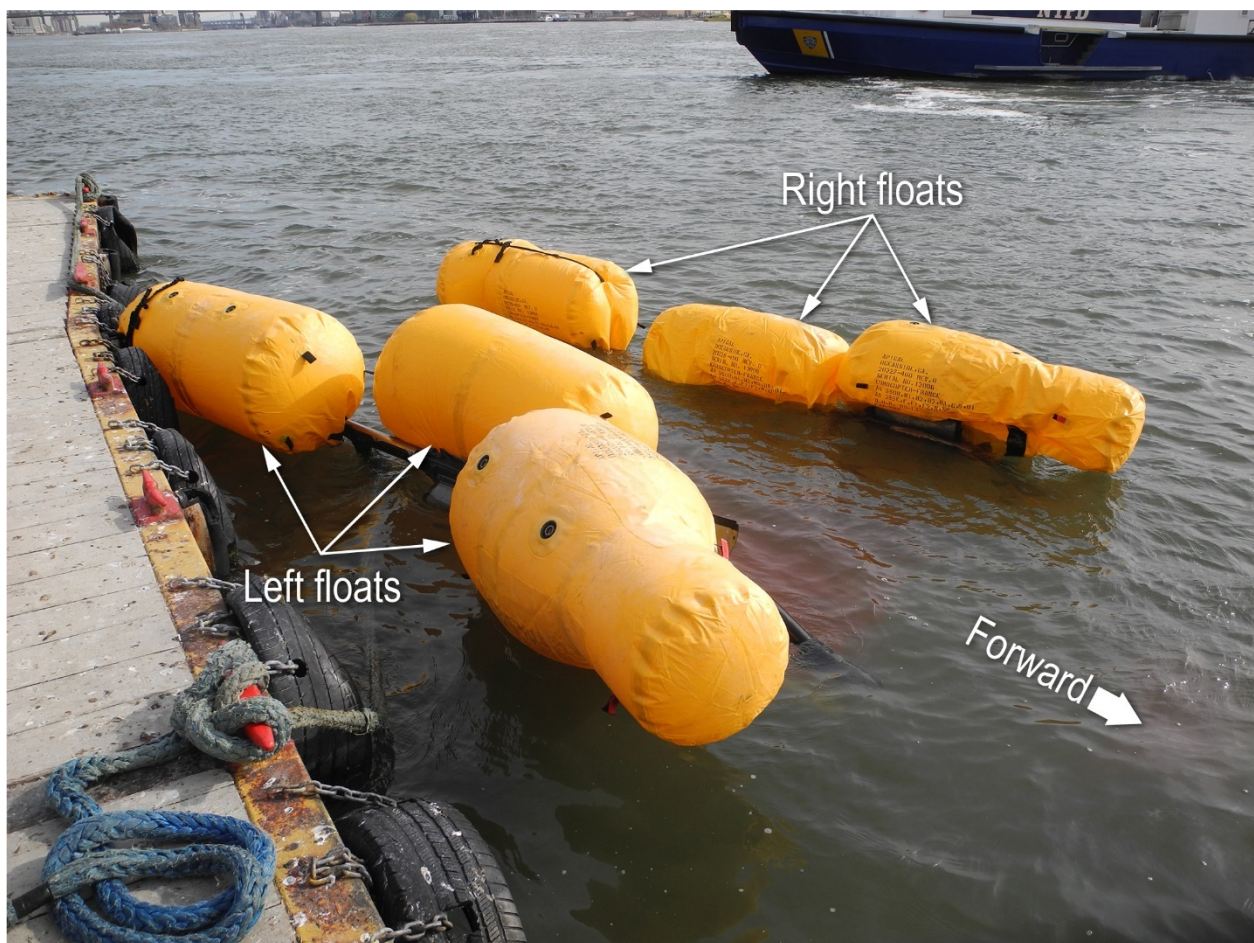
After the emergency response activities were completed (see section 1.8.2), the wreckage was moved and secured to a pier. The day after the accident (before the wreckage was recovered from the water), the helicopter’s six floats (three mounted on each skid) were visible on the surface. The three right floats appeared to be less inflated than the three left floats (see figure 4).

**Figure 4.** Emergency floats visible above inverted, submerged wreckage.

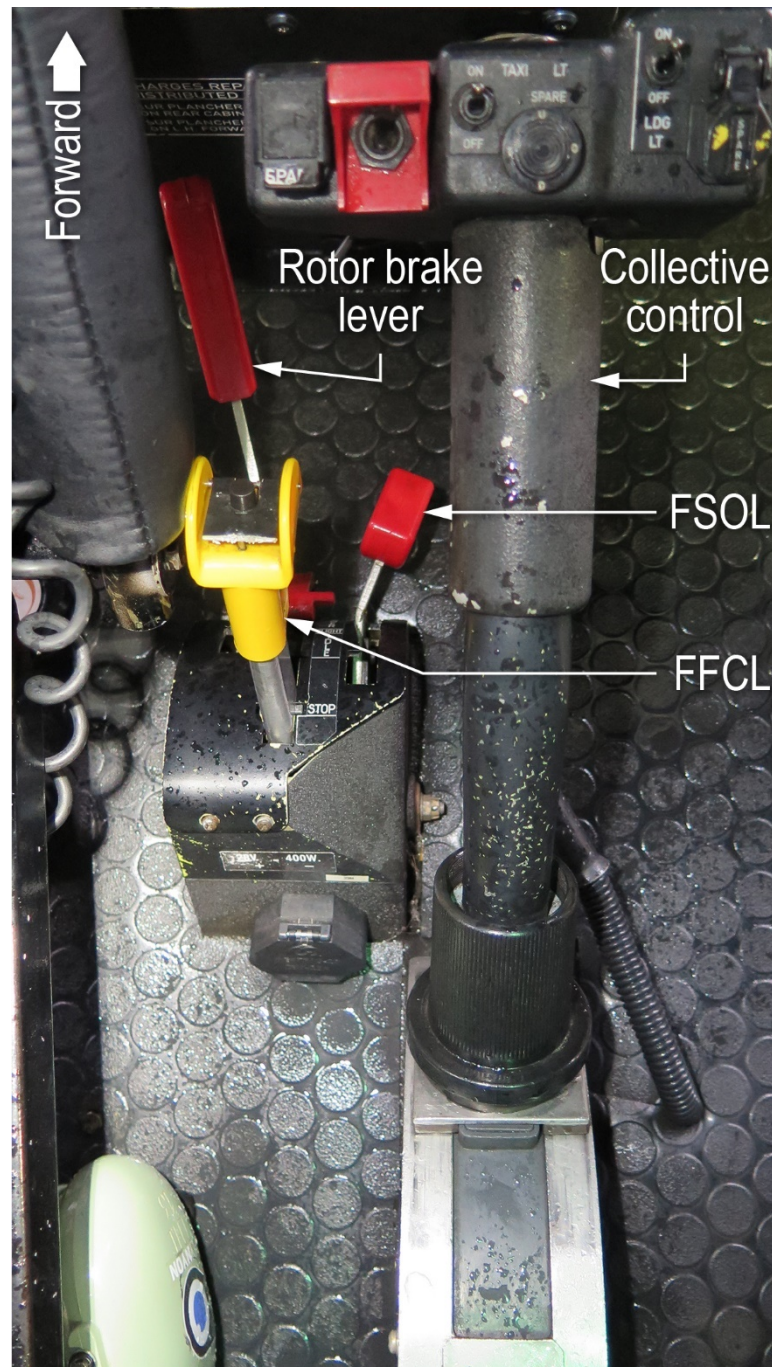
**Figure 5.** FSOL and other floor-mounted controls in the accident helicopter.

During postaccident examination, the FSOL was found positioned forward and down with the snap wire broken adjacent to the fuel control plate hole. Examination of a fractured segment of the wire using a scanning electron microscope revealed elongation deformation and other features consistent with ductile overstress.

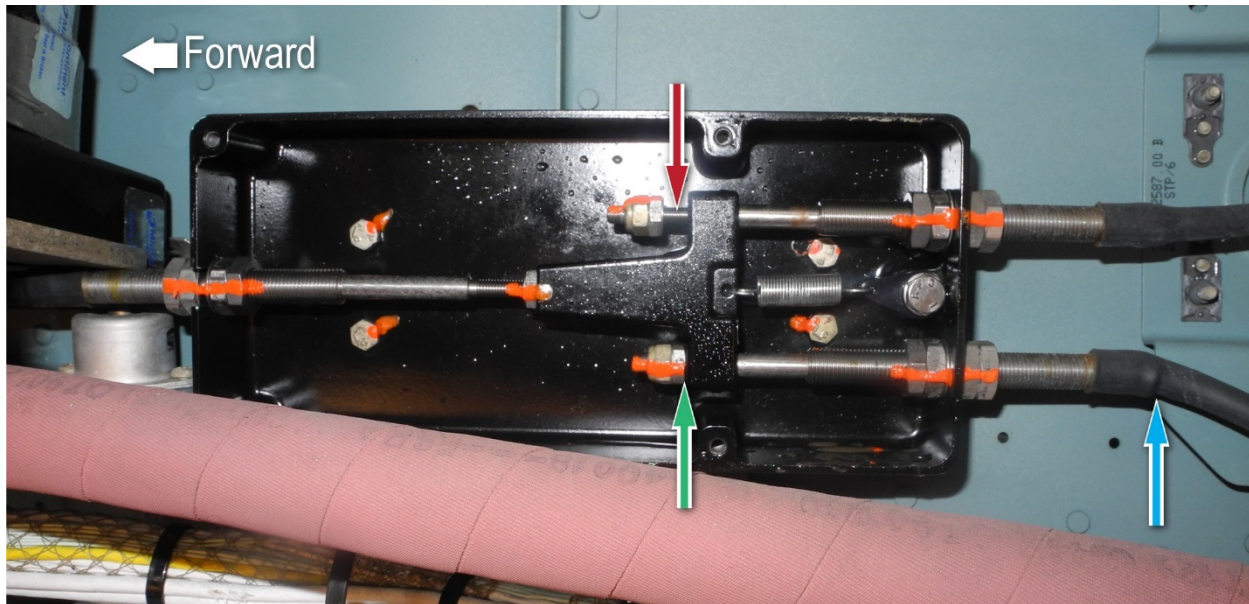
The pull-cable routing from the activation handle to the dual cable block in the junction box was continuous, and the handle shear pin was not present. The aft-upper and aft-lower cables were attached to the dual cable block in the junction box, and their routing was continuous to the left and right reservoir assemblies, respectively. The exterior cover (sheathing) of the cables exhibited no anomalous damage. The pull-cable rigging met the specified 0.625-inch minimum travel requirement for the pull-cable clevis at each valve assembly.

The accident helicopter's aft-upper cable exited the junction box aligned about horizontal, and the aft-lower cable showed a downward bend about 30° from horizontal. Inside the junction box, the aft-upper cable showed a gap of about 0.25 inch between its jam nut and the dual cable block surface, and the aft-lower cable showed no gap between its jam nut and the cable block (see figure 8).

**Figure 8.** View inside the junction box for the accident helicopter's emergency flotation system.

Note: A gap between the dual cable block surface and the jam nut of the aft-upper cable (for the left reservoir assembly) is indicated by the red arrow, the lack of a gap between the block surface and jam nut of the aft-lower cable (for the right reservoir assembly) is indicated by the green arrow, and the blue arrow indicates the downward bend of the aft-lower cable.

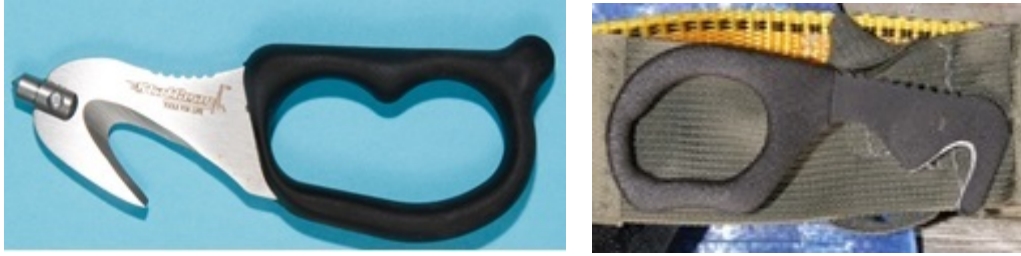
**Figure 11.** Two types of cutting tools recovered from the accident flight.

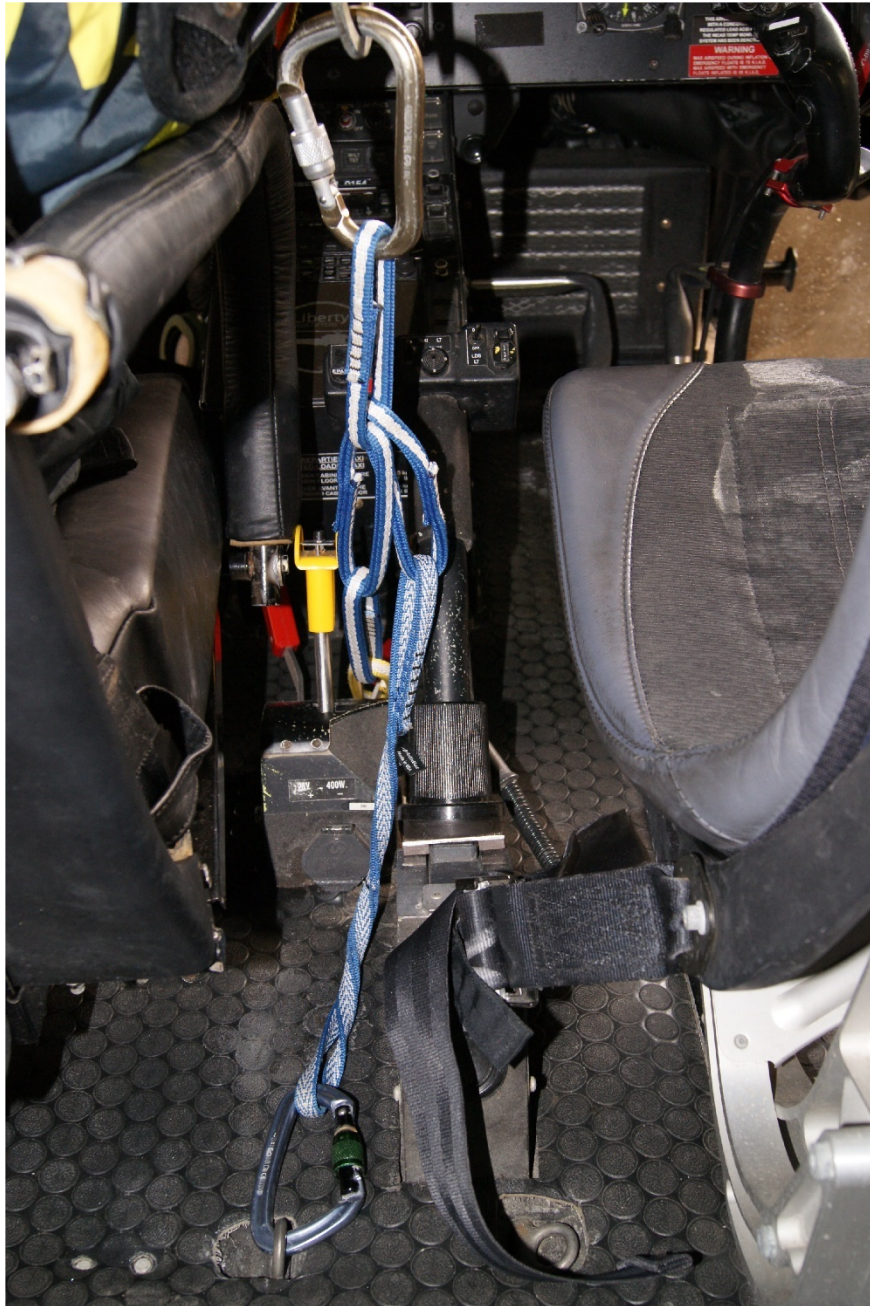
**Figure 14.** Front passenger's tether from the accident flight with top locking carabiner inserted through third webbing loop (from floor) with three excess loops hanging as a tail.

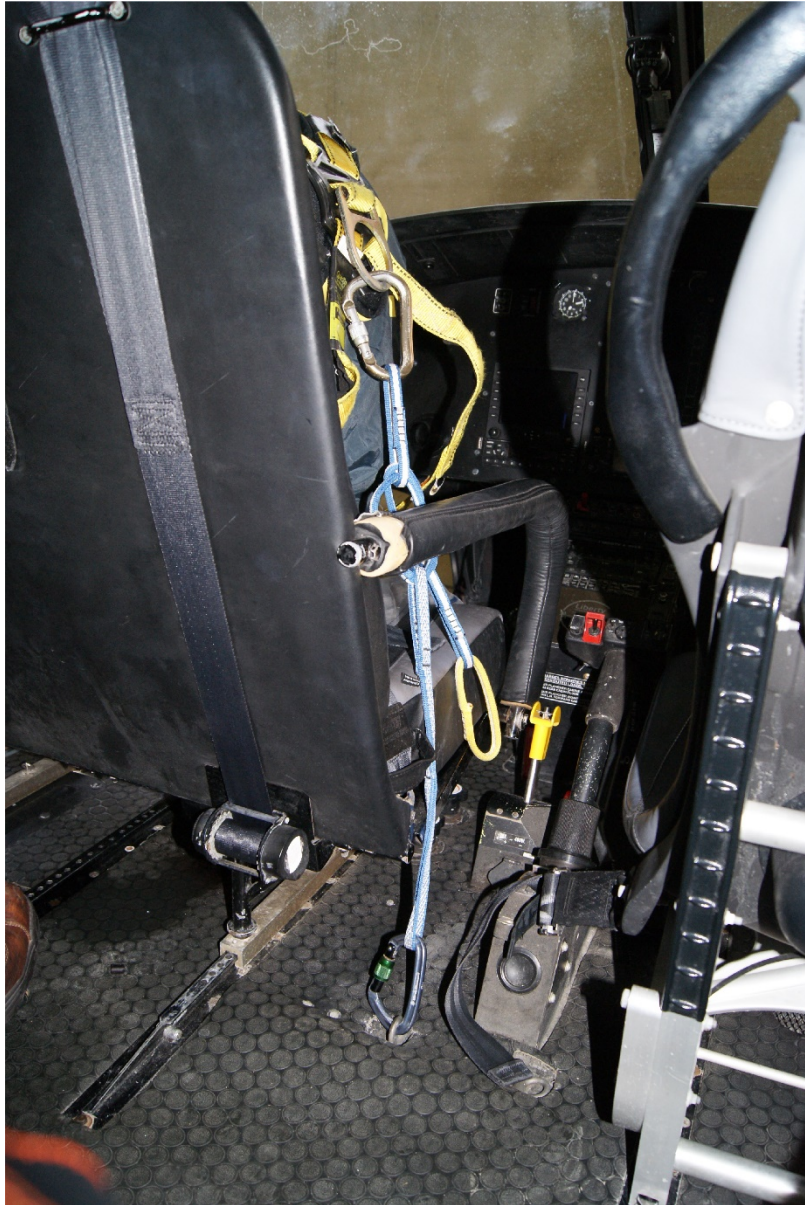
**Figure 16.** Front passenger's tether (attached to exemplar occupant) routed under the armrest.

When the exemplar occupant leaned back while facing outboard to assume body positions similar to those of the front passenger (as captured by the onboard video), the loops of the tether tail dangled into the floor-mounted controls.<sup>32</sup>
