Aviation Investigation Final Report

Location:	Pylesville, Maryland	Accident Number:	ERA20LA160
Date & Time:	April 25, 2020, 12:40 Local	Registration:	N9159F
Aircraft:	Hughes 369	Aircraft Damage:	Substantial
Defining Event:	Fuel starvation	Injuries:	1 None
Flight Conducted Under:	Part 133: Rotorcraft ext. load

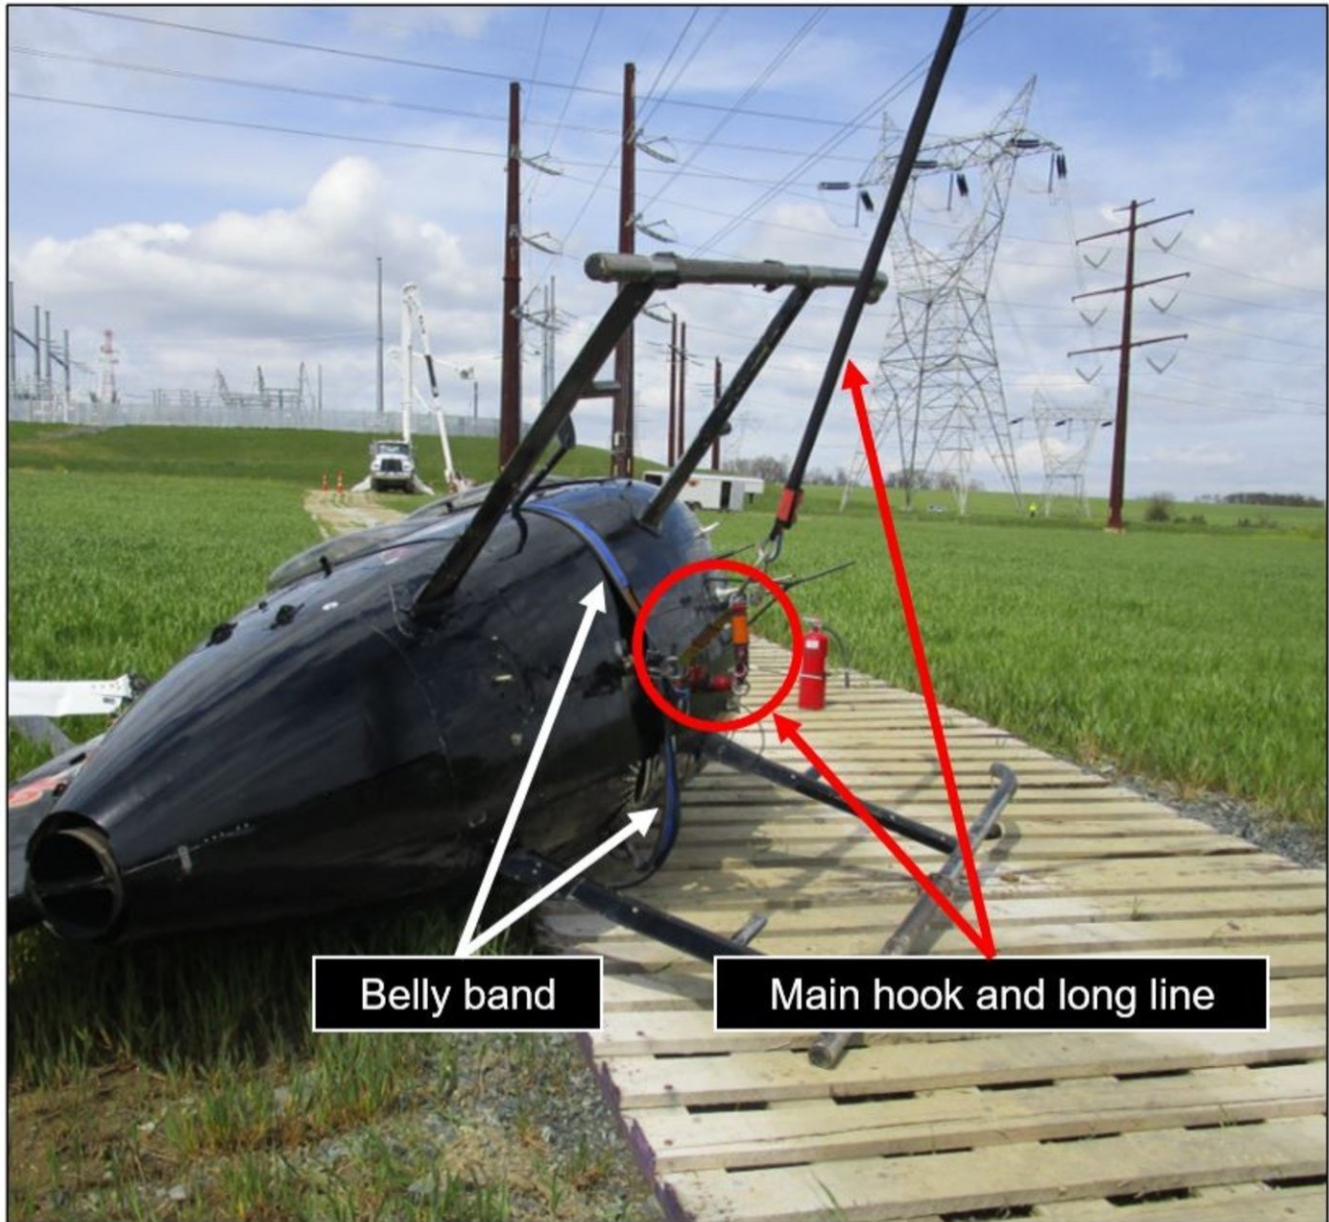
As the helicopter entered the flare, the pilot pulled the collective up to complete the autorotative landing, but the long line, which remained attached to the helicopter and conductor wire, became taut and caused the helicopter to roll onto its left side. The main rotor blades impacted the ground.

The following figure shows the belly band around the fuselage, the main hook, and long line.

Figure. View of the helicopter at the accident site

Photographs provided by a Federal Aviation Administration (FAA) inspector who examined the helicopter at the accident site found that the helicopter had rolled over and come to rest on its left side, and the long line remained attached from the main hook on the helicopter to the power line. The tail boom and main/tail rotors sustained substantial damage. There was no evidence of fuel spillage at the accident site.
