HN-210  
DN-150  
N-38  
N-27

# SERVICE BULLETIN

**SUBJECT:** START PUMP WIRE ROUTING AND FUEL QUANTITY SENDERE INSPECTION.E

**MODELS AFFECTED:** All MD Helicopters, Inc. (MDHI) 369A (OH-6A), 369H, 369HE,/ 369HM, 369HS, 369D and 369E Series helicopters. In addition, all 369F/FF/ Series helicopters equipped with internal start /umps./

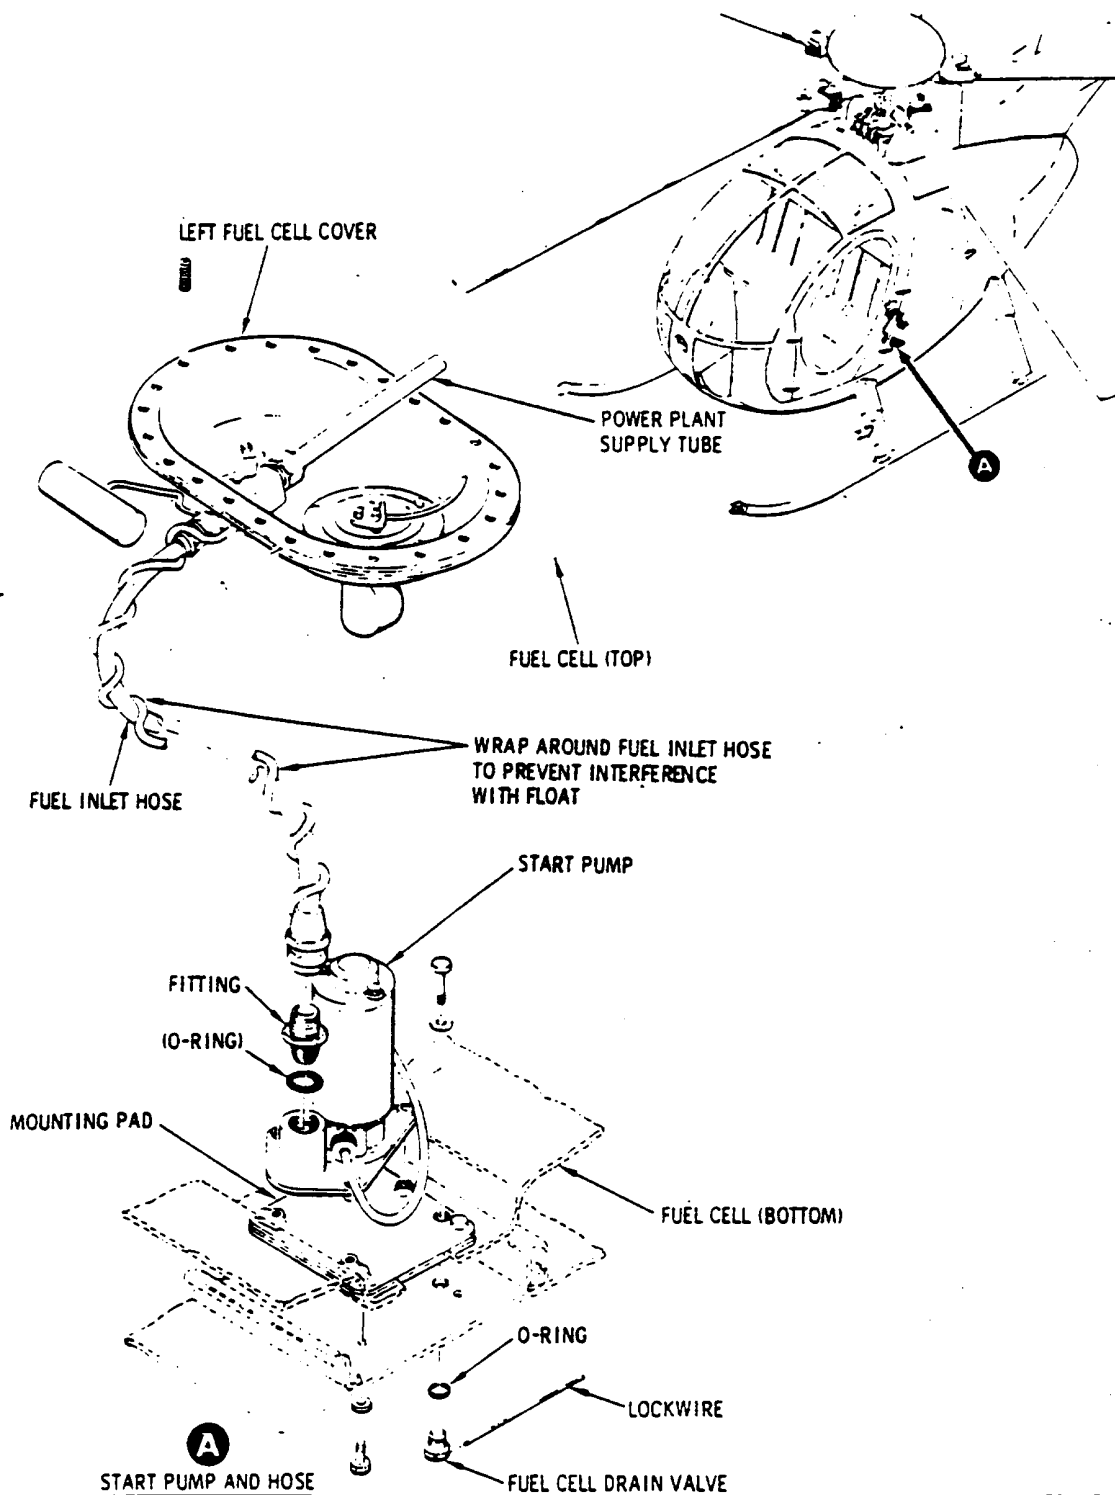
Figure 1. Fuel Start Pump Wire Routing Inspection

**PREFACE:** There have been recent incidents where the fuel tank start pump wiring in-/ terfered with the 369A4245 fuel float after the start pump and fuel quantity sending unit had been replaced in the field. This interference /an /result in/ erroneous fuel quantity indications. T/ / event / this situation, the fuel /ump/ wiring shall be wrapped around / / ie-wrapped / /the fuel inlet hose /er / he/ HMI. This Notice provides for an inspection to be /erformed /to ensure / er/ start pump wire routing and fuel quantity sender unit / eration./

- Ensure all electric power is off.
- Remove left fuel cell access cover per applicable HMI, Section 12.
- Disconnect start pump electrical harness from access cover. (See Figure 1.)
- Ensure that electrical harness is wrapped around fuel inlet hose preventing any interference with the fuel quantity float arm as shown in Figure 1.
- Inspect fuel float arm and low level warning contact spring for damage. Replace any damaged parts as necessary.

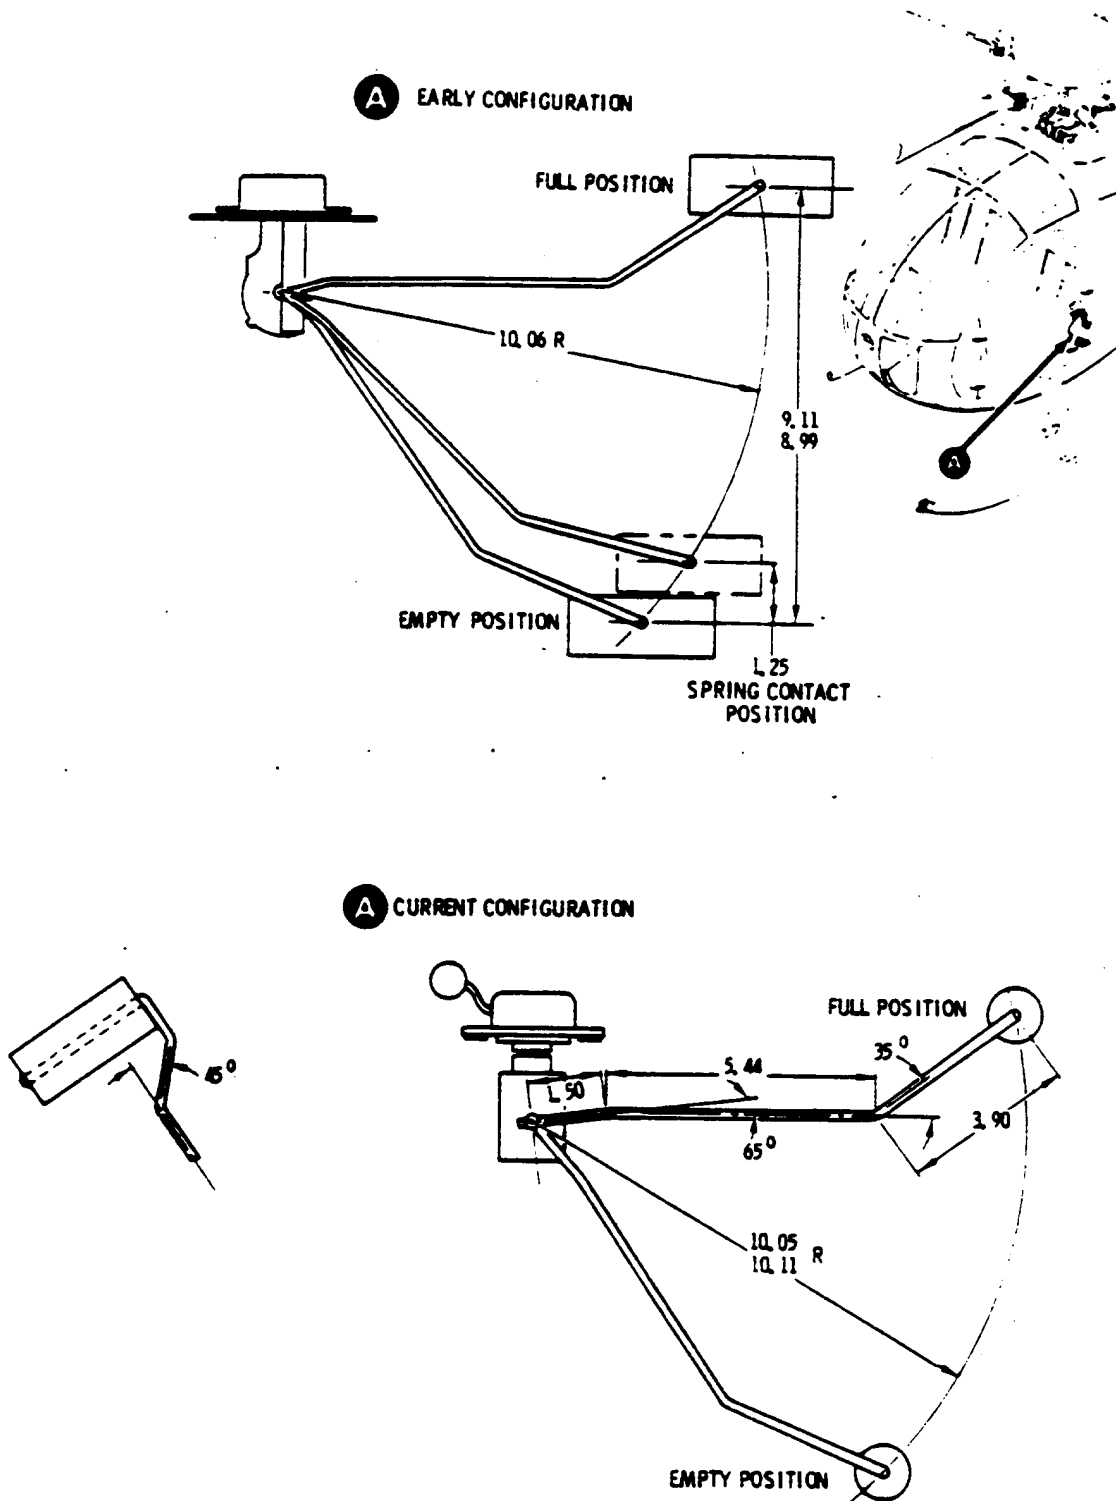
Figure 2. Fuel Float Arm Assembly InspectionE

Do not reinstall any current configuration float assembly that shows indications that attempts have been made to adjust fuel level indications by bending fuel float arm. (See Figure 2.)
