# Aviation Investigation Final Report

| <b>Location:</b> | Peach Springs, Arizona | <b>Accident Number:</b> | WPR18MA087 |
| <b>Aircraft:</b> | Eurocopter EC130 | <b>Aircraft Damage:</b> | Destroyed |
| <b>Defining Event:</b> | Loss of control in flight | <b>Injuries:</b> | 5 Fatal, 2 Serious |

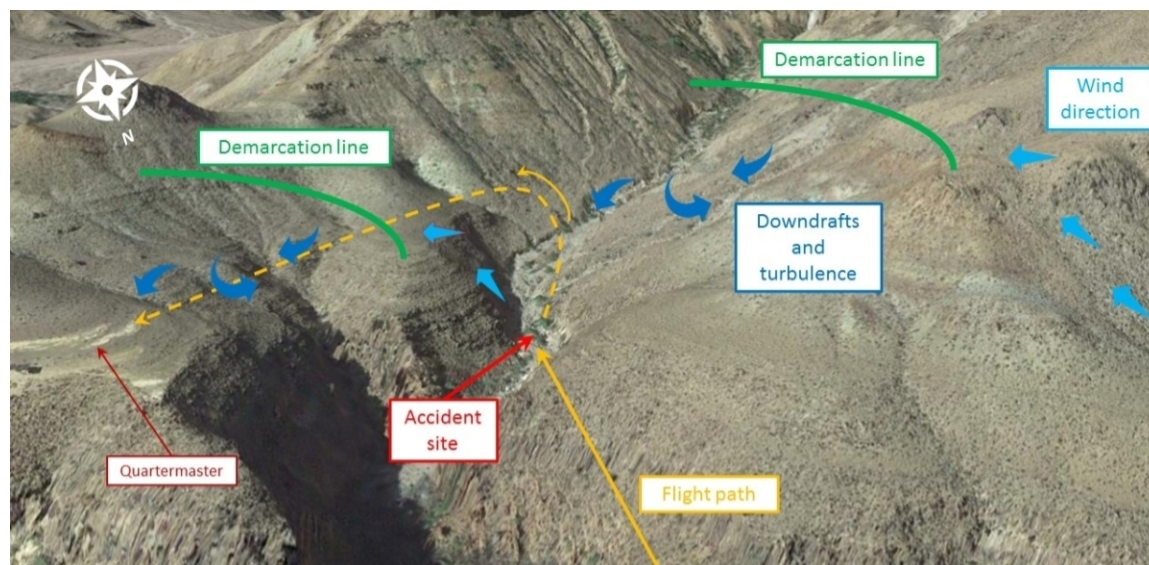
The landing site was located on a plateau and provided limited approach options due to its local topography. At the time of the accident, potential demarcation lines (boundaries of updrafts and downdrafts) would have been on the pinnacles of ridges located along the approach to the Quartermaster west pads. Figure 8 shows a conceptual illustration of potential demarcation lines and wind directions based on the terrain and wind environment present around the accident site at the accident time, and suggests areas where downdrafts, updrafts and turbulence could have impacted the accident flight's approach to the landing site.

*Figure 8. Conceptual display of demarcation lines at accident site*

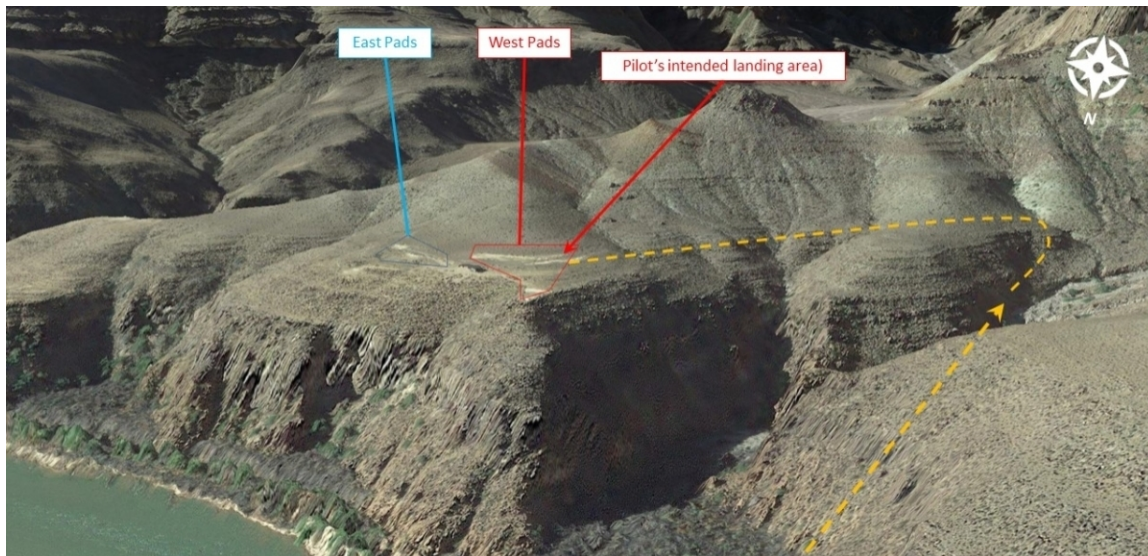
The pilot stated that he normally remained on the north side of the Colorado River, crossing the river between 200 and 300 ft above ground level (agl) while approaching Quartermaster for landing. After crossing the river, he entered a left turning descent toward the landing area. (See figure 1.) He stated

that, as he made the left turn, the helicopter encountered what he described as a “violent gust of wind” and began to spin, and as a result he was unable to maintain directional control.

*Figure 1. Graphical representation of typical approach to west pads*

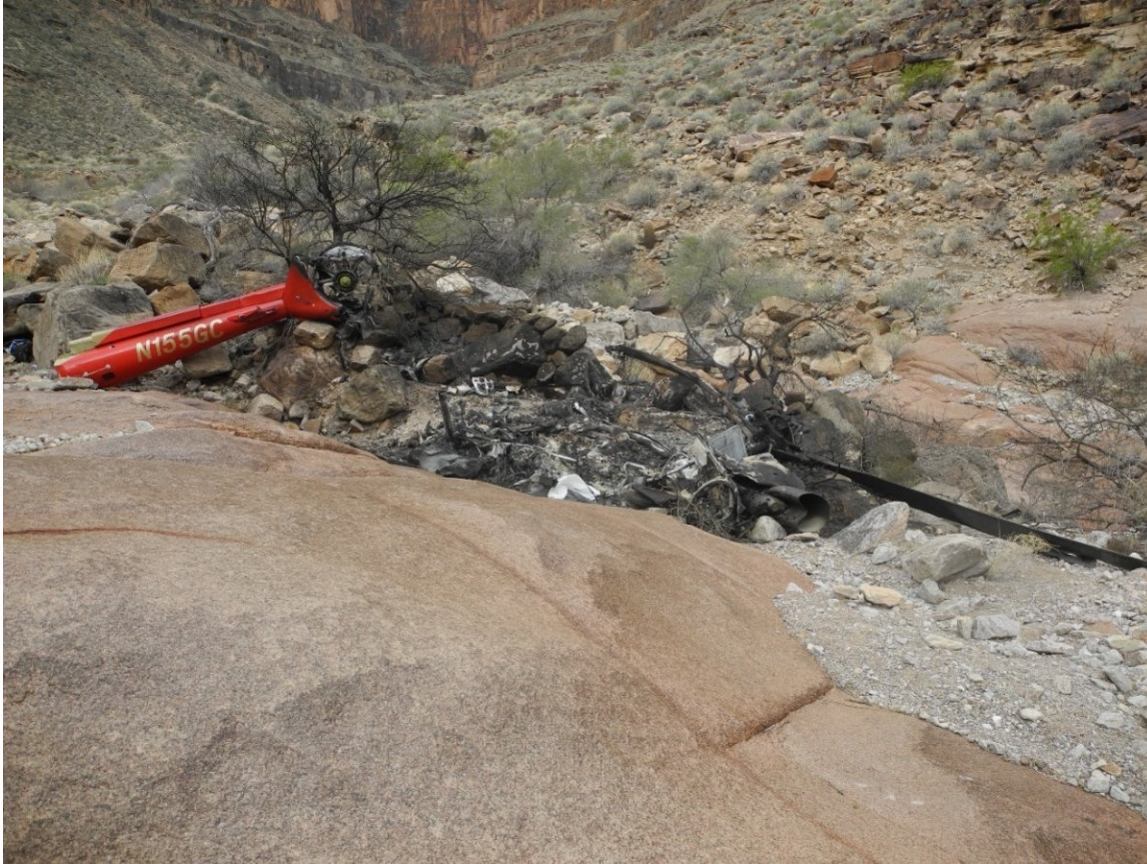
The helicopter came to rest upright in rocky terrain about 300 ft below the landing site on a heading of 222° magnetic. Most of the wreckage was consumed by the postcrash fire except for the tail boom and fenestron, which had separated from but were collocated with the fuselage. (See figure 3.) The engine, still attached to the engine deck, was found in the main wreckage and sustained fire damage. All three main rotor blades remained attached to the main rotor hub and exhibited damage consistent with high rotational energy. The tail stinger, fenestron hub cover, a toe from a skid step, and small pieces of transparent windshield were found on a canyon slope east of the main wreckage.

*Figure 3. Photograph of accident site*

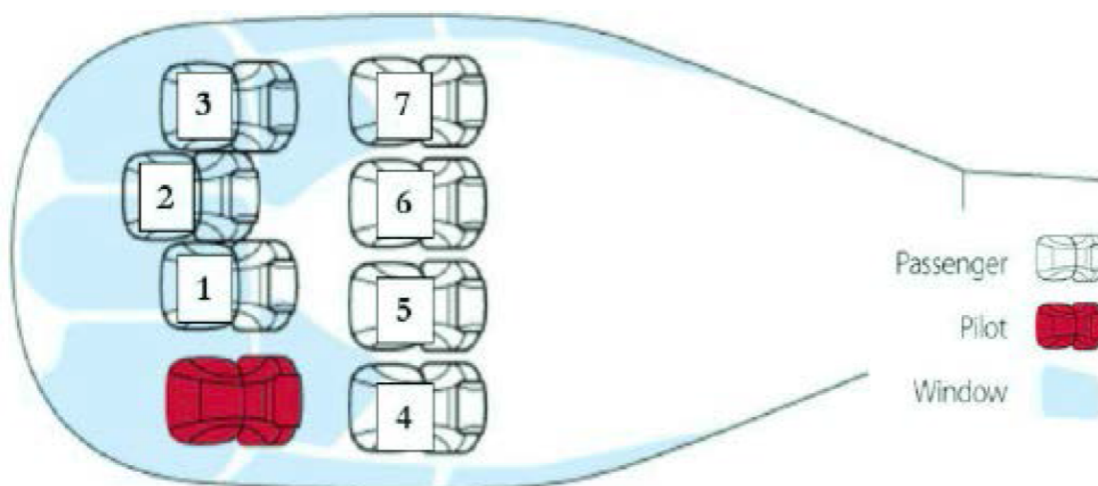
The helicopter was equipped with 8 single-occupant energy attenuating seats manufactured by Zodiac Seats, designed and certified to the standards contained in EASA ETSO C127a. (See figure 4.) All of the seats were destroyed by postcrash fire. Each of the eight seats was equipped with a 4-point rotary buckle restraint, all of which were recovered from the accident site.

*Figure 4: Accident Helicopter Seat Configuration*

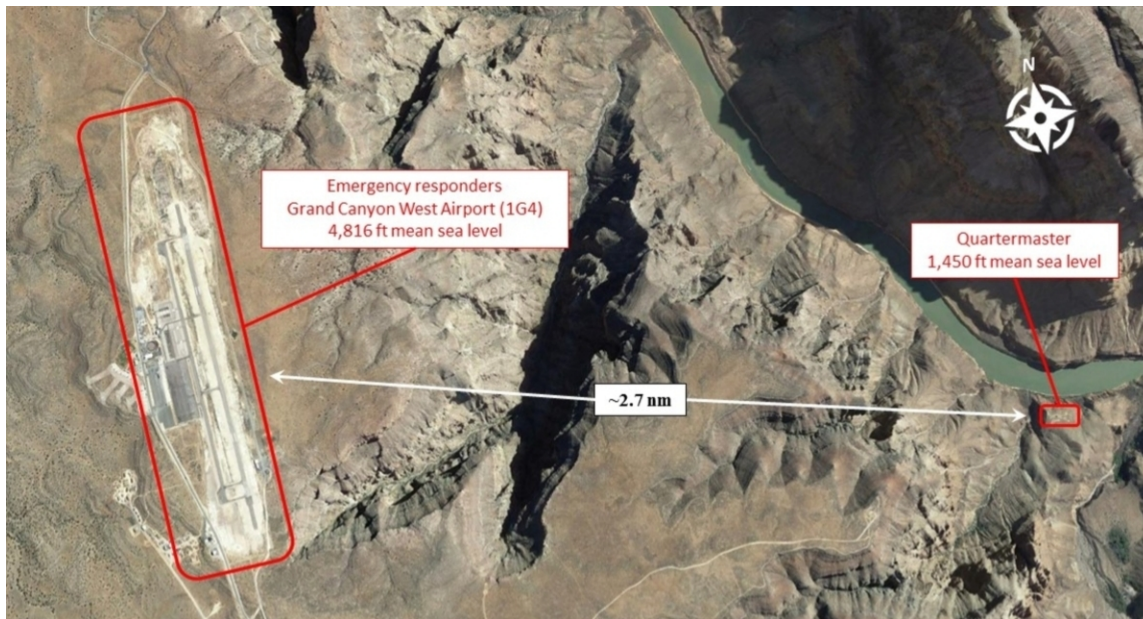
The location of the accident site posed significant challenges and extended the response time for emergency personnel, who had to be flown in by helicopter. (See figure 6.) These first responders reached the accident site about 45 minutes after the accident.

Figure 6. The location and terrain elevation difference between first responders at Grand Canyon West Airport and Quartermaster
