# Aviation Investigation Final Report

| <b>Location:</b> | Palmer, Alaska | <b>Accident Number:</b> | WPR21FA143 |
| <b>Date &amp; Time:</b> | March 27, 2021, 18:36 Local | <b>Registration:</b> | N351SH |
| <b>Aircraft:</b> | Airbus Helicopters AS350-B3 | <b>Aircraft Damage:</b> | Substantial |

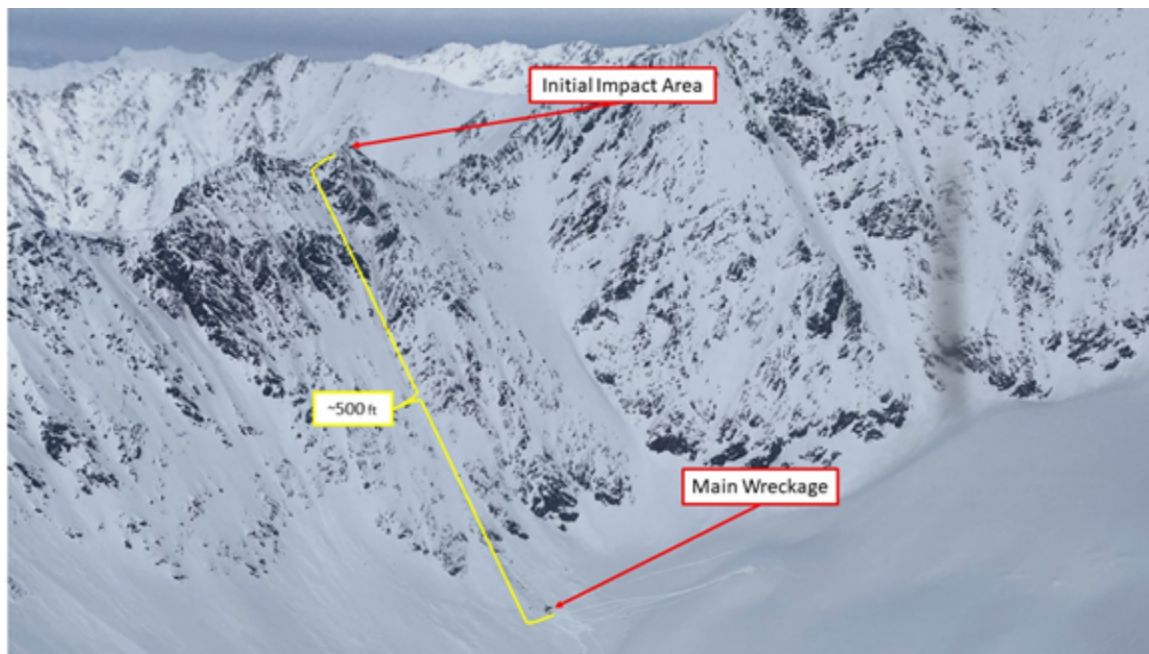
Figure 2. Accident site (Source: Alaska State Troopers).

Aerial assessment of the accident site on the day after the accident revealed that the helicopter impacted terrain about 15 to 20 ft below the top of the ridgeline. The main wreckage came to rest on its right side about 500 ft downslope from the initial impact area, as shown in figure 2. The debris field extended about 900 ft downslope from the top of the ridgeline.

Postaccident examination of the airframe and engine revealed no preimpact mechanical malfunctions or failures that would have precluded normal operation of the helicopter.

The ELT's installed location (the upper right side of the right baggage compartment) was found packed with snow. The ELT remained secured to its airframe mount via a velcro strap. The ELT's antenna coaxial cable and remote cockpit control wiring remained connected. The ELT switch was found in the ARM position. The external antenna had been fractured from its mount and was not located. Postaccident testing of the ELT found that it was working properly and that the ELT had transmitted during and after the accident sequence for 178 hours (12,884 bursts at 50-second intervals).

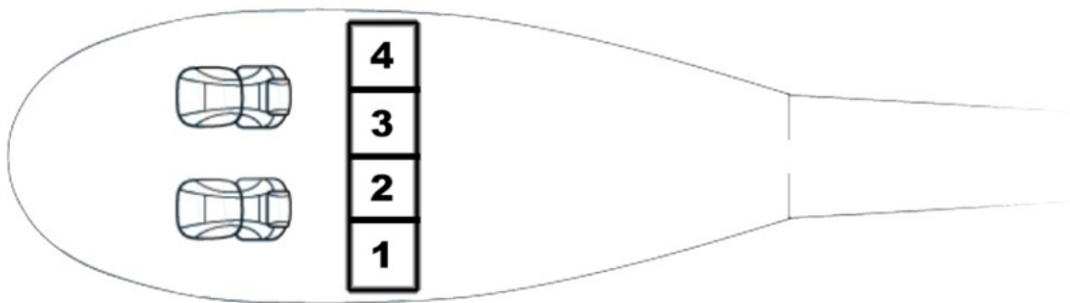
Figure 3. Simplified drawing of the accident helicopter showing seating positions with rear bench seat position numbers annotated.

The helicopter was configured with the pilot's seat in the front right seat position. Passenger seats were located in the front left seat position and a bench in the cabin with four seating positions. Figure 3 shows the helicopter seating configuration. The senior lead guide was in the left front seat; the other lead guide was in aft seat No. 1. The deceased passengers were in aft seat Nos. 2 and 4; the surviving passenger was in aft seat No. 3.
