C I V I L A E R O N A U T I C S B O A R D  
A I R C R A F T A C C I D E N T R E P O R Tdated: **March 19, 1963**Released: **March 22, 1963**

UNITED AIR LINES, INC., VICKERS-ARMSTRONGS VISCOUNT, N 7430,  
NEAR ELLICOTT CITY, MARYLAND, NOVEMBER 23, 1962

SYNOPSIS

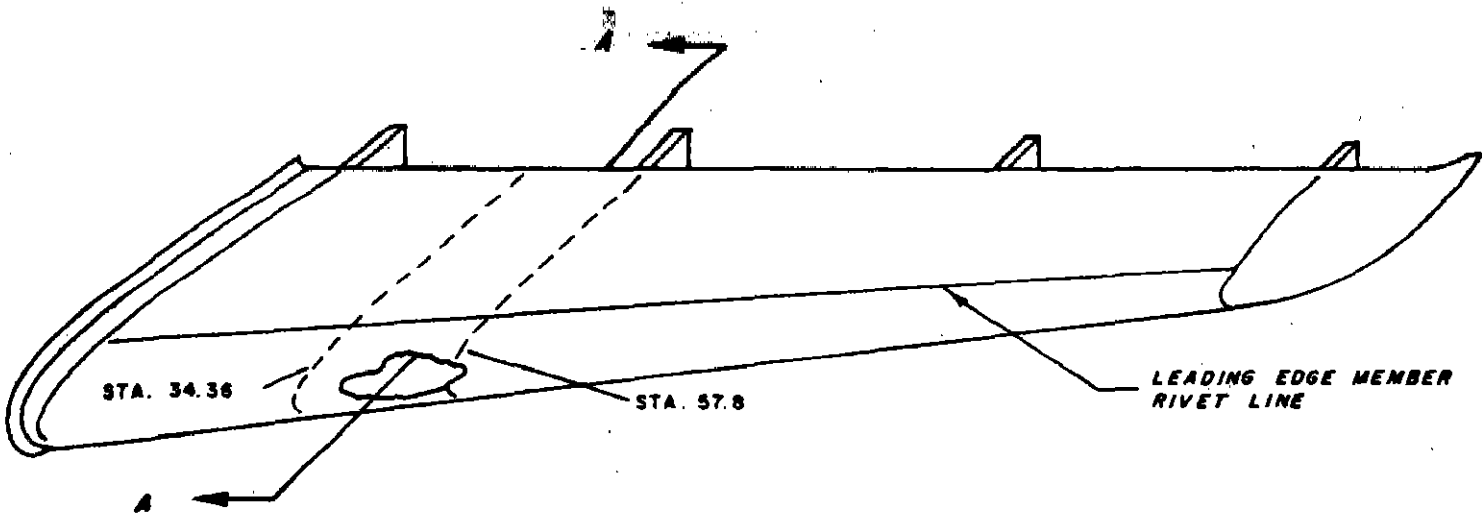
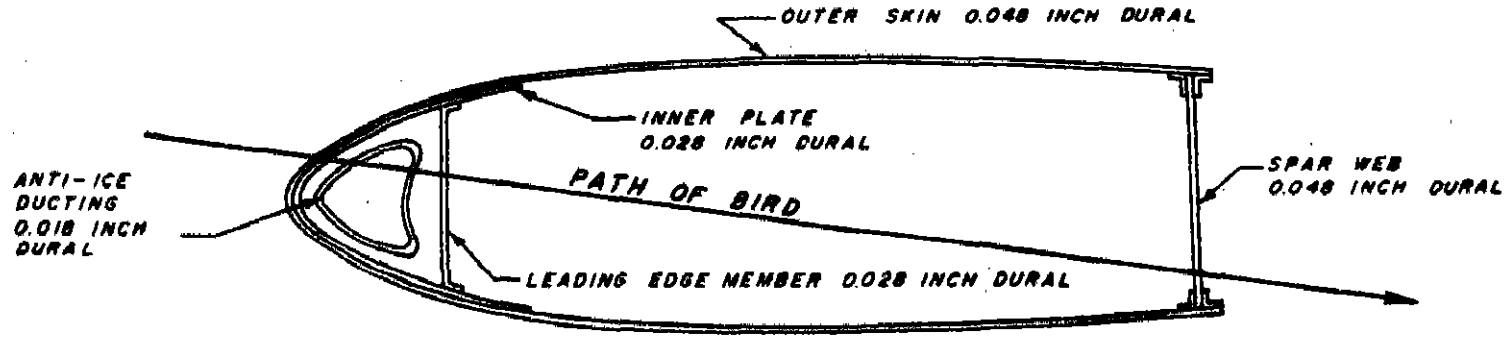
LEFT HORIZONTAL STABILIZER

Bird remains were found on both horizontal stabilizers, indicating two distinct bird strikes on these surfaces. Superficial damage occurred on the right horizontal stabilizer, 22 inches outboard of the fuselage. This strike was a glancing blow and did not result in penetration. The other strike was on the left horizontal stabilizer, approximately 49 inches outboard of the fuselage. <sup>3/</sup> In this instance the bird penetrated the leading edge and passed through the leading edge member. Continuing aft the bird fractured the spar web, partially separating it from the top and bottom caps, and then made final contact with the lower leading edge of the elevator, which resulted in denting but no penetration.

The left horizontal stabilizer and elevator failed along a chord plane generally following the travel of the bird through the structure. The direction of failure was downward and slightly aft. In addition to this failure, the right horizontal stabilizer and elevator separated downward and aft approximately 57 inches from the fuselage. Subsequently, the weakened inboard portion of this horizontal stabilizer also failed.

In contrast to this, the bird strike on the left horizontal stabilizer was concentrated nearly at the most forward point of the leading edge. At this point the angle between the line of force and the stabilizer skin resulted in penetration. The damage sustained in this instance weakened the structure so that the normal down load initiated immediate failure of the horizontal stabilizer and elevator along a chord plane directly aft of the initial impact point. As these parts failed downward and slightly aft, a violent instantaneous nose-down pitching moment was generated. During the left horizontal stabilizer failure sequence, the elevators were displaced beyond their limit, trailing edge upward, thus imposing a severe down load on the right horizontal stabilizer which also failed downward. As the outboard 11 feet of the right horizontal stabilizer and elevator were in the process of separation they weakened the structure of the remaining inboard stabilizer section, which subsequently separated prior to impact. This breakup rendered the aircraft uncontrollable.
