# Loss of Thrust in Both Engines After Encountering a Flock of Birds and Subsequent Ditching on the Hudson River

US Airways Flight 1549  
Airbus A320-214, N106US  
Weehawken, New Jersey  
January 15, 2009

NTSB/AAR-10/03  
PB2010-910403

# Aircraft Accident Report

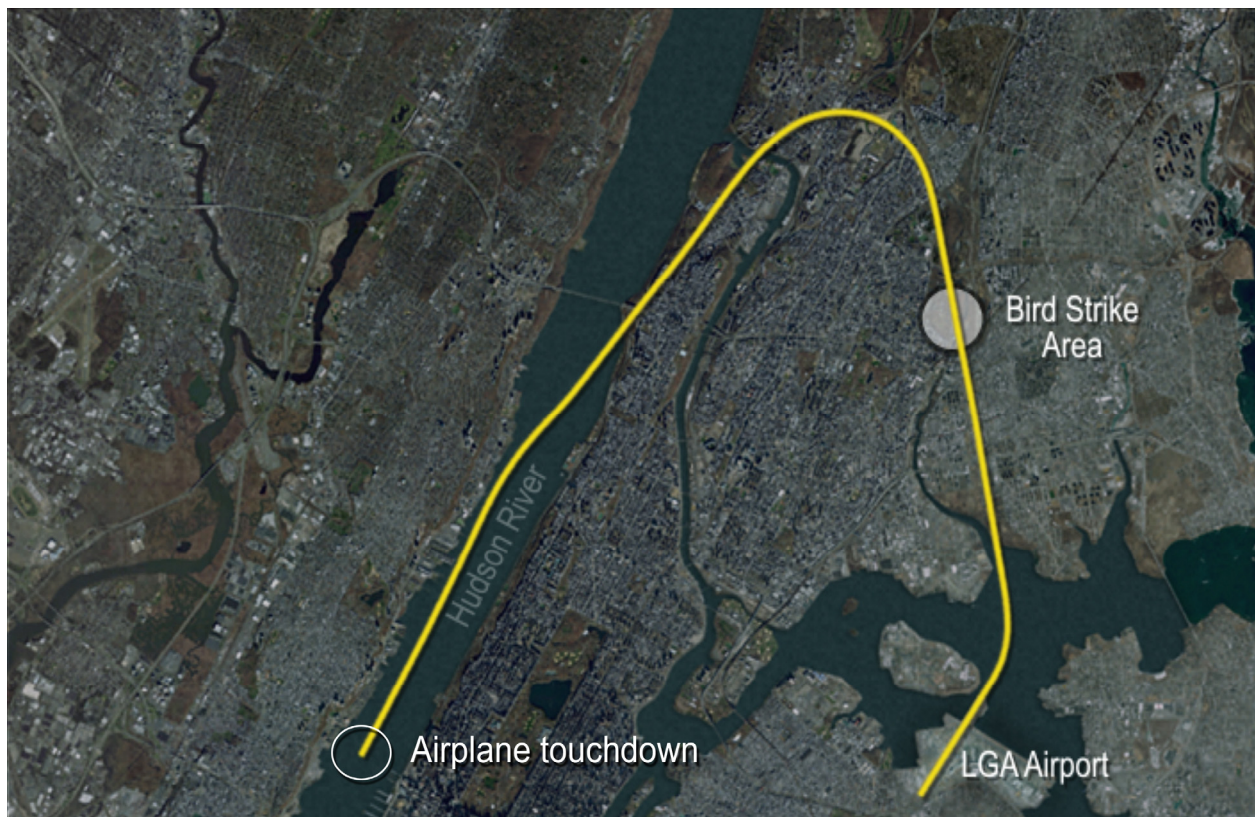
**Figure 1.** Flight track of the airplane.

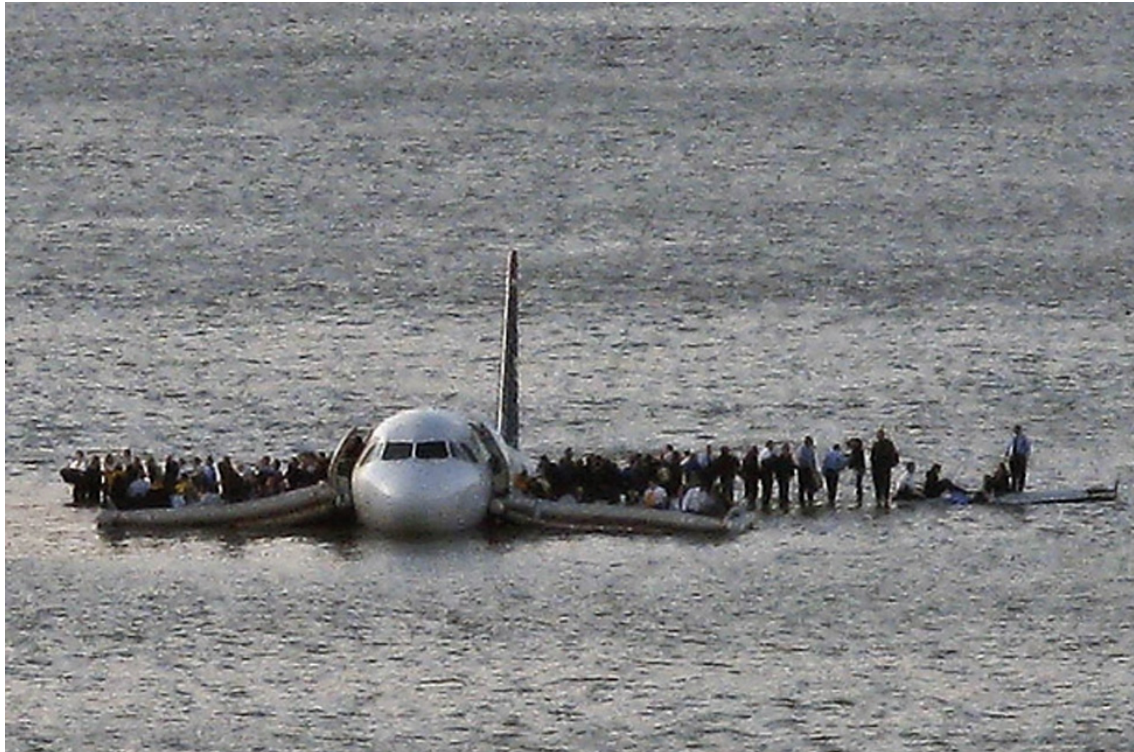
**Figure 2.** A photograph showing the airplane occupants on the wings and in the slide/rafts after the evacuation.

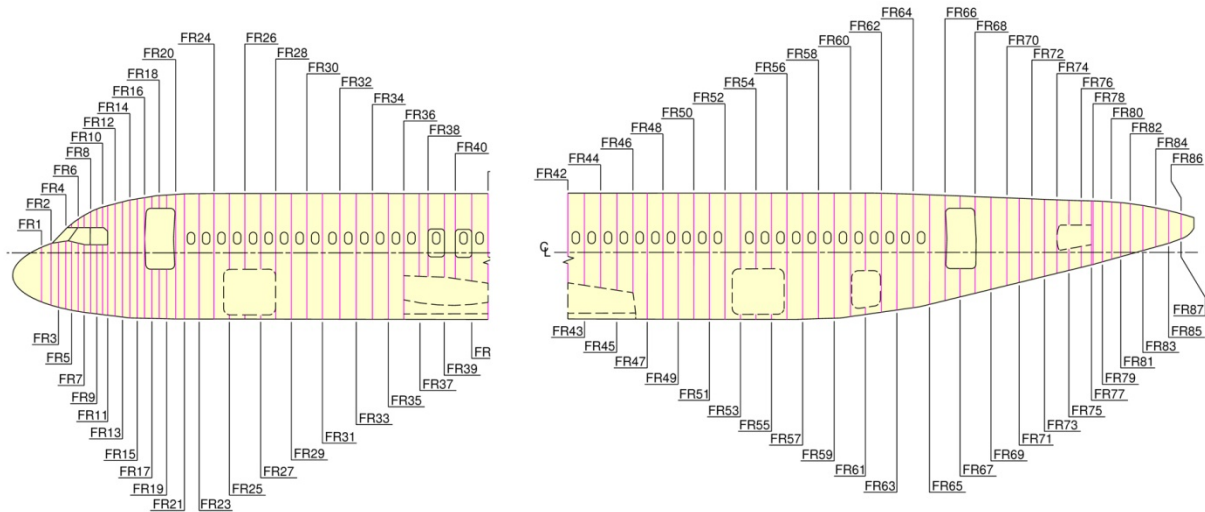
**Figure 6.** Diagram showing the A320 fuselage frame locations.

The crossbeams from FR66 aft were sheared in the aft direction, but the longitudinal seat tracks remained in position. The lower third of the aft pressure bulkhead was sheared away, and the lower part of the fuselage was torn in the aft direction. The tail cone, including the APU, was separated from its attachment points to the fuselage, except for the right-side lower location, and no longer retained its conical shape.

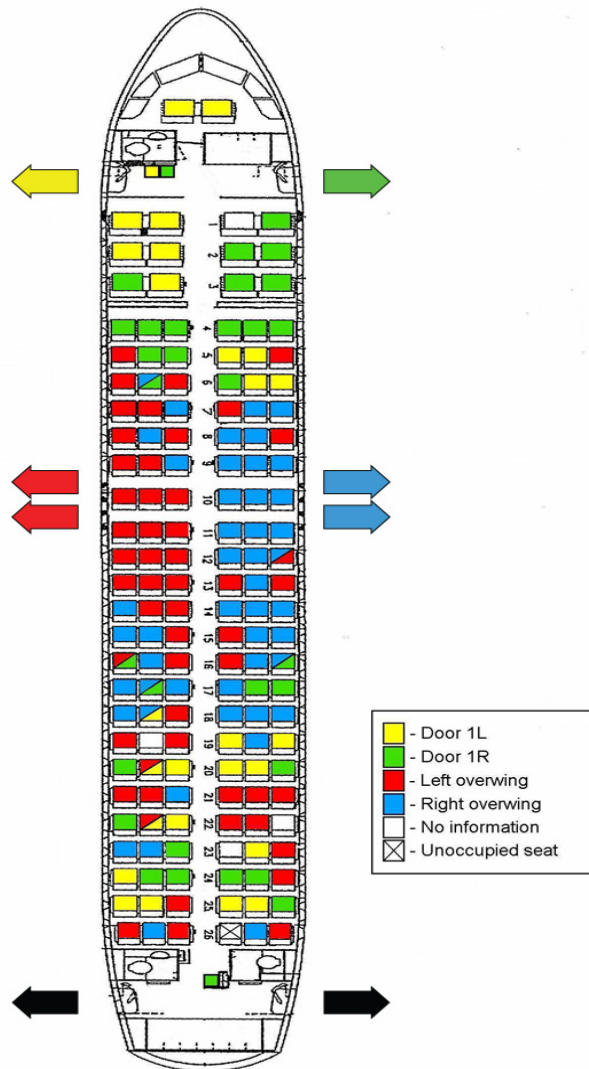
**Figure 9.** Occupant evacuation exit usage.

Note: Because of postevacuation passenger movement, the chart does not accurately indicate the locations where people were rescued. Additionally, several passengers exited the airplane, reentered, and exited the airplane a second time. These passengers' seat locations are designated with a '/'. The first exit used is represented by the upper color while the second exit is shown by the lower color.
