**In-Flight Separation of Vertical Stabilizer
American Airlines Flight 587
Airbus Industrie A300-605R, N14053
Belle Harbor, New York
November 12, 2001**

NTSB/AAR-04/04

**NTSB/AAR-04/04
PB2004-910404
Notation 7439B
Adopted October 26, 2004**

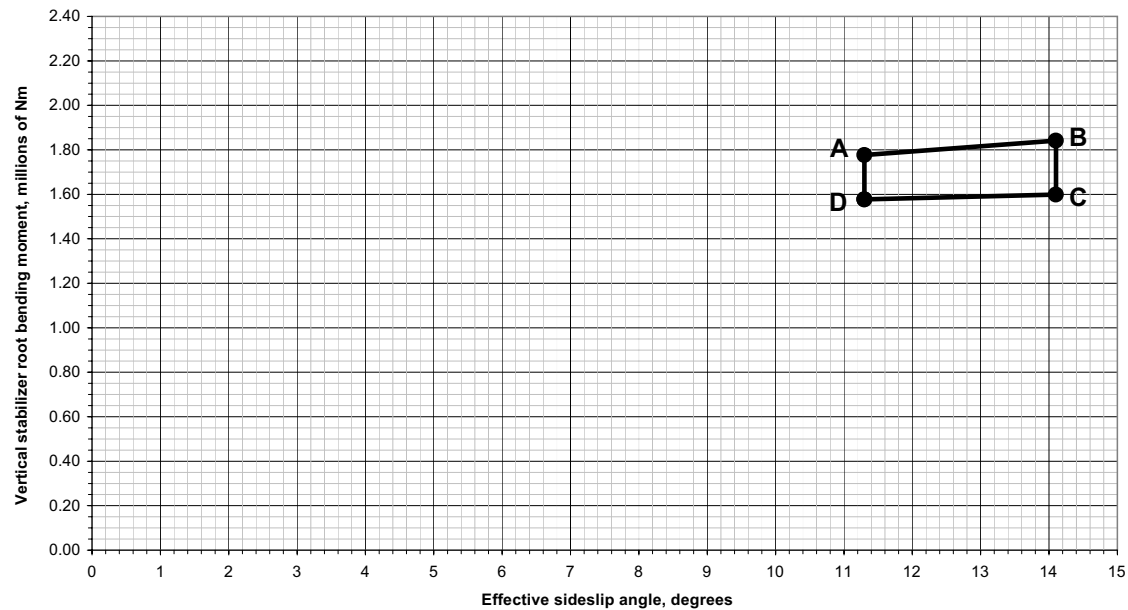
Figure 14. Bending Moment Load Range at the Time of Vertical Stabilizer Separation

The Safety Board was especially interested in determining the loads when the right rear main attachment lug fractured (0915:58.4). This time was established by the following:

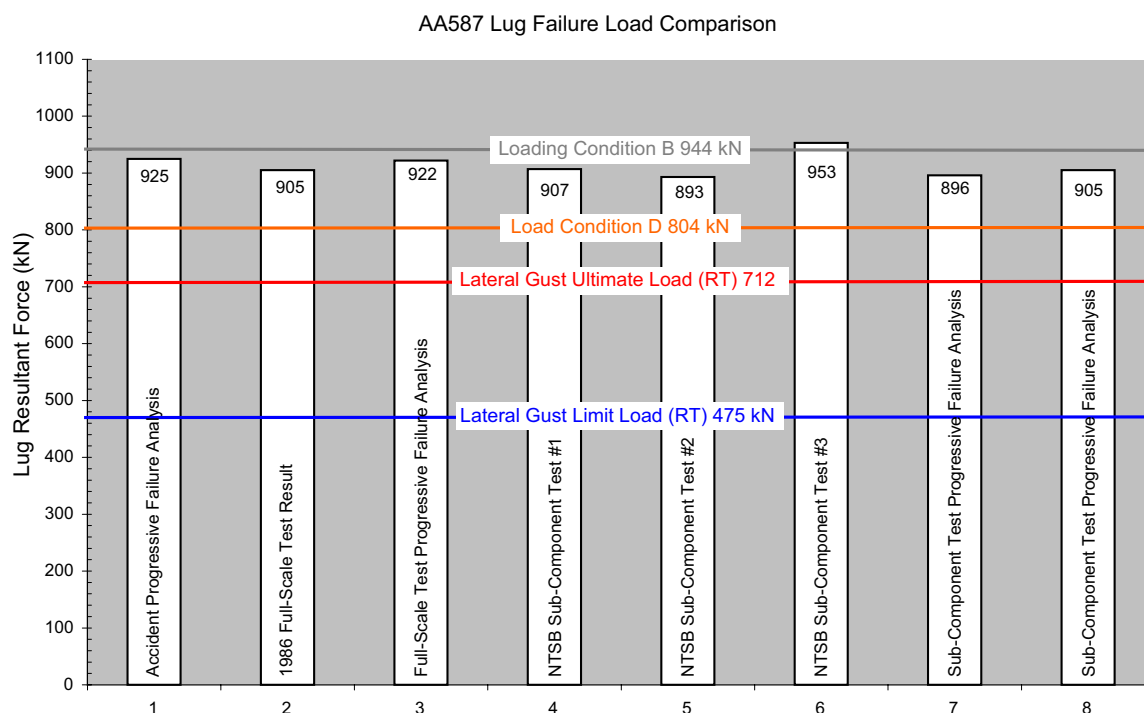
Figure 16. Comparison of Lug Forces at the Time of Fracture

NASA's and Airbus' FEA models determined that failure of the right rear main attachment lug was the most probable initial failure. The FEA models and NASA's PFA model also determined that the failure initiated at the final observed maximum vertical stabilizer root bending condition during the accident flight, when the vertical stabilizer

was subjected to a global root bending moment of more than two times the value defined by the limit load design envelope. (As previously stated, for certification, the vertical stabilizer is only required to support loads of 1.5 times limit load without catastrophic failure.) The structural analyses showed that the large aerodynamic loading produced by the accident scenario would result in the right rear main attachment lug experiencing reaction forces and associated stresses that were equivalent to those that produced lug fractures in the Airbus full-scale certification test (lateral gust condition) and the Safety Board's static lug tests. Figure 16 compares the resultant lug forces at the time of fracture for the tests and analyses that were pertinent to the flight 587 investigation.

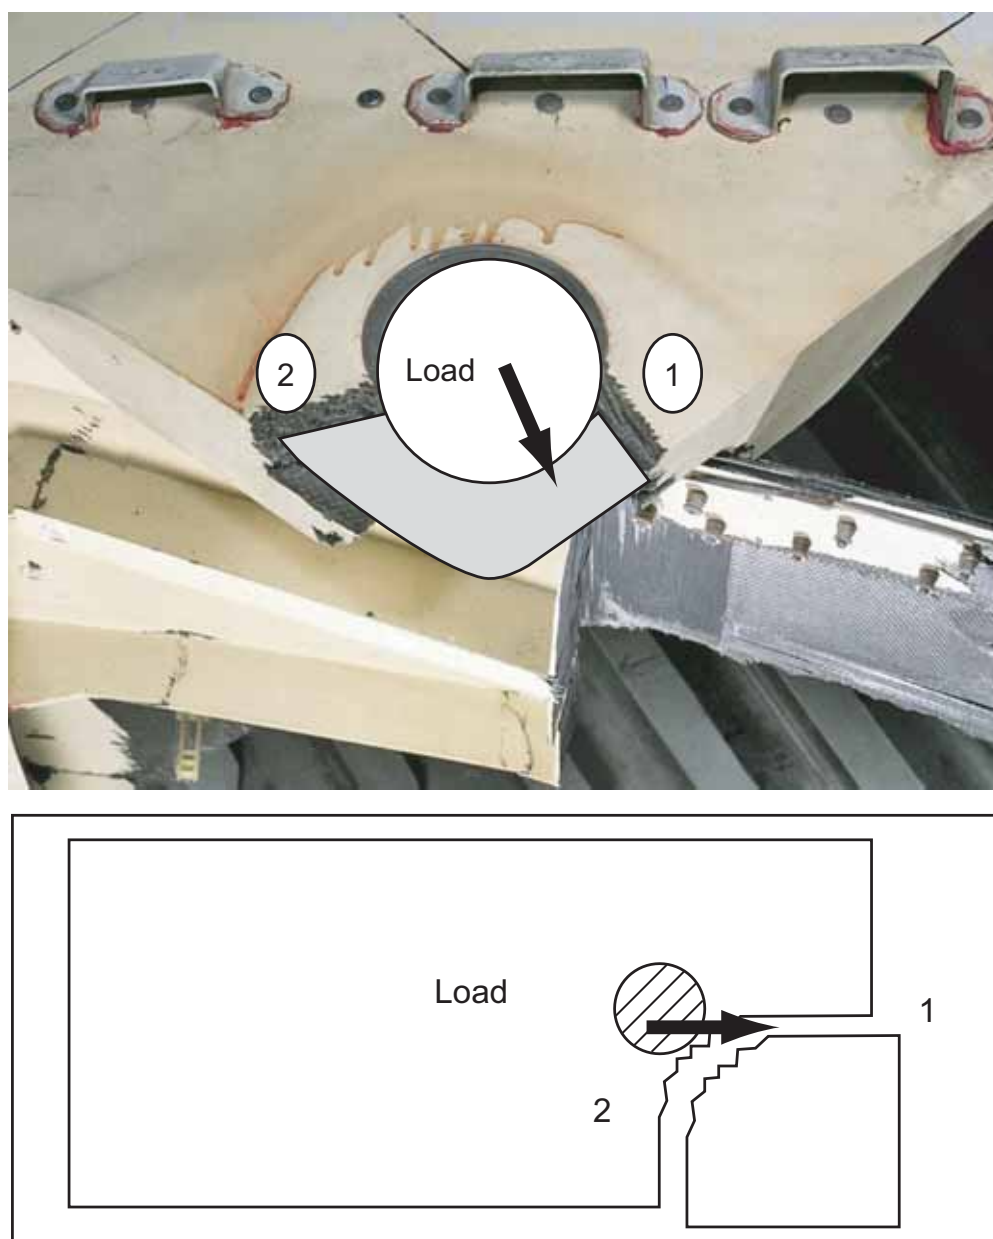
Figure 17. Load on the Flight 587 Right Rear Main Attachment Lug and a Depiction of the Cleavage-Tension Failure Mode

The stresses developed exceeded the strength values for the CFRP material used in the manufacturing of the lugs; thus, the accident lug and the tested lugs fractured because of a tensile static overload. The physical evidence and the structural analyses showed that the accident lug's and the tested lugs' fracture features were consistent with a cleavage-tension failure observed in composite-bolted joints. Figure 17 shows the load on the flight 587 right rear main attachment lug and a depiction of the cleavage-tension failure mode.

Note: Number 1 is the initiating fracture, and number 2 is the secondary fracture. The circle indicates the location of the pin and bushing, which were missing from the lug when it was found in the wreckage.
