# **NATIONAL TRANSPORTATION SAFETY BOARD**

## **AIRCRAFT ACCIDENT REPORT**

**DELTA AIR LINES, INC.,  
LOCKHEED L-101 1-385-1, N726DA  
DALLAS/FORT WORTH -  
INTERNATIONAL AIRPORT, TEXAS  
AUGUST 2, 1985**

**NTSB/AAR-86/05**

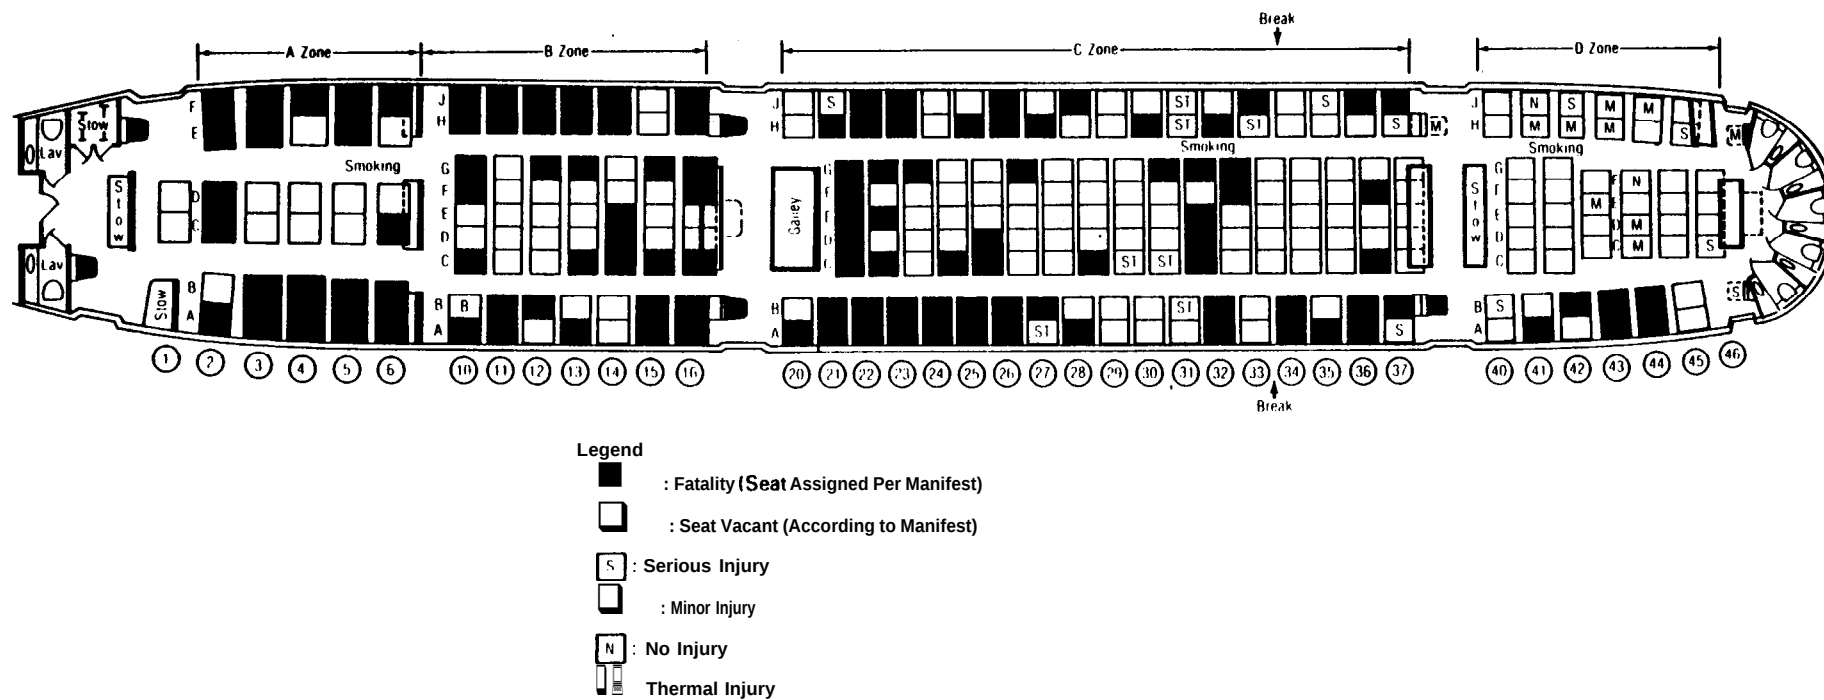
Except for the left cabin wall, which was missing, the remainder of the separated rear cabin section from row 40 aft to row 46 was relatively undamaged. Six passengers seated along the missing left cabin wall were killed. The remaining 16 occupants of this cabin section, including 2 flight attendants, sustained serious and minor injuries, and 2 passengers were not injured.

Figure 3.--L-1011 cabin seat diagram.
